NRC Presentation Current Status of the Arkansas Nuclear One Unit One Steam Generators

Entergy/AREVA NP December 2009

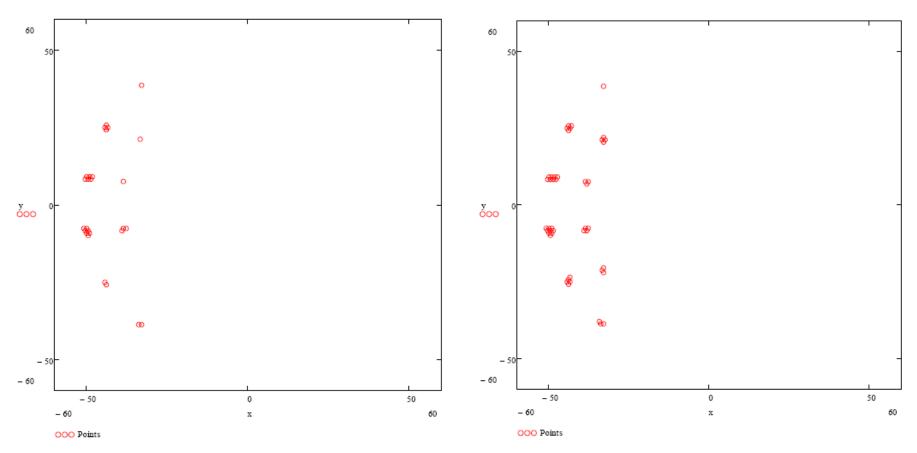
Figure 3-1: Tubesheet Map of Proximity Signal Locations, 1R20

Figure 3-2: Tubesheet Map of Proximity Signal Locations, 1R21

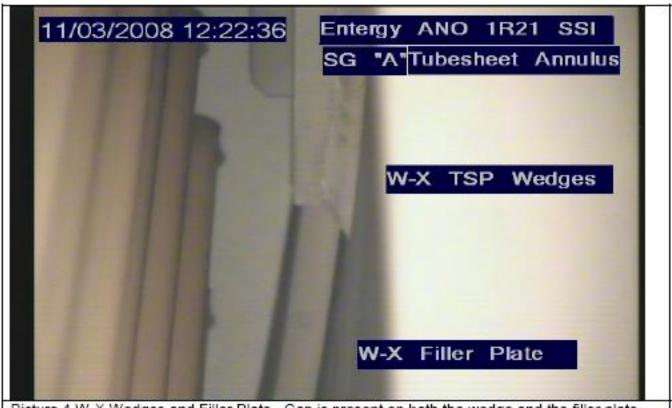
<u>Picture 4 W-X Wedges and Filler Plate.</u> Gap is present on both the wedge and the filler plate. Gap between the TSP and filler plate is larger than between the filler plate and the shroud.

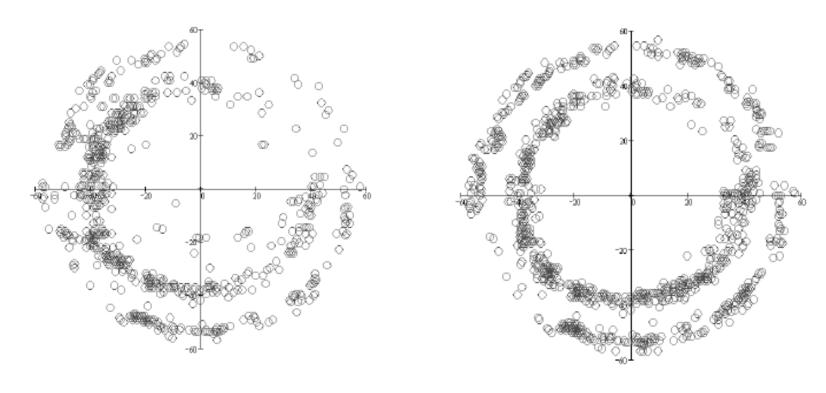
1R20 - SGA

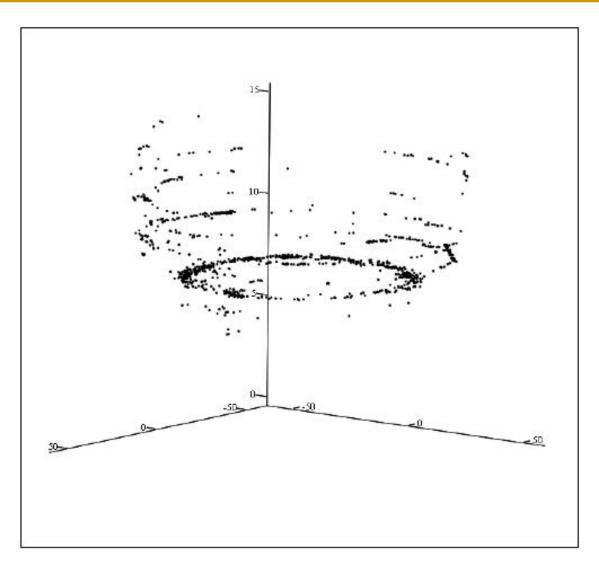
SGA - 1R21

SGA	SGB
Total Number of Tubes examined	15595	15596
# of Wear Indications	990	1029
# of Tubes with Wear	913	823
% of Tubes with Wear	5.85%	5.28%
# New Wear Indications	524	685
# Repeat Wear Indications	466	344
New Average Depth	7.6%TW	8.2%TW
New + Repeat Average Depth	7.7%TW	9.1%TW
Maximum Depth	32%TW	32%TW
# of Indications > 40% TW	0	0
# of Indications ≥ 20% but ≤ 39%	13	30
# of Indications > 1% but < 19%	977	999
New+Repeat Average Growth	2.84 %TW/EFPY	4.34 %TW/EFPY
95/50 Growth (New Indications)	8.56 %TW/EFPY	9.99 %TW/EFPY
95/50 Growth (Repeat Indications)	3.57 %TW/EFPY	5.71 %TW/EFPY
Max Growth (New Indications)	22.11 %TW/EFPY	19.97 %TW/EFPY
Max Growth (Repeat Indications)	15.69 %TW/EFPY	14.27 %TW/EFPY
# Tubes Plugged	8	5

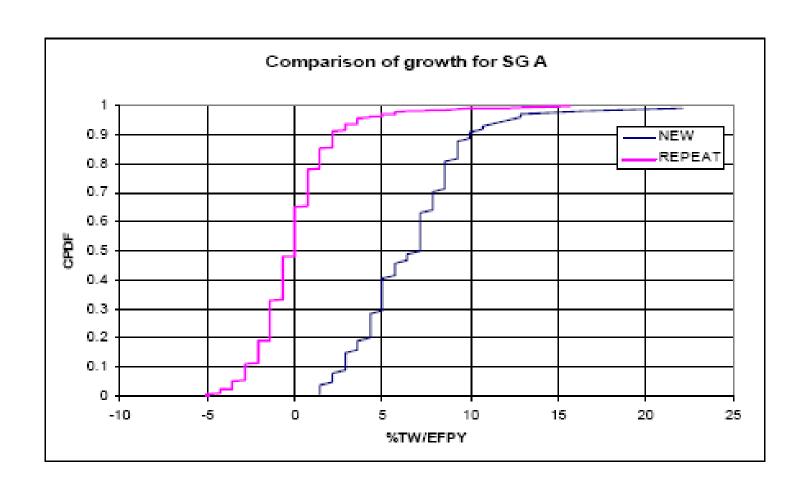
TSP Wear Growth Rate

Growth Rate Data from 1R21

New+Repeat Average Growth	2.84 %TW/EFPY	4.34 %TW/EFPY
95/50 Growth (New Indications)	8.56 %TW/EFPY	9.99 %TW/EFPY
95/50 Growth (Repeat Indications)	3.57 %TW/EFPY	5.71 %TW/EFPY
Max Growth (New Indications)	22.11 %TW/EFPY	19.97 %TW/EFPY
Max Growth (Repeat Indications)	15.69 %TW/EFPY	14.27 %TW/EFPY
