SUMMARY REPORT OF  
REINSPECTION AND APPRAISAL OF THE INDIAN POINT NO. 3  
REACTOR PRESSURE VESSEL SUBSEQUENT TO HOIST  
FAILURE ON JANUARY 12, 1971

D. A. Canonico      R. W. McClung  
J. G. Merkle

Summary Report of ORNL Consulting Services to  
Consolidated Edison Company of New York, Inc.  
per  
Consultant Contract OIC-C-45

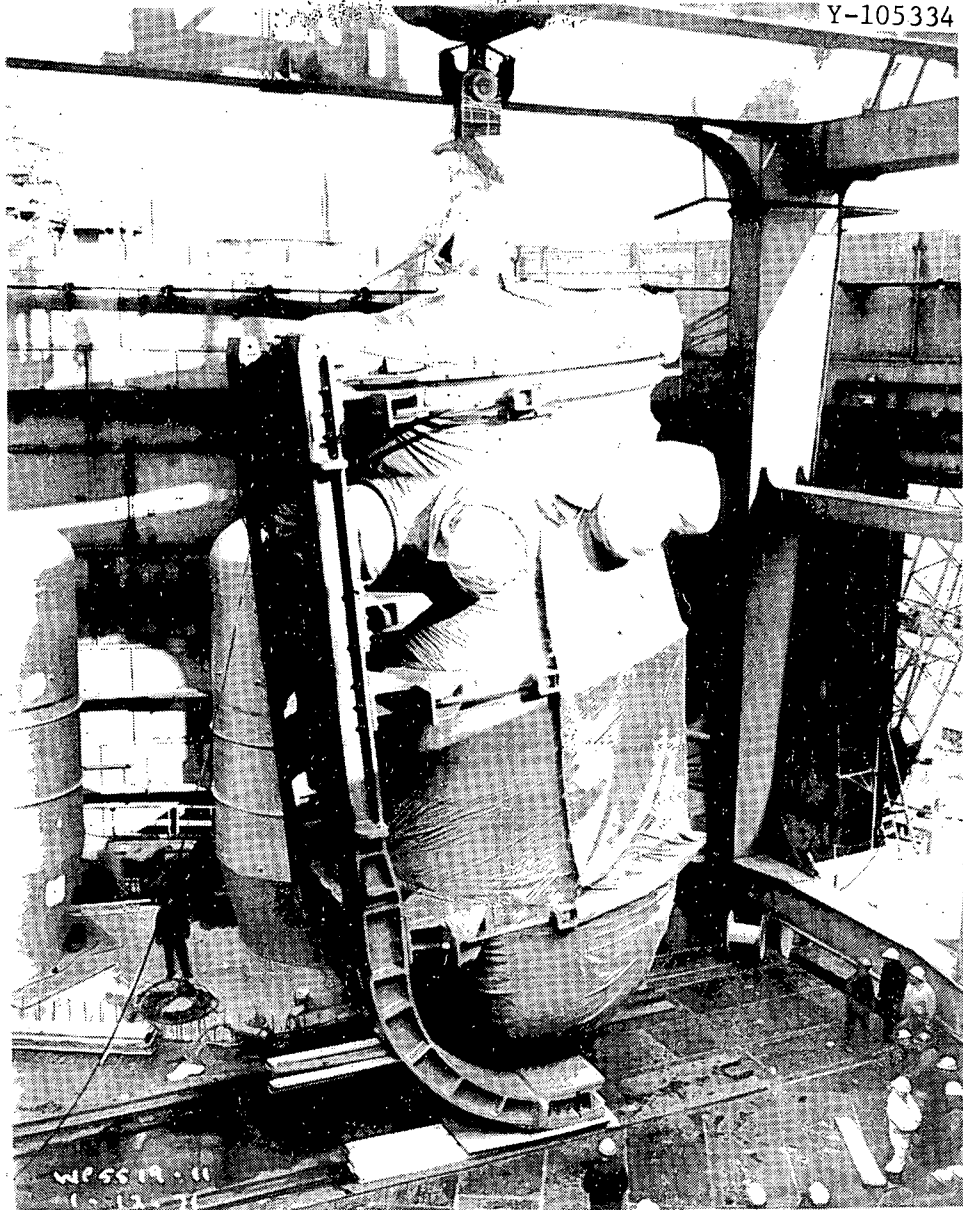
During hoisting, photographs were made showing the vessel at various stages of ascent up to about an 85° angle with the horizontal. This position of the vessel and shipping sled is shown in Fig. 2. When the vessel was raised to about 85° angle, the hoist motor in the crane overheated

Fig. 2. Vessel and Shipping Rig at About 85° Elevation. At this position the lifting operation was halted to allow the crane motors to cool. Vessel, crane hook, shipping rig, and covers weigh about 456 tons.

and hoisting was subsequently halted. When hoisting was restarted, the vessel and its skid fell back to the horizontal position and close to their original location on the floor. The incident was caused by the failure of the hoist.

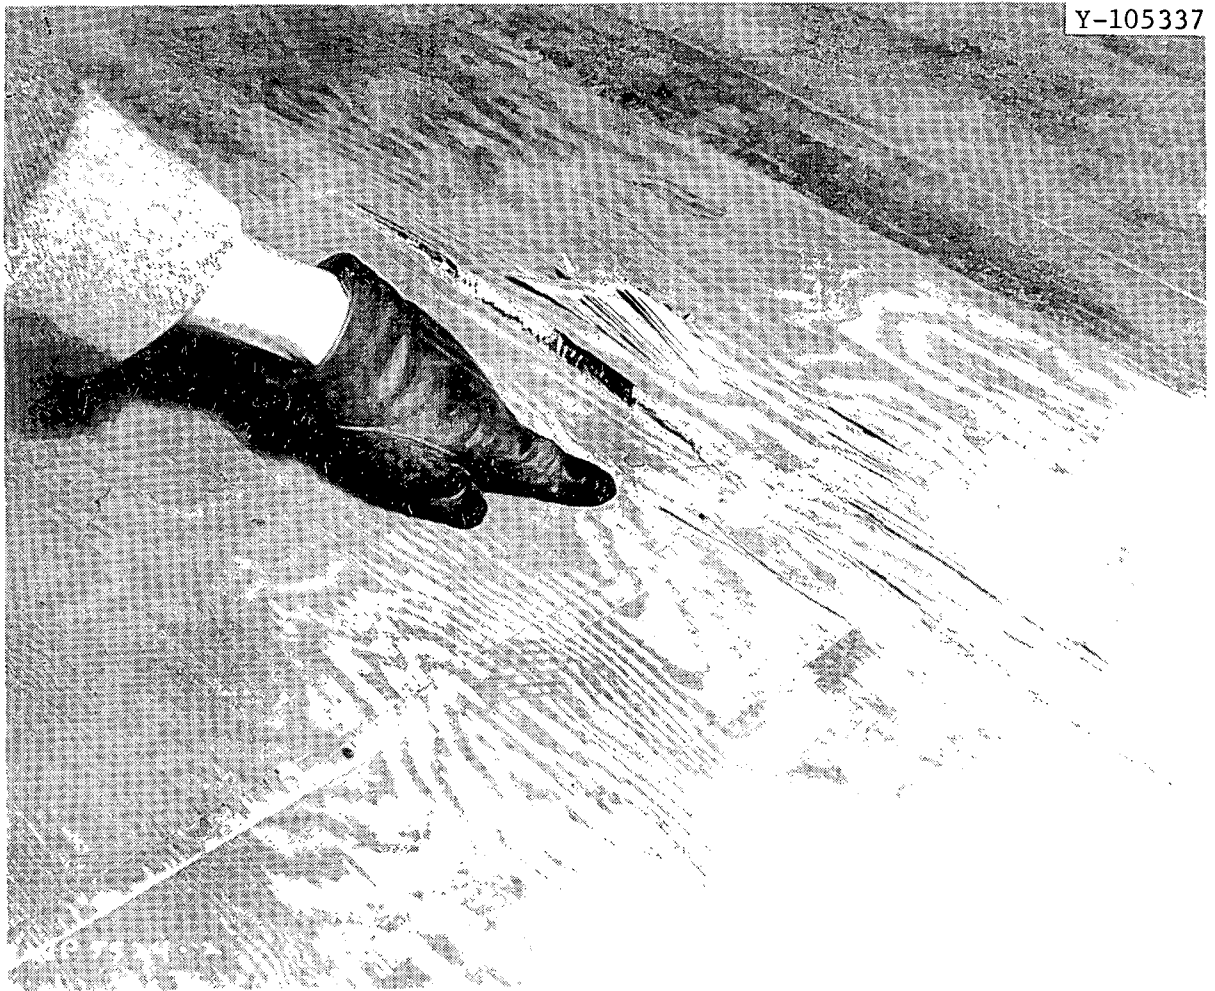
A photograph (Fig. 3) of the plywood sheet which was under one of the "runners" of the shipping rig revealed a set of circular indentations due to the sled runners and a second set of less-distinct marks about 1 ft behind the first. This evidence indicates that the vessel may have just begun to leave the floor (at which time the crane was bearing the full load) when the crane failure occurred. This would have resulted in the slight skip backward. The vessel then realigned itself in the horizontal position. The wire ropes that were attached to the hoist (and, consequently, hoist house) dragged the operator's cabin as the vessel realigned itself. The cabin could have acted as a brake.

Fig. 3. Plywood That Rested Below Front "Runners" of Shipping Rig (see Fig. 2). Note circular indentations caused by bolt holes in shipping rig (see Fig. 1). Double set of indentations indicate vessel plus shipping rig was off the ground.

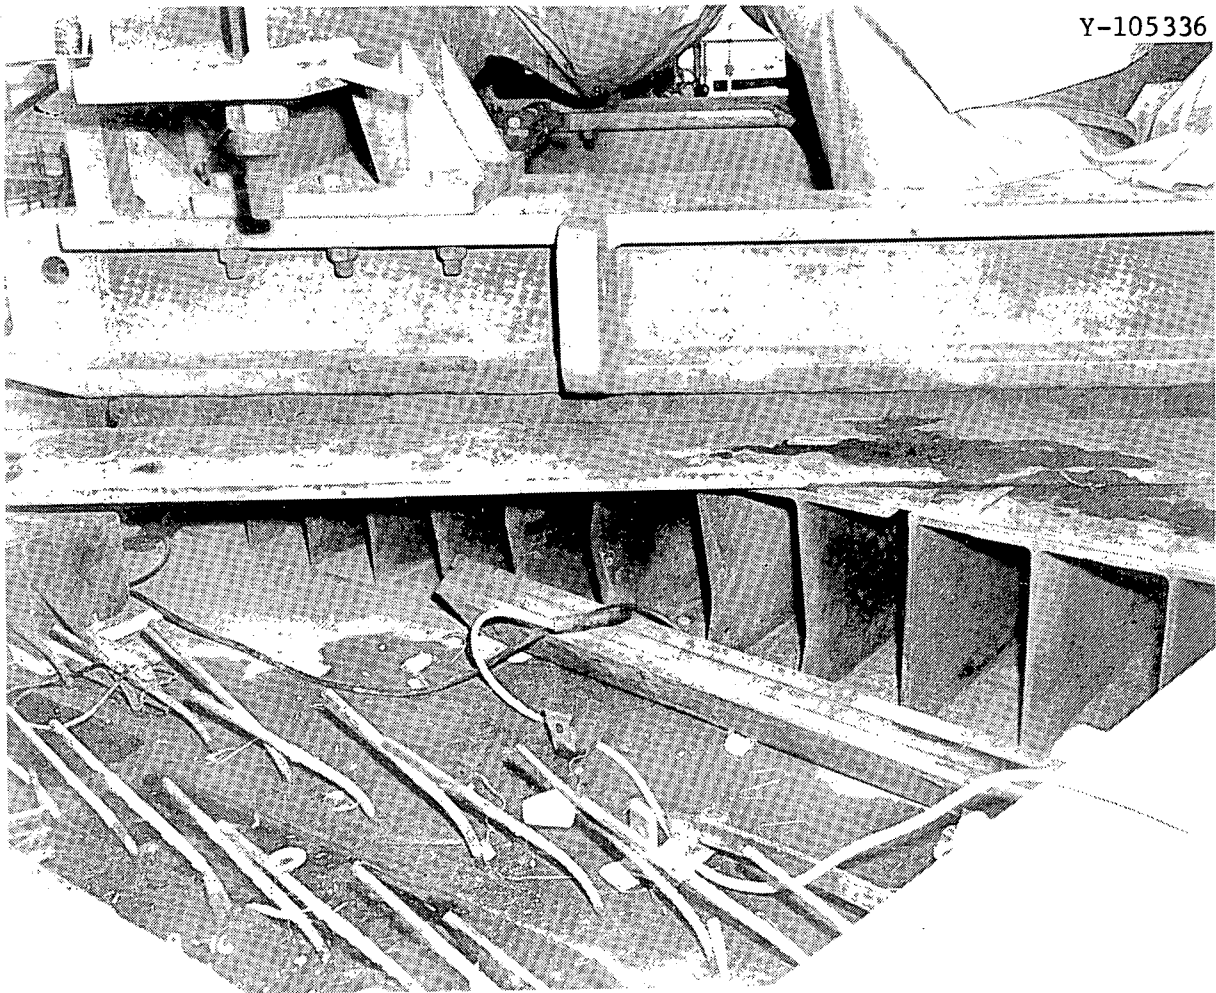
The vessel descended to the left of its original position. One track (channel) was flattened. The only obvious structural deformation occurred in the six 24-in.-wide flange beams buckled in the area on which the upper left portion of the vessel came to rest (Fig. 4). The deformation is in the web portion and was instrumental in permitting the estimation of stress required in the structural evaluation (Sect. 4).

Fig. 4. Buckled Wide Flange Beams at Top Left (as viewed from bottom) of Vessel. The shipping rig "runner," 1 1/2-in.-thick plate is evident. The webs of six beams were buckled for a distance of about 5 to 6 ft. The shipping rig extended beyond the support floor at this location.

As estimate of the impact stresses in the vessel was made by calculating the load required to buckle the webs of the six wide-flange beams found buckled directly beneath the vessel. The calculated load was 1800 tons, which is about four times the weight of the vessel plus the skid. Assuming that this load was carried entirely by the thinnest part of the vessel, which is the cylindrical core region, the calculated maximum bending stress is 11,600 psi, which is far below the yield stress. Using this calculated stress, and assuming that the fracture toughness is the minimum dynamic fracture toughness of the midplate material, leads to a critical flaw size of 3.72 in.

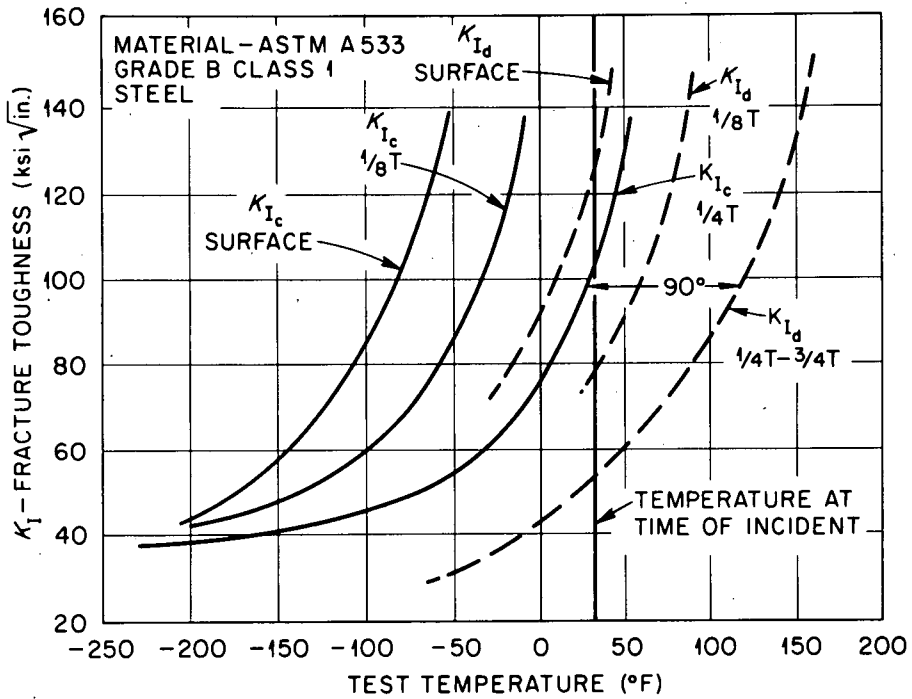
Figure 1 Fracture Toughness vs Temperature.

The impending accident resulted in the vessel being stressed at a rate somewhere between the static and dynamic conditions considered in Fig. 1. A reasonable value can probably be obtained by assuming a fracture toughness value somewhere between these two extremes. An average, such as that obtained with the following equation, will probably provide reasonably accurate values for the fracture toughness of the vessel at the time of the accident.

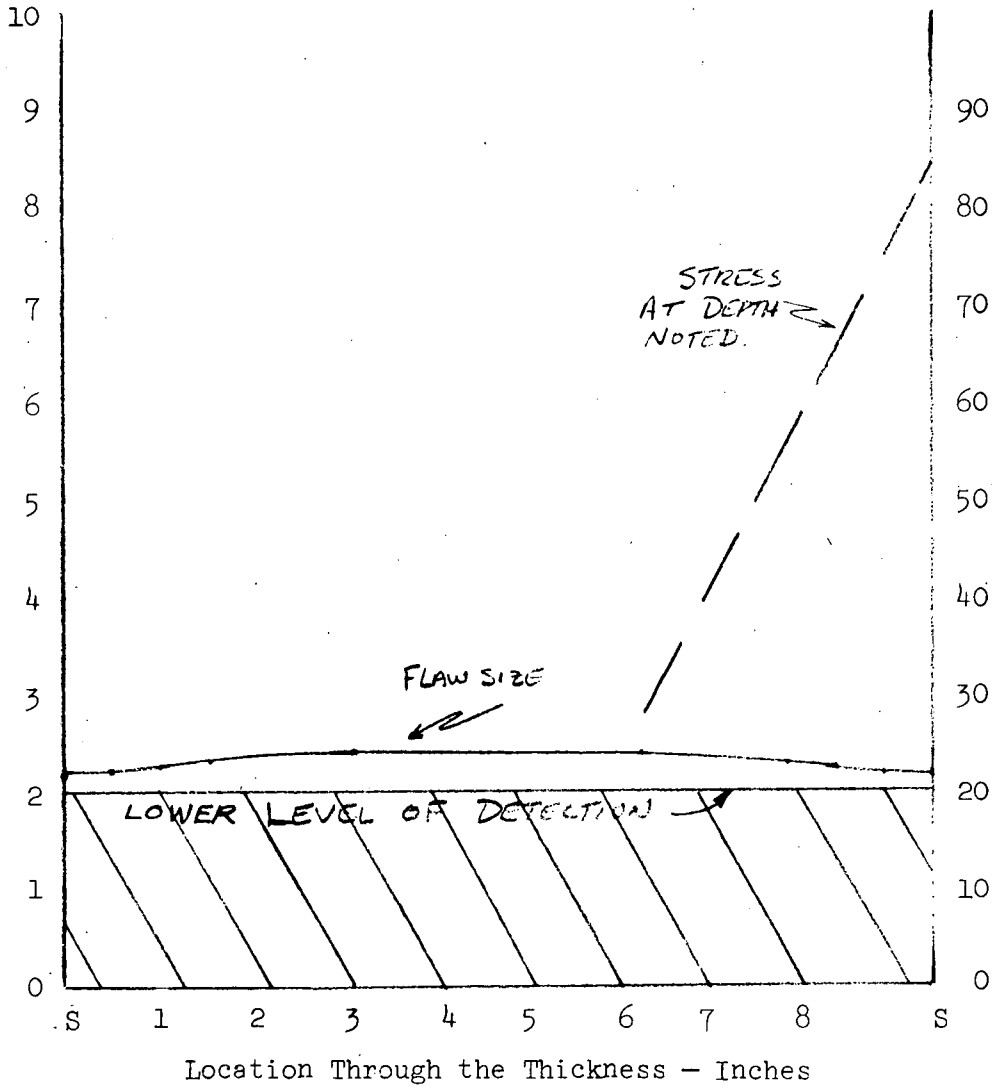
Figure 2

Flaw Size to Cause Failure at Various Depth Locations  
in the Indian Point III Reactor Pressure Vessel  
Upending Accident

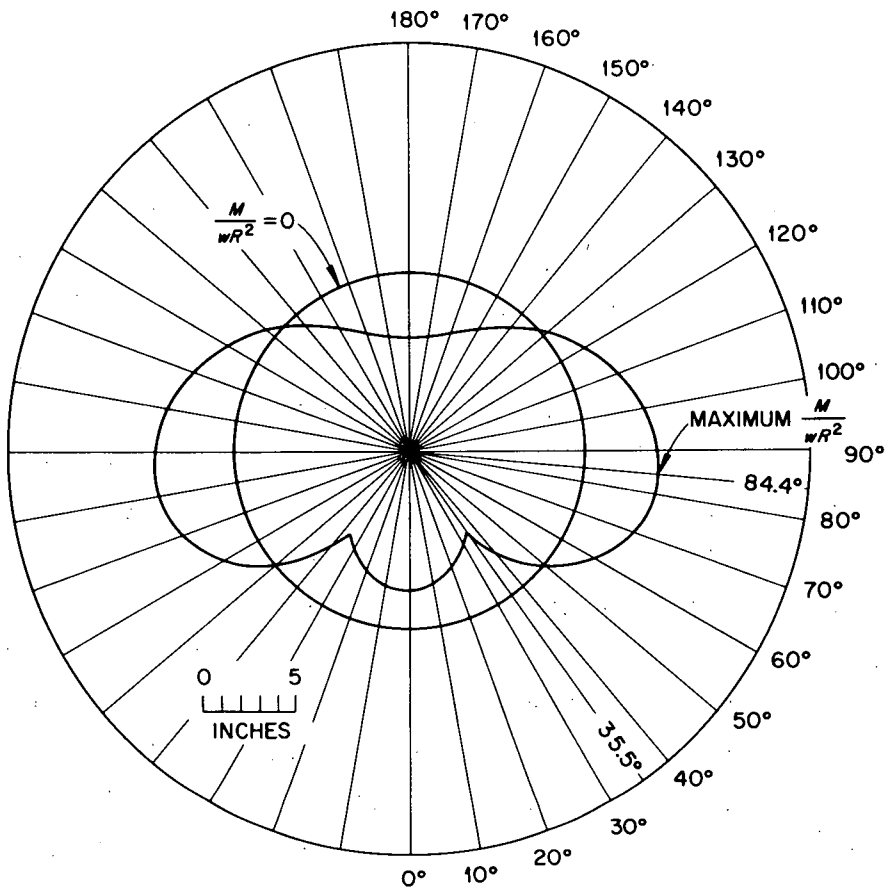
Figure 3 Polar Plot of  $\left(\frac{M}{wR^2}\right)$ .

c) Stress analysis. The stresses calculated are due to bending only. Some through thickness stresses do exist, but they are small compared to the bending stresses. A polar plot of the maximum bending stresses is shown in Fig. 3, with the direction of plotting from the zero line indicating the surface of the vessel at which the bending stress is tensile. The maximum calculated bending stress is 11,600 psi, and it occurs on the outside surface of the vessel, at an angle of  $84.4^{\circ}$  from the lower part of the vertical centerline. The maximum bending stress directly beneath the skid supports is almost the same in magnitude, 11,000 psi, and it is tensile on the inside surface.
