Crystal River Unit #3 Containment Investigation and Repair

June 30, 2010

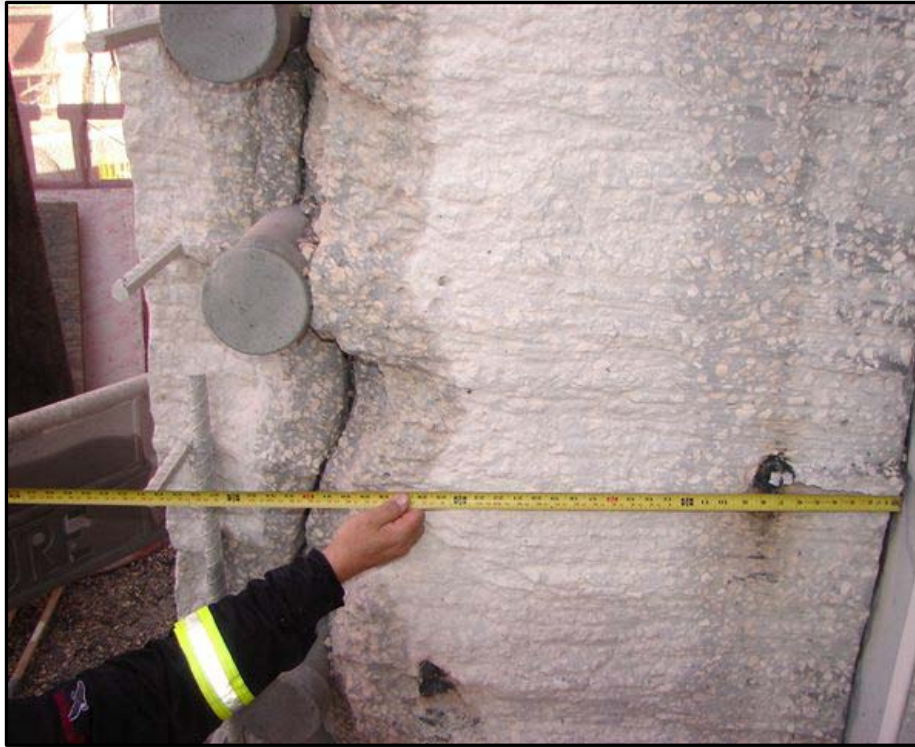
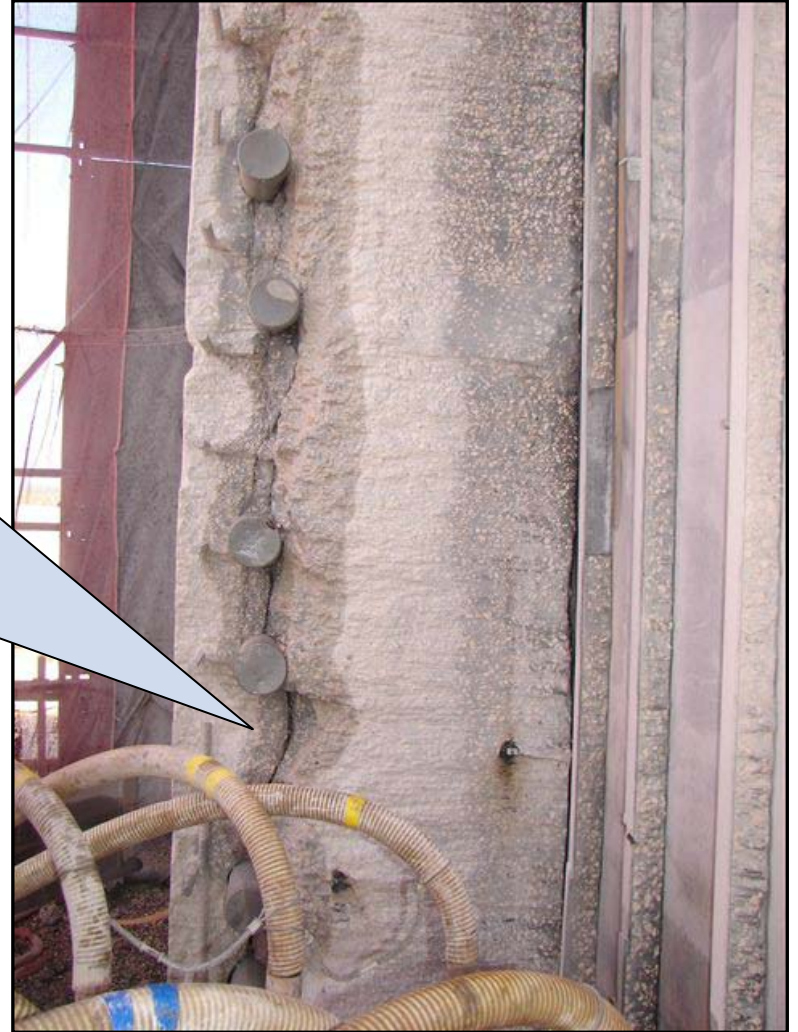
Delamination Close-up

Location of the Delamination

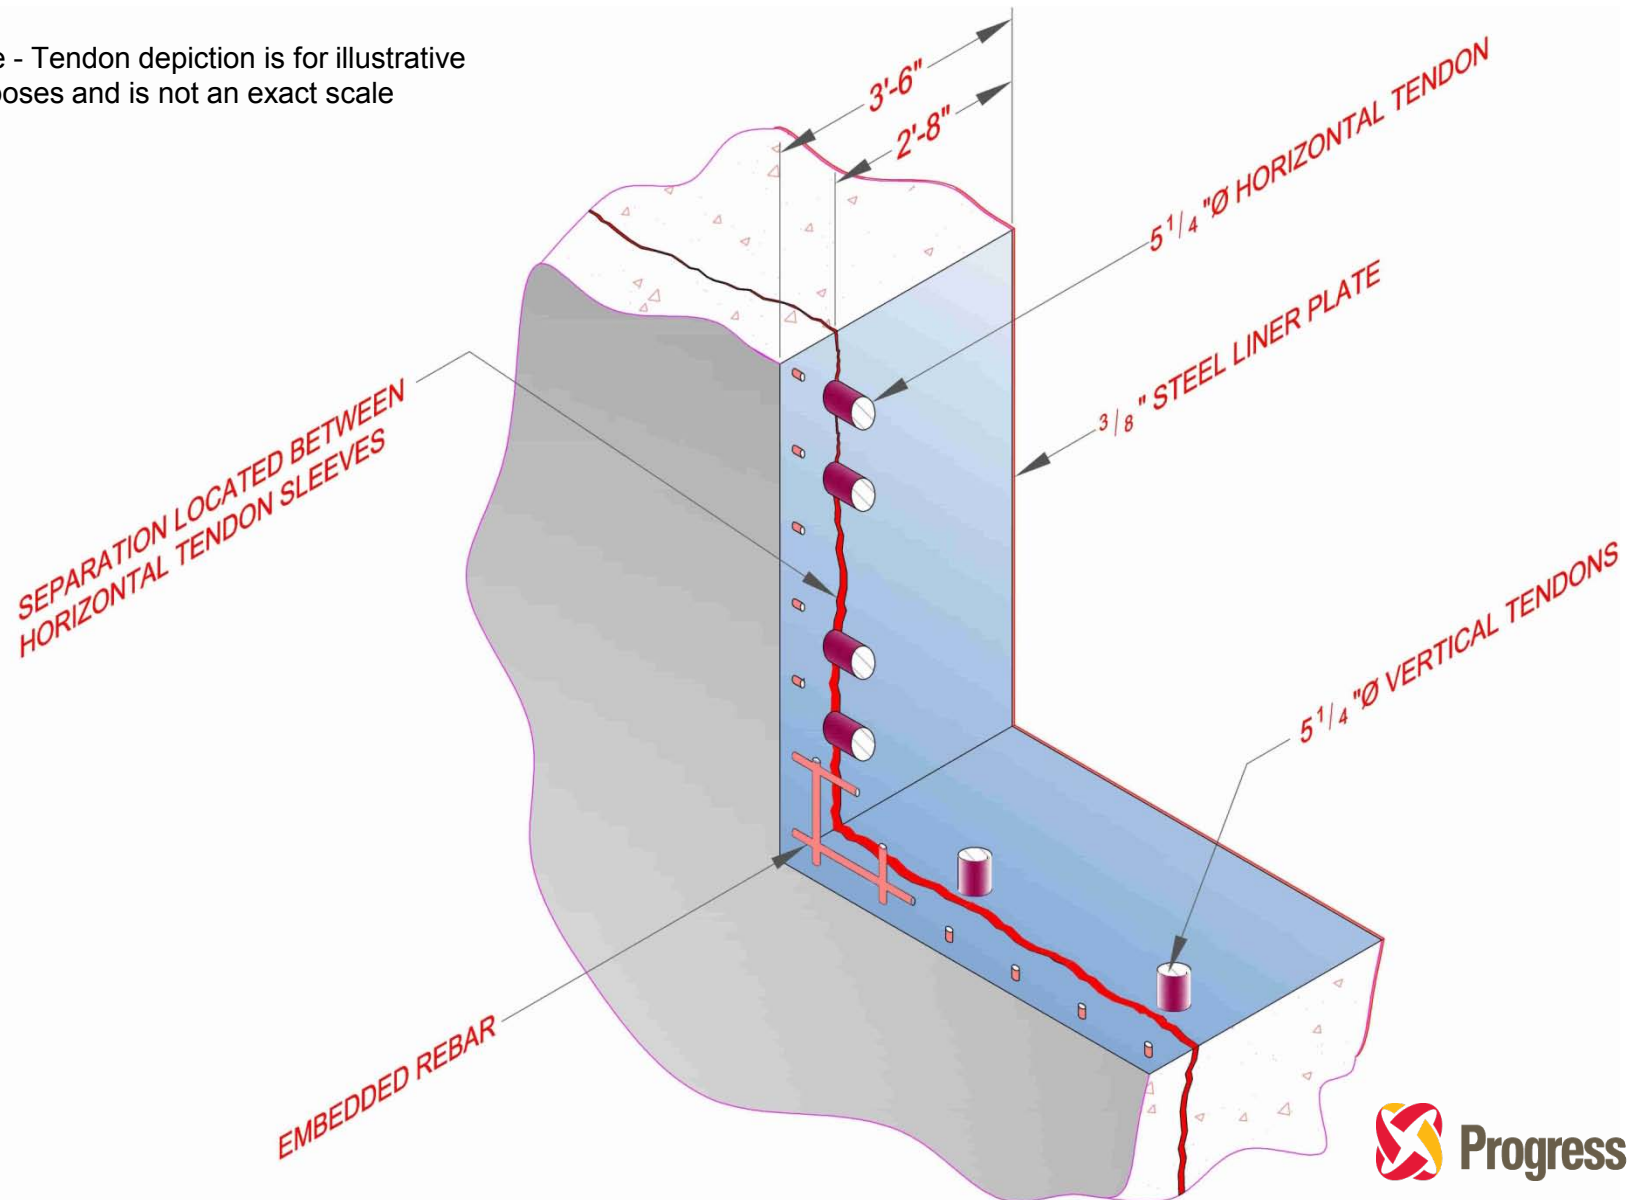
Note - Tendon depiction is for illustrative purposes and is not an exact scale

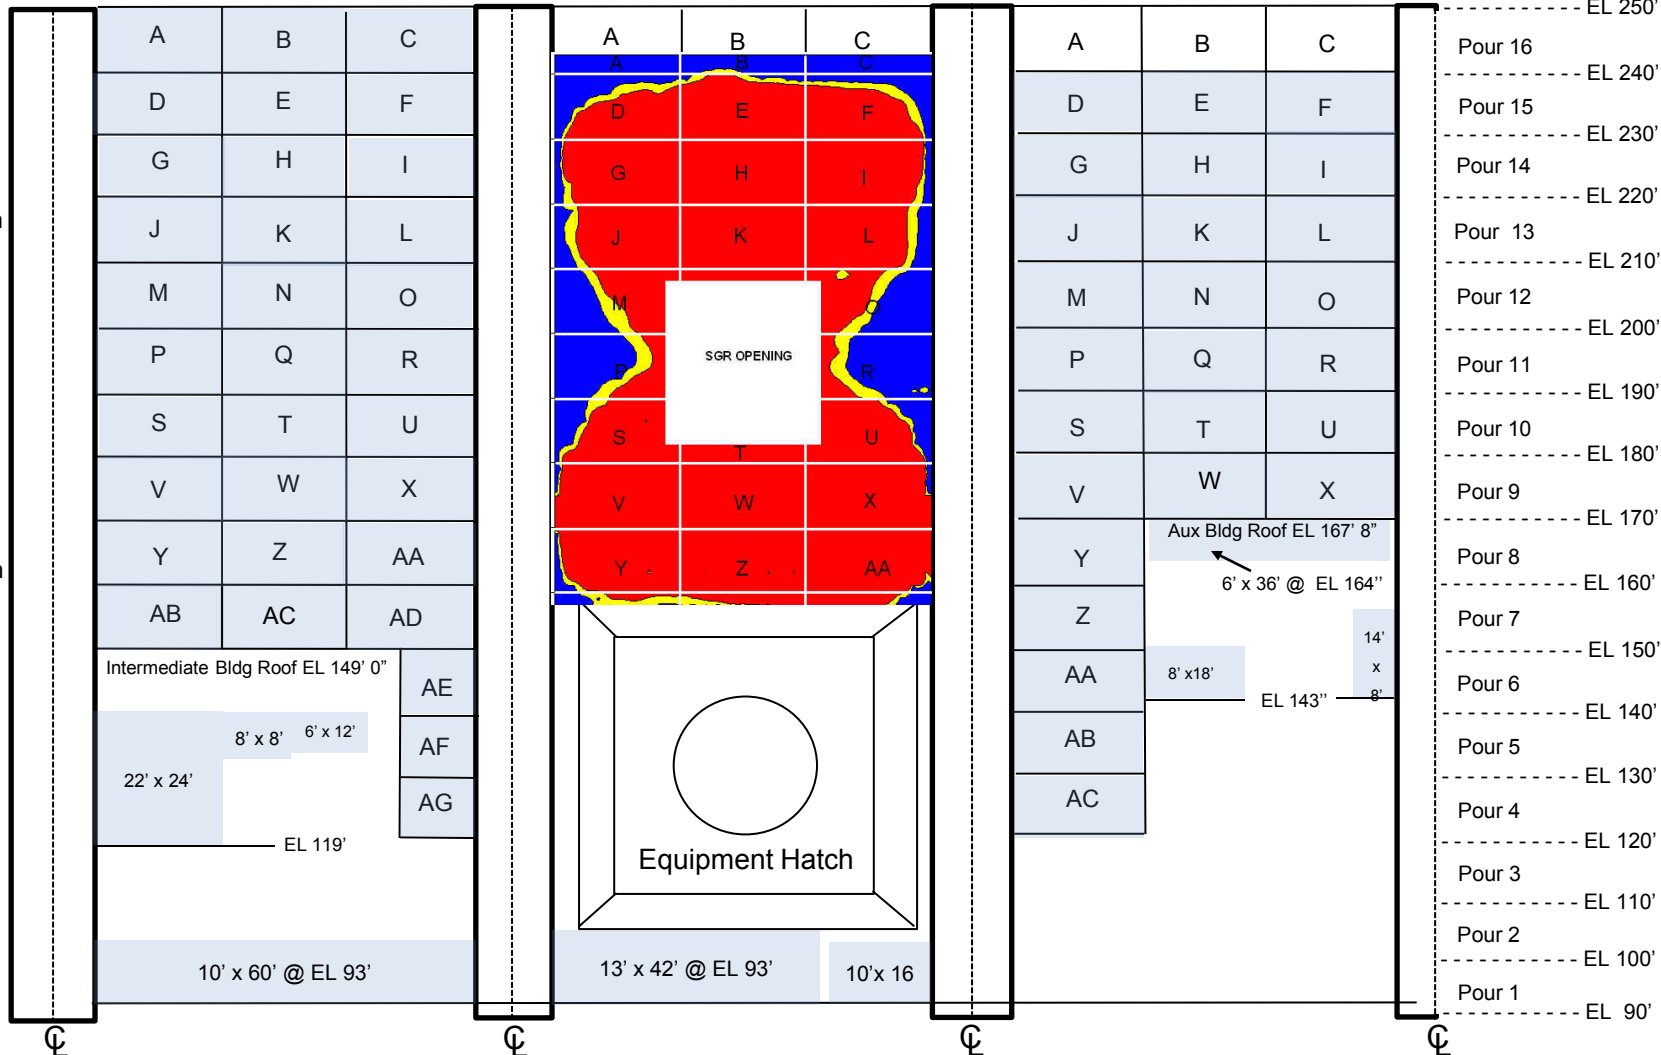
Containment "Unfolded" – Buttress 2 to 5

Actual IR scan output data:
Blue = no delamination
Yellow = transition
Red = delaminated

Conclusion – IR scans with confirmation core bores identified delamination only in the Buttress 3-4 span above the Equipment Hatch, as shown in red above

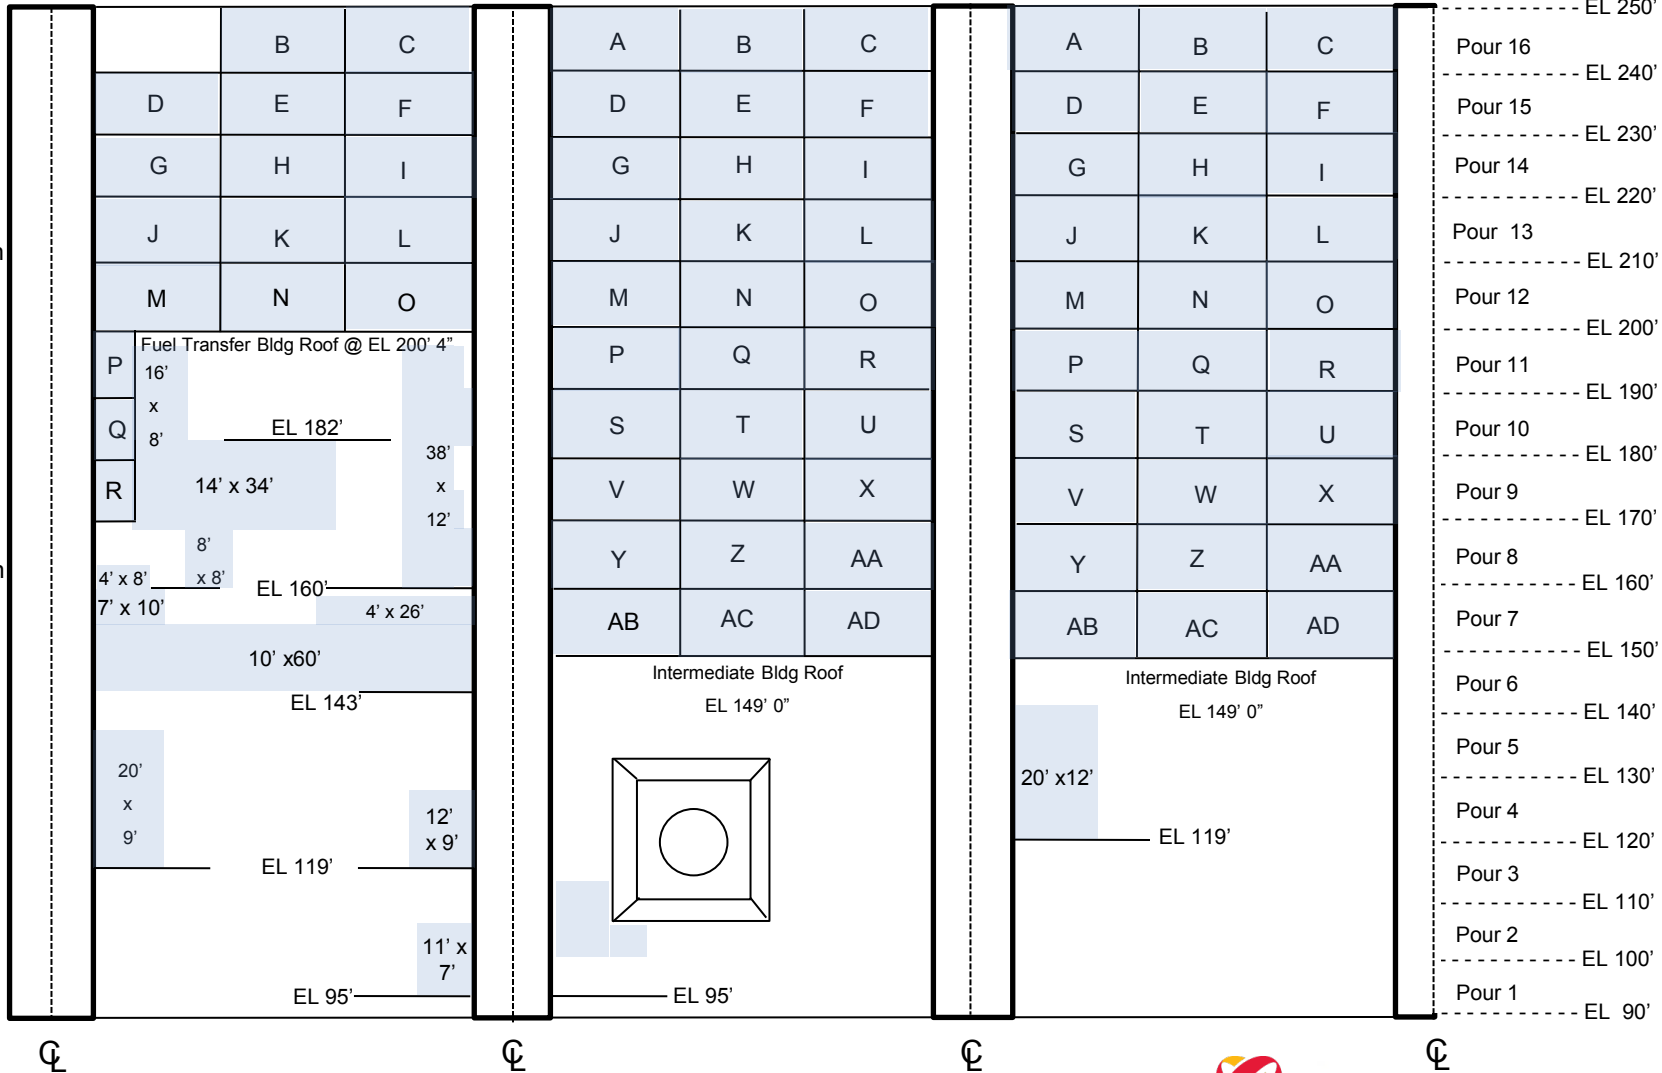
Containment "Unfolded" – Buttress 5 to 2

Conclusion – No delamination identified in these Buttress spans

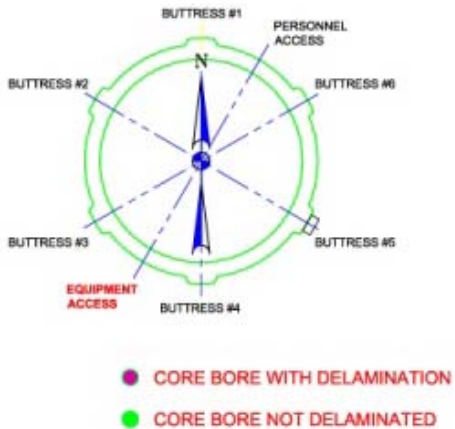
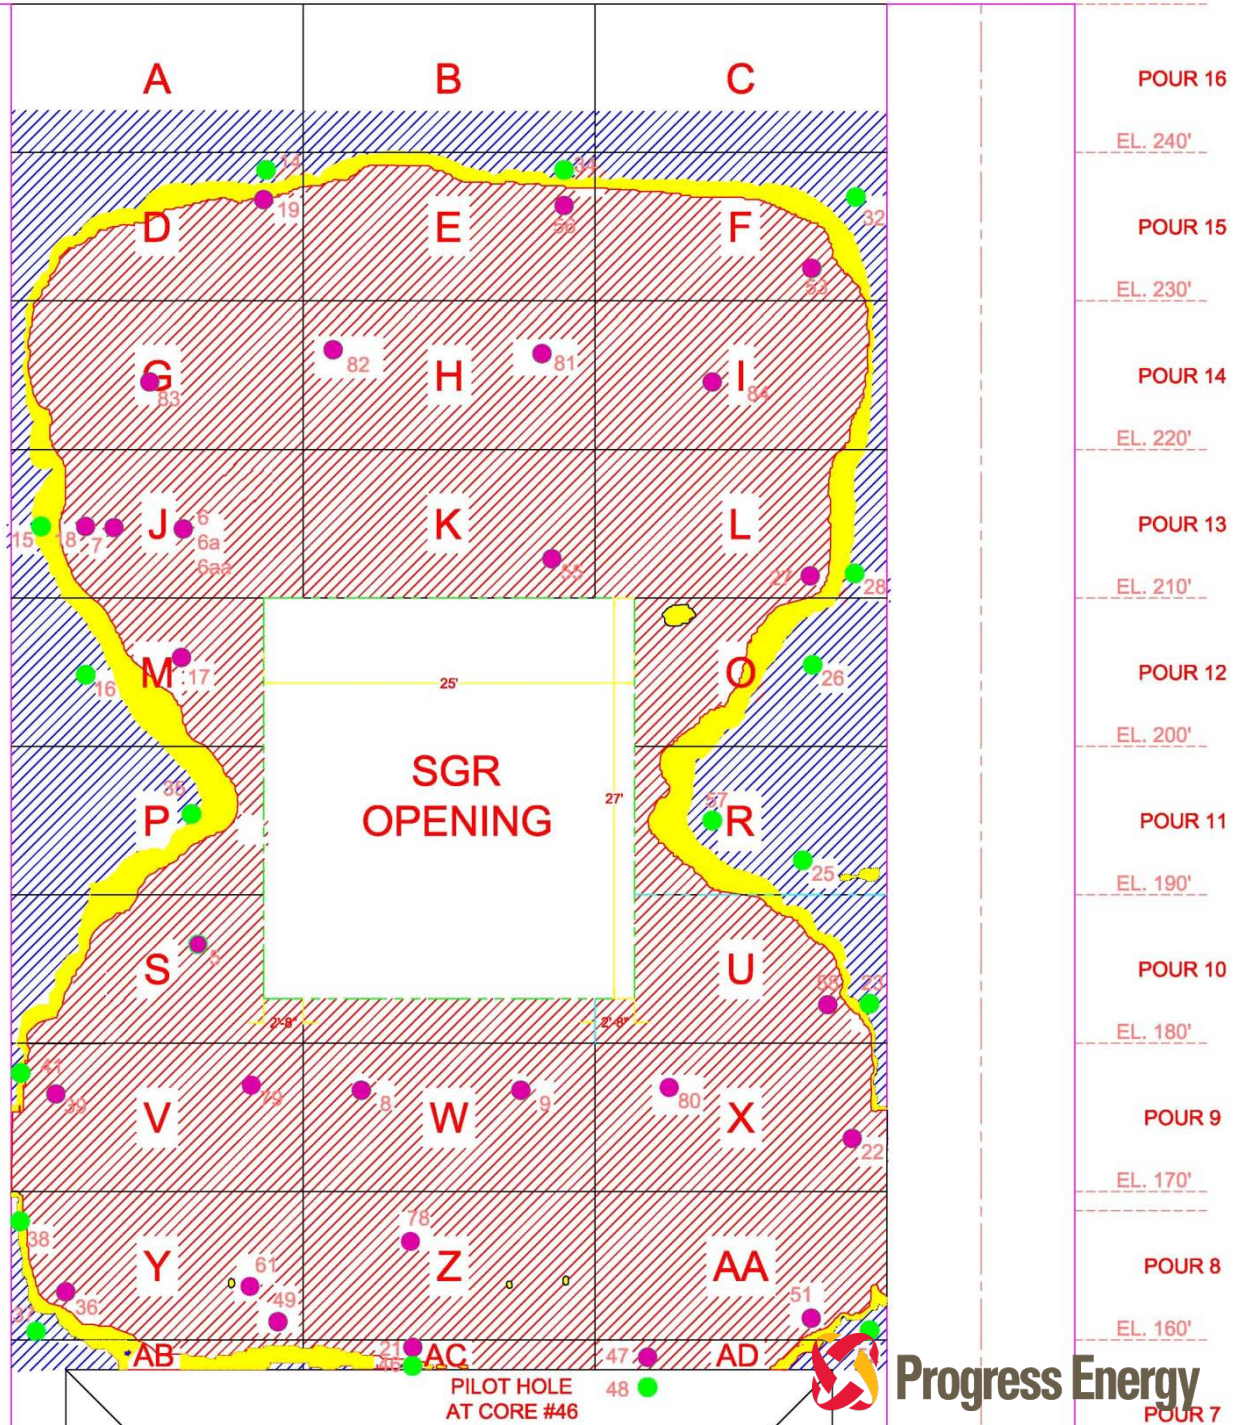
Core Borings

Conclusion – Physical observation of core boring has validated the delamination boundary, as accurately predicted by IR.

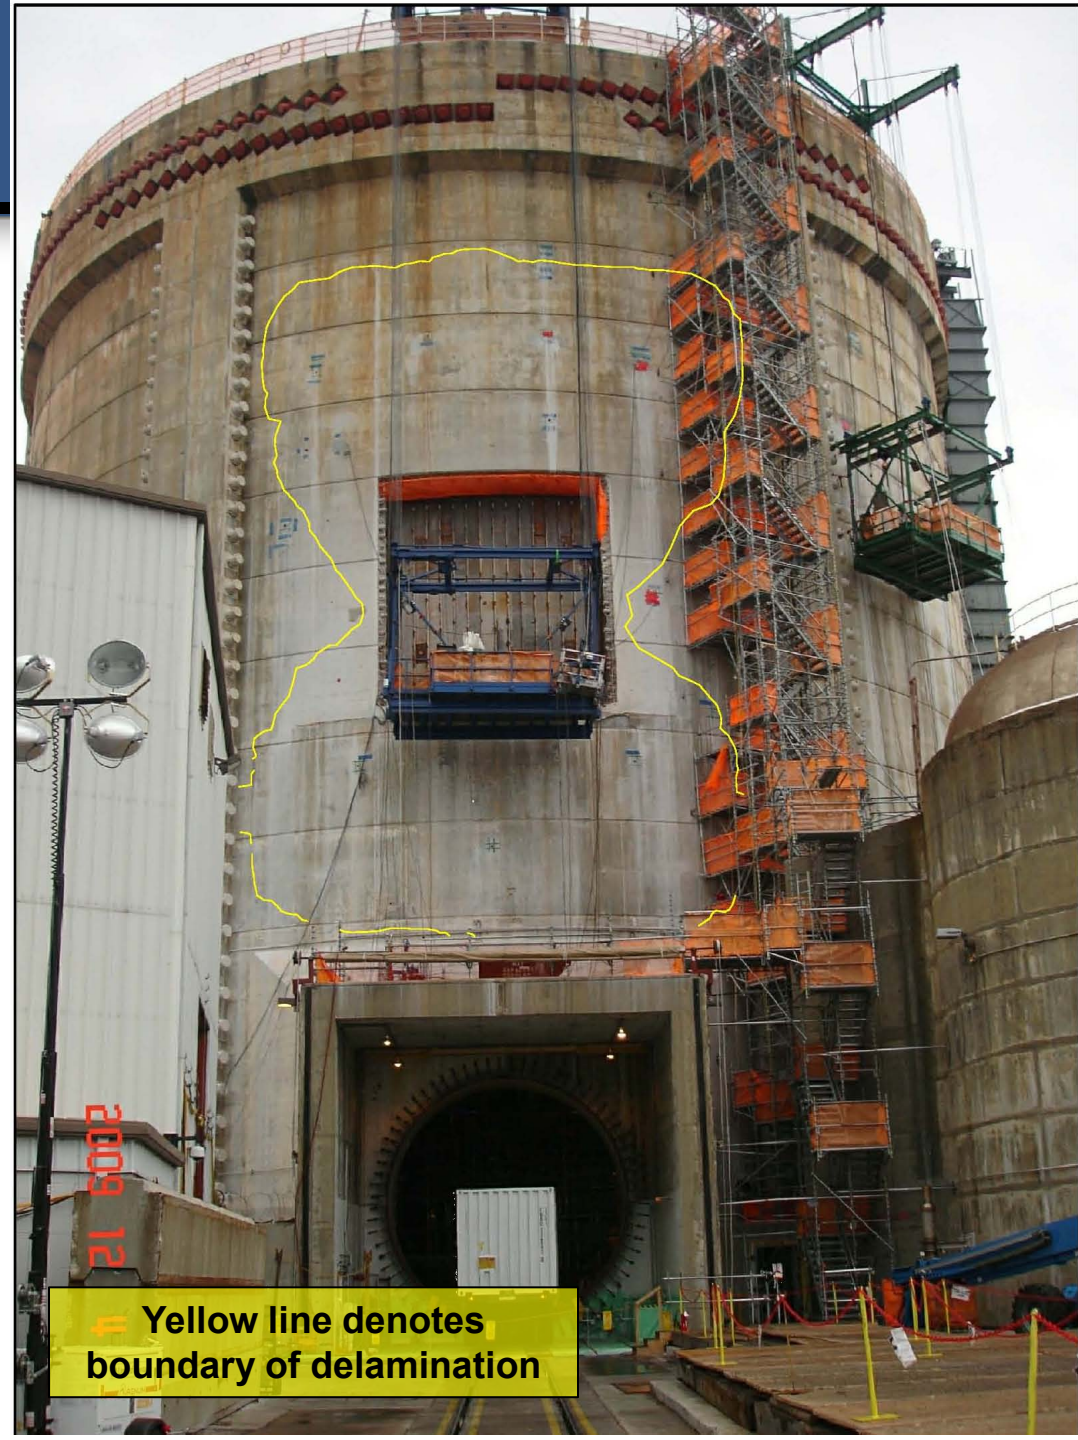
Showing Delamination Boundary

Yellow line denotes
boundary of delamination

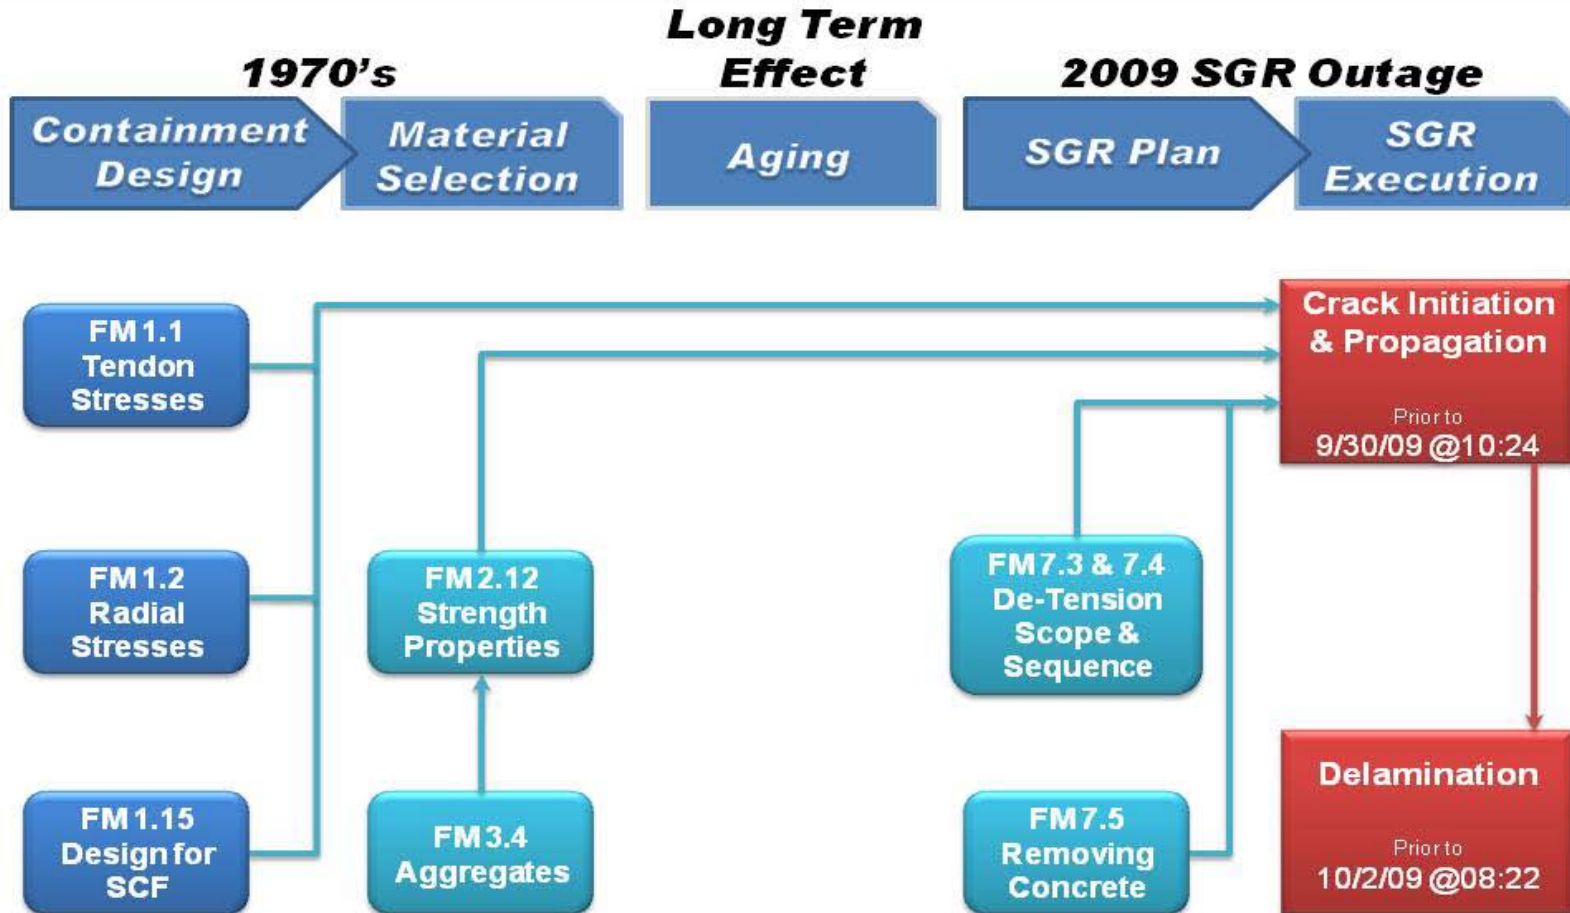
FAILURE MODES TIMELINE

- **Failure Modes 7.3 & 7.4 – De-tensioning Scope and Sequence** (*Root Cause*)
 - The number and order of de-tensioned tendons resulted in redistribution of stresses in the containment wall that exceeded tensile capacity, initiating the delamination
- **Failure Mode 7.5 – Added Stress Due to Removing Concrete at the Opening**
 - Removal of concrete increased the stress in the remaining concrete, contributing to the final extent of delamination

- **Root cause:** De-tensioning scope and sequence resulted in redistribution of stresses that exceeded tensile capacity
 - Could not have been predicted based on existing information and models at that time
- **Conclusion:** Delamination occurred as a result of outage activities to create an opening for steam generator replacement

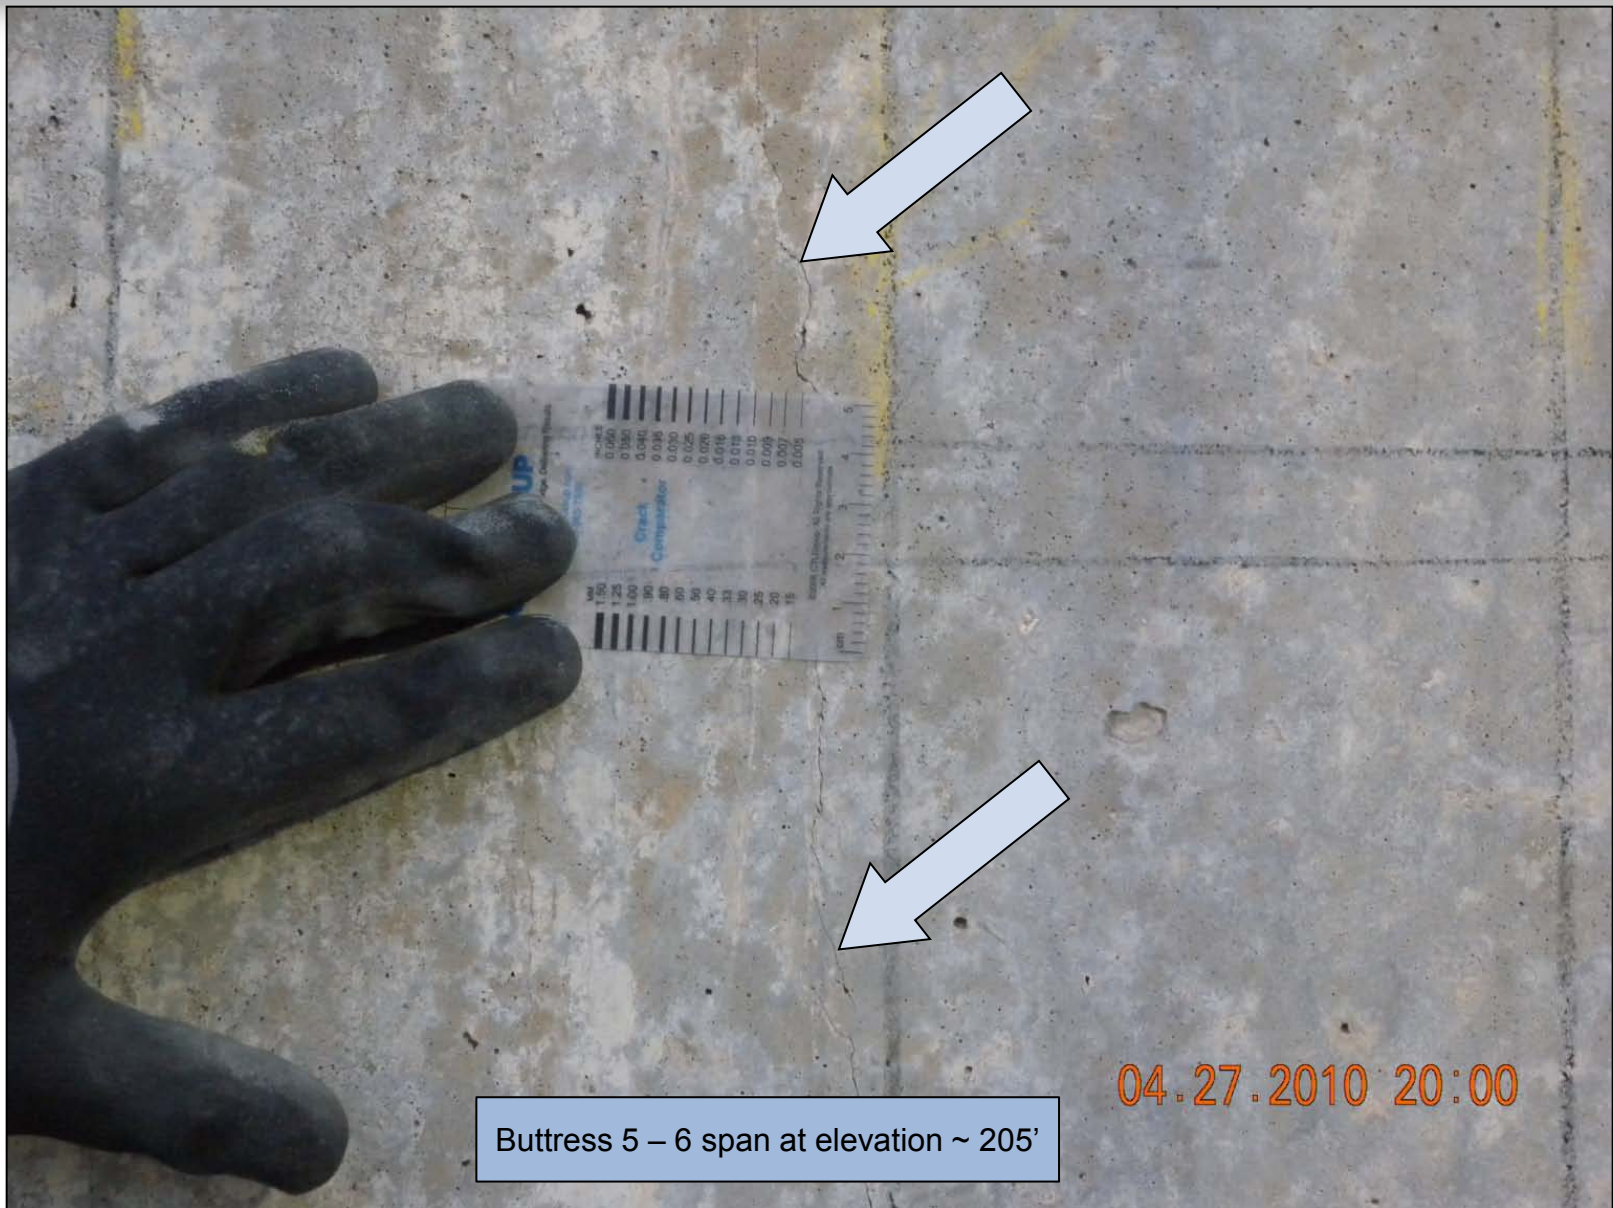
Hairline Cracking Outside of Restoration Area

- Vertical hairline cracking was identified in de-tensioned areas of the containment cylinder outside Bay 3 - 4
 - Observed after expanded de-tensioning
 - Located near some vertical tendon locations
 - Width < 0.010" (as measured at surface and within concrete core holes)
- In all areas of the containment cylinder still tensioned - no observations of vertical hairline cracking during detailed inspections

- Stress Reversal - Initial Tensioning to De-tensioning
 - After initial tensioning - the steel liner, reinforcement and tendon conduits increased in compressive elastic strain due to concrete creep
 - After de-tensioning - the steel liner, reinforcement and tendon conduit elastic strains reversed, but the concrete did not due to creep
 - Result was tensile stress in the concrete at the vertical tendons that exceeded tensile capacity

- Updated PII model (Abaqus) analysis supports hairline cracking development
 - Model executed both with and without the liner, reinforcement and tendon conduits for the de-tensioning sequence
 - Vertical hairline cracks do not develop when these steel components taken out of model
- Contributor
 - Portion of volume change in concrete due to concrete shrinkage

- **Even without hoop tensile capacity in these areas, design basis satisfied**
 - Concrete behaves as an un-cracked section
 - For design loads
 - Concrete remains in compression
 - For factored load case - $1.5P + T_a$
 - Concrete has tensile stresses due to liner expansion
 - For areas with concrete tensile stresses, prestressed steel and reinforcing steel to be evaluated consistent with ACI 318-63 and ACI 505-54 requirements
 - **Liner strain and stress acceptance criteria is met for all load cases**
- **Expected to be acceptable under current licensing basis**

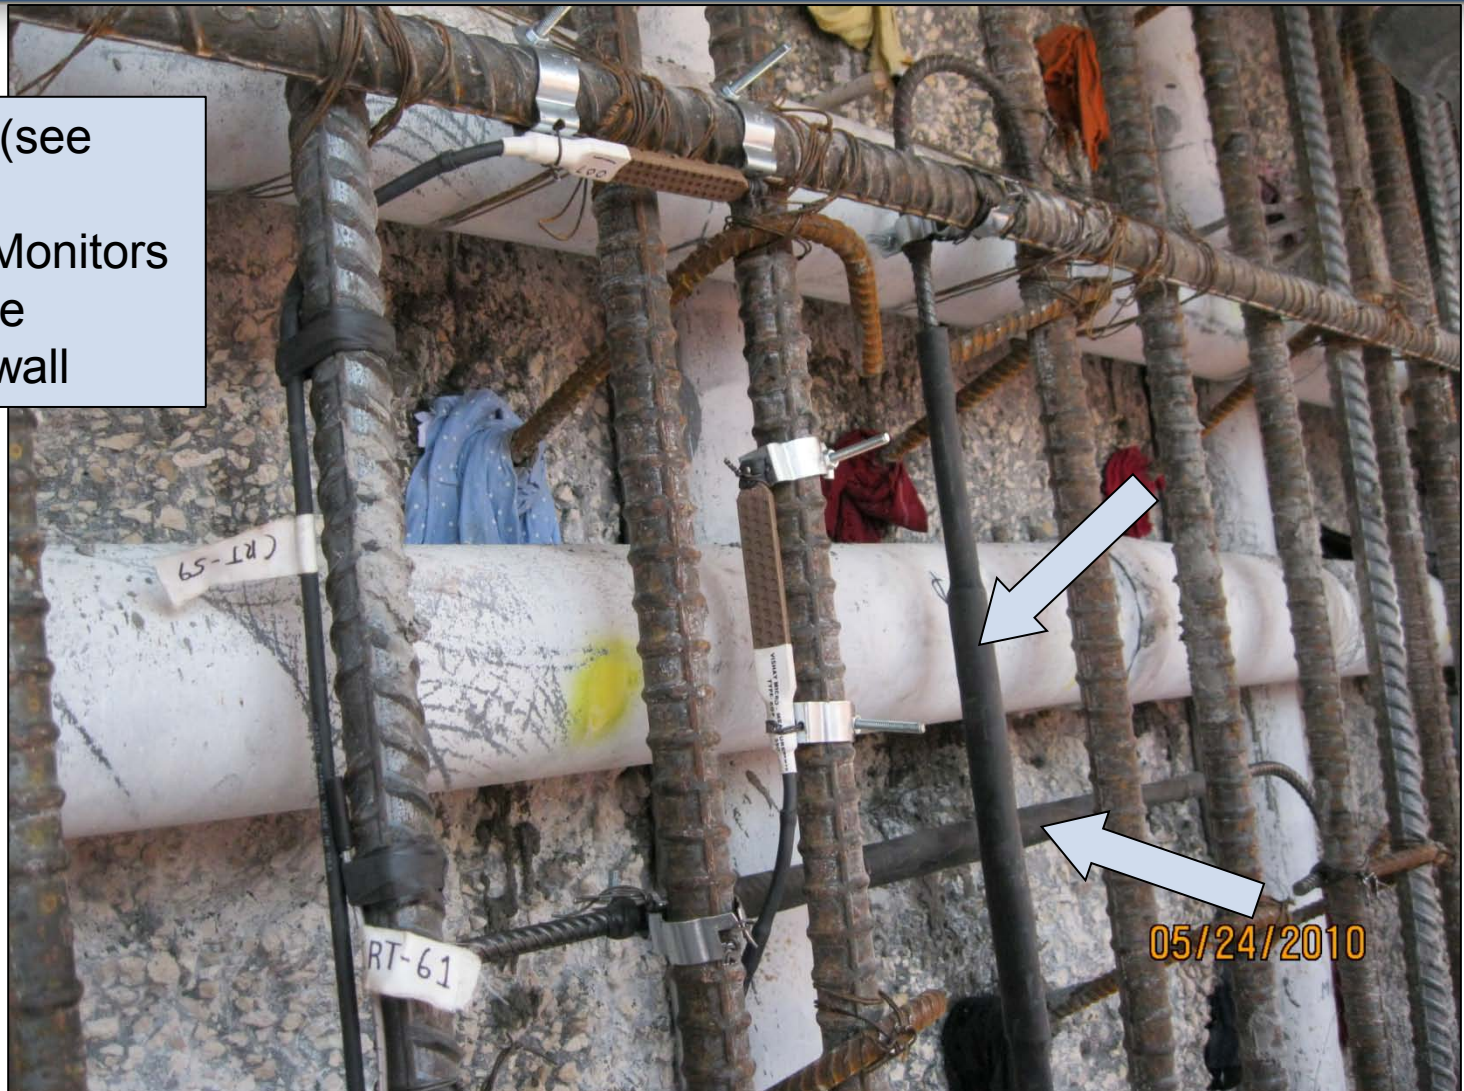
Strain Gauge (see arrows) & Temperature Monitors installed on the Containment wall
