**Title:** ELEVATED TRITIUM VALUES IDENTIFIED IN 2 STORM DRAINS DUE TO  
THROUGH-WALL LEAKS IN UNDERGROUND PIPING

**Unit(s):** Dresden Station Units 2/3

**Action Tracking Item Number:** 00928304

**Report Date:** 07/24/09

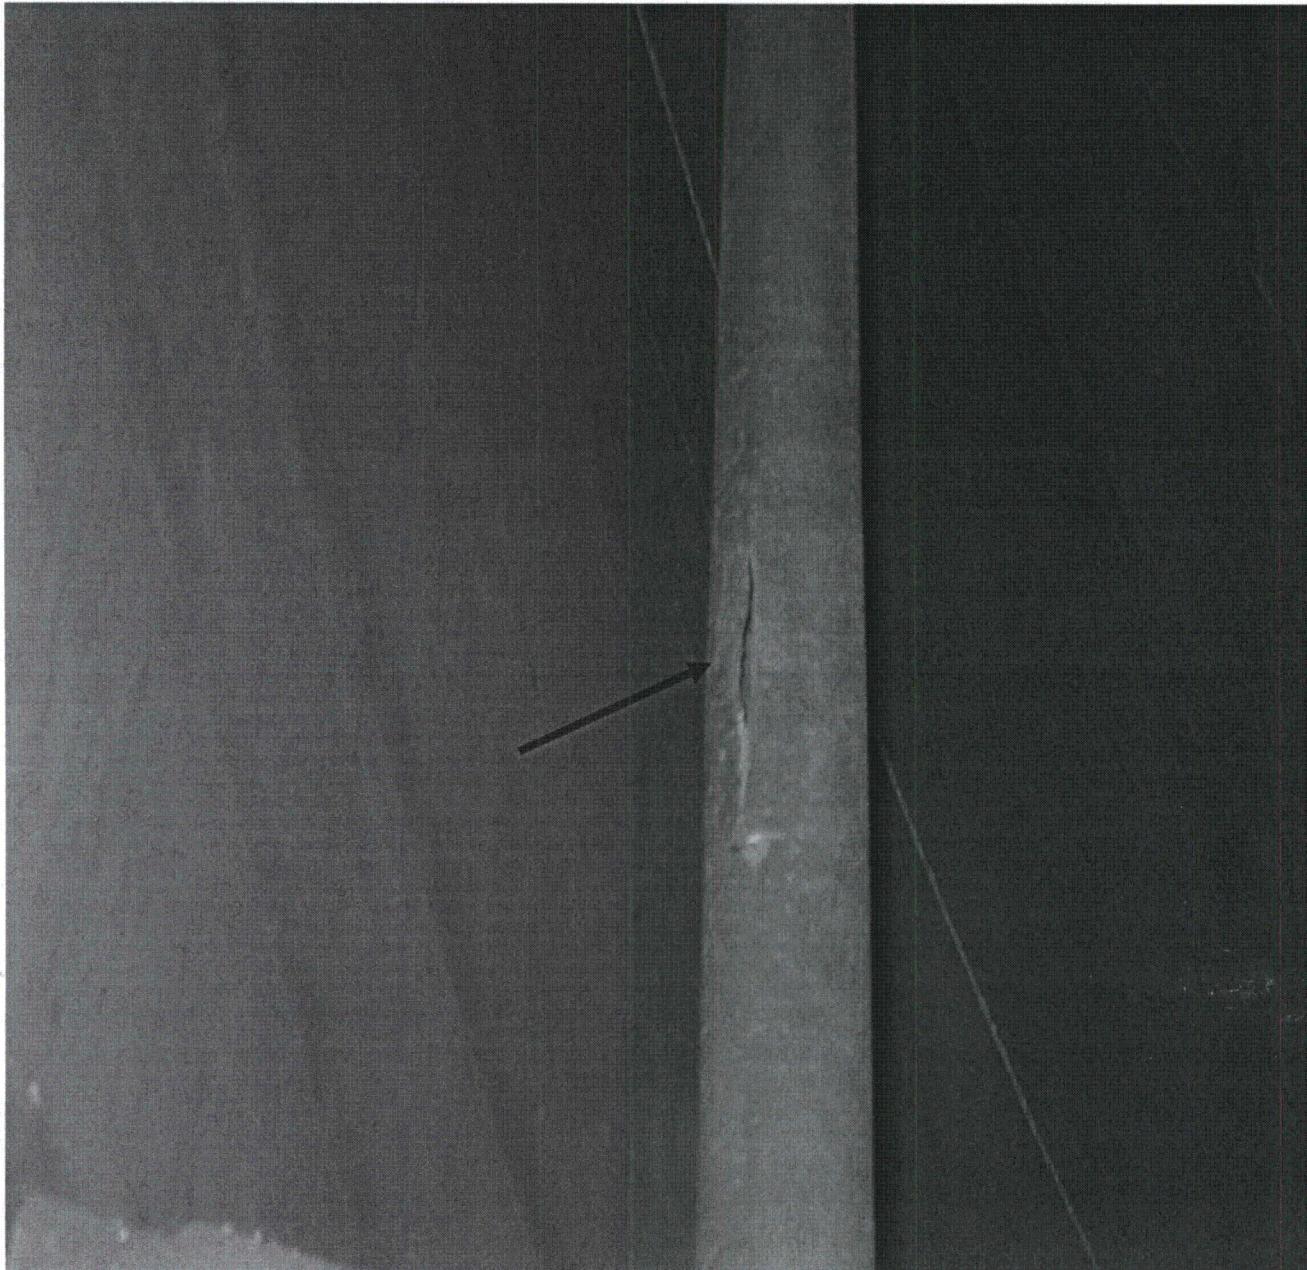
The visual inspection completed on 6/17/09 of the Unit 1 Condensate Storage Tank (CST) standpipe revealed two areas with fish mouth ruptures as well as another area with a through-wall crack. It has been determined that the most probable root cause of these is the freezing of the standpipe during historical operating methods.

It is suspected that the tank was left empty with no heating during weather conditions that were cold enough to freeze the residual water in the pipe causing the indications noted when the pipe was inspected. The reason that this evolution was used was to have the available inventory to allow the drain down to commence in a faster manner. This method of water management hasn't been used in the last seven years and it is believed that the damage to the standpipe is historic in nature.

Lowest Standpipe Failure, ~10 ft off the bottom

Root Cause Being Addressed (Include TapRoot Codes)	Corrective Action to Prevent Recurrence (CAPR) (Include AT Assignment #)	Owner	Due Date
Degraded Standpipe due to freezing	<p>Remove standpipe and install blind flange</p> <p><b>Work Order: 01241421-43</b></p>	Maintenance	Complete

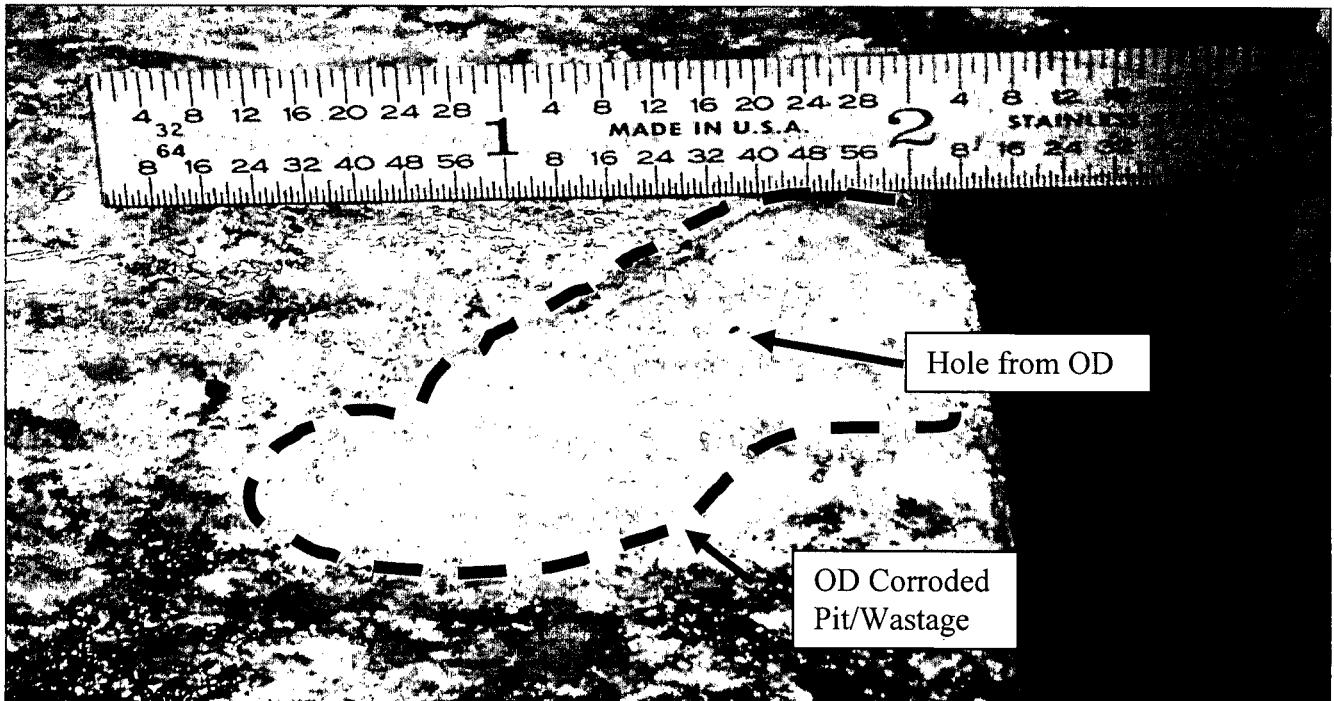
The through-wall leaks identified on lines 2/3-4324-4" and 2/3-3346-24" were the result of external corrosion caused by the degraded protective moisture barrier wrap. The leak on line 2/3-4324-4" was approximately 1/16" in size and was located within a 2" area of external corrosion. The moisture barrier wrap installed on this line was a bituminous coating. Initial inspection of the leak location identified that the protective moisture barrier wrap was degraded to the extent that a section of the wrap was missing from this specific area. The leak on line 2/3-3346-24" was approximately .2" in size and was located within a 1" area of external corrosion. This area was not identified by G-scan due to the limitations of the technology, specifically the distance this indication was from a circumferential weld. Corporate engineering is addressing the limitations identified with this technology and have also published letter VPE090609 titled "Oyster Creek Guided Wave Inspection Root Cause which provides a status of lessons learned with guided wave and the implementation plan in support of the buried piping program at Exelon plants. The moisture barrier wrap installed on this line was a thin form of tape coating. This coating had degraded and fallen off the pipe in certain areas and had numerous areas where the taped had curled edges. Neither Design Engineering nor Sergeant & Lundy Engineers could find the pipe coating specifications for either coating. Moisture barrier wrap degradation can be attributed to various causes, soil stresses, loss of electrical resistance, improper application, improper backfill procedures, contaminants in soil, biodegradation of the adhesive and age. Although the cause of the degradation could not be determined it is believed that the most probable cause of the degradation can be attributed to biodegradation of the adhesive and age. This was determined by the brittleness of the bituminous coating, which resulted in cracking of the coating. Per previous conversations with an industry coatings expert, the life

Through-wall leak from OD
