**GROUNDWATER TRITIUM
STATUS REPORT
WATTS BAR NUCLEAR PLANT**

August 2005

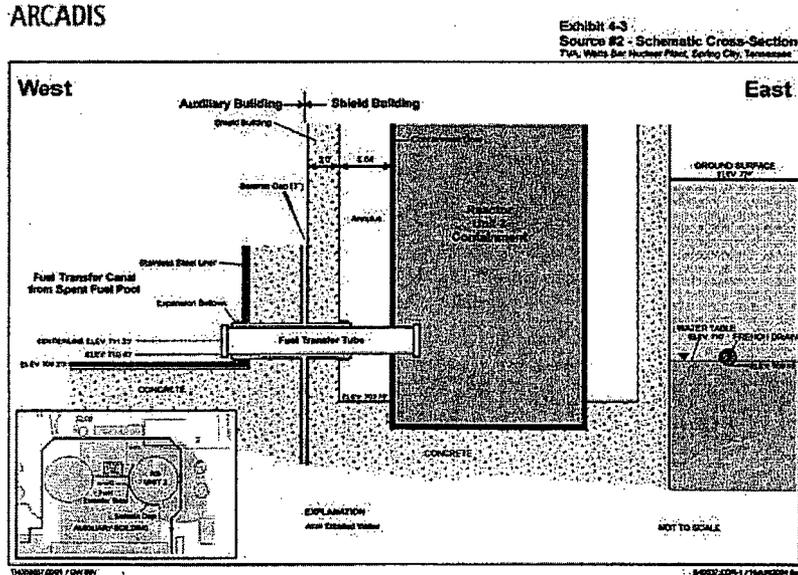
Figure 1

Leaks through the FTT sleeve and seismic gap have resulted in groundwater impact surrounding the Unit 2 Shield Building (Figure 1). Occasional FTC leakage has been identified over the past 5 to 6 years. The SFP and adjacent CLP, along with the FTC, have individual "tell tale" drain systems to detect leakage through the liner welds. Neither of these drain systems has exhibited recent leakage, although investigations indicated that the drains for the SFP and FTC were clogged, so evidence of leakage by this method is problematic. Subsequent efforts to clear these drain systems have resulted in a functioning drain system for the FTC. The SFP system continues not to drain and additional efforts are under way to free this drain system. The

The difference in potential head between the bottom of the FTT sleeve and the French drain directly north of the seismic gap is approximately 1.25 feet, indicating that water would flow towards the French drain from this point (either to the north or to the east). Calculations using the tritium concentrations in these areas of nearly 100 million pCi/L indicate it would take a small volume of tritiated water to result in the concentrations being observed in the north leg of the French drain, and in groundwater monitoring points around the Unit 2 Shield Building.

Tritium found in geoprobes installed west of Unit 2 is influenced by the Unit 2 Fuel Transfer Bellows leak into the 1" seismic gap between the Auxiliary Building and the Unit 2 Shield Building as mentioned under the FTC discussion. Since the FTC has been coated and filled with water there has been no evidence of leakage in the U2 FTT sleeve. The seismic gap has been inspected with a boroscope and is covered with boron crystals.

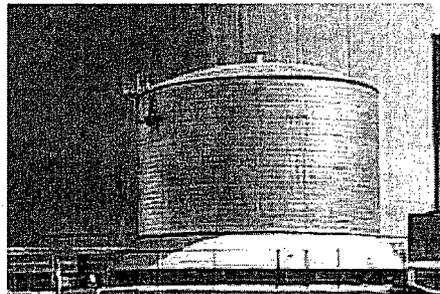
Photo 4

The RWST (Photo 4) is a large source of water used during refueling outages and is also a source of water to the reactor should there be a loss of coolant accident. The water from the RWST is used to fill the fuel transfer canal and the reactor cavity during refueling outages and is returned to the RWST at the conclusion of the outage.

Because the RWST is a large volume of water with elevated tritium concentration (approximately 28 million pCi/l) the integrity of the RWST was reviewed. The RWST was found to be losing water at a rate of approximately 150–200 gallons per day (gpd). Several valves associated with the piping to/from the RWST were examined and found to be leaking. The valves were repaired, reducing the water loss to approximately 45–50 gpd.

A transducer was installed in the RWST and water level was tracked between November 4 and December 18, 2003. The data was given to Pacific Northwest National Laboratory (PNNL) to perform a rough evaporation calculation. Results from PNNL indicate that most of the level loss can be attributed to evaporation.

Refueling Water Storage Tank - Investigated level loss. Repaired identified leaking valves. Installed wells near foundation of the tank to determine if the tank itself is leaking. Evaporation calculations revealed that level loss likely due to evaporation.

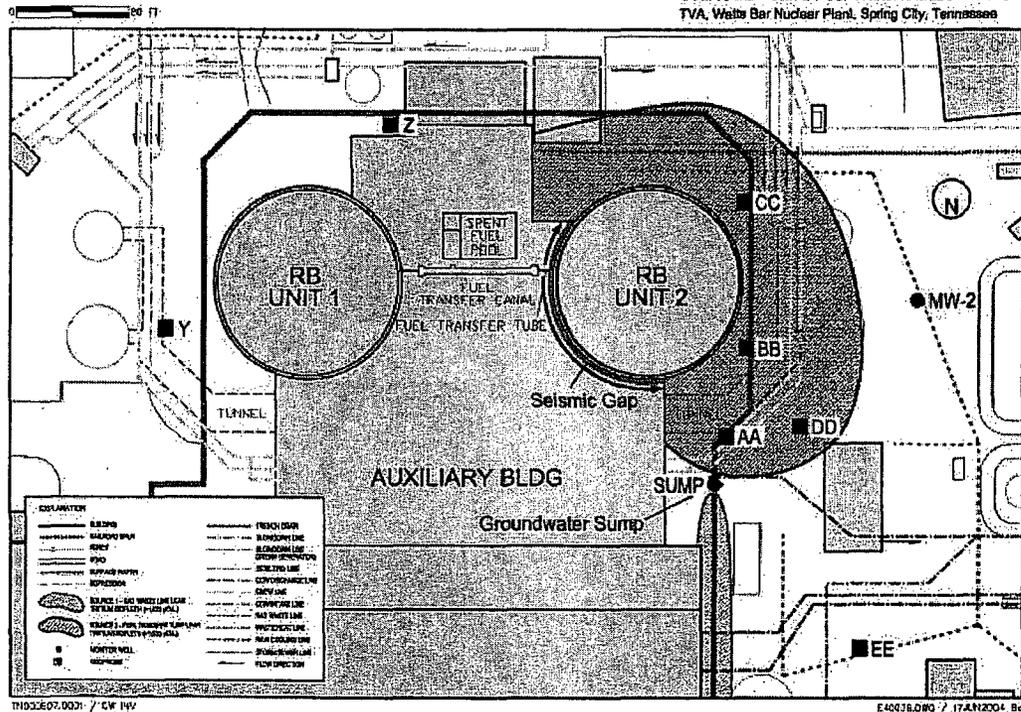
Figure 4-2
 Source #2 - Unit 2 Fuel Transfer Tube Sleeve
 TVA, Watts Bar Nuclear Plant, Spring City, Tennessee

In February 2003, it was identified that water was leaking into the Unit 2 Shield Building annulus, through the Unit 2 FTT sleeve connection between the Auxiliary Building and Unit 2 Shield Building. A 1-inch seismic gap exists between the Auxiliary Building and Unit 2 Shield Building where the FTT passes through these buildings (Figure 1). Tritiated water, between the steel tube (20-inch diameter) and the concrete building, was observed flowing into the Unit 2 Shield Building annulus in February 2003. This water must flow across the seismic gap to get from the Auxiliary Building to the Unit 2 Shield Building, which provides a pathway to groundwater. This gap is filled with fiberglass and is glued on one side to the Unit 2 Shield Building. Potentially, water from the SFP, CLP, or FTC that has leaked behind the stainless-steel liner could migrate to the Unit 2 FTT sleeve.

Leaks through the FTT sleeve and seismic gap have resulted in groundwater impact surrounding the Unit 2 Shield Building (Attachment 2). The difference in potential head between the bottom of the FTT sleeve and the French drain directly north of the seismic gap is approximately 1.25 feet, indicating that water would flow toward the French drain from this point (either to the north or to the east). Calculations using the tritium concentrations in these areas of nearly 100 million pCi/L indicate it would take only a small volume of tritiated water to result in the concentrations being observed in the north leg of the French drain, and in groundwater monitoring points around the Unit 2 Shield Building.
