Study of the Unit 2 Spent Fuel Pit Permeability

**Entergy Nuclear Northeast
Indian Point Unit 2**

*Report No. 1464385-R-004
Revision: Draft B*

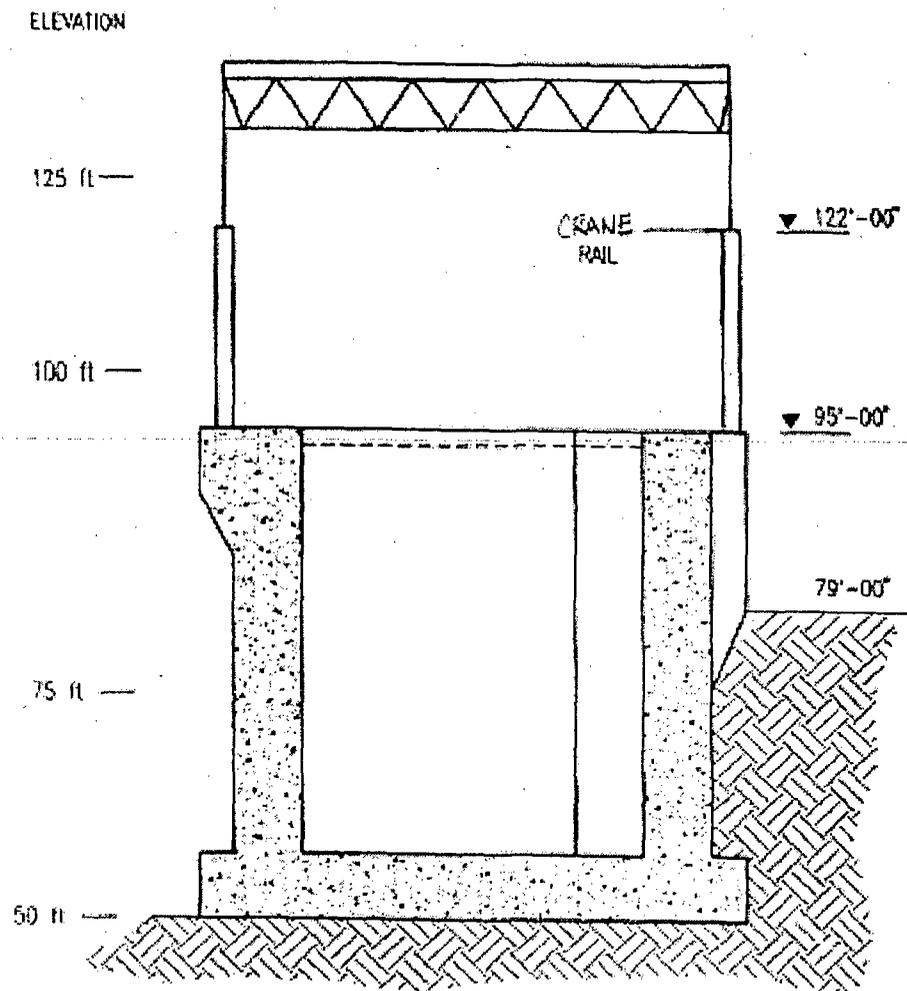
Figure 1: FHB Looking North

The pit has walls of 4'0" and 6'-3" thick with a 3'-0" thick base mat. The structure is founded on rock at elevation (El.) 50'-0" beneath the spent fuel pit, see Figure 1 and Figure 2.

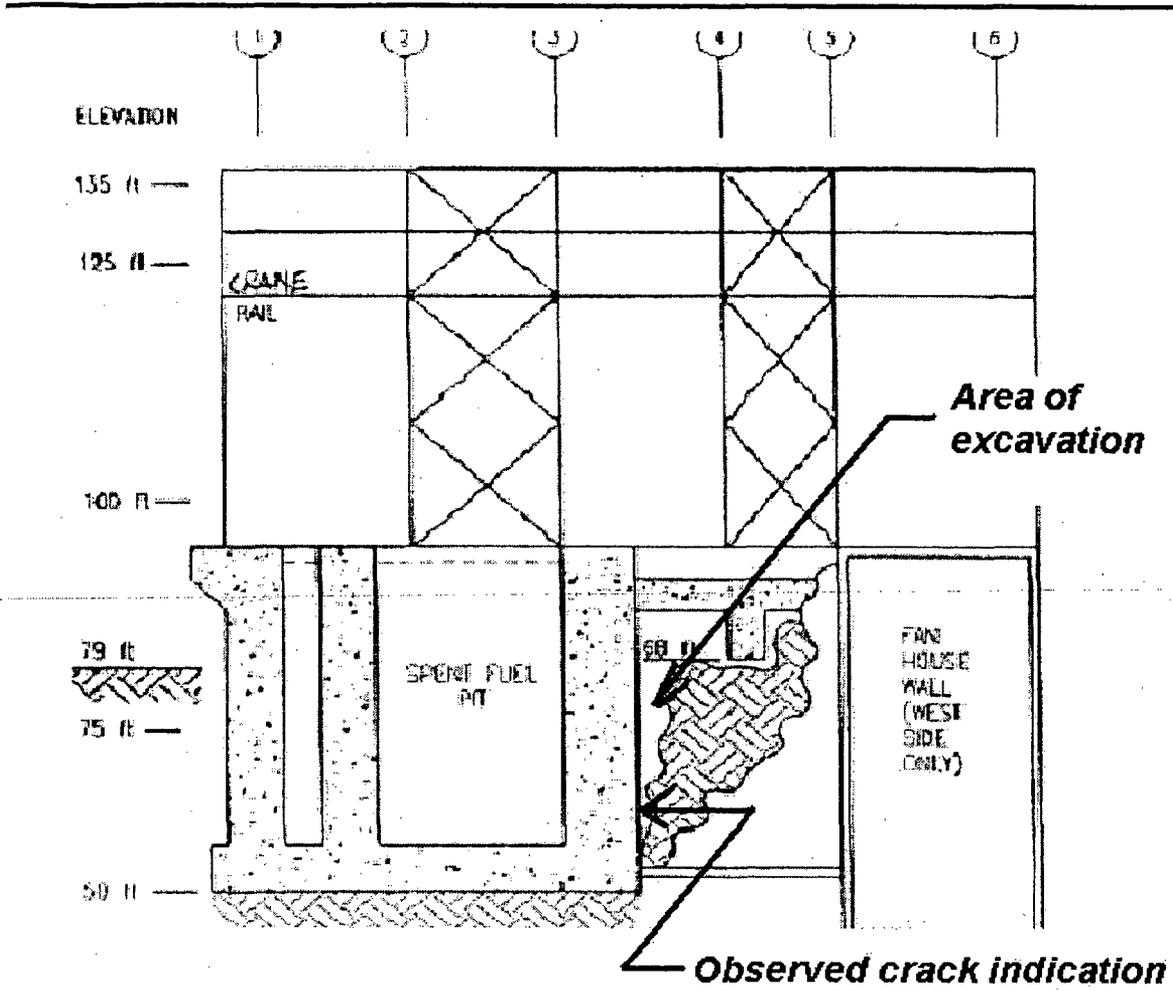
Figure 2: FHB Looking East

The south wall of the SFP was originally covered by the back-filled soil and rock material in the space between the outside of the wall, and the excavated rock to its south, see Figure 2. The back-filled material (soil) provided an overburden pressure against the wall. During excavation of this soil it was noted that the composition contained large rock with voids being present. With the soil in place, the concrete of the wall and a portion of the soil adjacent to the wall will with time approach the temperature inside the pool, approximately 100 degrees F. With the soil removed adjacent to the wall, the exterior of the wall is exposed to ambient air conditions.

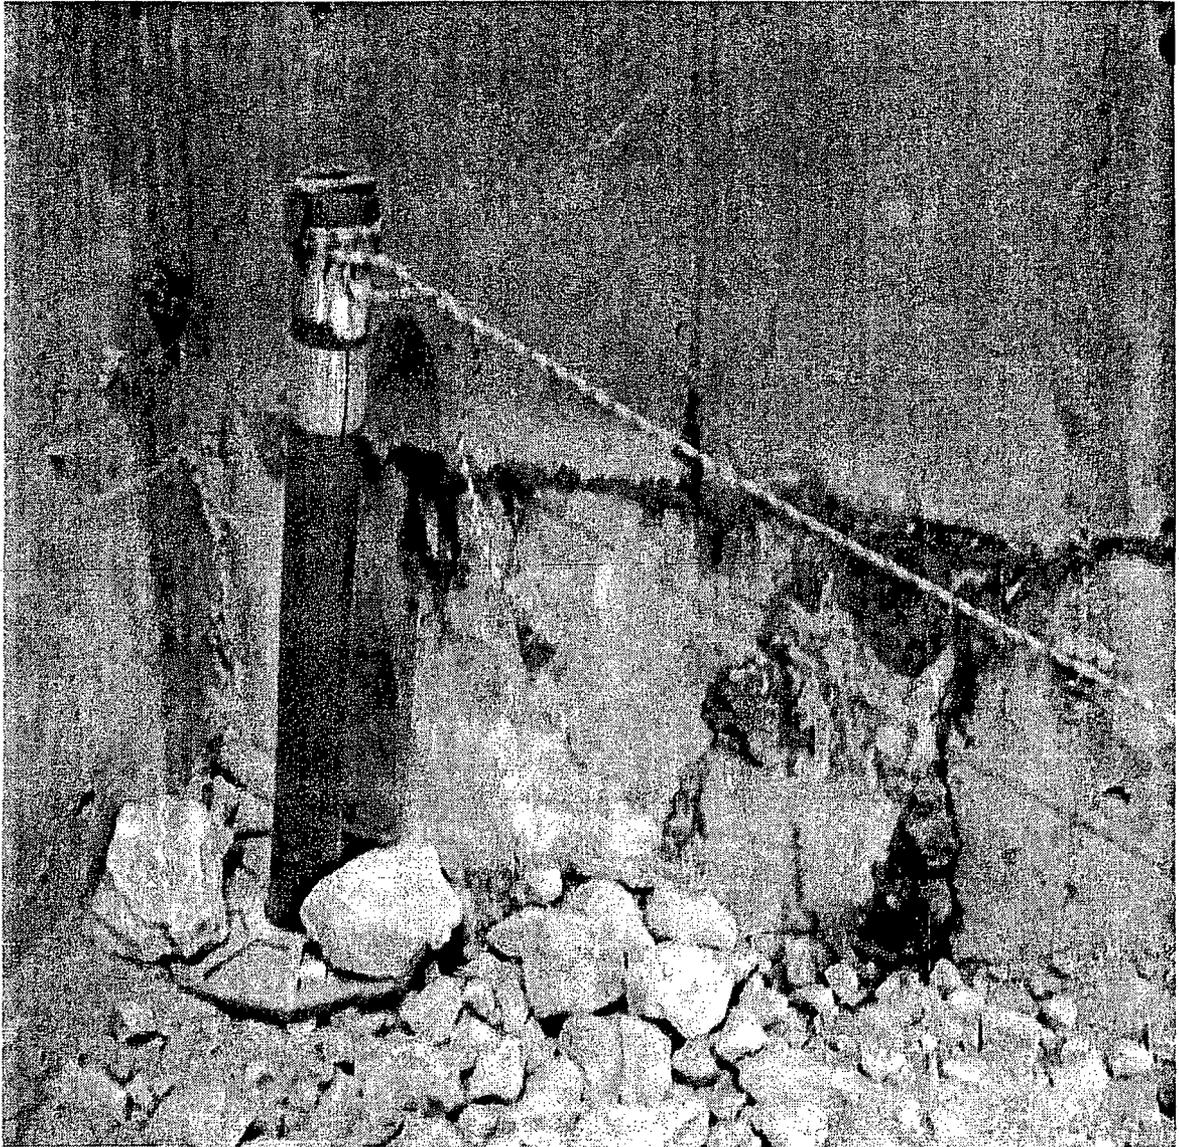
Figure 3: Crack Like Indication & Moist Region – Approx. El. 64 ft.

A crack like indication has been identified on the SFP south wall, located at El. 64 ft, approximately 10 feet up from the base slab. The south wall of the SFP at this location is 4 ft thick. At one location along this horizontal indication a moist region of concrete has been identified with dimensions of approximately 20" wide by 20" high, Figure 3. This region has been observed for approximately two weeks, and the moist location of the wall is drying and disappearing. Further excavation to a depth approximately two feet below the first indication identified a similar indication, which is now currently moist.

During excavation work adjacent to the south wall of the IPEC Unit 2 spent fuel pit (SFP), a crack like indication was observed in the wall at El. 64 ft., approximately 10 feet above the SFP base slab. This crack like indication appears to be relatively tight, hairline in nature, and is likely associated with shrinkage cracking. A portion of the indication near the southwest corner was found to be moist. This region has been observed for a period of approximately two weeks and the surface appears to be drying. A portion of the soil below this region of the indication was subsequently excavated an additional two feet, identifying a similar indication, which also was initially moist.

It should be noted that the leakage rates in areas adjacent to the test are not known, although they are likely to be lower than the rate in areas that were observed to be wet on the surface. Additional testing is recommended to quantify leakage rates over the remainder of the crack.

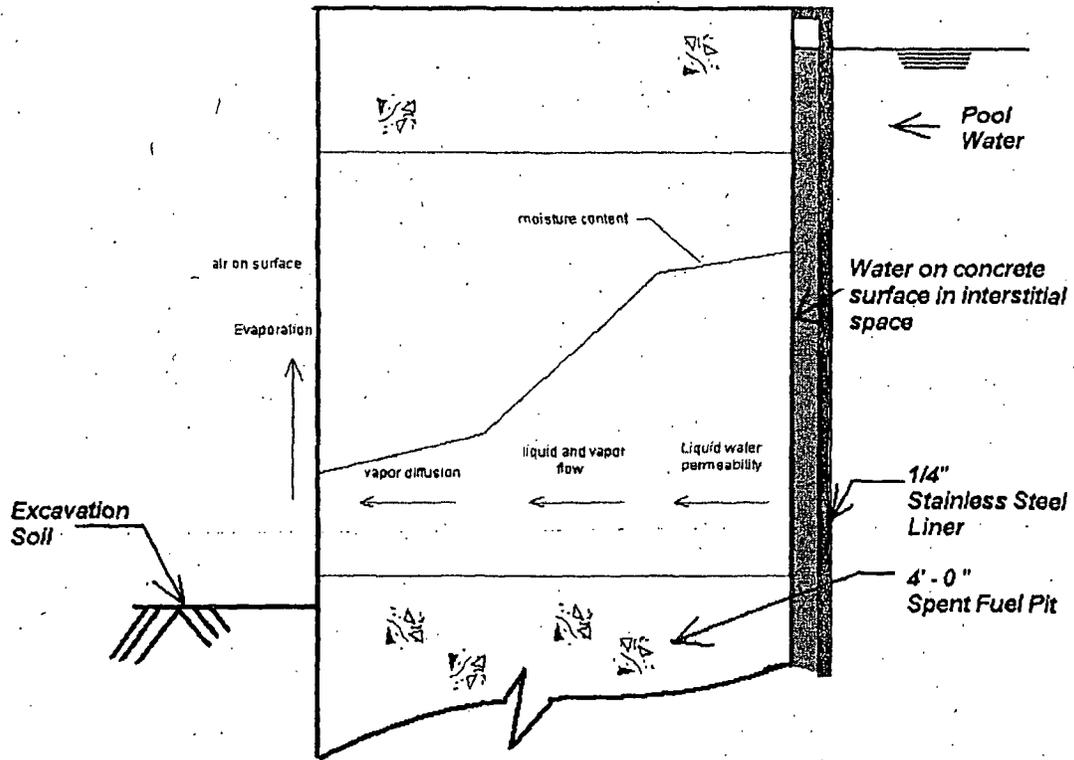
Figure 4: Unsaturated Flow Through SFP Wall

The transfer of water through the concrete wall is a function of the transfer of liquid water, water vapor, and of the removal process at the exterior wall (Ref. 2). A diagram showing the penetration of water into the concrete wall, from right to left, is presented in Figure 4. In this diagram, the liquid is driven to some depth in the wall by the head of water in the interstitial space between the inner exposed concrete surface and the liner. At a mid-wall point, vapor diffusion and liquid flow are combined, and at the final section of the wall, vapor diffusion carries the flow to the outside surface. If liquid water does not continue to the outside wall, the surface appears dry. If liquid does reach the outside wall, the surface appears wet, and evaporation or drainage carries away the surface moisture.

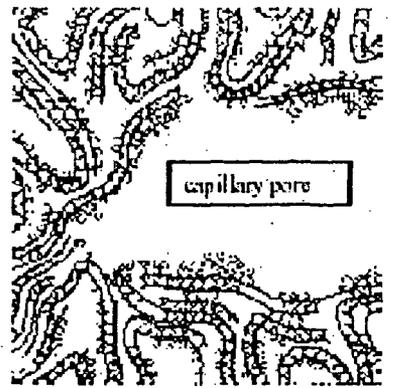
Figure 5: Concrete Size Scale Relative to Water Movement

At the smallest scale, water may move into concrete through interconnected capillary porosity. Capillary pores are essentially a residue of the originally water filled spaces in fresh concrete. Capillary pore scale is important with respect to durability of concrete as it is the path by which water and other aggressive ions penetrate into the concrete matrix. A depiction of this is shown in Figure 5 (A).

Somewhat larger but of similar magnitude to capillary pores are micro-cracks and transition zones. Micro-cracks may be formed due to internal thermal and shrinkage forces or stress due to external loads. The transition zone is a weak permeable layer that occurs around aggregate particles. This scale is also of importance with respect to movement of water and other aggressive chemicals within the concrete matrix and thus is important from a durability standpoint as well. A depiction of micro-cracks and transition zone is shown in Figure 5 (B) and Figure 5 (C), respectively.

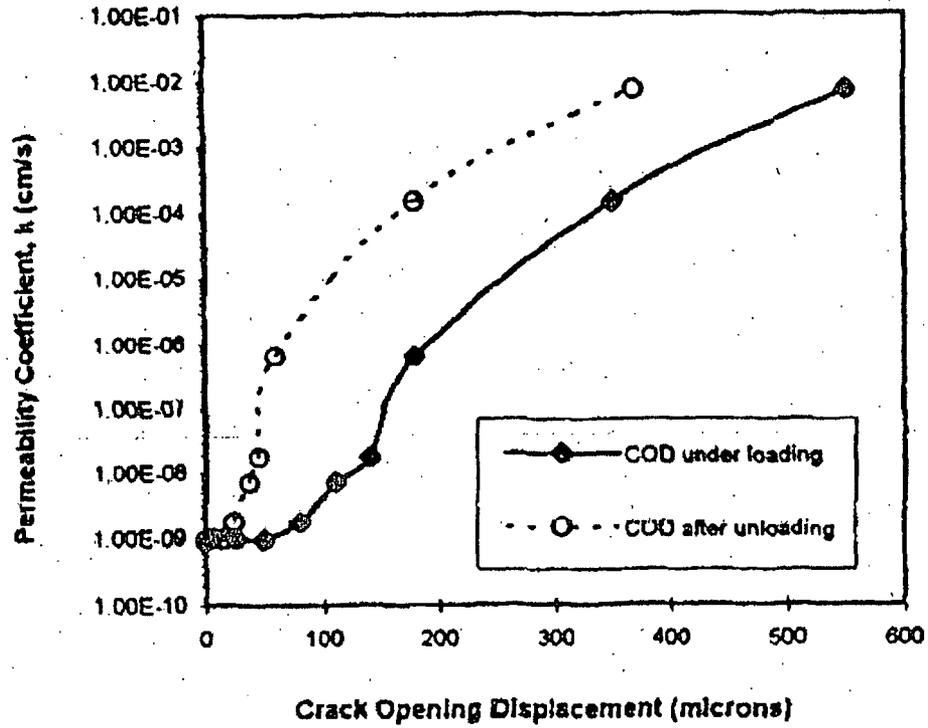
Figure 6: Crack Opening vs. Permeability Coefficient (Ref. 3)

For uncracked concrete, the permeability constant K is on the order of 2×10^{-12} in/sec or 5×10^{-12} cm/sec, as determined for the SFP concrete by the core bore testing performed in 1992 (Section 2.1). For an uncracked wall, the leakage rate based on the permeability constant and driving pressure would be very small, and leakage would not be expected to noticeably penetrate the 4ft.. If a micro or macro crack were to occur within the wall of the SPF, the permeability constant would increase. A study performed by Wang and Jansen (Ref. 3) determined values of permeability versus crack size, Figure 6. Observations of the wall indication, Figure 3 identified a hairline crack at the surface. Based on the field observations the width of this crack through the wall is impossible to determine at this time. A concrete crack of 150 micron (0.006 in) would increase the permeability constant to approximately 7×10^{-5} cm/sec (Figure 6, Ref. 3).

The leak rate of the second identified crack indication was assessed, using the increased permeability values for cracked concrete as shown in Figure 6. Considering the indication as through wall with a crack width of 200 micron, the leakage was determined to be on the order of 0.08 gal per day (12.6 mL/hr) for the 3 foot long section, Attachment A. A total leak rate can then be projected as 4.2 mL/hr per linear foot of indication, or 126 mL/hr for the 30' long crack. Based on these leakage rates, pool water would penetrate the 4 ft. wall in approximately 18 hours.
