SUBJECT: PUBLIC MEETING SUMMARY– REGULATORY CONFERENCE FOR
BROWNS FERRY NUCLEAR PLANT, DOCKET NO. 50-259

REGULATORY CONFERENCE
 TENNESSEE VALLEY AUTHORITY
 APRIL 04, 2011
 NRC REGION II, ATLANTA, GEORGIA

**TENNESSEE VALLEY AUTHORITY
BROWNS FERRY NUCLEAR PLANT, UNIT 1**

**Low Pressure Coolant Injection Valve
1-FCV-74-66**

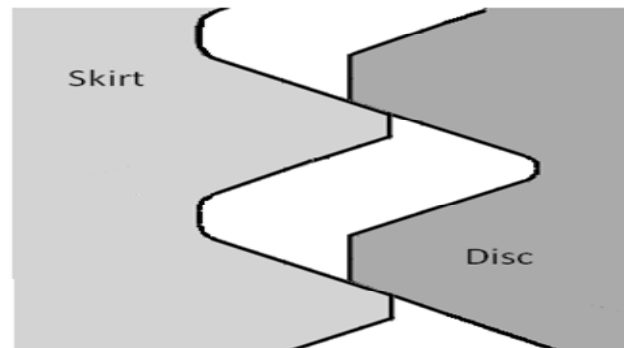
As-Found Thread

- Disassembly of the valve revealed the disc separated from the stem and lodged in the seat
- The disc separation from the stem resulted from an original manufacturing defect, undersized threads in the disc skirt/disc assembly

- The valve was purchased as an assembly that would not be taken apart to perform receipt inspections
 - Undersized skirt thread diameter caused the threaded connection between disc and skirt to be 38 percent of design strength

- Short-term corrective actions
 - Repaired valve 1-FCV-74-66
 - Verified discs attached in all like valves, with tack welds intact and in good condition
 - Implemented controls limiting back-pressure on valves
- Long-term corrective actions
 - Restore or repair valve skirts to address potential undersized thread issue

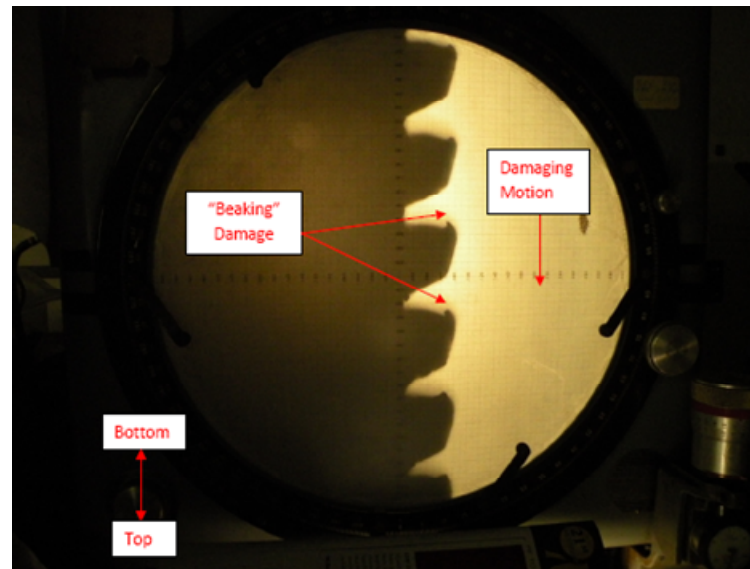
Forensic examination found axial damage on the threaded connection between disc and skirt

Optical Comparator Image of Damaged Threads

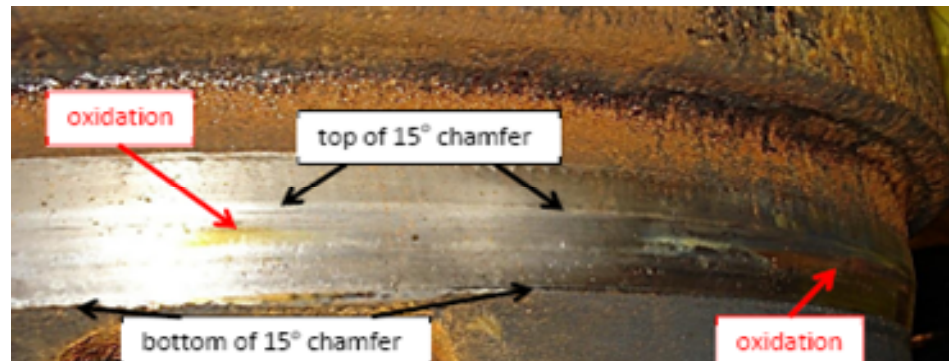
74-66 valve disc contacting surface immediately after removal (11/2/10)

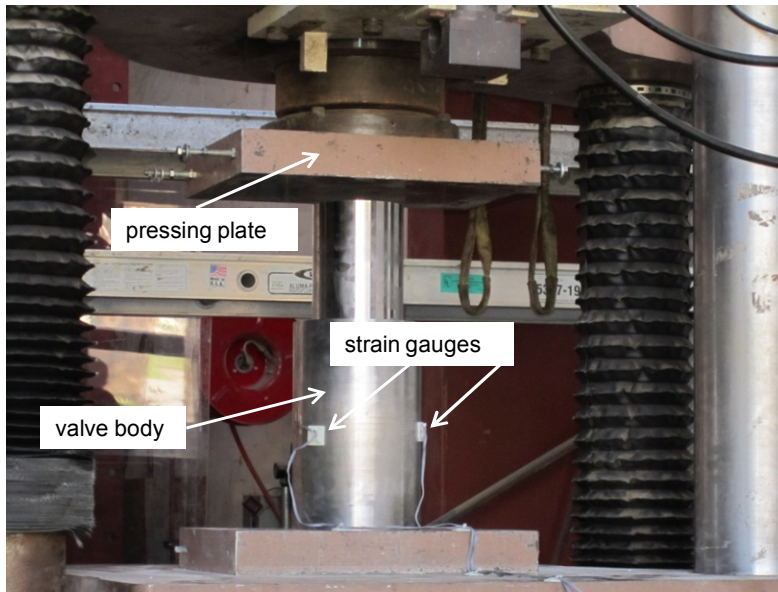
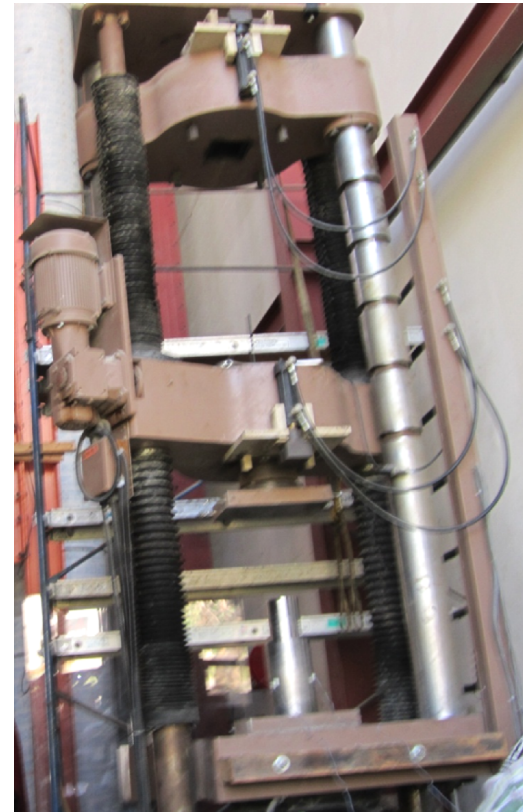
- The valve disc was compressed into the valve body by a hydraulic press.
- Strain gauges were positioned on the outside of the valve body.
- Vibrations were applied to the disc modeled on the plant configuration.

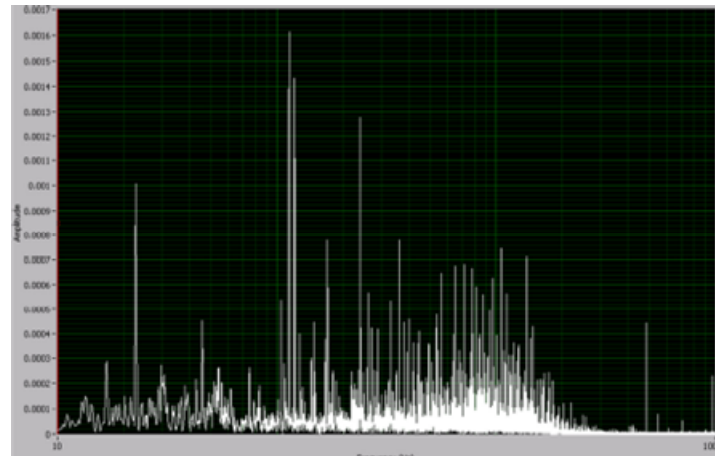
- Pressure amplitude and frequency data were measured at Browns Ferry Nuclear Plant using a high-speed recorder with the RHR pump running
- Fast-Fourier Transform was performed and utilized in laboratory mockup testing
