## June 2009 Collision of Two Washington Metropolitan Area Transit Authority Metrorail Trains Near Fort Totten Station, Washington, DC

### PURPOSE

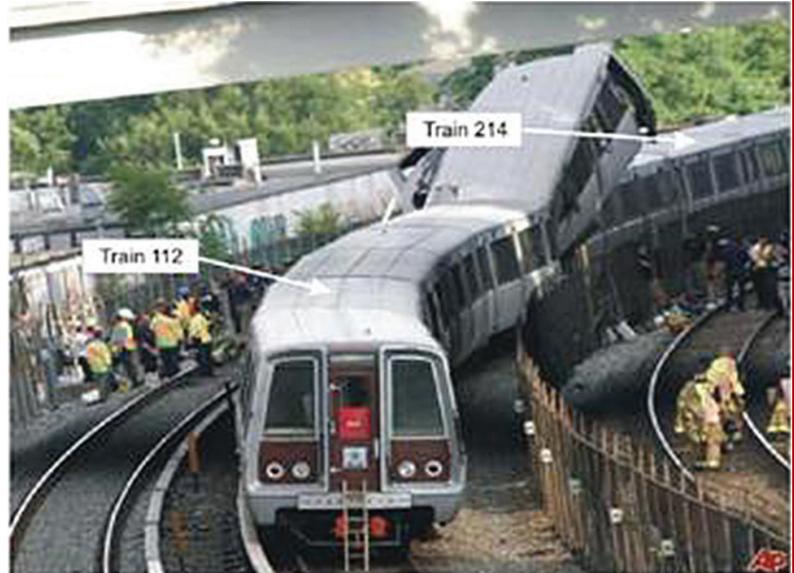
On Monday, June 22, 2009, at about 4:58 p.m. eastern daylight time, WMATA Metrorail train 112 struck the rear of stopped Metrorail train 214. The powerful impact caused the rear car of train 214 to telescope into the lead car of train 112, resulting in a loss of occupant survival space in the lead car of about 63 feet (about 84 percent of its total length). Nine people aboard train 112, including the train operator, were killed. Emergency response agencies reported transporting 52 people to local hospitals. (NTSB/RAR-10/02)

- “A failure of track circuit modules caused the automatic train control system to lose detection of one train (train 214) allowing a second train (train 112) to strike it from the rear.” (NTSB NEWS SB-10-29)
- WMATA failed to institutionalize and employ across the system an enhanced track circuit verification test procedure that was developed following a near collision in Rosslyn, VA, in 2005. **If this test procedure had been institutionalized and used systemwide, it would have identified the faulty track circuit before the accident.** (NTSB/RAR-10/02)
- Other major contributing factors were “WMATA’s lack of a safety culture” and WMATA’s failure to replace or retrofit 1000-series railcars, which were shown in a 2004 accident to exhibit poor crashworthiness. (NTSB/RAR-10/02)
