Report of Japanese Government
to the IAEA Ministerial Conference on Nuclear Safety
- The Accident at TEPCO's Fukushima Nuclear Power Stations -

June 2011

Nuclear Emergency Response Headquarters
Government of Japan

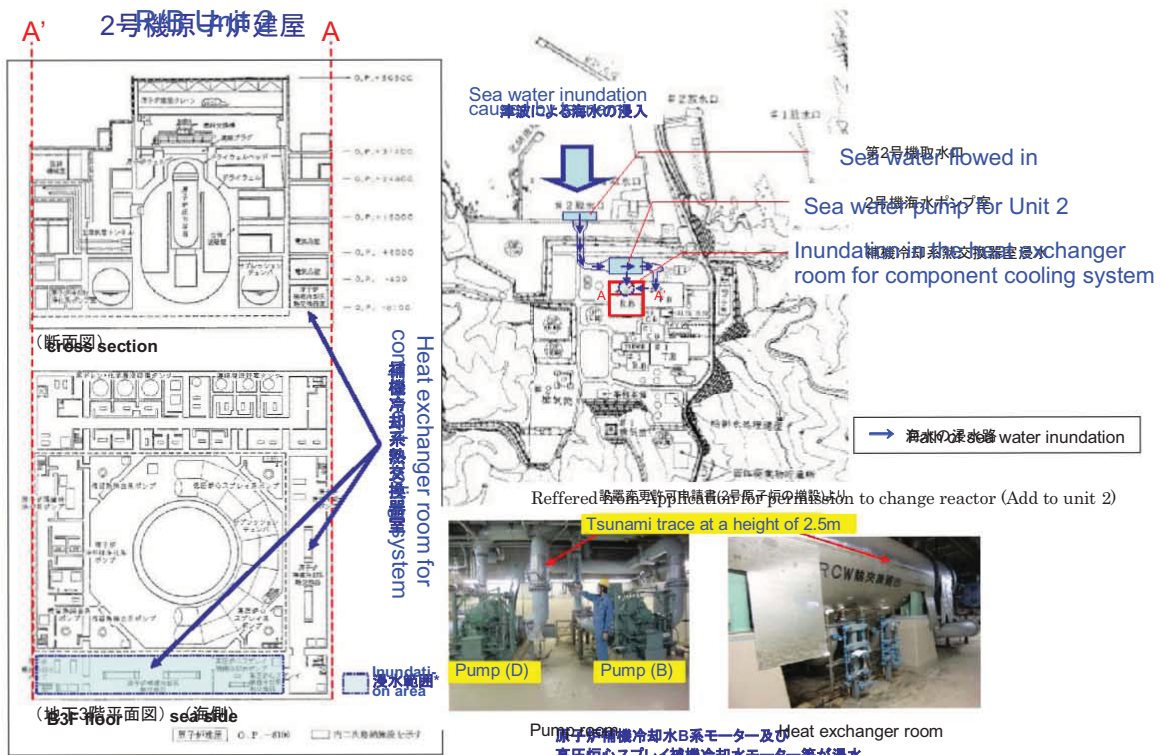
Fig. III-3-5(a) Inundation in the heat exchanger room for a component cooling system (1) at Onagawa NPS.

[Inundation pathway to Heat exchanger (B) room for component cooling system]

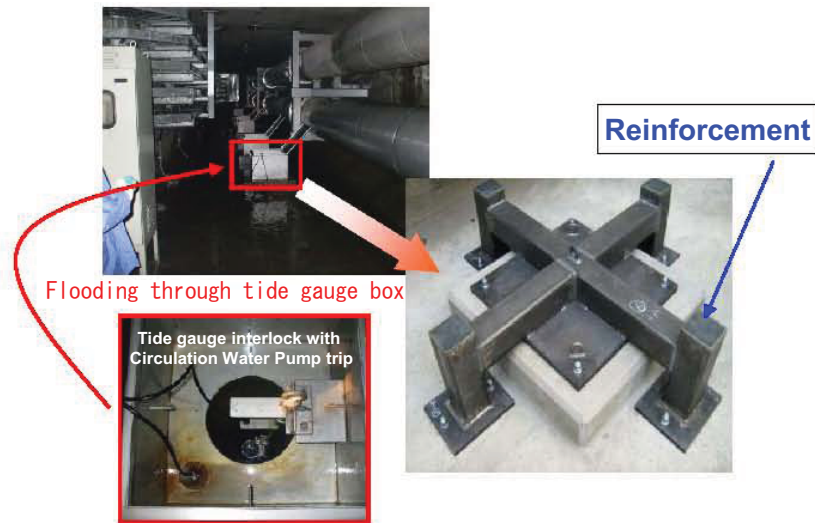
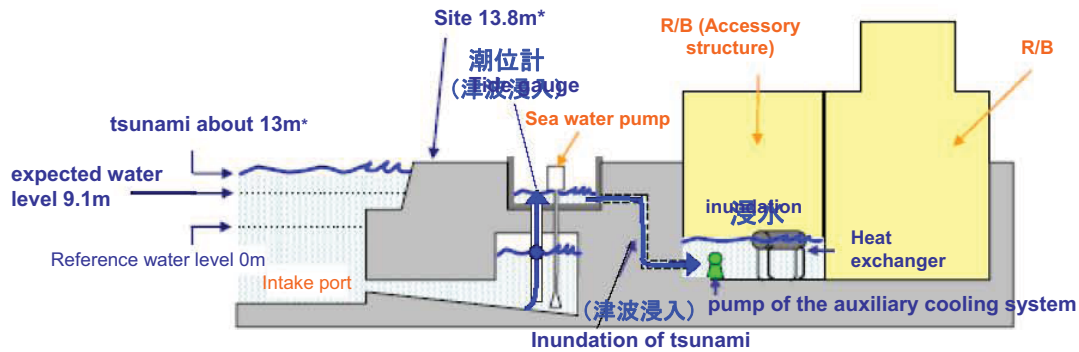
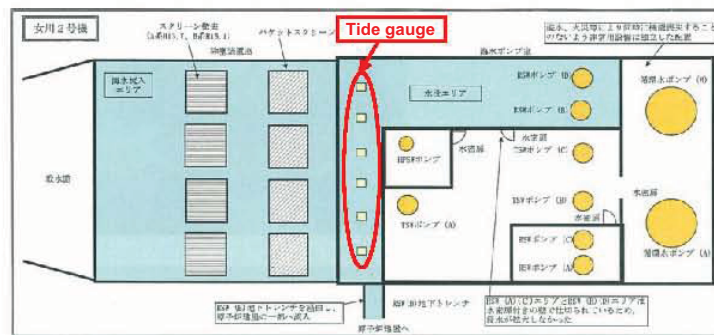
Fig. III-3-5(b) Inundation in the heat exchanger room for component cooling system (2) at Onagawa NPS.

*Subsidence of 1m at Onagawa site is considered

[Installation position of tide gauge interlock with Unit 2 Circulation Water Pump trip]

[Tsunami countermeasure for tide gauge]

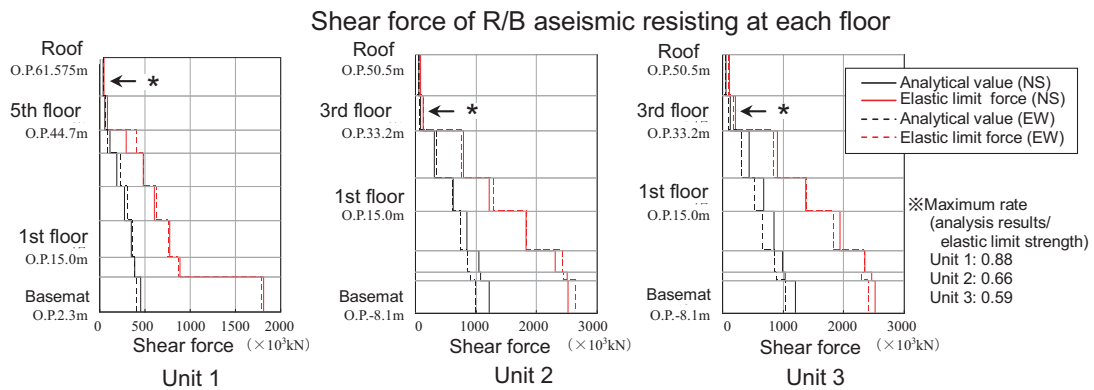
Fig. III-3-6 Verification of shear strain and shear force acted on seismic walls at each floor in R/Bs of Onagawa NPS.

* Standard values are established in JEAC4601-2008 (Japanese seismic design code for nuclear power plants; Japan Electric Association). They are twice the value of ultimate shear strain for reinforced concrete shear walls as safety factor.

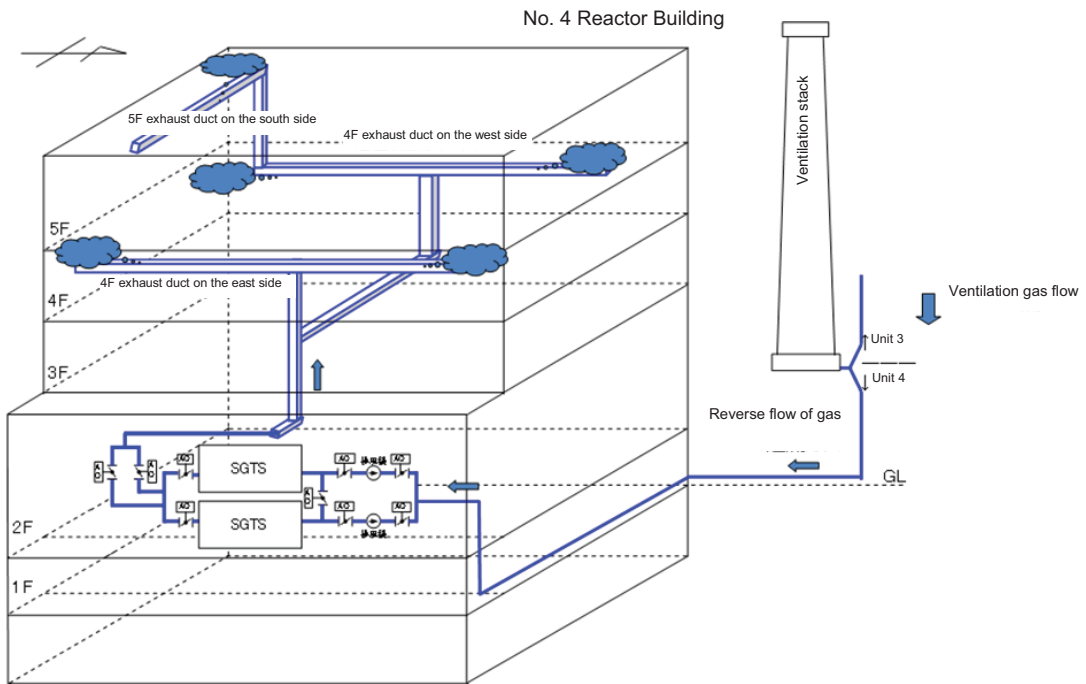
Fig. IV-5-10 Hydrogen flow route from Unit 3 to Unit 4 (estimated)

- (Explosion in the reactor building) At around 6:00 on March 15, an explosion in reactor building occurred, and all the walls above the bottom of the operation floor, and the walls on the west side and along the stairs collapsed. A fire broke out near the northwest corner on the 4th floor of reactor building at 09:38 on the same day. With regard to the explosion in the reactor building, one may doubt the possibility of inflow of hydrogen from unit 3 as the exhaust pipe for venting the PCV joins the exhaust pipe from unit 4 before the exhaust stack. However, the cause of explanation has not yet been identified.
