General Electric Advanced Technology Manual

Chapter 7.1

Brown's Ferry Fire Log Summary

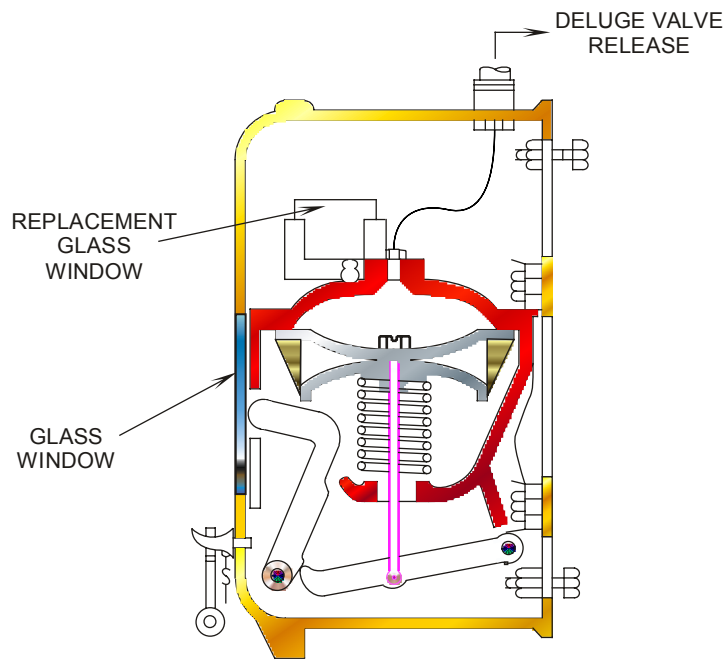
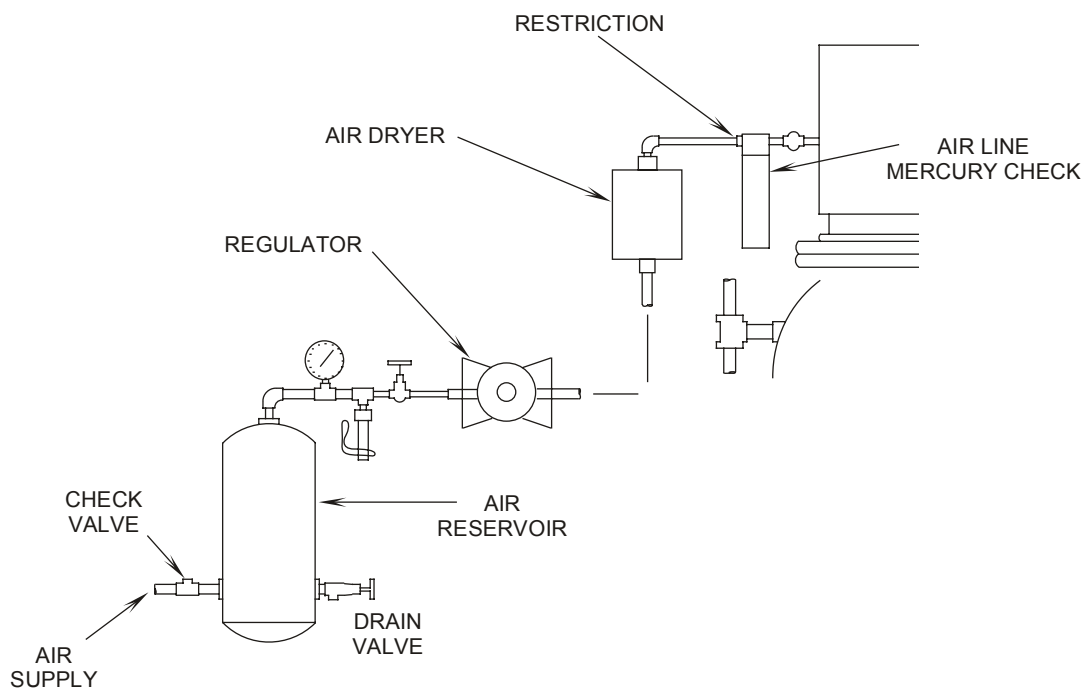
Figure 7.1-5

Contrary to these requirements, the fire protection system for the cable spreading room was not fully operational in that metal plates had been installed under the glass in the manual stations during the construction of the plant and had not been removed. The approval of the installation of the plates had not been documented prior to or subsequent to the issuance of the operating license and the installation had not been reviewed by PORC. Additionally, the CO₂ manual automatic initiation system had been electrically disabled by the construction workers without documented approval of the Plant Superintendent.
