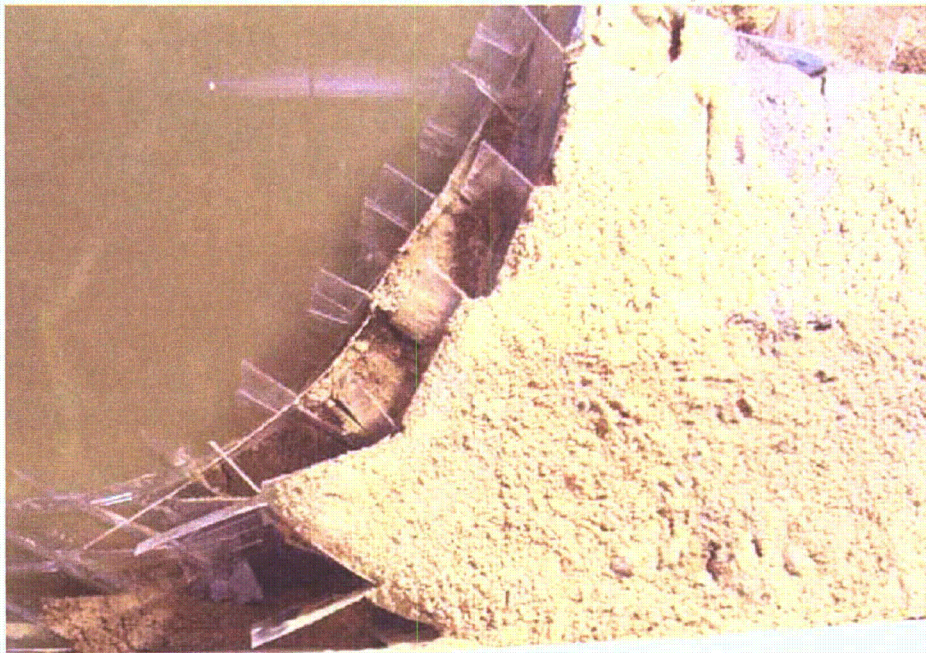
Figure 2-132. Left concrete wall abutment

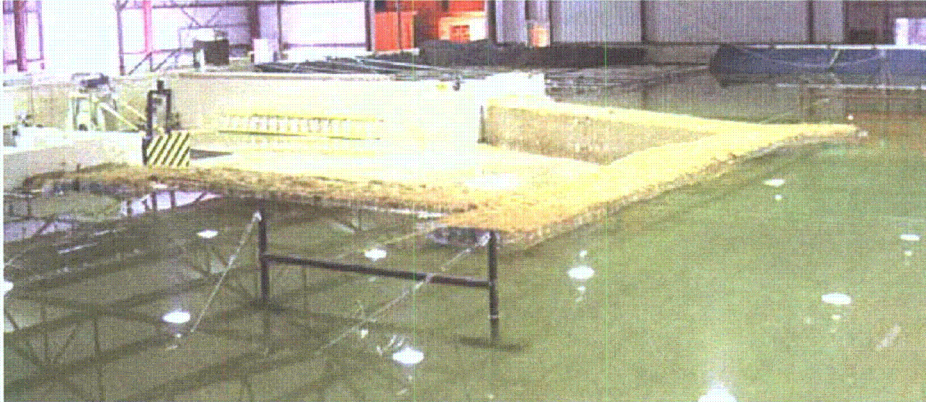
Hydrostatic head test, 3-ft reservoir (95 percent height). The water level in the reservoir on the pool side of the levee was raised to a height of 34 in. (95 percent of levee height) as shown in Figure 2-133. Seepage flow rate was measured in the range from 0.084 to 0.108 gpm/ft (Figure 2-134), and no displacement was observed. Figure 2-135 shows that most of the leakage was observed coming from the wall corners. Figure 2-136 shows settlement along the right outside edge.

Figure 2-133. View from pool side

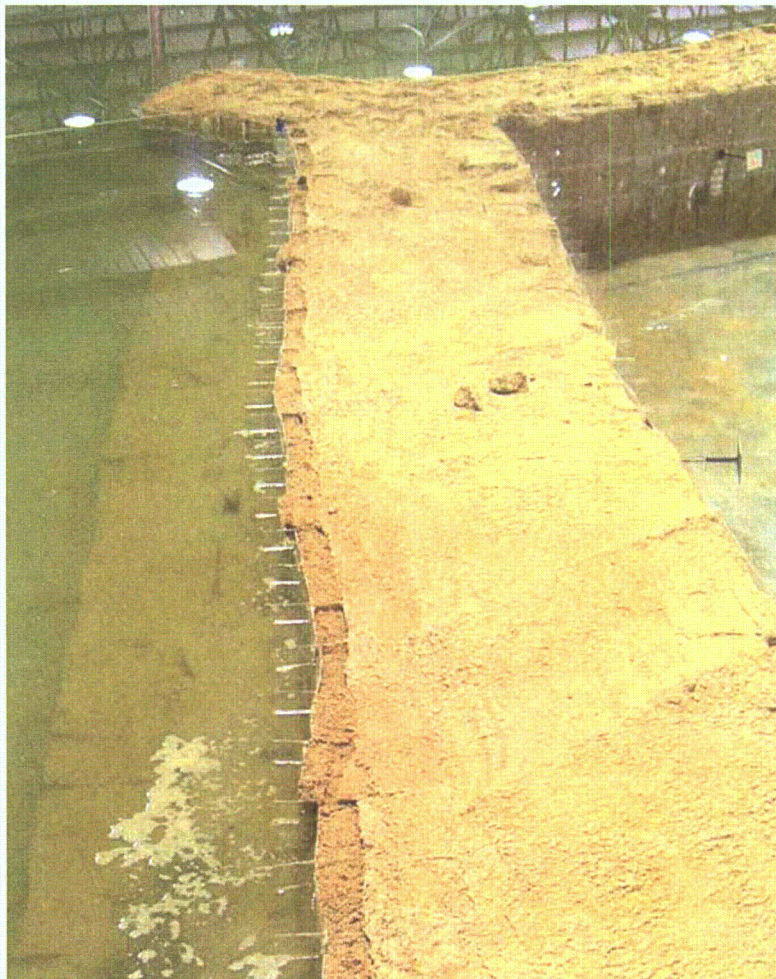
Figure 2-136. View looking down left wall

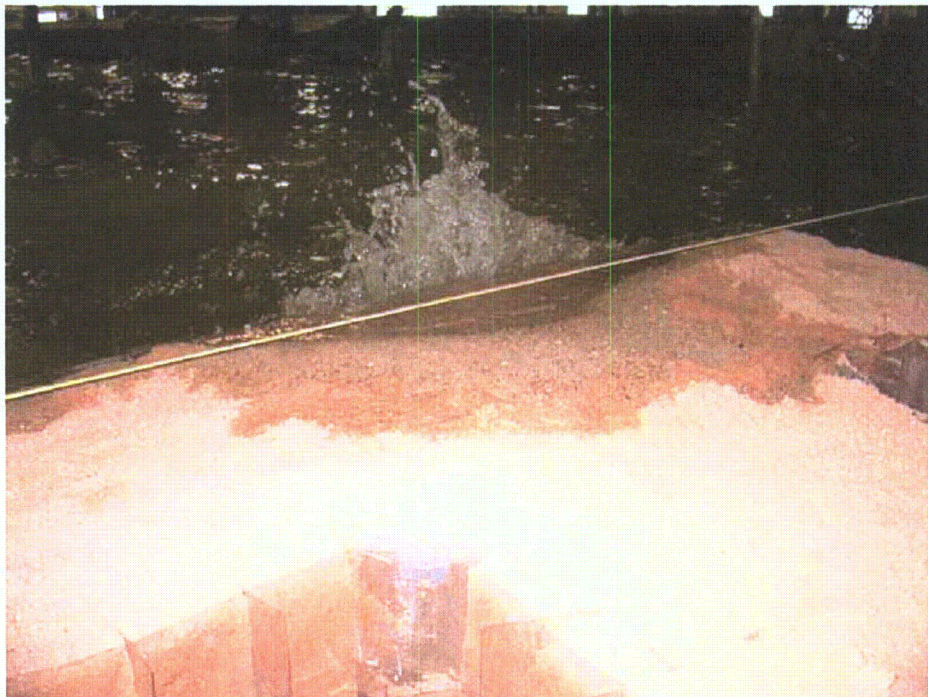
7- to 9-in. wave test, reservoir level at 66 percent levee height. The water level in the reservoir on the pool side of the levee was held at a height of approximately 24 in., the wave generator was activated, and the waves began to impact the levee. Seepage flow rate was measured in the range from 0.025 to 0.042 gpm/ft (Figure 2-140), and no displacement or overtopping was observed. Figure 2-141 shows wave impact against the center wall near the right buttress.

Figure 2-141. Wave impact against center wall

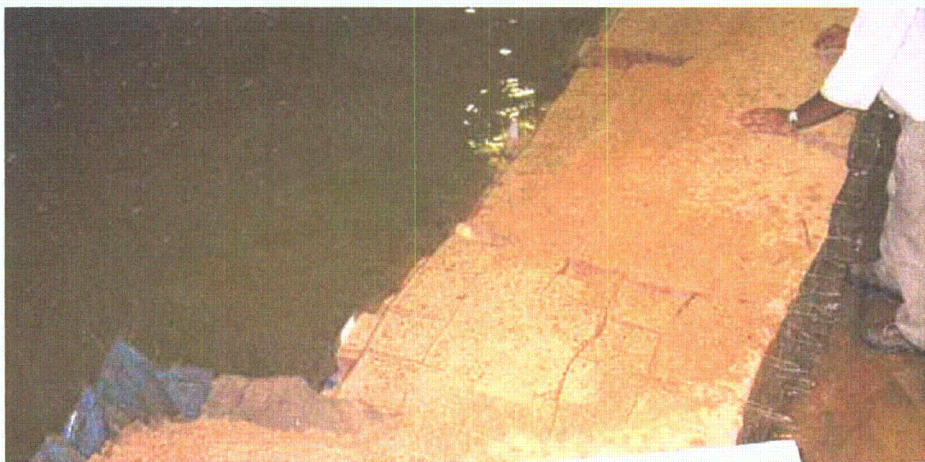
displacement was observed. Overtopping did occur sporadically, which contributed to the flow rate increase. Figure 2-143 shows aftermath of wave action against the left wall near the concrete wall abutment. Minor surface erosion was evident.

Figure 2-143. Surface erosion from wave action

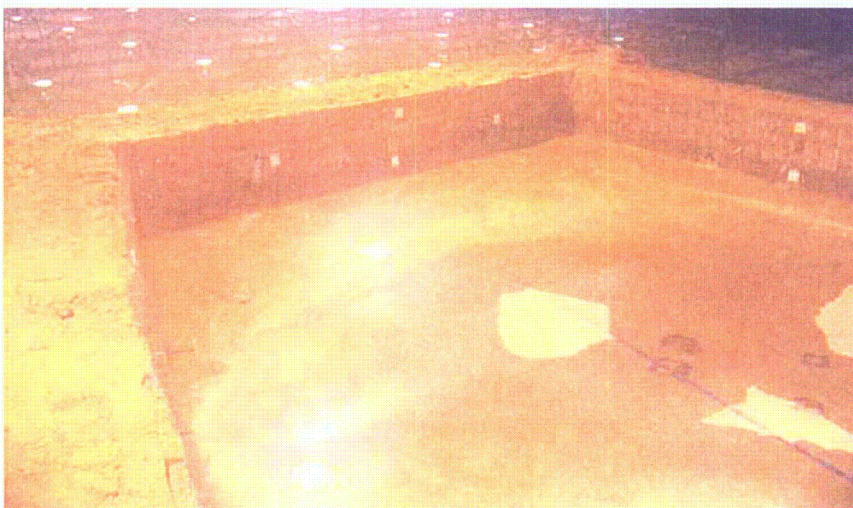
3-in. wave test, reservoir level at 80 percent levee height. The water level in the reservoir on the pool side of the levee was raised to a height of approximately 29 in., the wave generator was activated, and the waves began to impact the levee. Seepage flow rate was measured in the range from 0.039 to 0.046 gpm/ft (Figure 2-144), and no displacement was observed. No overtopping was observed, but some surface sand settling was observed (Figure 2-145).

Figure 2-145. View immediately after test showing some sand settling on left wall surface

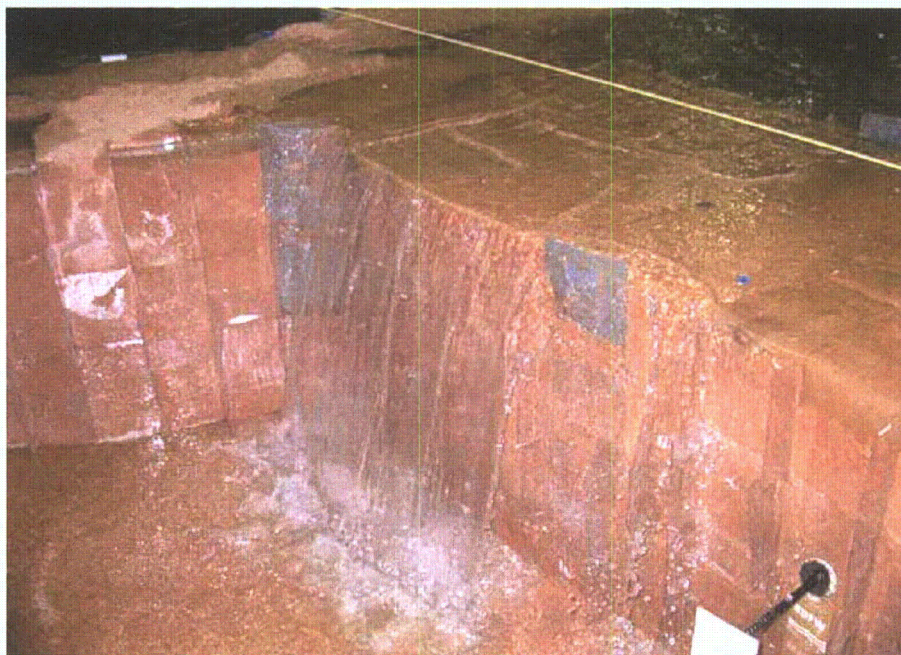
7- to 9-in. wave test, reservoir level at 80 percent levee height. The water level in the reservoir on the pool side of the levee was held at a height of 29 in., the wave generator was activated, and the waves began to impact the levee. Seepage flow rate was measured in the range from 0.048 to 4.48 gpm/ft (Figure 2-146), and no displacement was observed. Overtopping did occur sporadically, which contributed to the flow rate increase (Figures 2-147 and 2-148).

Figure 2-147. Sporadic wave overtopping at intersection of left and center walls

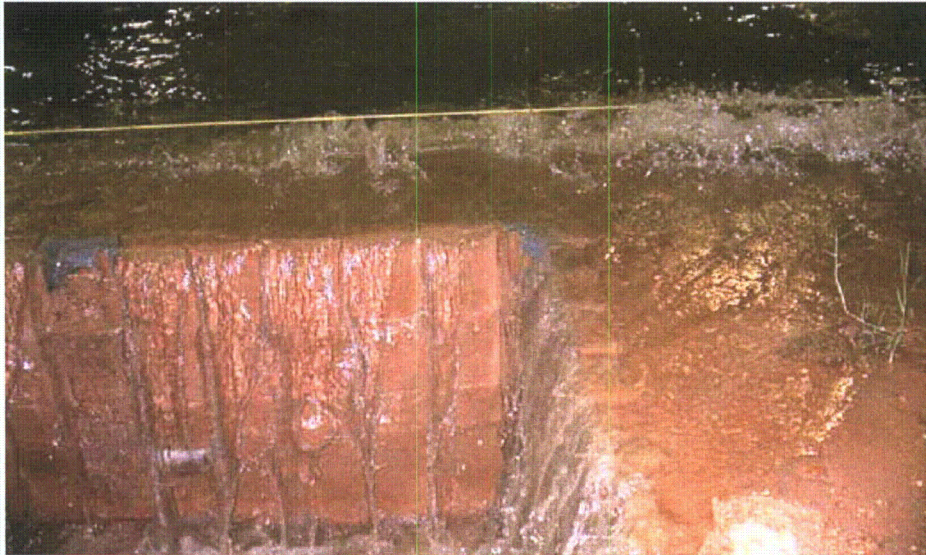
Figure 2-148. Sporadic wave overtopping at intersection of right and center walls

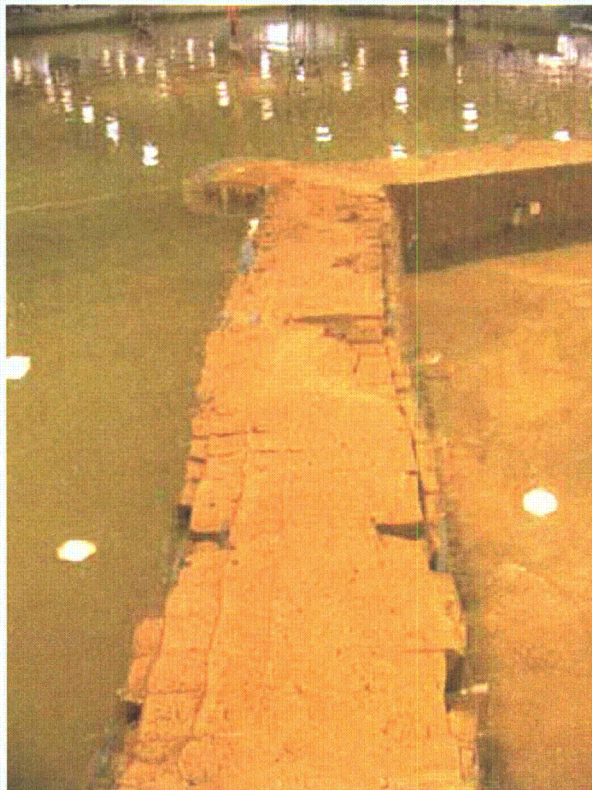
At the conclusion of the test, the condition of the levee structure was observed. As seen in Figures 2-149 and 2-150, minor surface erosion resulted from the sporadic wave overtopping action.

Figure 2-149. Surface erosion on left wall at conclusion of test

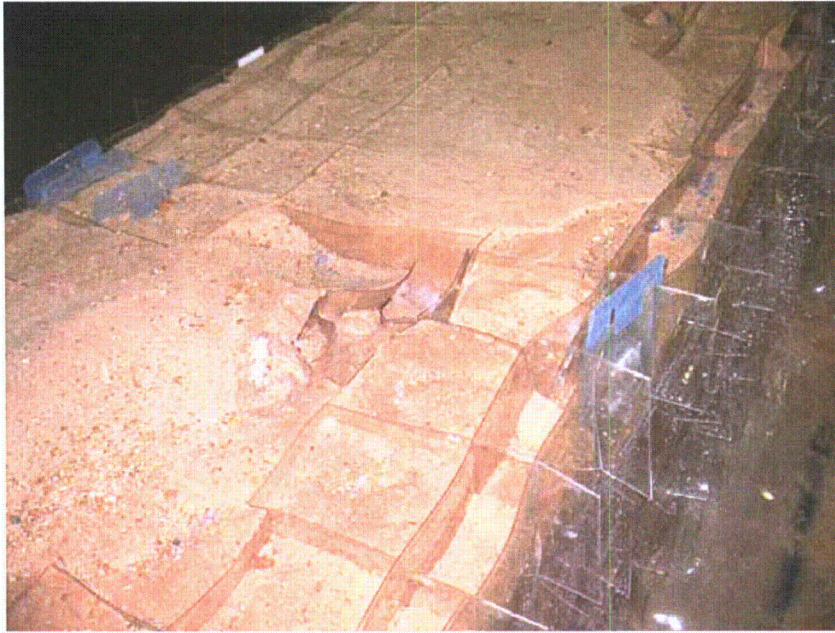
Figure 2-150. Close-up of surface erosion on left wall

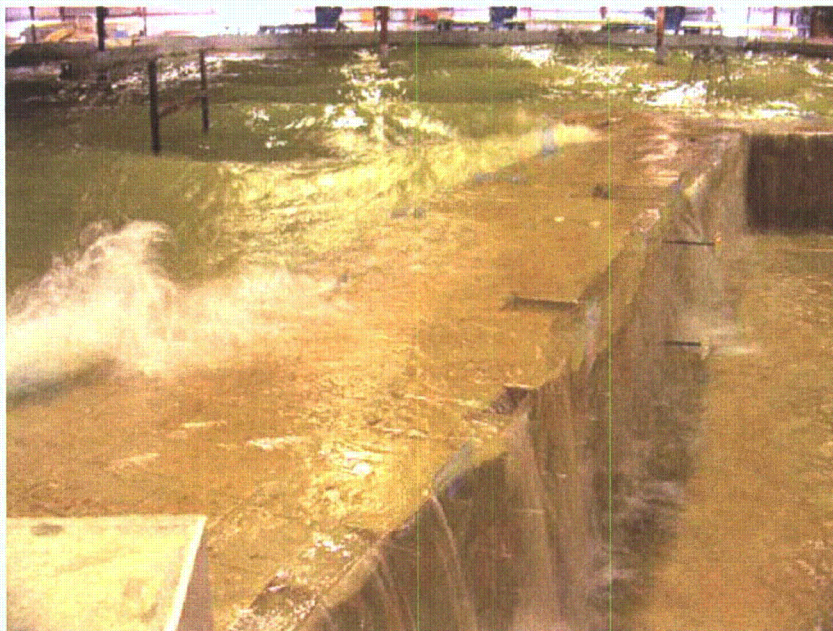
Figure 2-151. Waves overtopping left wall

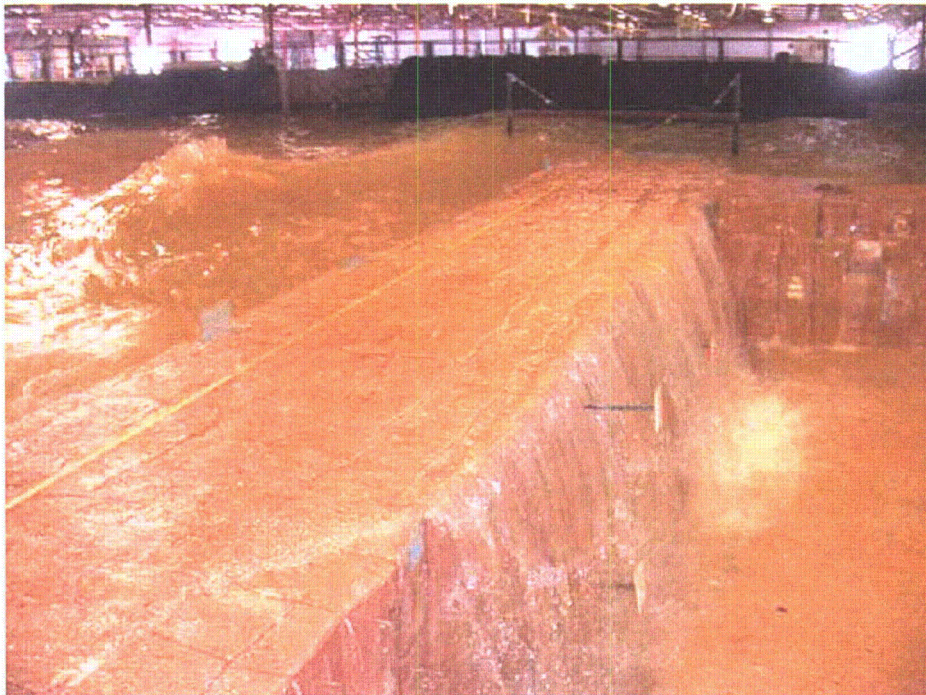
10- to 13-in. wave test, reservoir level at 80 percent levee height. The water level in the reservoir on the pool side of the levee was held at a height of 29 in., the wave generator was activated, and the waves began to impact the levee. Seepage flow rate was measured in the range from 0.08 to 8.85 gpm/ft (Figure 2-151), and no displacement was observed. Overtopping occurred with each wave front (Figures 2-152 and 2-153).

Figure 2-153. Waves overtopping center wall

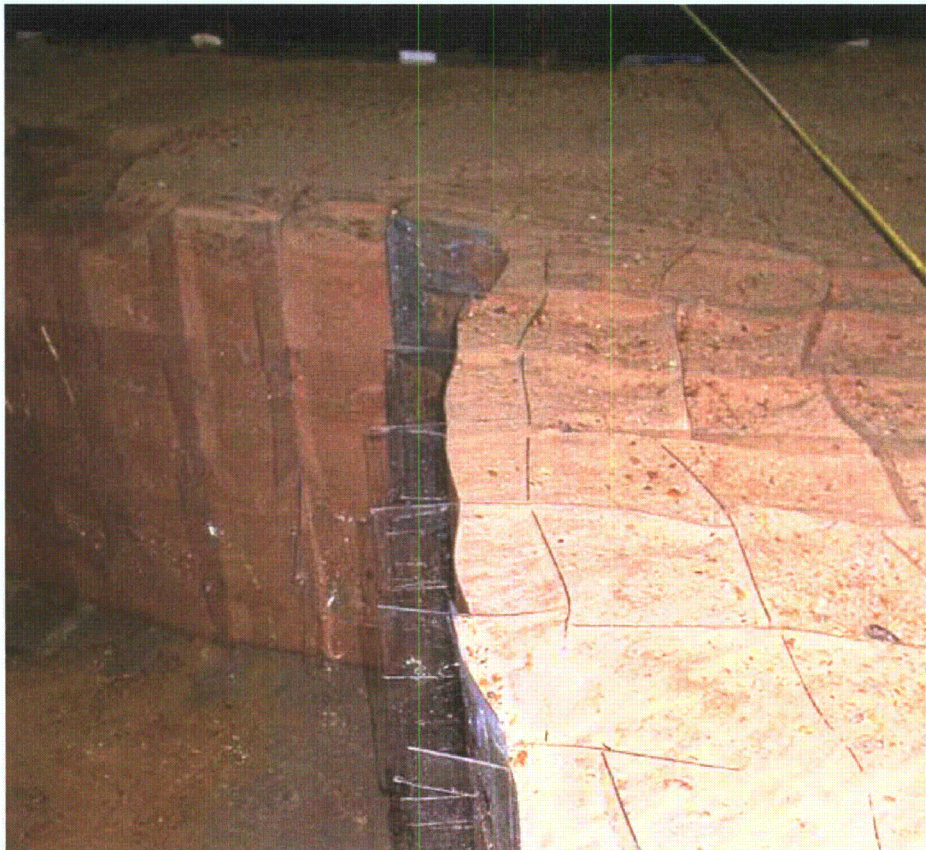
Figures 2-154 and 2-155 are close-ups of the surface erosion observed at the test conclusion.

Figure 2-155. Close-up at intersection of left and center walls

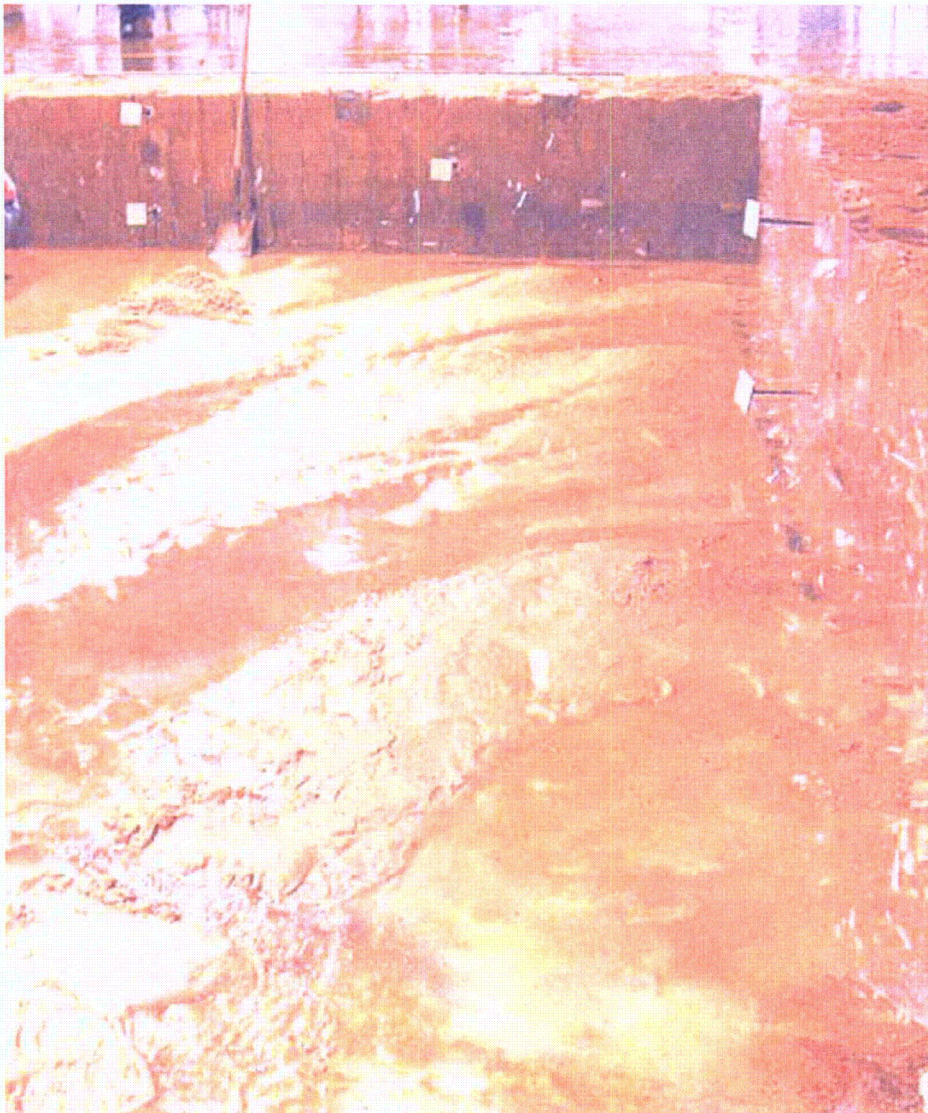
Figure 2-159. Eroded sand deposited on floor (view toward center and right walls)

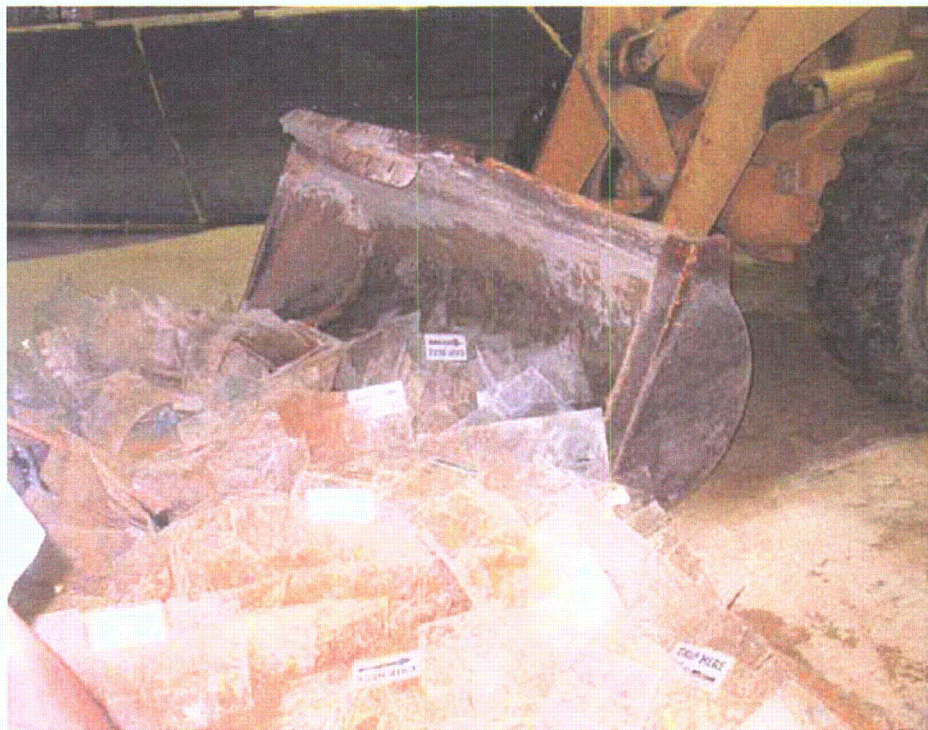
Due primarily to the effects of disassembly, approximately 10 percent of the plastic material was nonreusable and nonrepairable. According to the manufacturer's literature, normally-anticipated breakage is repaired by replacing the broken grid unit piece or by reinforcing the broken piece. Manufacturer stipulations apply regarding reusability and placement of repaired grid units back into service.

Figure 2-183. Some nonreusable grid units

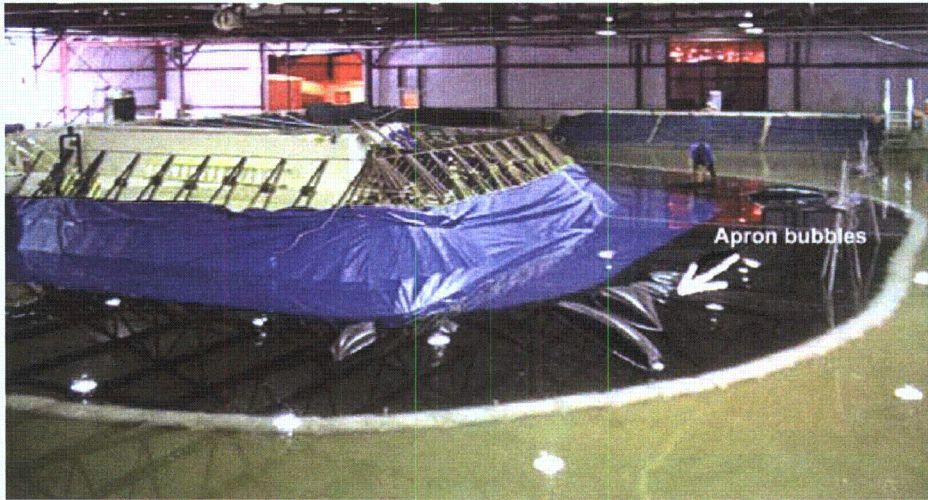
Hydrostatic head test, 1-ft reservoir (33 percent height). The water level in the reservoir on the pool side of the levee was raised to a height of 1 ft (33 percent of levee height). As the initial pool elevation began to rise, some air pockets under the apron were observed. The supervisor walked out and placed a few sandbags on these air pockets to flatten them out (Figure 2-215). The barrier had very little water seepage, ranging from

Figure 2-215. Air bubbles beneath apron

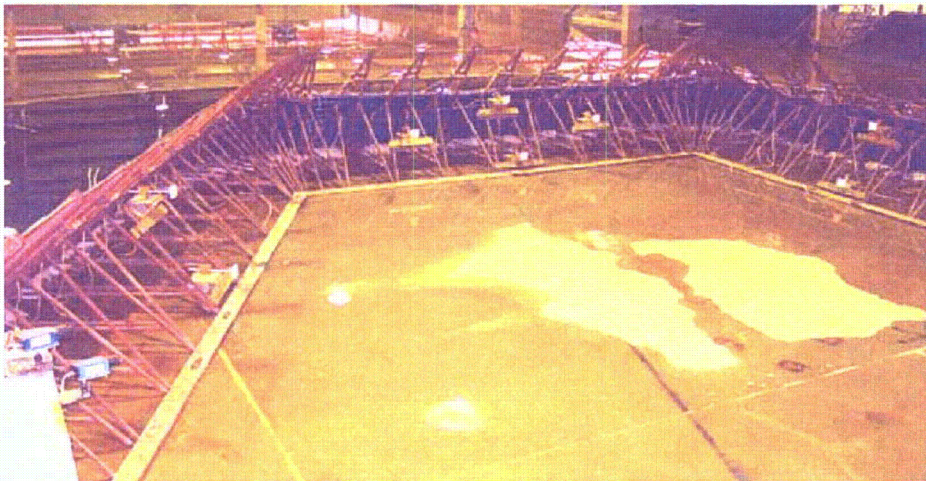
0.08 to 0.11 gpm/ft (Figures 2-216 and 2-217). Zero displacement was observed. Prior to the next test, Repair 1 was performed (discussed in the following paragraphs).

Figure 2-216. Under-apron seepage at 1-ft hydrostatic test
