Field Installation and Performance of Sandbag Barrier

Field Installation and Performance of Hesco Bastion Concertainer

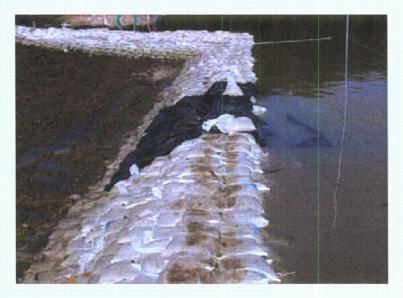
During the field test, seepage was collected in a buried concrete tank (Figure 3-51a, b). Seepage rates were determined by computing the change in volume in the tank over a specific time. As the water level against the structure rose, the seepage rates increased. The first photo was taken on 5 June 2004 while the seepage rate was low. The second photo was taken on 6 June 2004 when the seepage rate had increased. Figure 3-52 is a photo of the seepage observed through the overlapping sandbags. Figure 3-53 shows the seepage water on the protected side of the structure. To compare seepage rates for all four structures, the wetted area for each structure for given water surface elevations was computed (Figure 3-54). The seepage rate for the sandbag structure exceeded 4,500 gal/hr when the structure had almost 700 sq ft of wetted area. The rate of seepage increased markedly when the wetted area reached 500 sq ft. As the seepage rate increased, an attempt was made to reduce the seepage by draping the east tieback with plastic sheeting and weighting the sheeting with sandbags (Figure 3-55a, b). The draping of the sheeting did not decrease the flow of water through the structure. The plastic sheeting was also draped over a low section of the riverward face to protect against concentrated flow (Figure 3-56). These were the only modifications made to the sandbag structure.

Figure 3-56. Plastic sheeting over riverward face

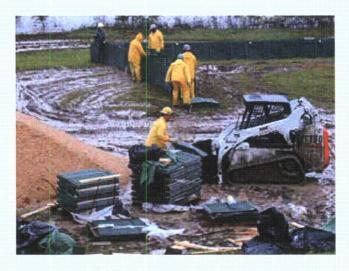
Figure 3-73. Construction of base row tieback section

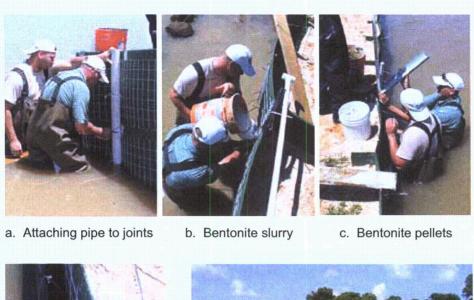
The second repair was made on 9 June. This repair consisted of attaching half sections of 4-in. PVC sewer pipe across the unit joints with zip ties. Bentonite slurry, dry powder, and pellets along with sand was poured into the top of the pipes and packed down (Figure 3-92). Hesco representatives expected the bentonite in the pipes to swell and seal the joints. This repair was made with just over 3 ft of water against the structure. After the pipes were installed, the seepage rate continued to increase. Once the river levels dropped after the testing was completed, the Hesco Bastion structure was visually inspected. Apparently, an excess of bentonite was packed into the pipes. As the bentonite swelled, the pipes were pushed away from the joints thus providing no sealing of the joints.

Figure 3-92. Attempt to reduce seepage using bentonite

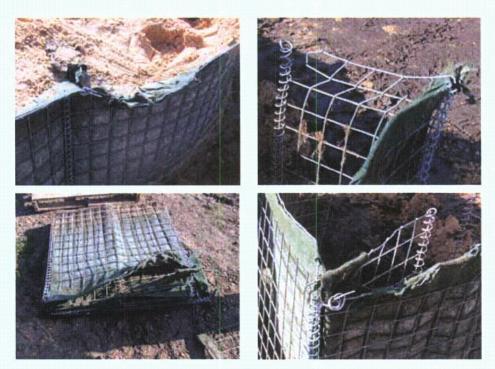
Table 3-4 shows that the Hesco Bastion units received limited damage with over 95 percent of the side panels, over 96 percent of the cross panels, and over 98 percent of the coils reusable. Damaged or cut pieces can be replaced, making the unit reusable. All damage to the Hesco Bastion units occurred during removal. The damage can be directly attributed to the use of heavy machinery. Once the top row units were removed, a frontend loader was used to scrape the remaining sand from these units off of the bottom row units, which damaged some panels and coils. Also, the front-end loader and chains were used to hoist some of the bottom row sections that were heavily weighted with sand. This lifting damaged some panels to which the chains were attached. Figure 3-104 provides examples of the damage that the units experienced during the removal process.

Figure 3-104. Units damaged during removal process
