## Hydrostatic head tests

## **RDFW® Levee Tests**

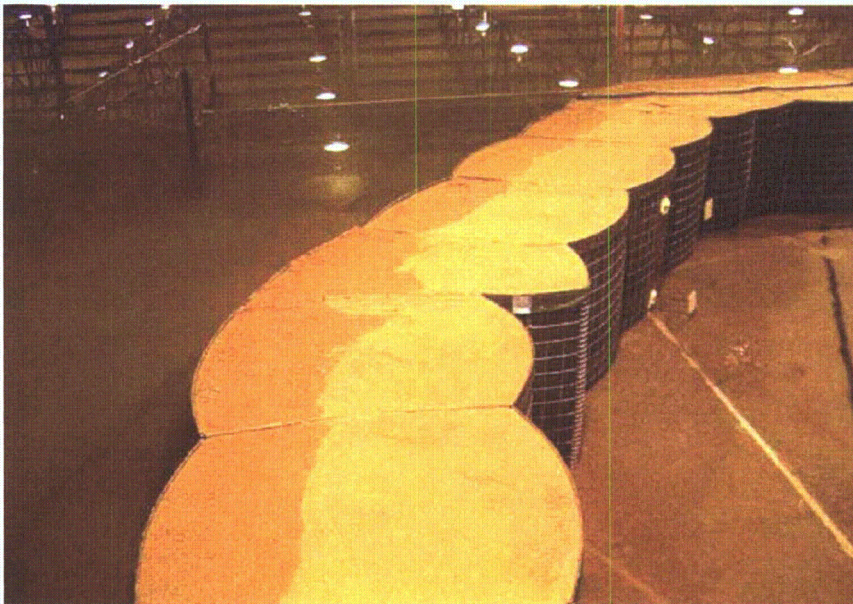
Figure 2-63 shows the wetting front observed on top of the structure as the water saturated the dry sand. Figure 2-64 is a close-up of seepage occurring at a vertical joint between units.

Figure 2-63. View of left wall water saturation

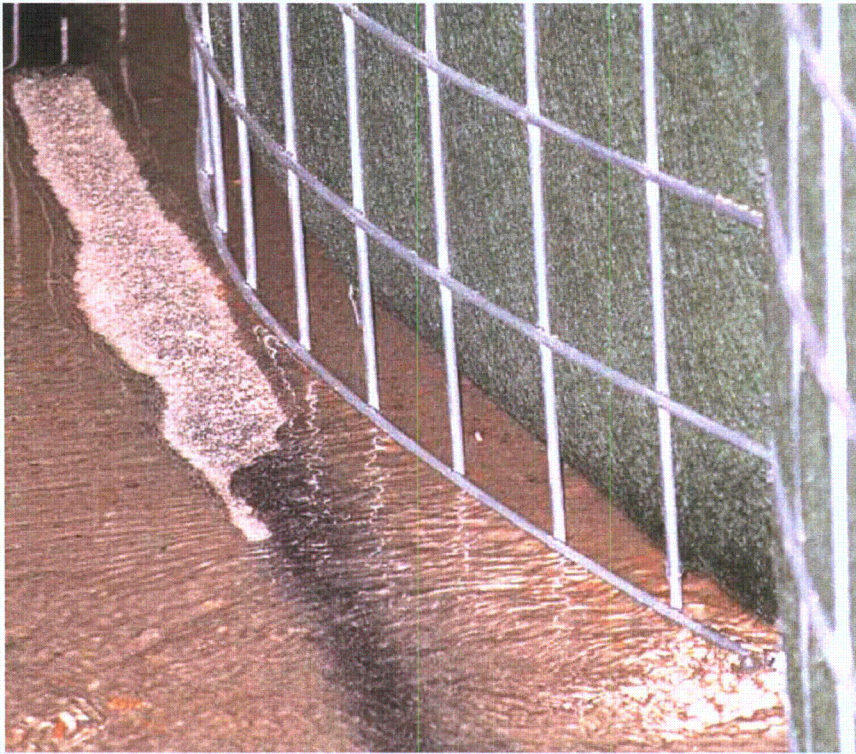
Figure 2-64. Close-up of seepage through vertical joint between units

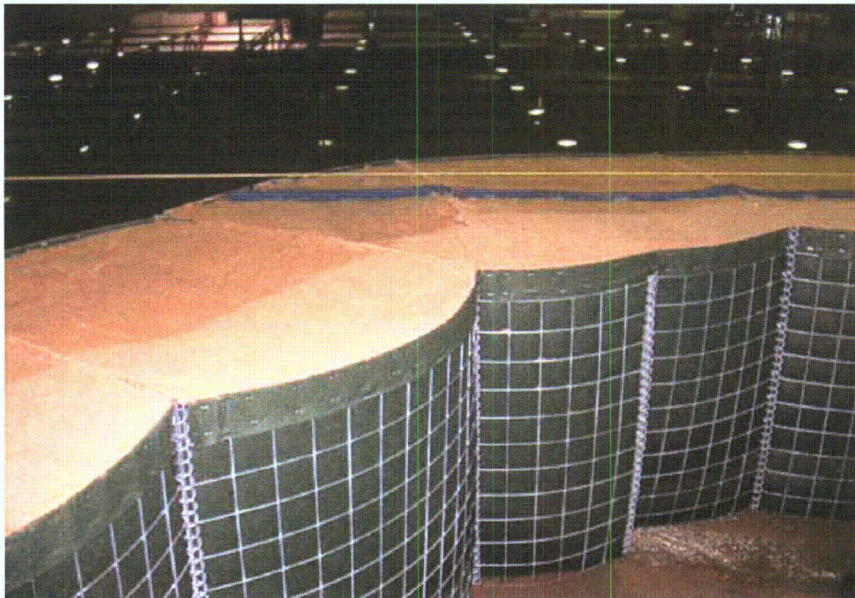
**3-in. wave test, reservoir level at 66 percent levee height.** The water level in the reservoir of the levee was lowered from the 95 percent level to a height of 24 in. within an interval of about 2 hr. The wave generator was activated and the waves began to impact the levee. Flow rate was observed to range from 0.81 to 0.83 gpm/ft (Figure 2-68), with no displacement. No wave overtopping was observed. Figure 2-69 is a view of the left wall and center wall intersection showing seepage at the wall base.

Figure 2-69. Left wall and center wall intersection

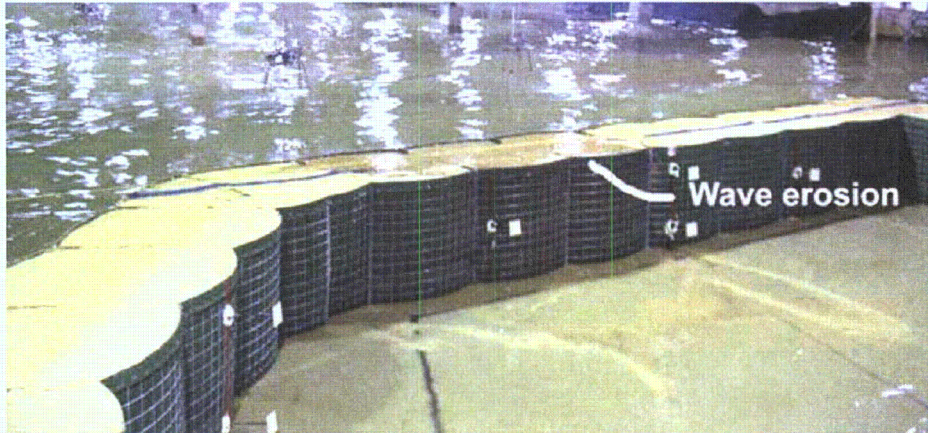
**10- to 13-in. wave test, reservoir level at 66 percent levee height.** The water level in the reservoir on the pool side of the levee was held at a height of 24 in., the wave generator was activated, and the waves began to impact the levee. Flow rate was observed to range from 0.78 to 0.98 gpm/ft (Figure 2-71), with no displacement. Minor sporadic wave overtopping was observed, primarily along the center wall (Figure 2-72).

Figure 2-72. Center wall wave-induced erosion

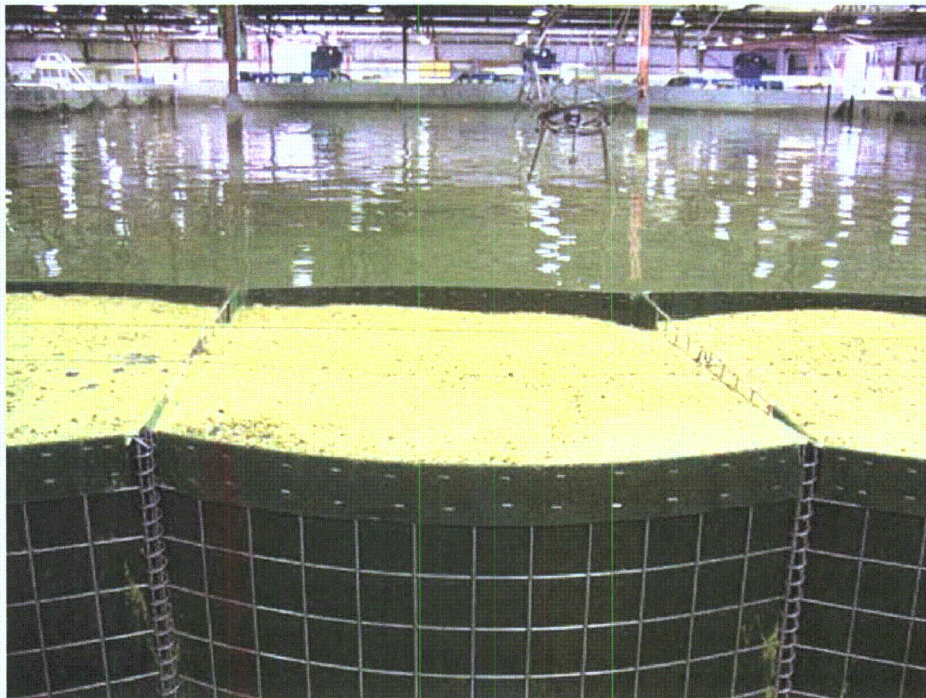
At the conclusion of the test, sand had eroded and settled from the top of the center wall (Figure 2-73), and a solution was devised to prevent further erosion during subsequent testing. As shown in Figures 2-74 and 2-75, a tarp covering was placed on the wall top and secured with cable ties.

Figure 2-73. Sand eroded from top of center wall

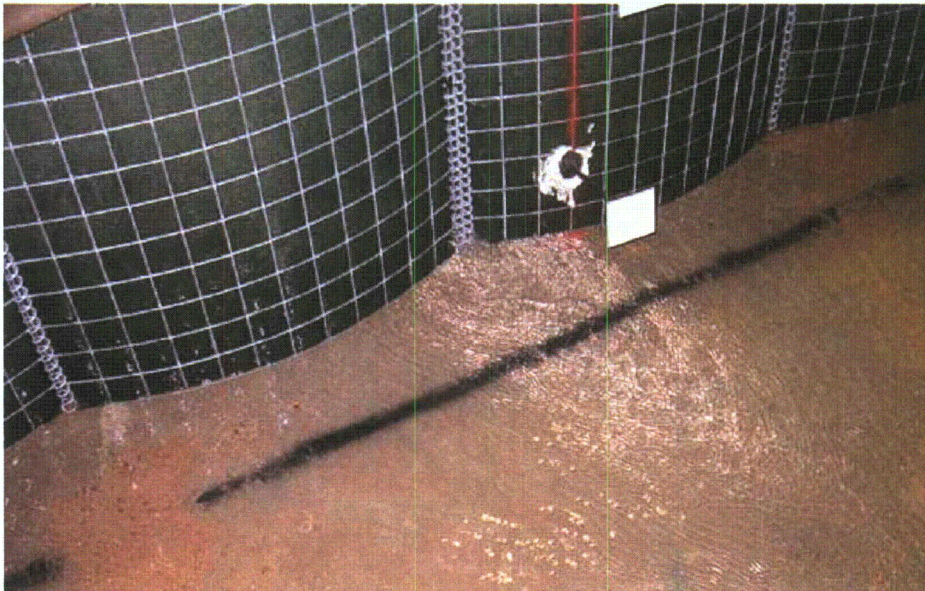
was activated, and the waves began to impact the levee. Flow rate was observed to range from 1.03 to 1.04 gpm/ft (Figure 2-76), with no displacement. No wave overtopping was observed. Figure 2-77 shows seepage under the center wall base.

Figure 2-77. Seepage at vertical joint and wall base

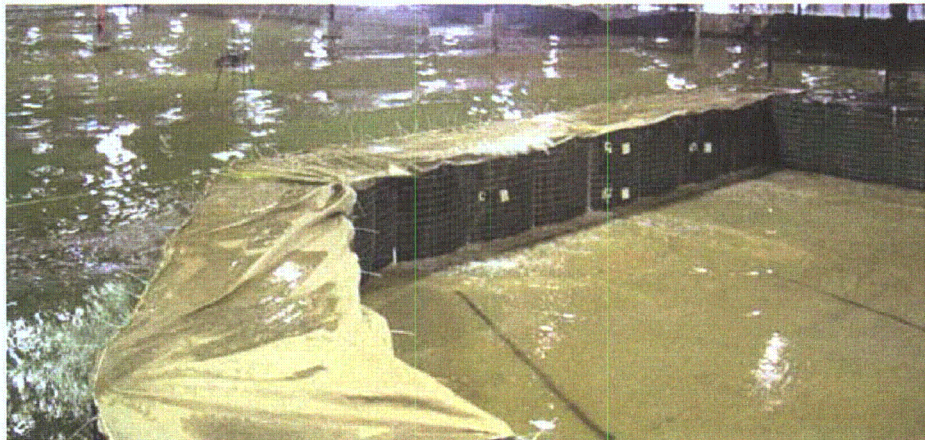
**10- to 13-in. wave test, reservoir level at 80 percent levee height.** The water level in the reservoir on the pool side of the levee was held at a height of 29 in., the wave generator was activated, and the waves began to impact the levee. Flow rate was observed to range from 1.05 to 3.14 gpm/ft (Figure 2-80), with no displacement. Wave overtopping was observed at each wave front, which contributed to the significant flow rate increase. Figure 2-81 shows wave overtopping.

Figure 2-81. Wave overtopping along center wall

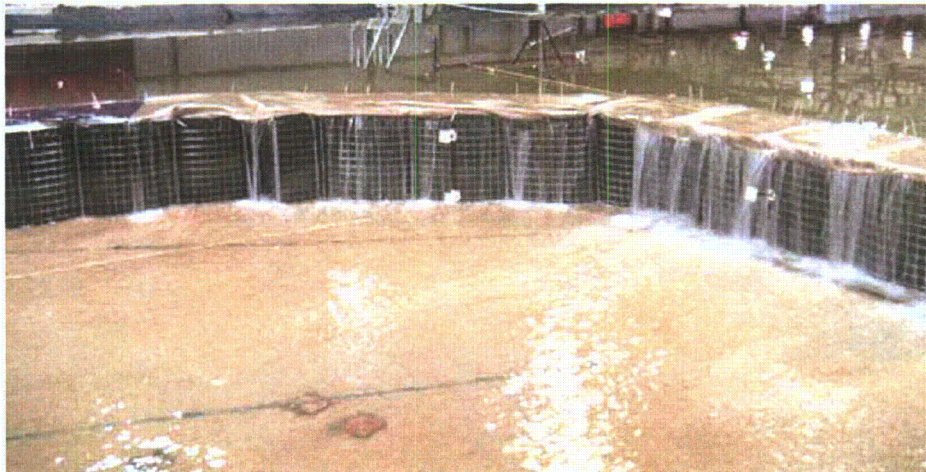
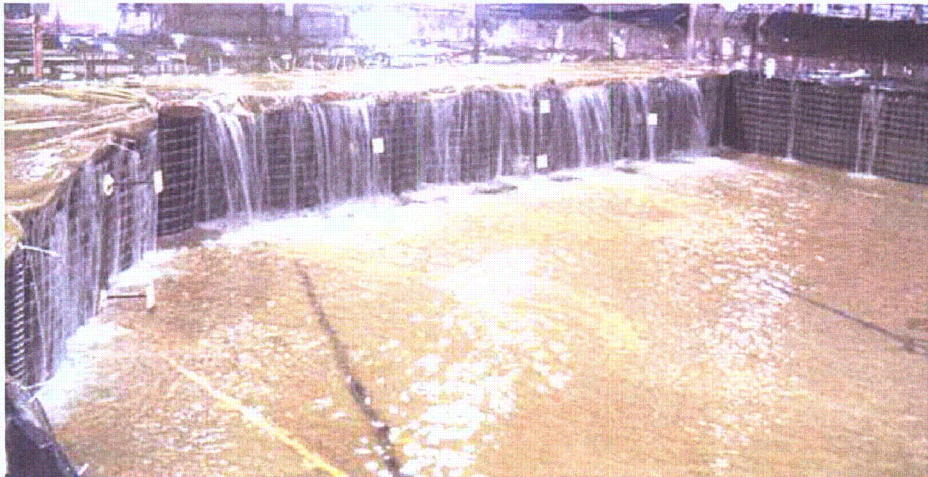
withstood overtopping without failure. Overtopping water combined with seepage water to increase the measured flow rate within a range of 25.2 to 35.0 gpm/ft (1,800 to 2,500 gpm) in the span of 1 hr as shown in Figure 2-82. The overflow was uniform due to the uniform levee height. Figures 2-83 and 2-84, show the overtopped levee.

Figure 2-83. Overtopped levee structure, view from right wall

Figure 2-84. Overtopped levee structure, view from left wall

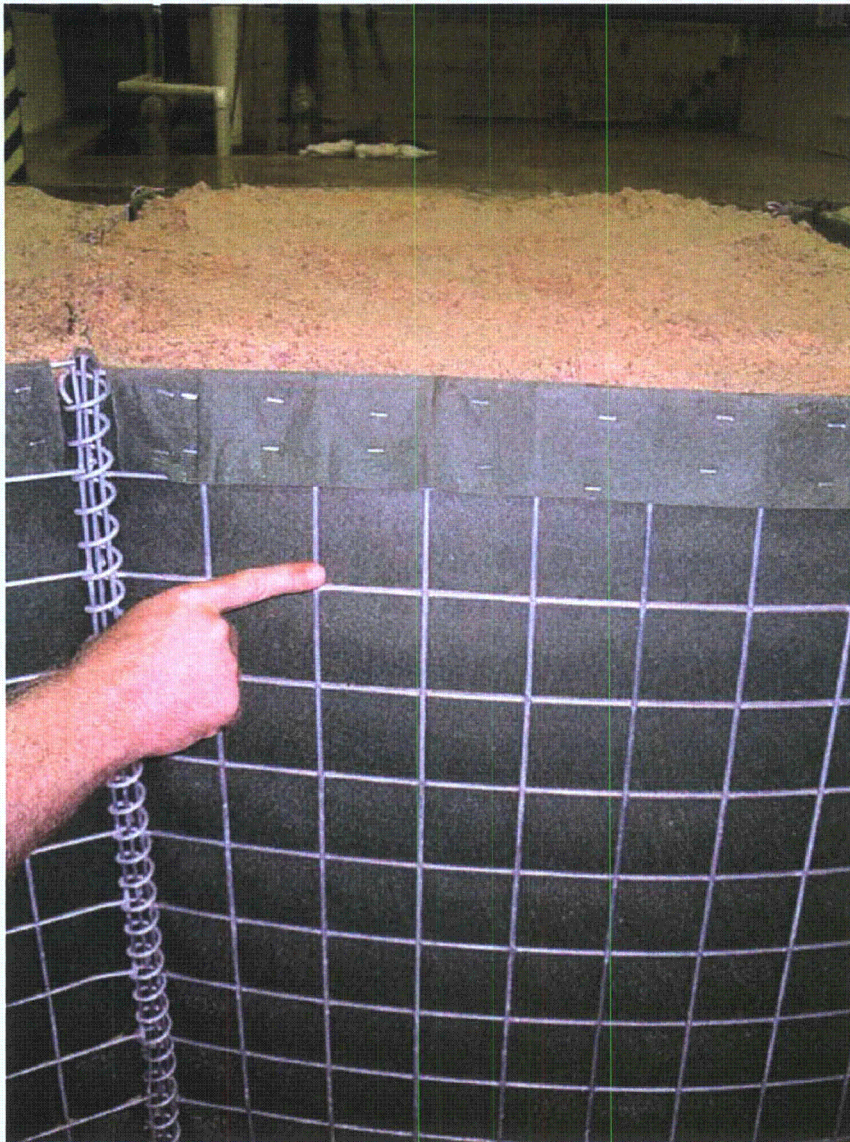
With reservoir level at 24 in., the log impact tests were begun. The 12-in. log impacted the structure and bounced back without causing noticeable damage. The structure displaced slightly and recovered to its original position. The 16-in. log impacted the structure and bounced back also without causing any noticeable damage. The structure displaced slightly and recovered to its original position, but vertical deformations of the sand fill ranging from 4.02 to 0.72 in. were noted. Figure 2-85 shows the minor change in seepage flow rate during impact testing and Figure 2-86 shows the area where the logs hit, viewed from the pool side.

Figure 2-86. Log impact zone on center wall, pool side

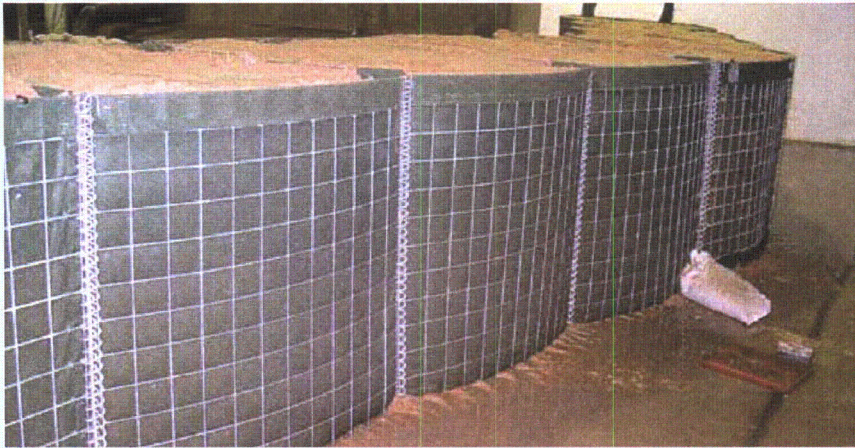
Figure 2-88. Added sandbag along left wall

Repair 2 was performed prior to overtopping. It took three men 5 min (0.25 man-hours) to add prefilled sandbags on the pool side for additional protection against joint seepage (Figure 2-88). Repairs 3 and 4 were not needed.
