From: Munday, Joel - R2
Sent: Monday, August 29, 2011 7:28 AM
To: Rivera-Ortiz, Joel
Subject: FW: Documents Related to North Anna NPP Earthquake Issue
Attachments: North Anna Site Visit Notes.word.docx; Talking Points for North Anna NPP Seismic Event final.word.docx; FW: North Anna timeline

North Anna Site Visit Notes (Week of August 22, 2011)

Talking Points for North Anna NPP Seismic Event

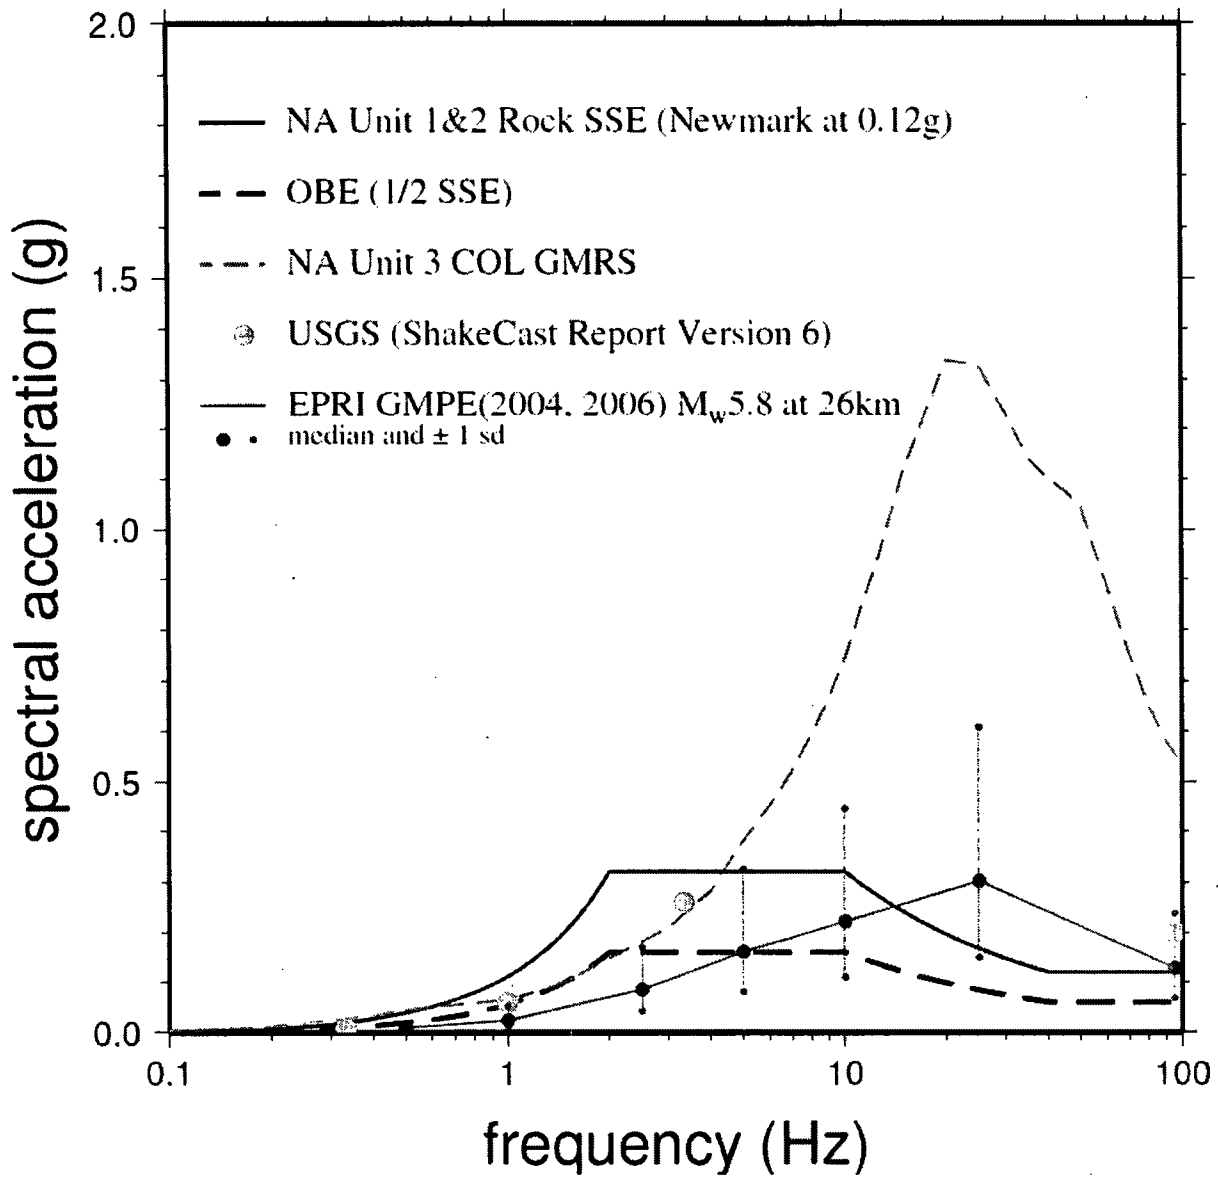
- NRC staff performed an independent analysis using the best estimate of the earthquake location and magnitude together with the EPRI ground motion prediction equations. The staff's calculation is lower than USGS' estimate on the ground motion at the site (see attached Figure).
