2011 Annual Site Inspection and Monitoring Report for Uranium Mill Tailings Radiation Control Act Title I Disposal Sites

January 2012

**U.S. Department of Energy
Office of Legacy Management**

**2011 Annual Site Inspection and Monitoring Report
for
Uranium Mill Tailings Radiation Control Act
Title I Disposal Sites**

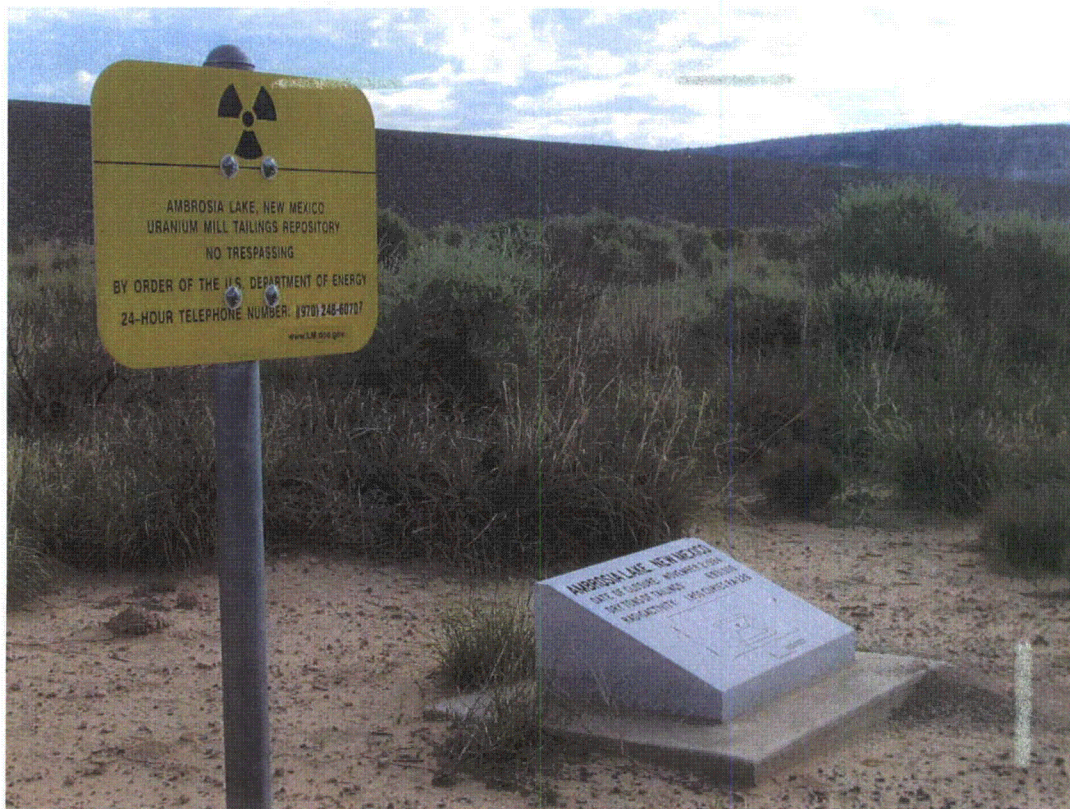
The entrance sign and all perimeter signs were in good condition (PL-1). Posts for perimeter signs P1 through P15 include mining restriction-area warning signs.

AMB 8/2011. PL-1. Entrance sign and site marker SMK-1.

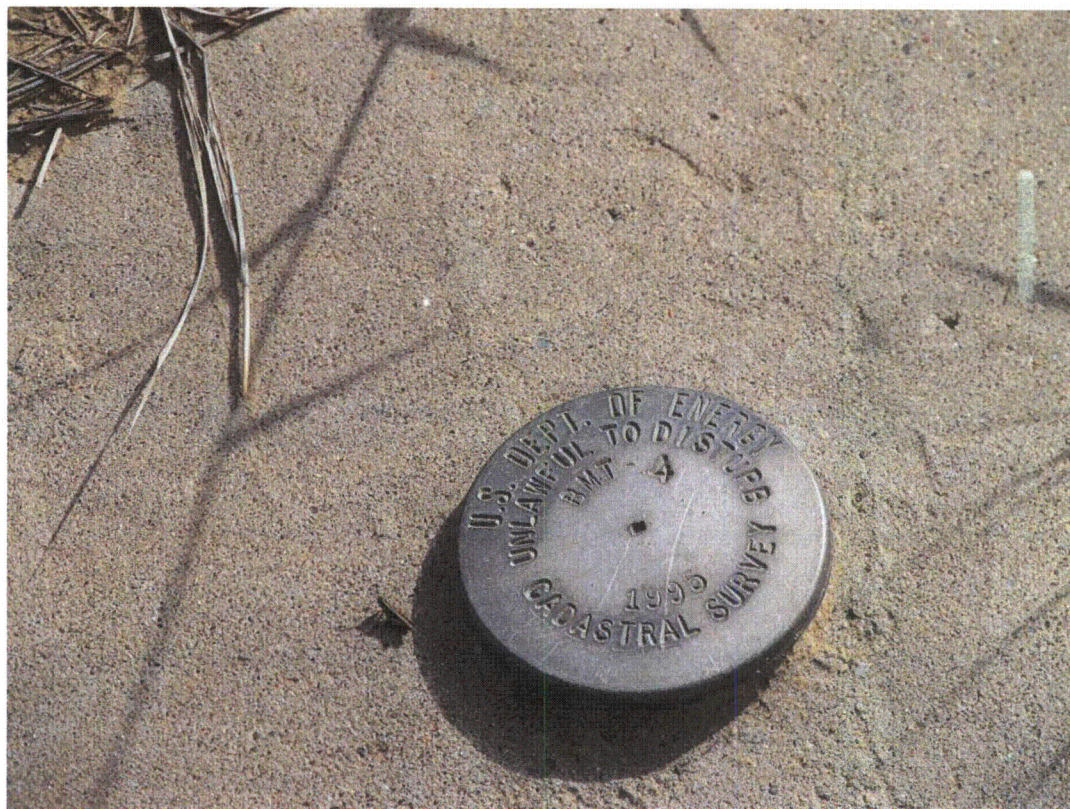
Site Markers and Monuments—The two granite site markers, three combined survey and boundary monuments, and five additional boundary monuments were all undisturbed and in excellent condition (PL-2).

AMB 8/2011. PL-2. Boundary monument BM-4.

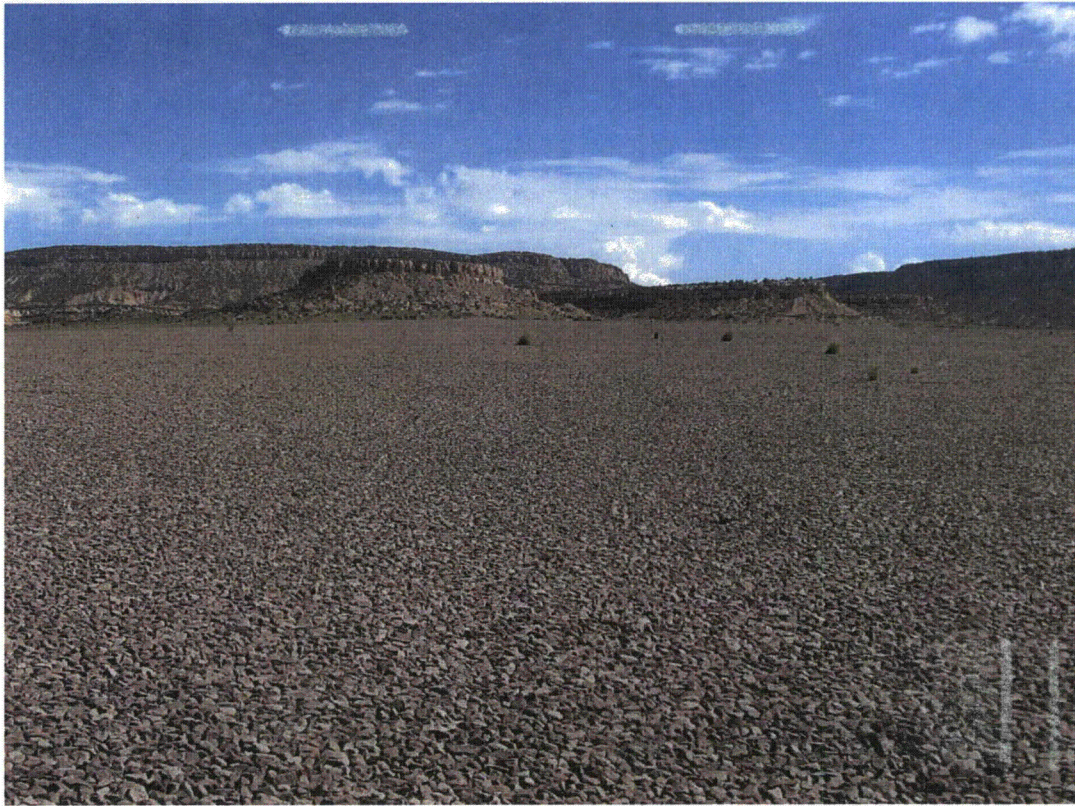
Top of Disposal Cell—The 91-acre disposal cell was completed in 1994. The basalt riprap-covered top of the disposal cell was in excellent condition. There was no evidence of cracking, slumping, or erosion (PL-3). No deep-rooted shrubs were present at the time of the inspection.

AMB 8/2011. PL-3. View northeast across the disposal cell cover.

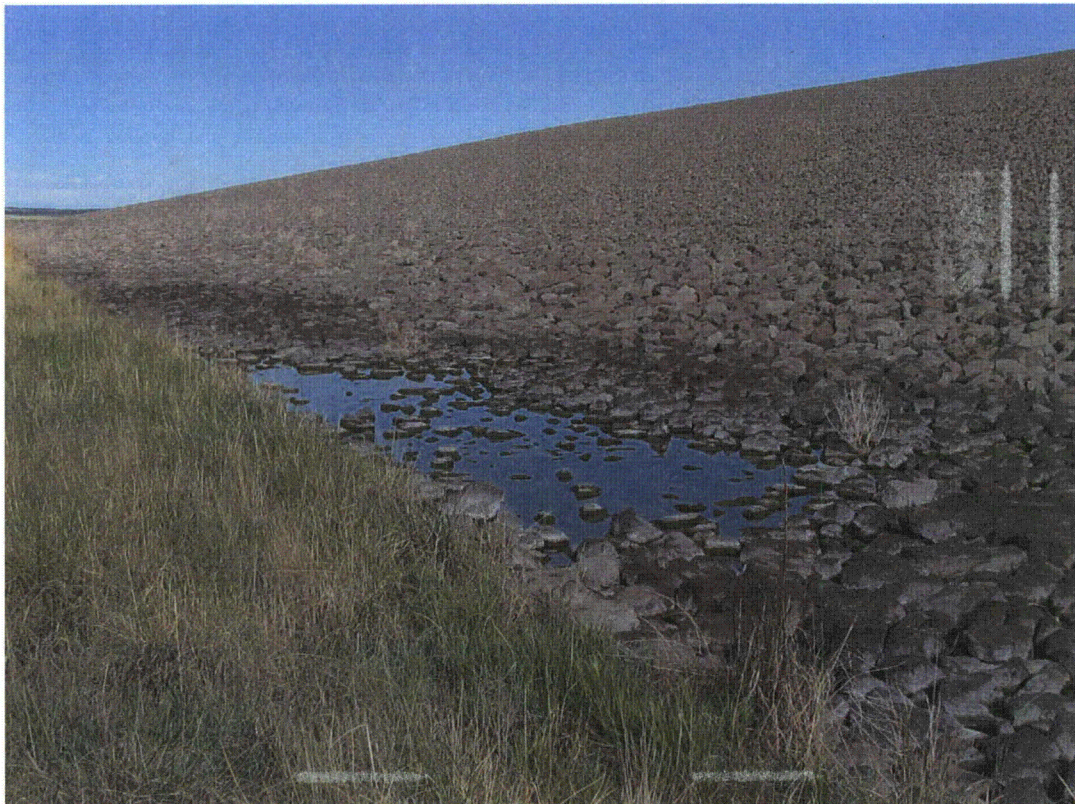
Side Slopes and Apron—The basalt riprap-covered side slopes and apron were in excellent condition and showed no evidence of cracking, settling, slumping, or erosion. Standing water from recent rainfall events was present in the apron along the south side of the disposal cell (PL-4). This water likely dissipates both through evaporation and through infiltration into the underlying alluvium.

AMB 8/2011. PL-4. Standing water in the south apron.

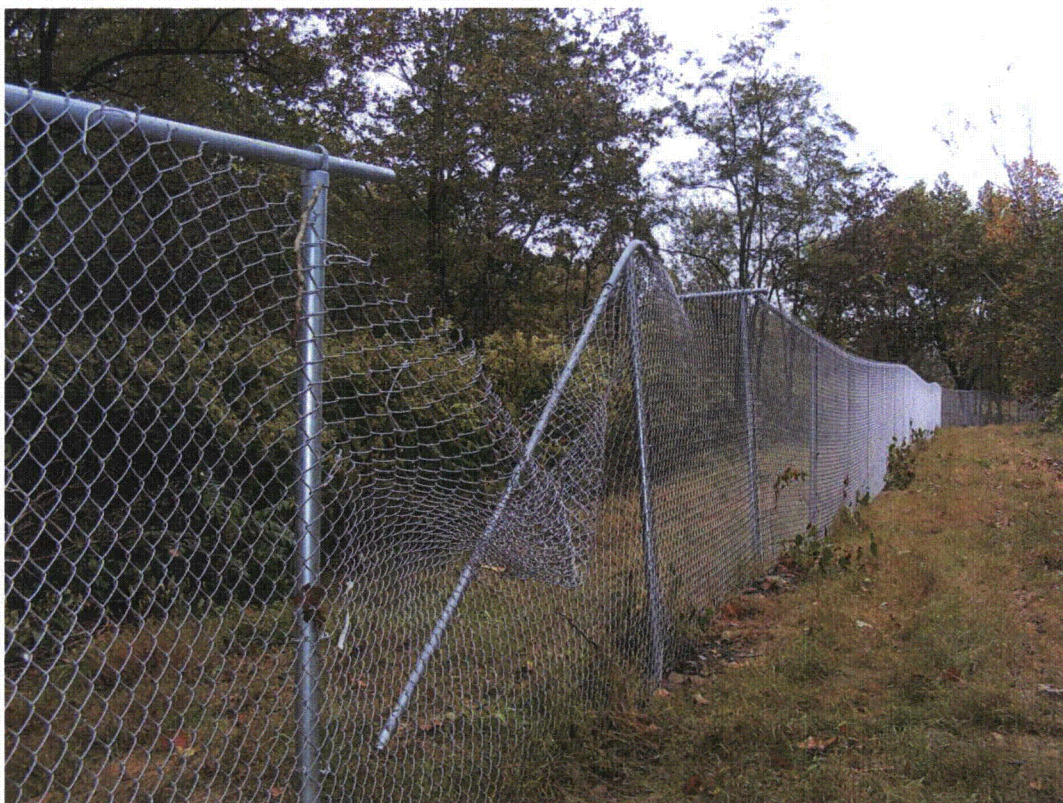
The chain-link security fence, replaced in 2007, remains in excellent condition, with the exception of a bent rail on the south fence (PL-1). The fence rail was damaged when a tree recently fell across it. The tree was safely removed from the fence shortly after being discovered. The top rail of the fence needs to be replaced. A vegetation-free corridor remains established along the fence line (PL-2). The entrance gate and four personnel gates were in good condition. Several of the 17 perimeter signs mounted on the security fence have been damaged by bullet holes, but they remain serviceable (PL-3).

BUR 10/2011. PL-1. Damage to perimeter fence.

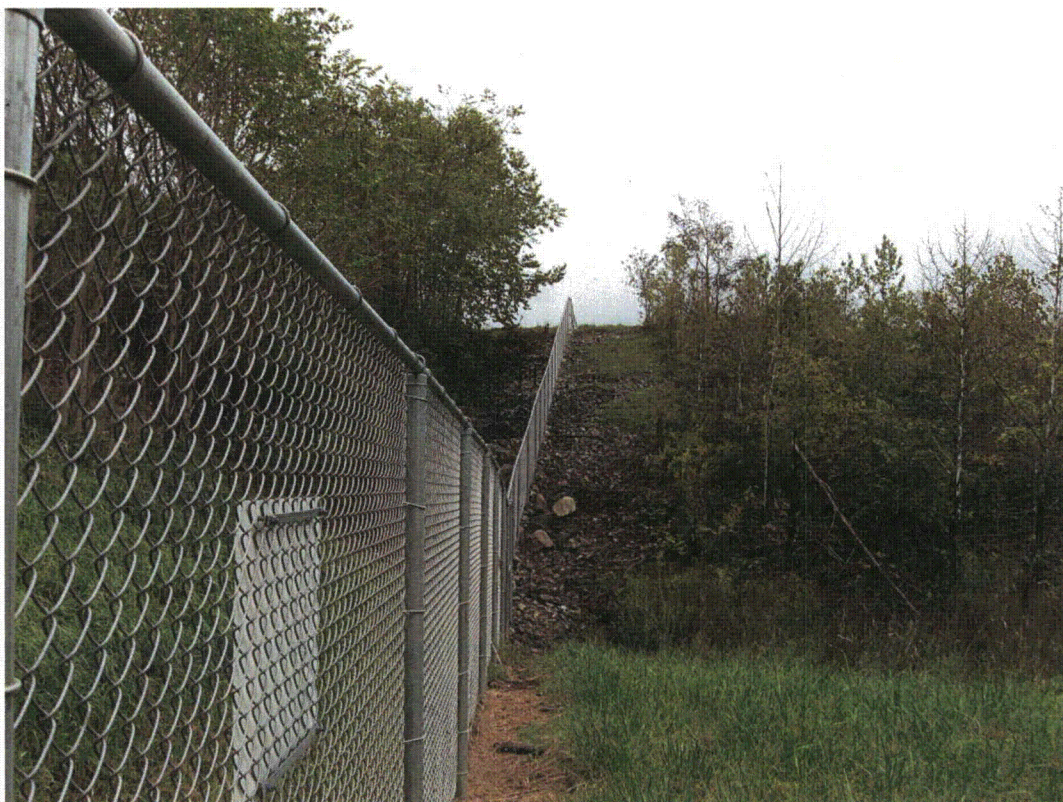
BUR 10/2011. PL-2. Vegetation cleared from perimeter fence.

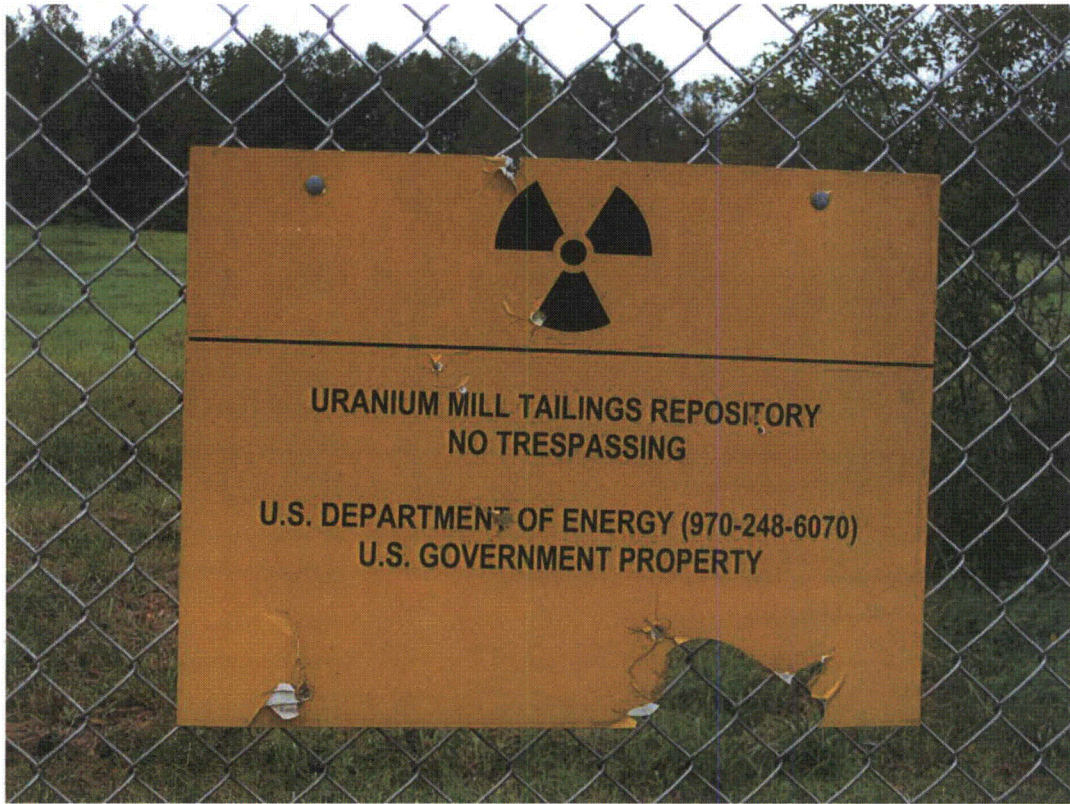
BUR 10/2011. PL-3. Bullet holes in perimeter fence sign P3.

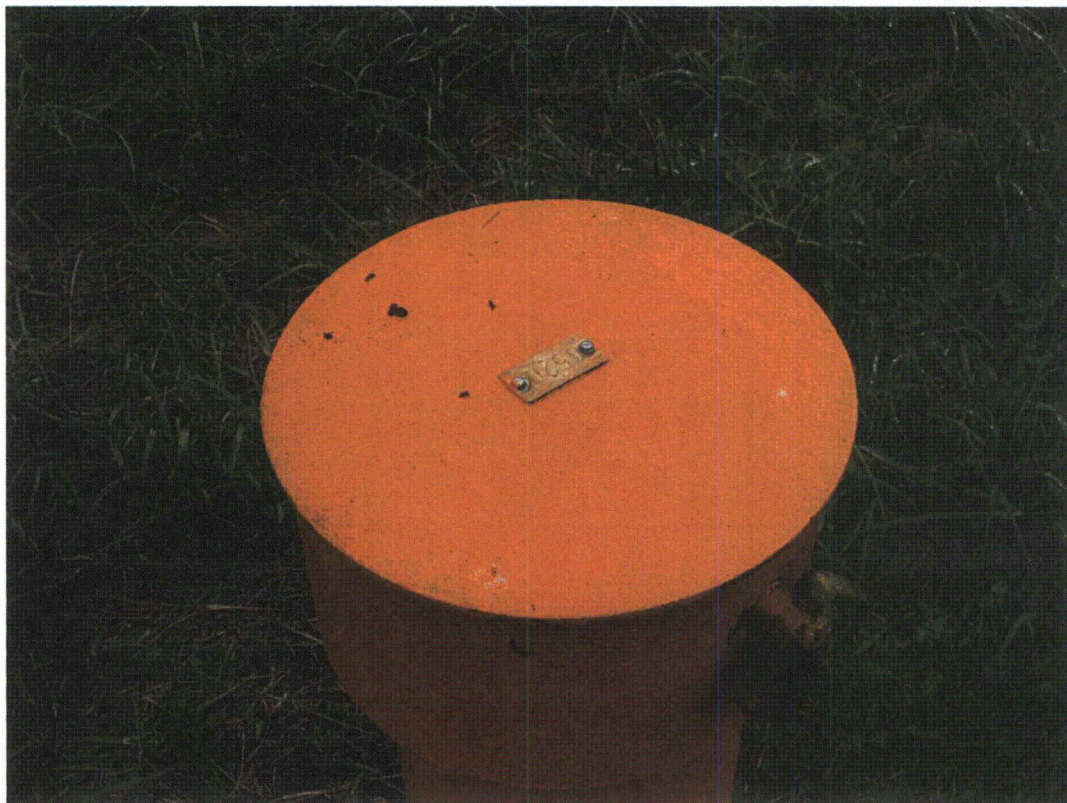
Monitoring Wells—The site has four pairs of monitoring wells. Each pair consists of a shallow (alluvial) completion and a deeper (bedrock) completion. Monitoring wells were not inspected in 2010. The water sampling crew last inspected them in 2009. The monitoring wells will be inspected again when they are sampled in 2014. All wells encountered during the 2010 site inspection were locked and secured. All of the outer protective casings had been recently painted and identified with brass identification tags (PL-4).

BUR 10/2011. PL-4. Brass ID tag, top of monitoring well 0520.

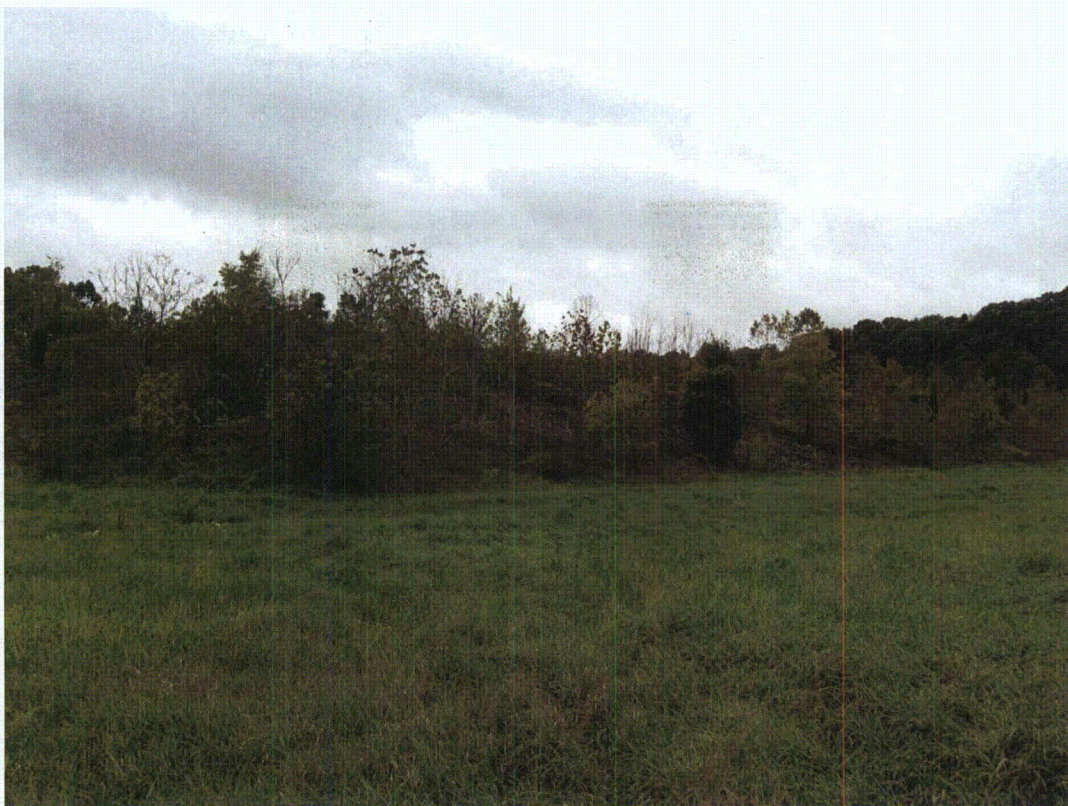
Disposal Cell—The riprap-covered disposal cell was in excellent condition (PL-5). There were no indications of cell instability, such as slumping, bulging, or differential settlement. Rock quality was excellent; degradation of the limestone riprap was not evident.

BUR 10/2011. PL-5. Northeast corner of disposal cell.

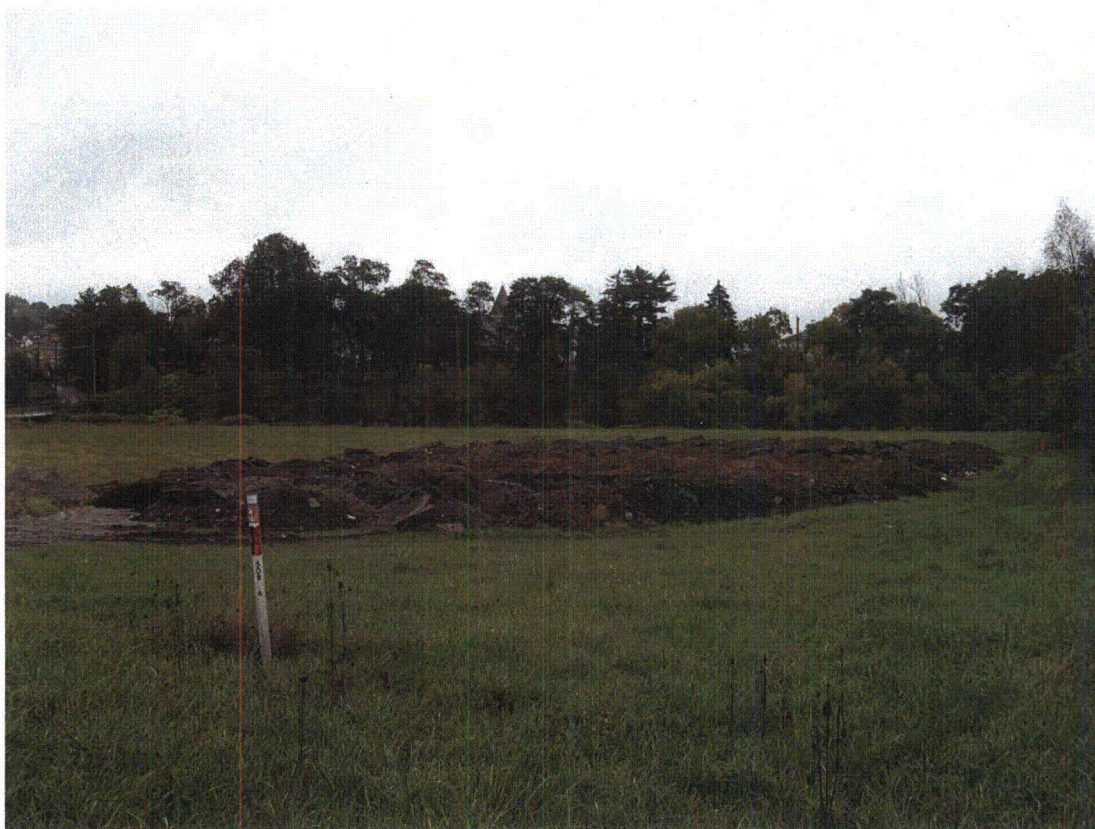
CAN 10/2011. PL-1. Fill material on Area C property.

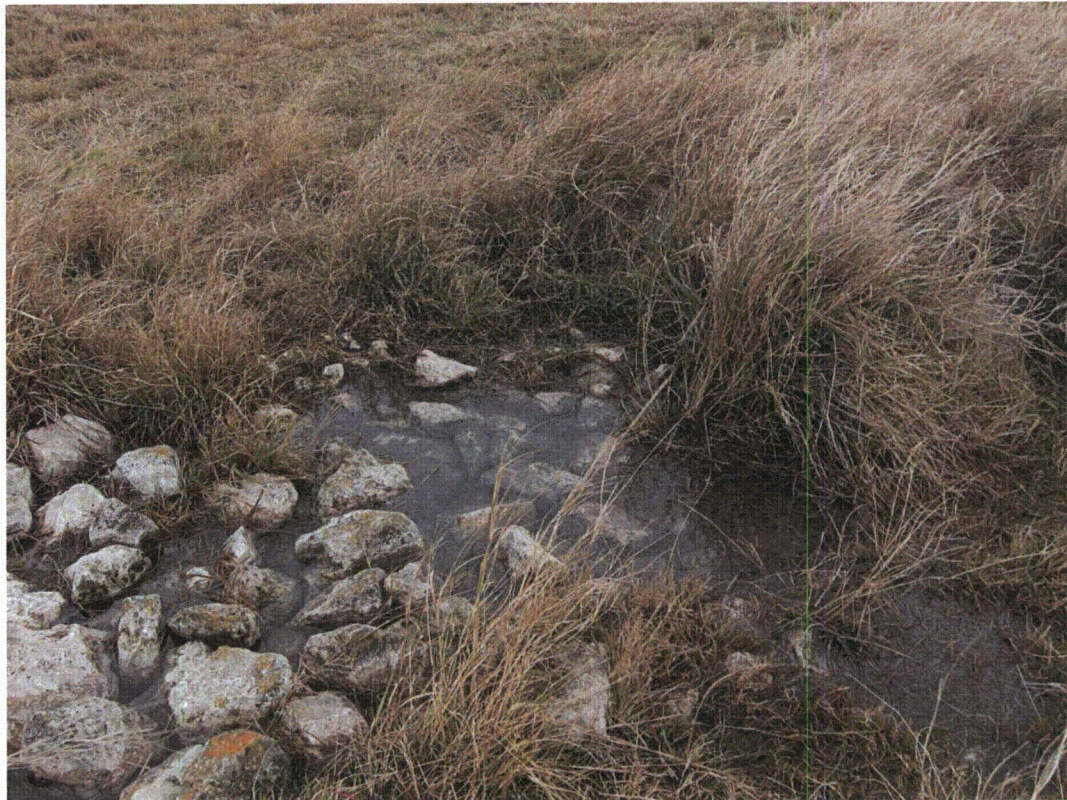
FCT 1/2011. PL-5. Water ponded at outlet of south rock drain.

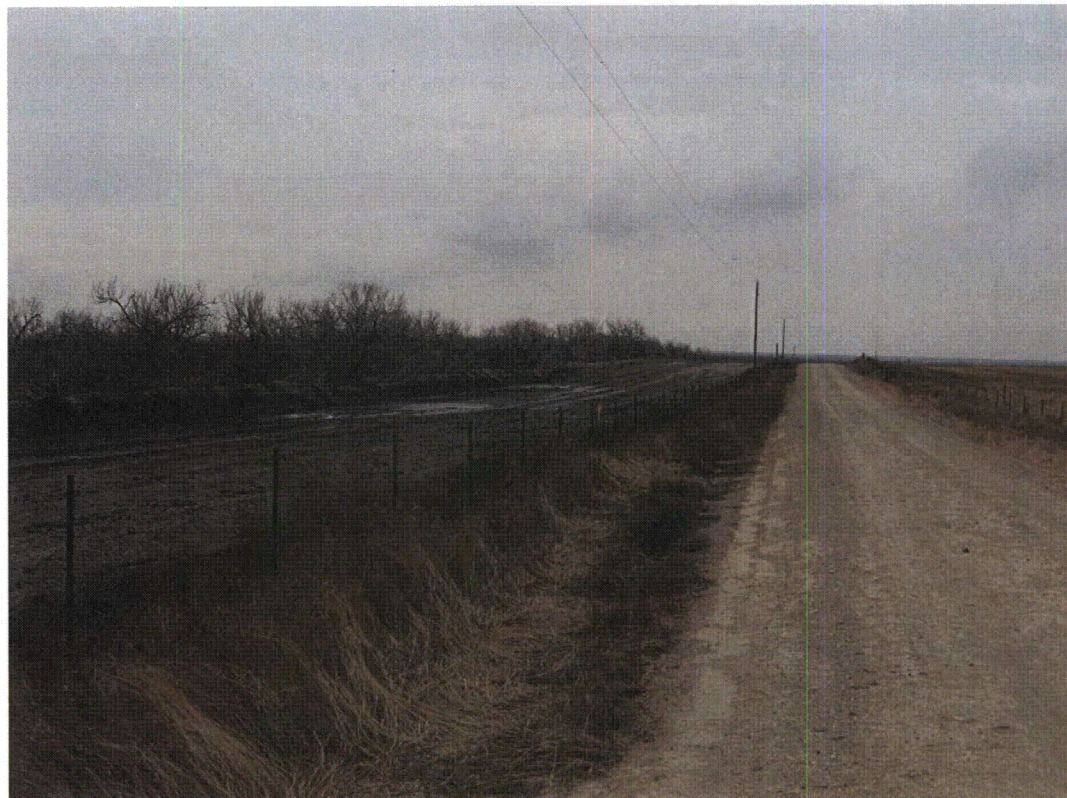
FCT 1/2011. PL-6. Cleared ground along northwest side of road marks installation of new underground pipelines for oil/gas industry next to site.

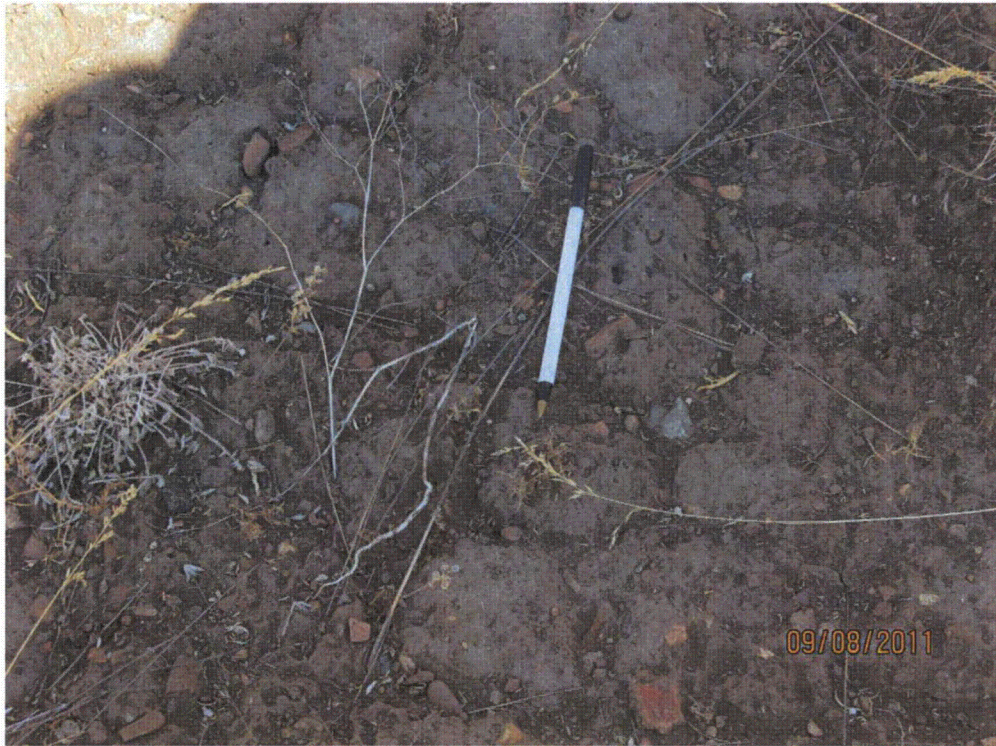
LKV 9/2011. PL-3. Sparsely vegetated area on top slope, showing some checkerboard erosion.
