## 10.0 Lowman, Idaho, Disposal Site

The Lowman, Idaho, Uranium Mill Tailings Radiation Control Act (UMTRCA) Title I Disposal Site was inspected on July 18, 2011. The disposal cell and site features were in excellent condition and functioning as designed. Vegetation continues to encroach on the top and side slopes of the disposal cell. To prevent potential cover degradation from tree blowdown, and as a best management practice, pine trees were removed from the western slope of the cell after the inspection. Steep areas to the north and west of the disposal cell remain stable and vegetated. No cause for a follow-up inspection was identified.

The Maybell, Colorado, Uranium Mill Tailings Radiation Control Act (UMTRCA) Disposal Site was inspected on August 10, 2011. The disposal cell and all associated diversion and drainage structures were in good condition and functioning as designed. No significant change was observed to the washout that occurred in the outlet of Swale No. 1 and Diversion Channel No. 1; riprap continues to armor the downstream channel created. Missing perimeter signs were replaced, and damaged strands of the perimeter fence were repaired. Deep-rooted plants growin

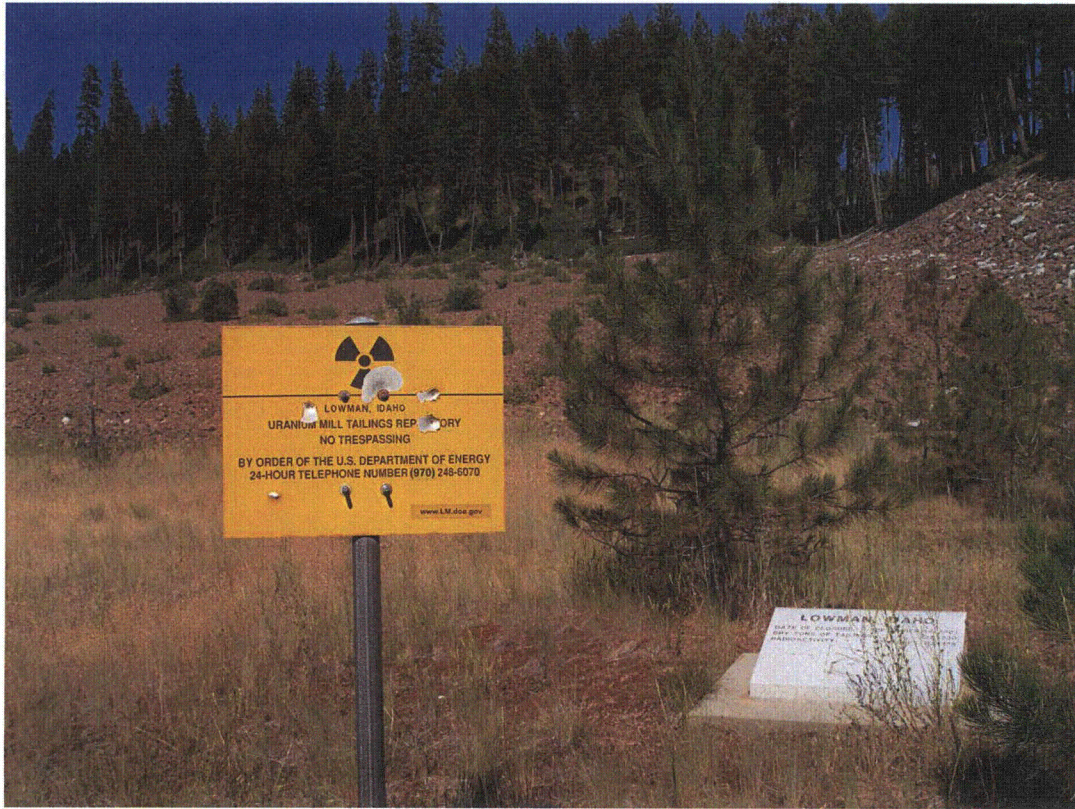
10A One entrance sign and 18 perimeter signs delineate the unfenced site boundary. The entrance sign is just inside the site boundary near site marker SMK-1 (PL-1). Although the sign has several bullet holes, it was still legible and does not need to be replaced. The 18 perimeter signs are on steel posts along the site boundary. Four signs (P2, P3, P13, and P15) have bullet holes or dents, but they were legible and do not need to be replaced. The other perimeter signs were in excellent condition. At the time of the inspection, ponderosa pine saplings were encroaching on perimeter sign P1, making it less visible. Inspectors cut down several of the trees to create a cleared buffer area around the sign. A fallen tree had dislodged another perimeter sign from the top of its post; the sign was repaired during the inspection.

LOW 7/2011. PL-1. Entrance sign and site marker SMK-1 (cut trees in background).

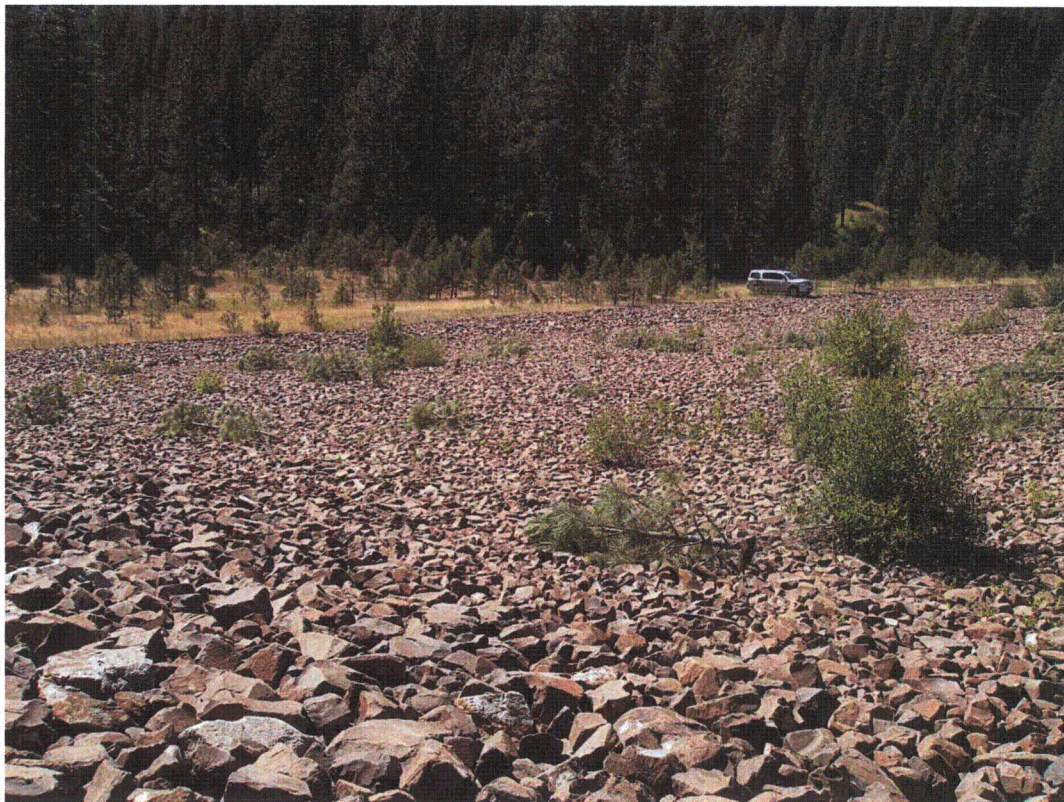
**Top and Side Slope of the Disposal Cell**—The 8-acre disposal cell was completed in 1991. Basalt riprap armors the top and west-facing side slope of the disposal cell. An apron of larger riprap surrounds the disposal cell on all sides. The riprap was in excellent condition, and no evidence of instability, such as subsidence, slumping, or cracking, was observed on any of the cell surfaces (PL-2).

LOW 7/2011. PL-2. View of riprap on southwest slope (cut trees in foreground).

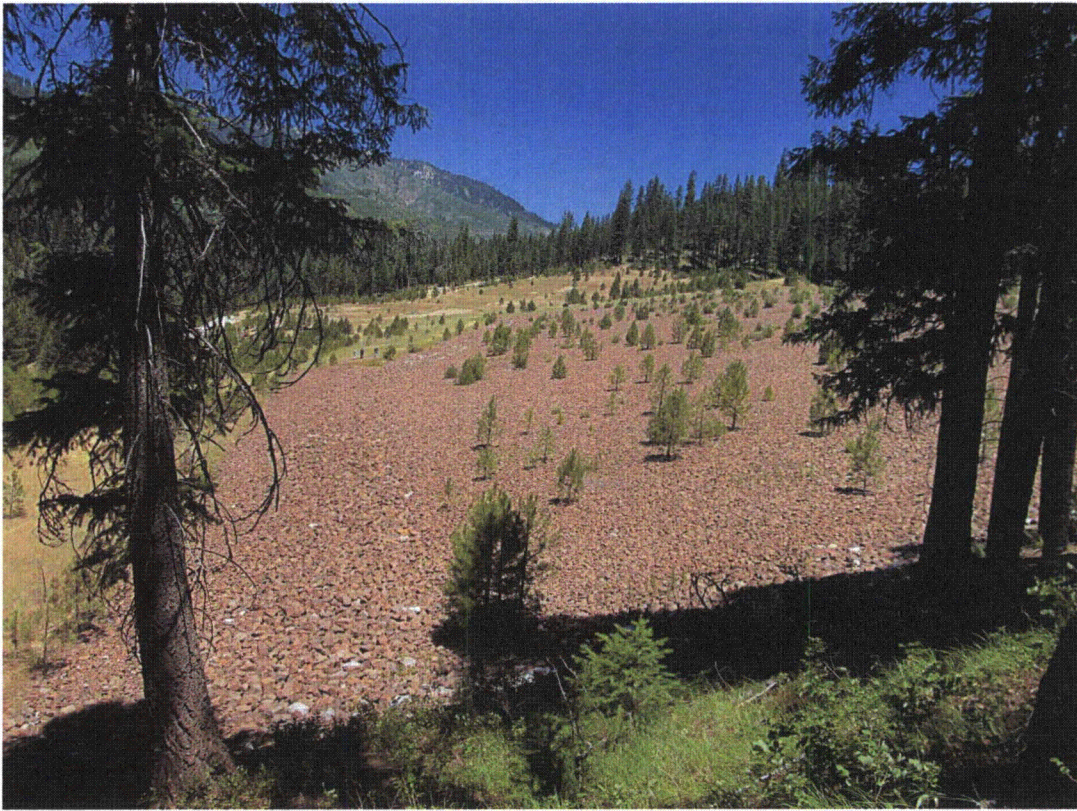
10B Vegetation encroachment by tree, shrub, and wildflower species continues on the top and side slopes of the disposal cell. Encroachment is a natural process operating at these locations and is allowed to continue in accordance with the LTSP. Although DOE is not required to remove ponderosa pine trees as they mature, the LTSP states that DOE will repair any damage that occurs to the riprap cover and underlying cover layers caused by blowdown or other processes to maintain protection from erosion and possible consequent dispersion of cell contents. At the time of the inspection, the largest ponderosa pine trees on the cover were approximately 13 feet tall and had trunk diameters of 7 to 8 inches (based on growth rings, the trees were probably 12 years old). Due to the increasing potential for blowdown, and the consequent potential for disposal cell damage, most of the larger ponderosa pine trees were cut down this year (PL-3, PL-4).

*LOW 7/2011. PL-3. View of south slope of cell before pine trees were cut.*

Numerous pine trees that had established on the top of the cell were cut and removed after the inspection to prevent potential cover degradation that could result from tree blowdown. A perimeter sign dislodged by a fallen tree was repaired. No other routine maintenance or repairs were required in 2011.

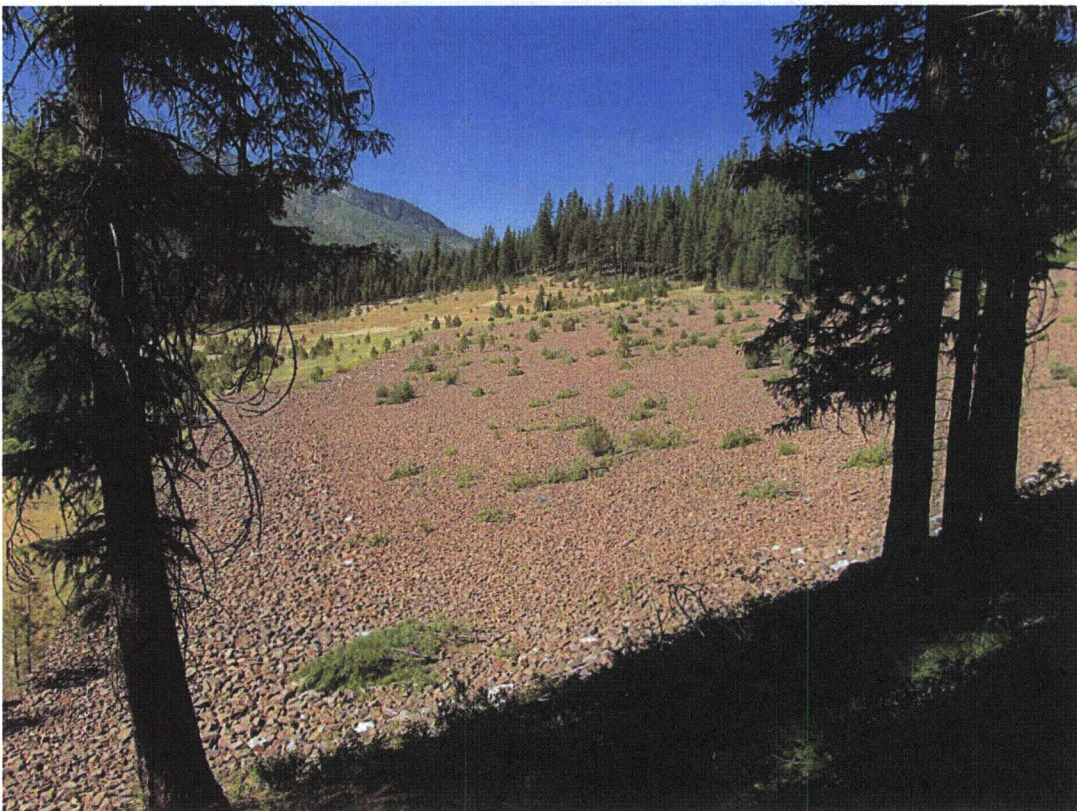
*LOW 7/2011. PL-4. View of south slope of cell after trees were cut.*

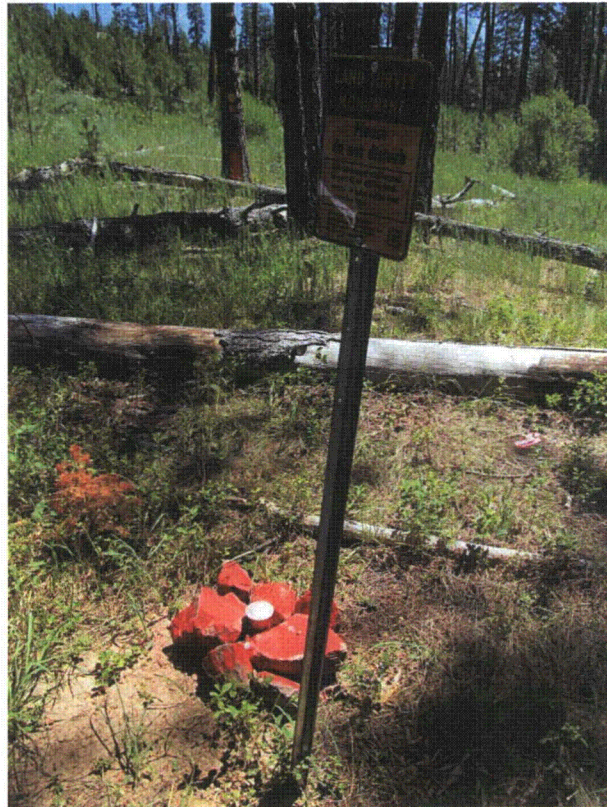
The areas east and south of the site are managed by the U.S. Forest Service (USFS) and remain relatively unchanged. During the 2011 inspection, several new USFS benchmarks were found, most slightly within the DOE site boundary (PL-5). Although the area in question is on a ridge east of the cell unlikely to create an issue, USFS was contacted to determine why their monuments are within the DOE boundary. The survey discrepancy was discussed with USFS staff in Boise after the inspection. The discrepancy between boundary lines may be due to the two agencies' using different survey coordinate systems.

*LOW 7/2011. PL-5. U.S. Forest Service monument found within site boundary (~15 feet north of P15).*

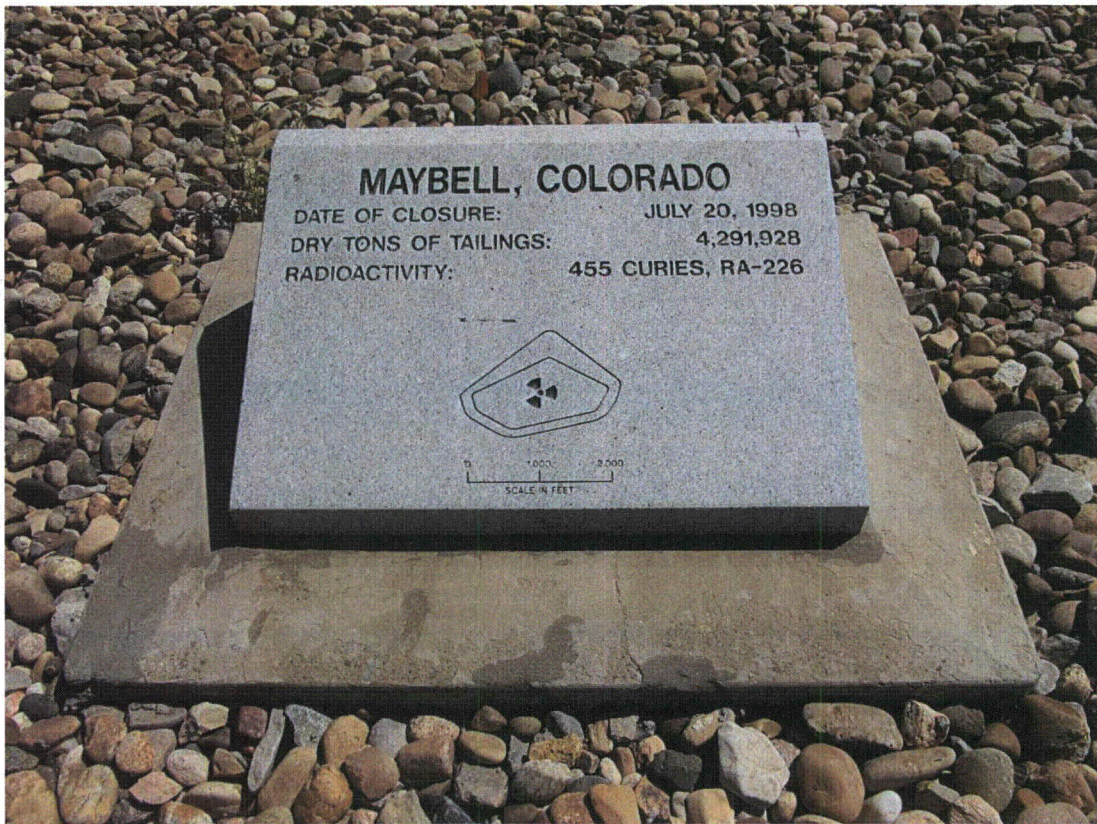
**Site Markers and Monuments**—The site has 2 granite site markers (PL-2), 19 boundary monuments, and 2 survey monuments. All markers and monuments inspected were in good condition.

MAY 8/2011. PL-2. Site marker on top of the disposal cell.

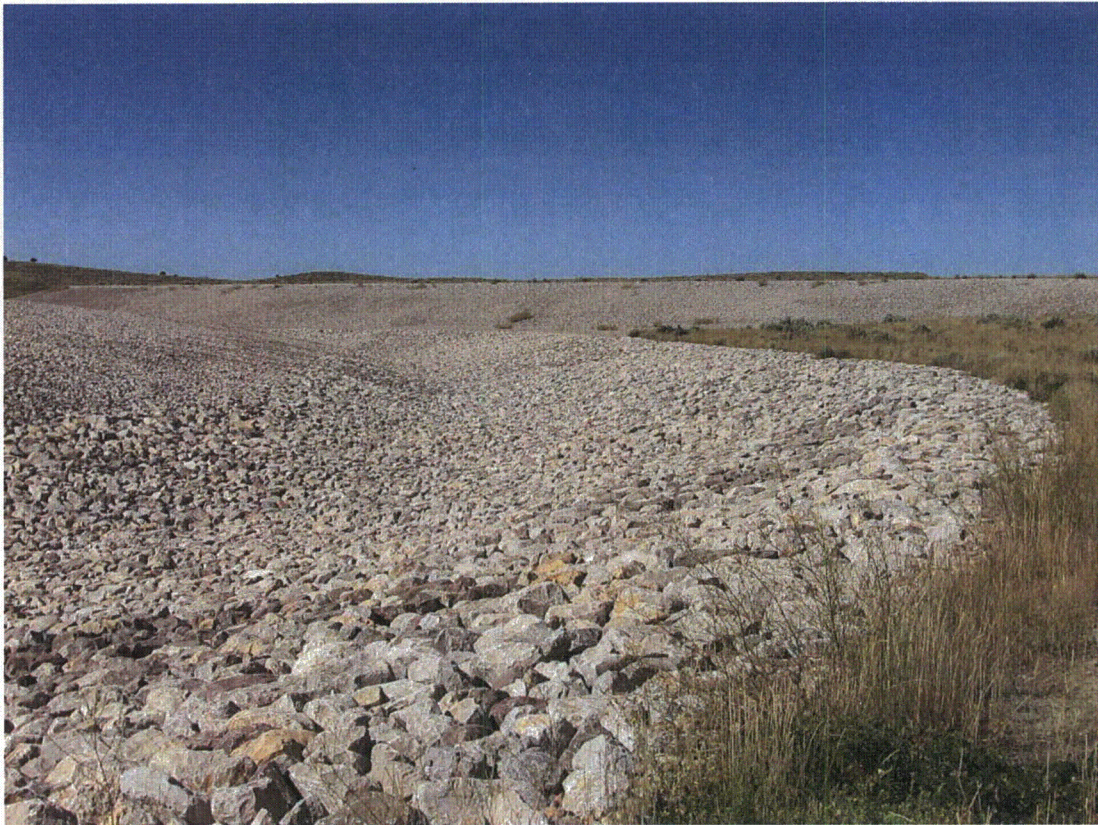
The rock-armored diversion channels, swales, and gullies were in good condition (PL-6). Erosion that has occurred directly downgradient of the outlet to Diversion Channel No. 1 remains protected by the rock armoring within the channel. Exposed geo-fabric just upgradient of the outlet is not currently compromising the performance of the channel (PL-7). Additionally, the washout in the outlet to Swale No. 1 had not changed significantly, and the riprap placed within the swale remains protective and continues to provide armoring against downgradient erosion, as designed. Exposed geo-fabric was also observed at the outlet to Swale No. 1. Small rills observed adjacent to Swale No. 1 and Gully No. 1 continue to stabilize. None of these areas of erosion currently threaten the integrity of the disposal cell, but they will continue to be monitored.

*MAY 8/2011. PL-6. Diversion Channel No. 1; rock-covered slope west of cell in background.*

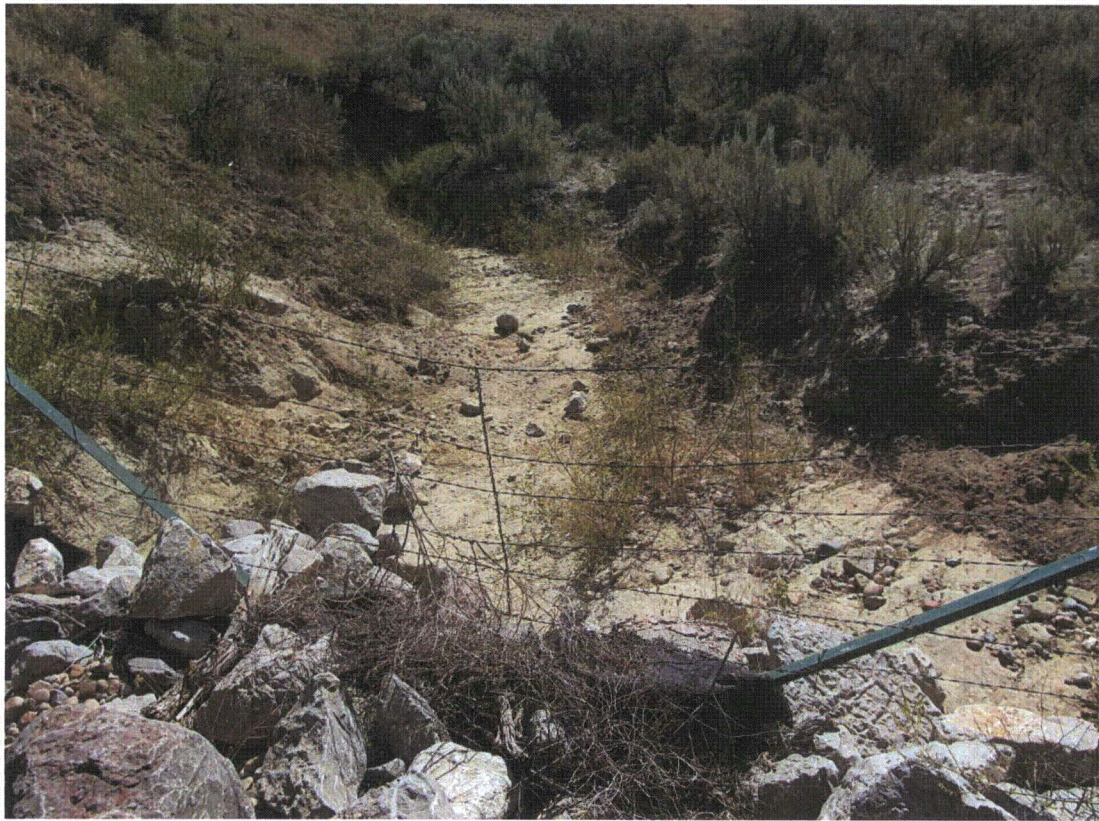
MAY 8/2011. PL-7. Exposed geo-fabric and erosion at the discharge point of Diversion Channel No. 1.

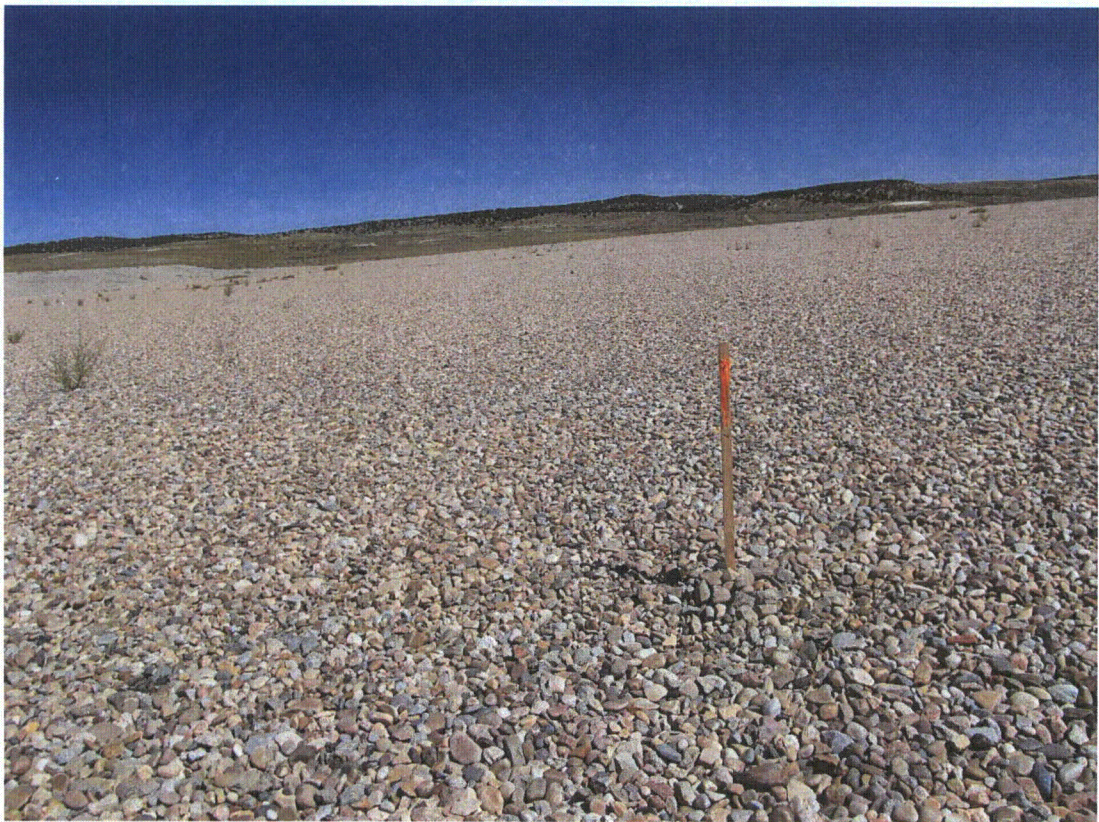
In 2011, new lode mining claim locator stakes were found on site, including on the disposal cell (PL-8). BLM notified the claimant that those stakes located on the withdrawn portion of the site were placed in error. Title information indicates that the complete mineral estates were not acquired for the two private parcels that make up the balance of the site. However, protection of the disposal system from third-party surface and subsurface activities is provided under the NRC general license at 10 CFR 40.27(d). This regulation requires that any activity allowed by NRC should not disturb the residual radioactive materials that have been disposed of, or—if an activity does disturb the materials—ensures that the materials be restored to a safe and environmentally sound condition. DOE has not been contacted in regard to any of the previous uranium exploration locator stakes found on site in 2006, 2008, and 2009 (no stakes were found in 2010).

MAY 8/2011. PL-8. Mining lode claim stake found on the top of the disposal cell.

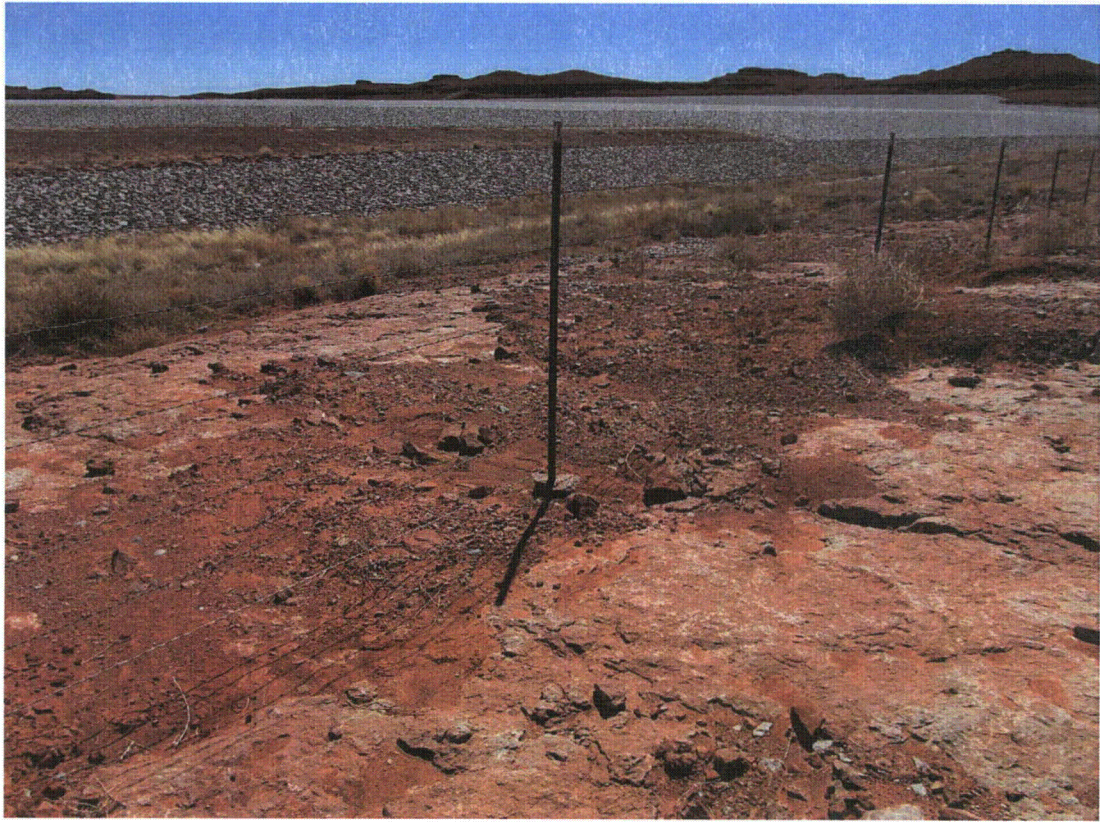
*HAT 4/2011. PL-1. New fence strand added to the bottom of the fence in October 2010.*

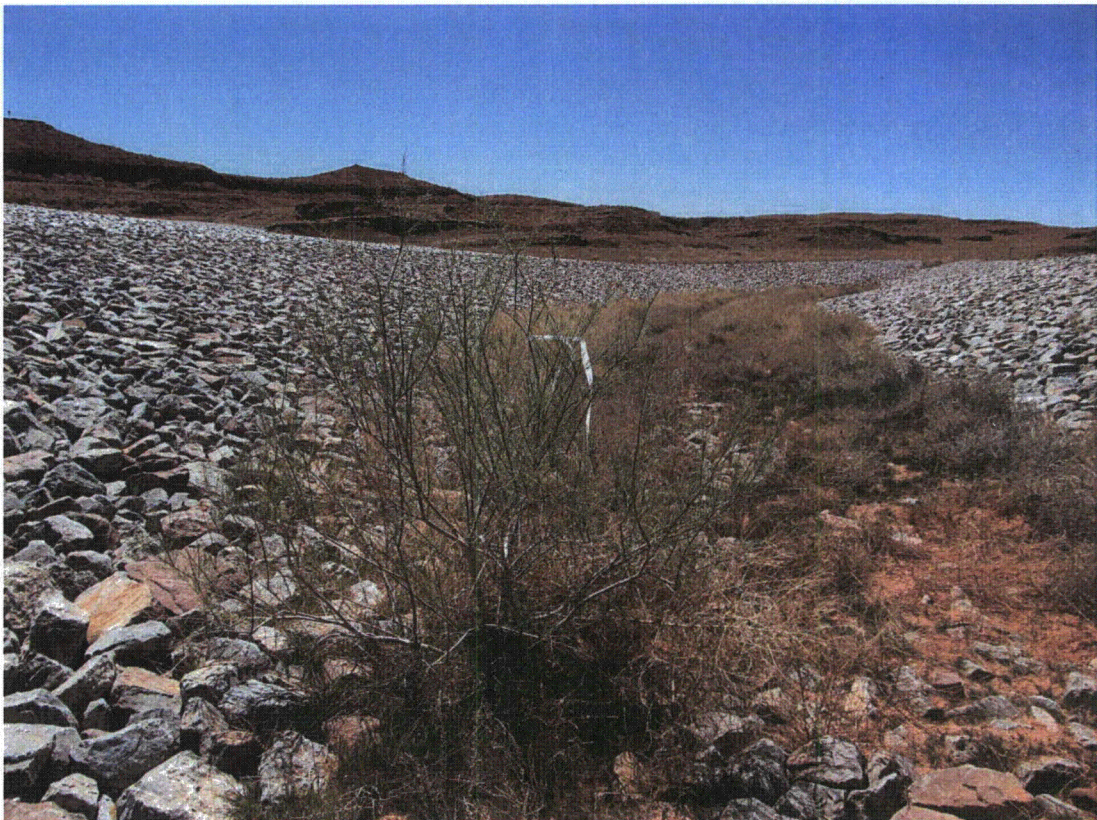
*HAT 4/2011. PL-4. Tamarisk in west diversion channel.*

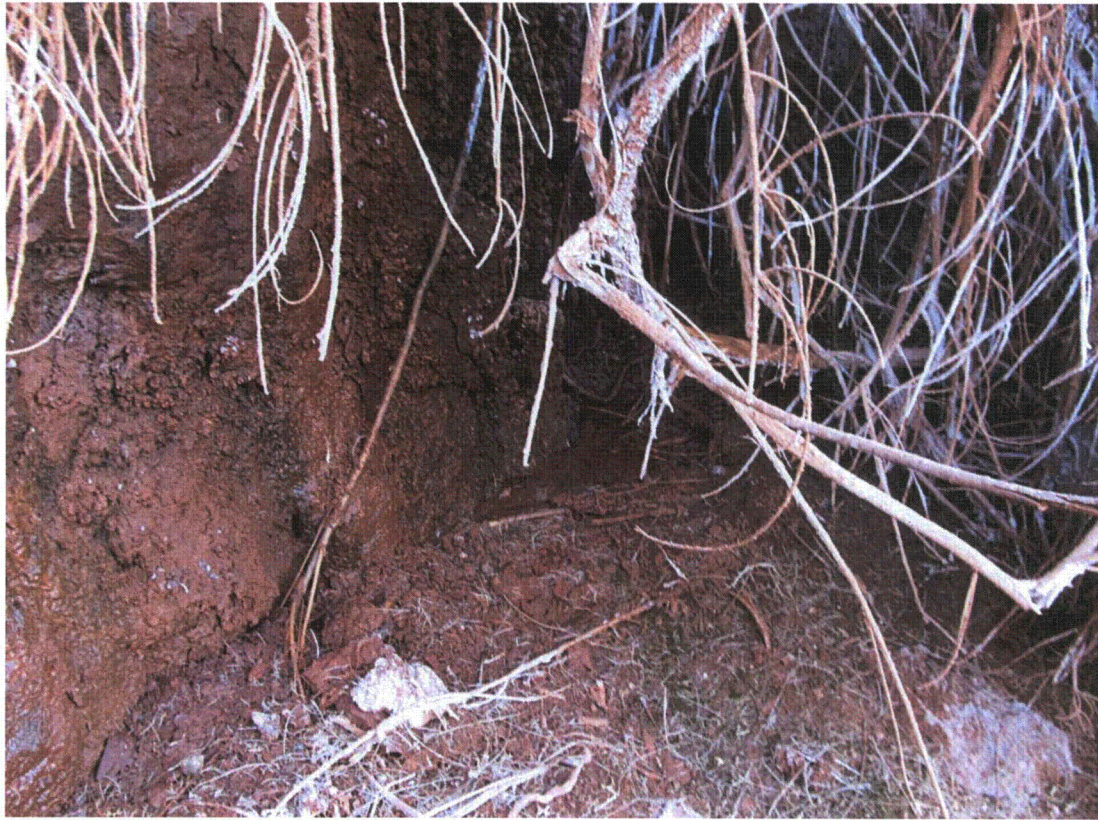
*HAT 4/2011. PL-5. Seep 0248 dripping with small pool.*

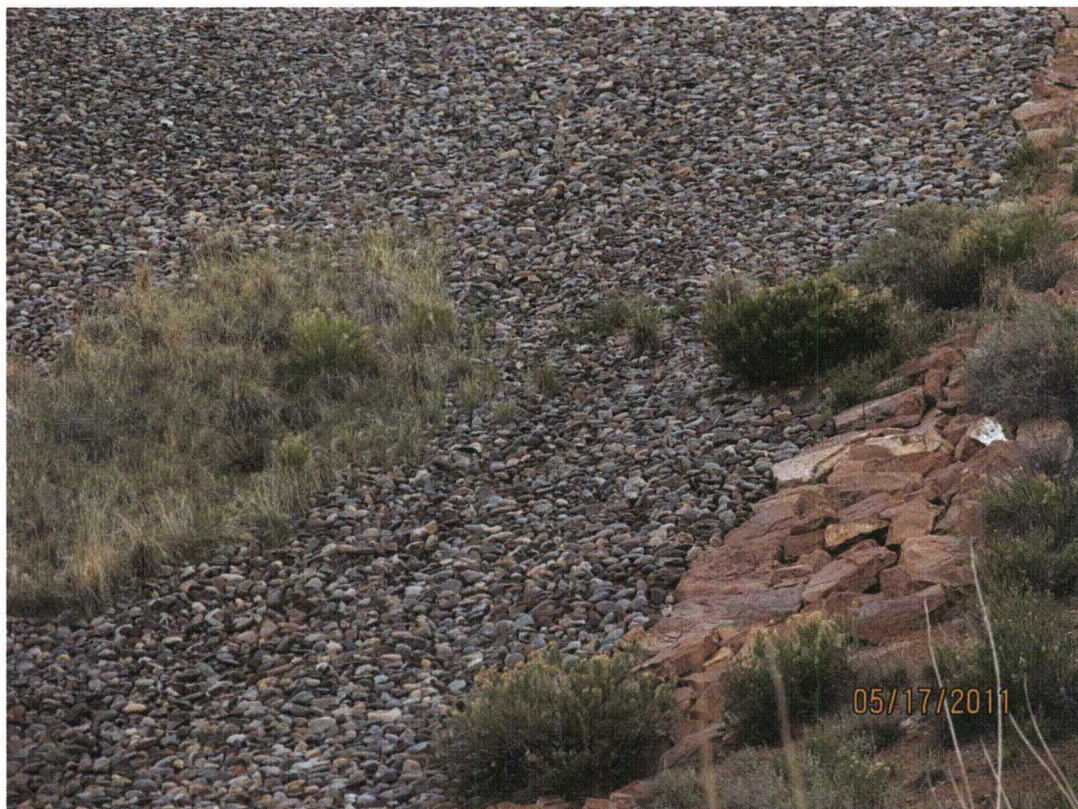
NAT 5/2011. PL-2. Vegetation in toe drain east of perimeter sign P-19.

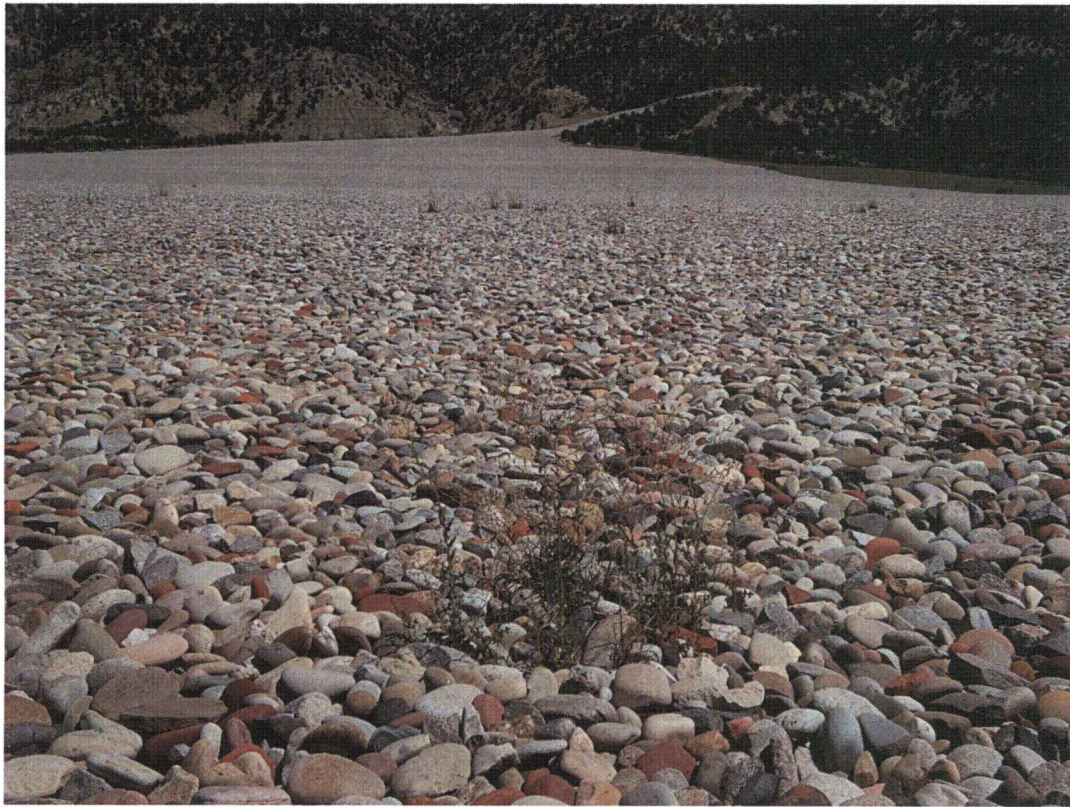
*RFL 8/2011. PL-3. View (to northeast) of isolated shallow-rooted weeds on cell.*

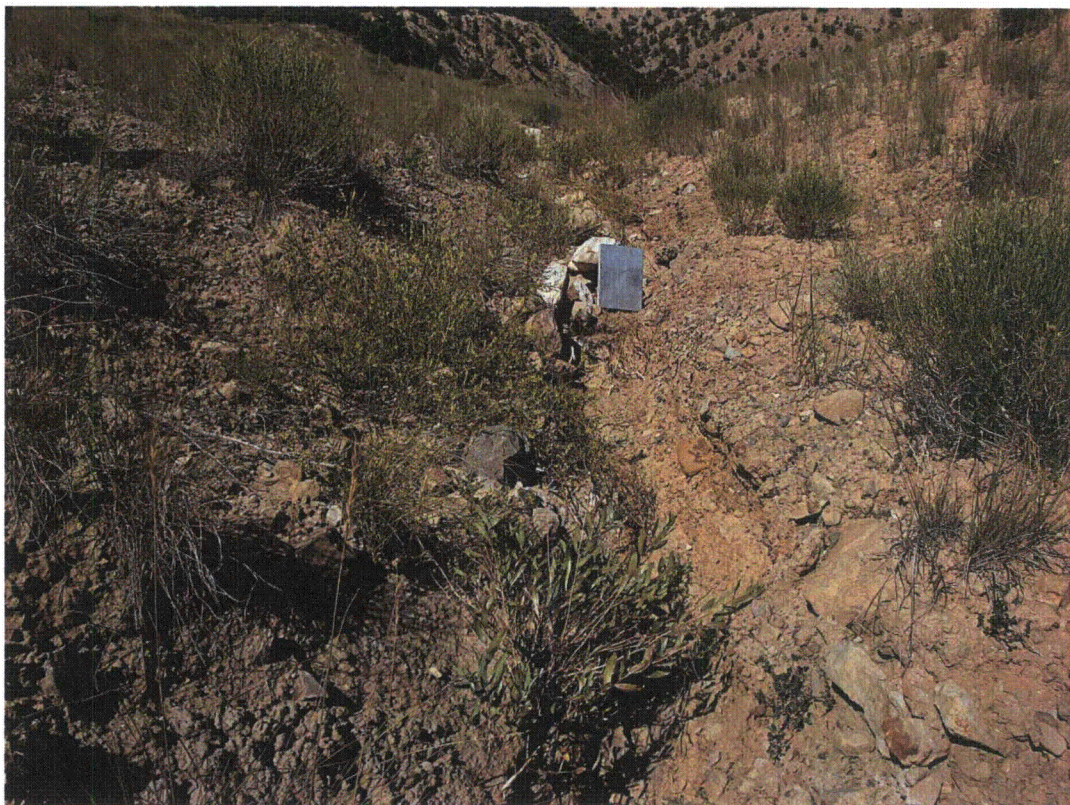
*RFL 8/2011. PL-4. New gully erosion (4 to 6 inches) in upper section of inceptor trench.*

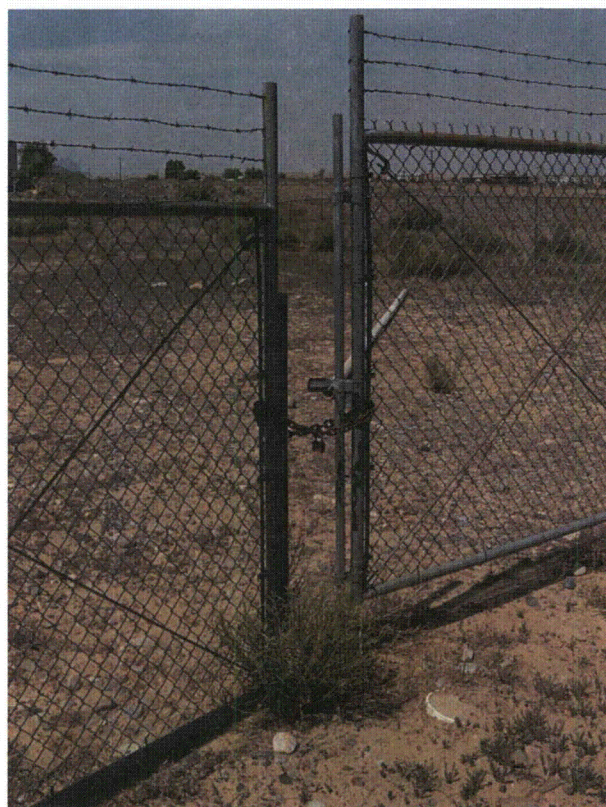
*SHP 6/2011. PL-1. Gap in northwest gate.*

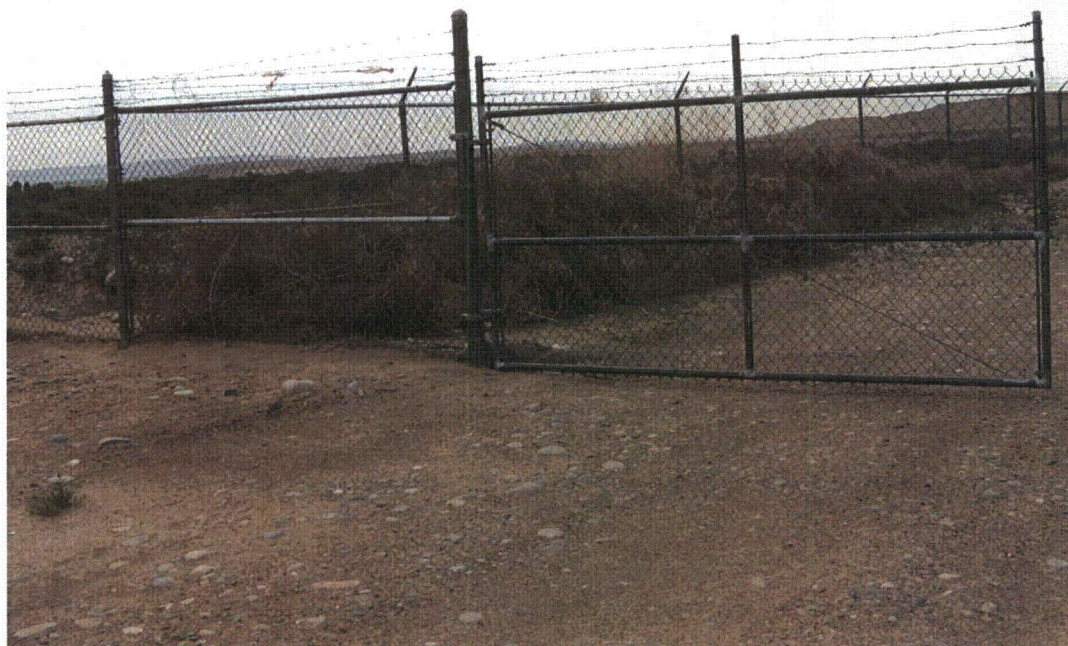
Tumbleweeds have accumulated in many places along the perimeter fence, particularly near the east gate (PL-2) and perimeter sign P8. These accumulations potentially represent a fire hazard and increase the possibility of damage to the fence, particularly during high winds. Trash has also accumulated along, and become entangled in, the fence. To improve the safety and appearance of the site, tumbleweed and trash around all site fences will be removed before the next annual inspection.

*SHP 6/2011. PL-2. Tumbleweed accumulation near east gate.*

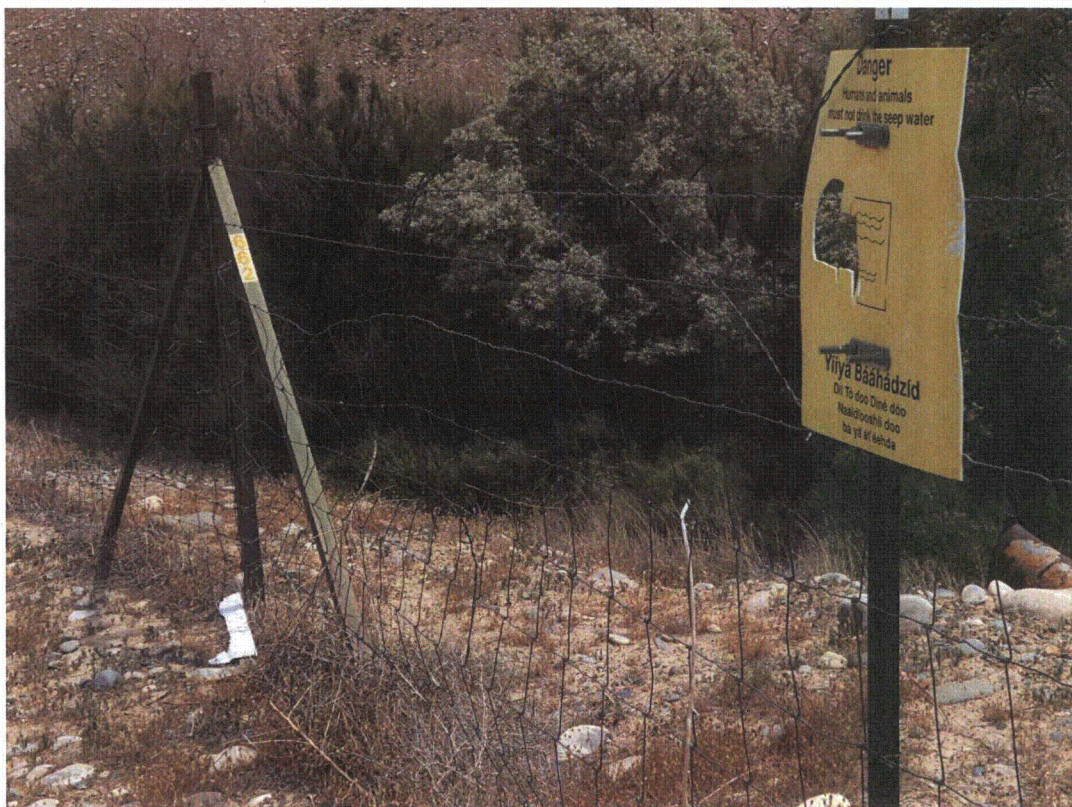
*SHP 6/2011. PL-4. Broken fence wire and warning sign.*

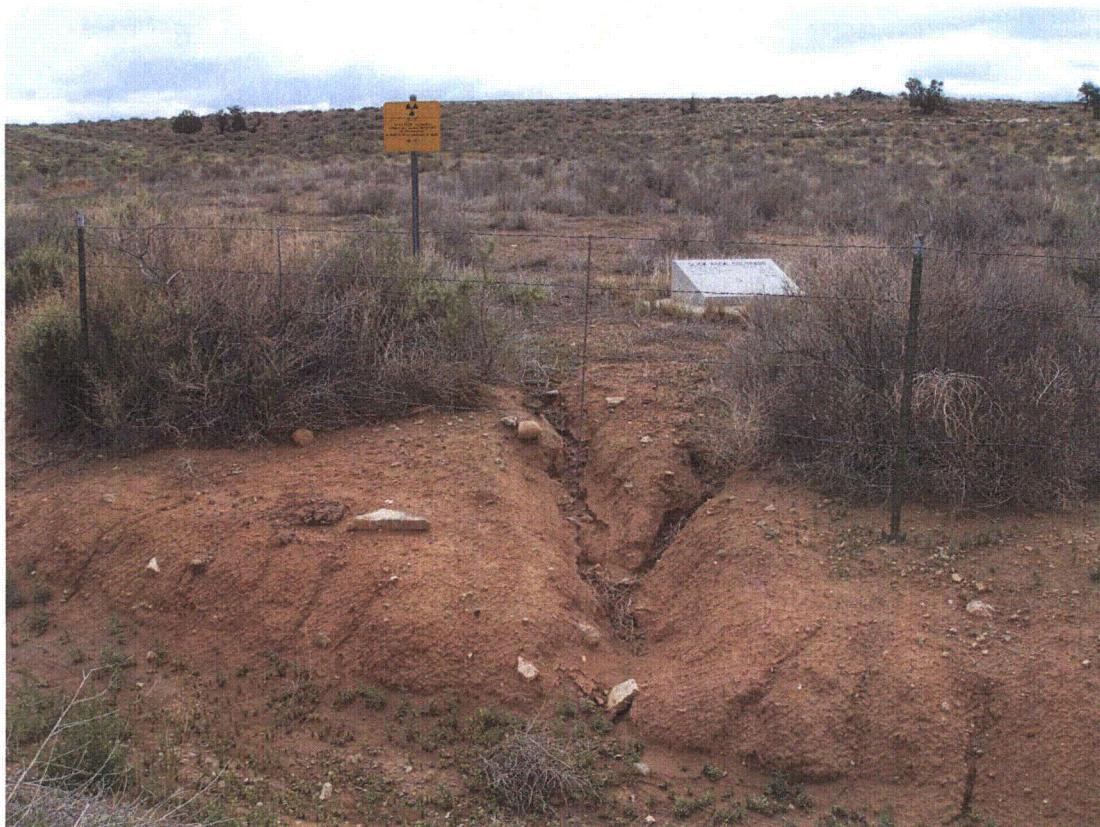
*SRK 7/2011. PL- 1. Erosion under fence near site marker SMK-1.*

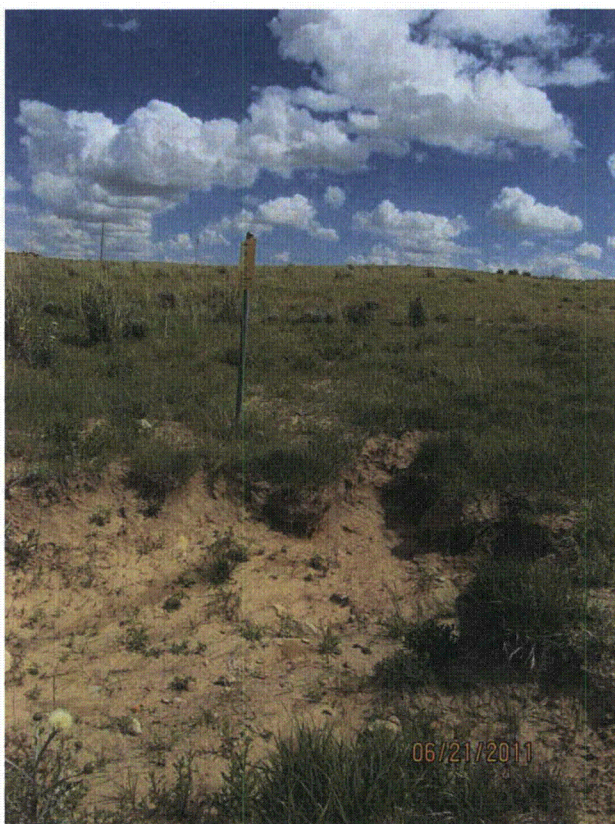
*SPK 6/2011. PL-4. Headcut erosion near perimeter sign P4.*

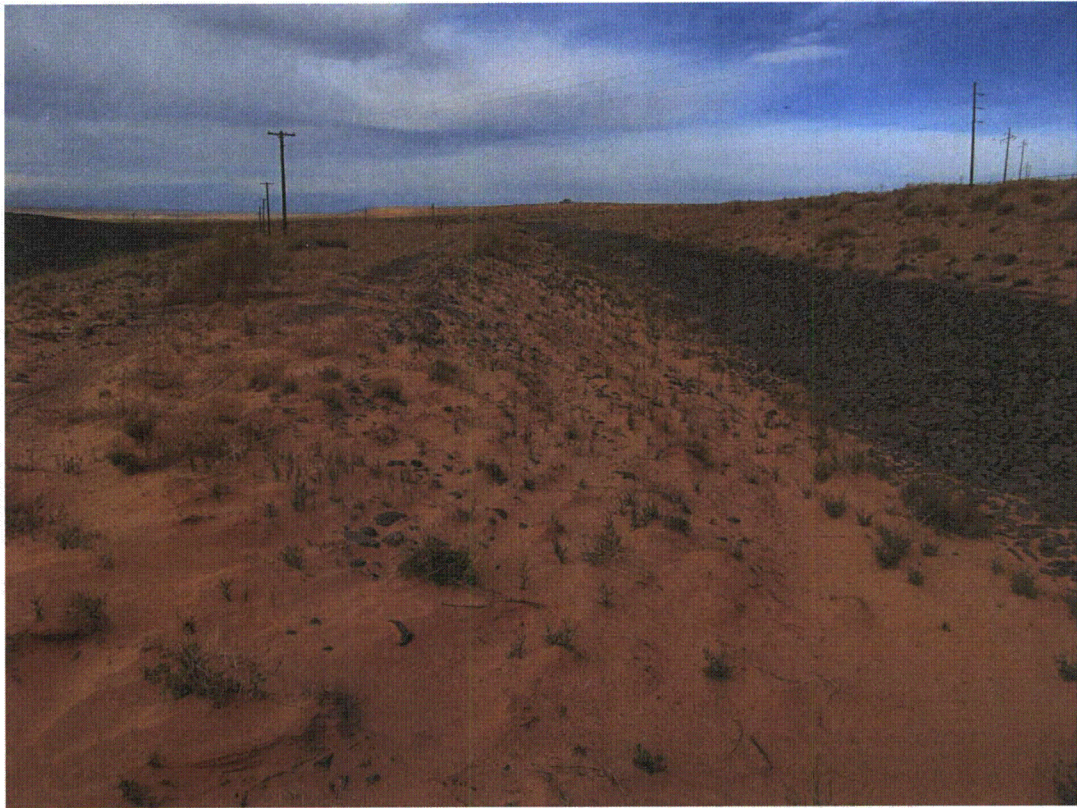
*TUB 4/2011. PL-7. Windblown sand deposition on the south bank of the diversion channel.*
