Subject: Regulatory Conferences Supporting Documentation for Apparent Violations
EA-11-241 and EA-11-243

Root Cause Evaluation – Service Water Pump P-7C Coupling Failure, Rev 0

Service Water Pump 7-C Line Shaft Coupling Failure

CR-PLP-2011-03902, EVENT DATE: 08-09-2011

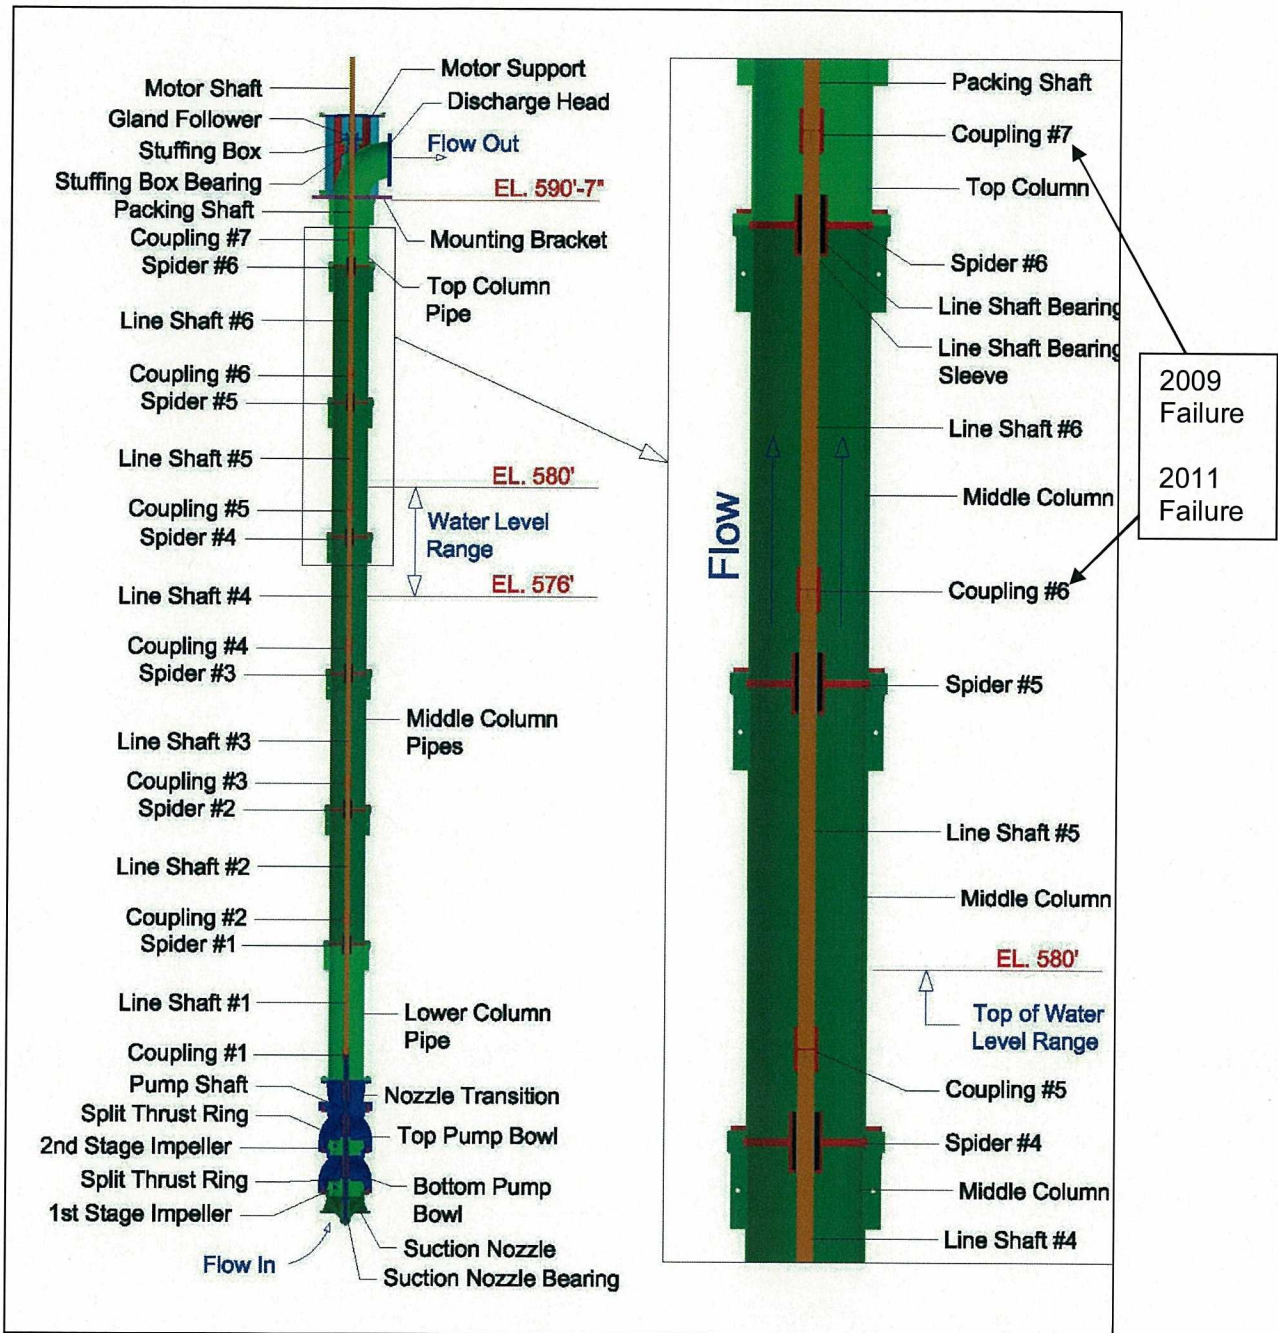
Figure 1: PLP SWP Rendering Showing 9/29/09 and 8/9/11 Coupling Failure Locations

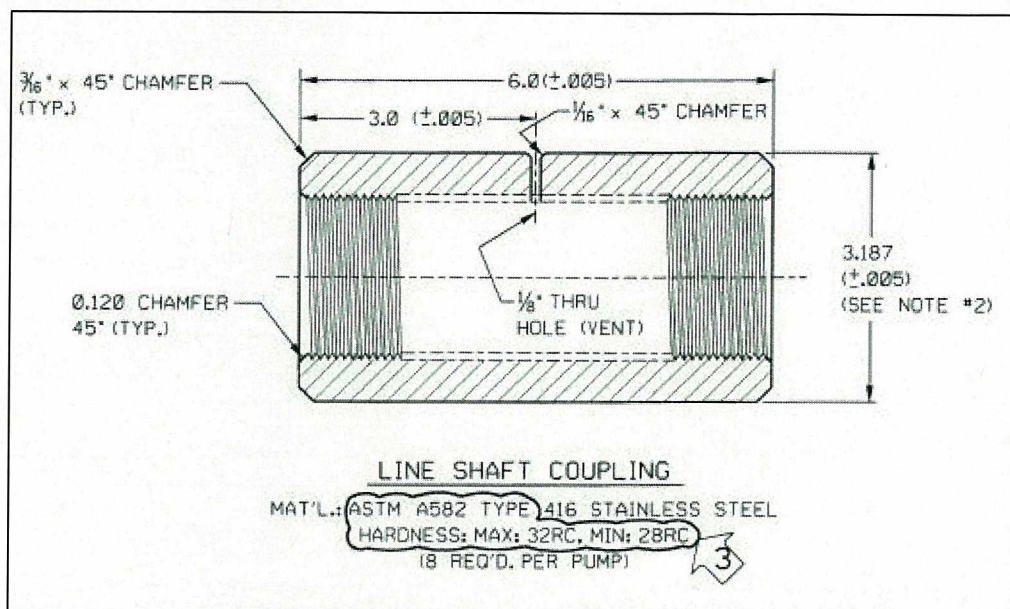
Figure 2: Coupling Drawing from VEN M-11 Sheet 55

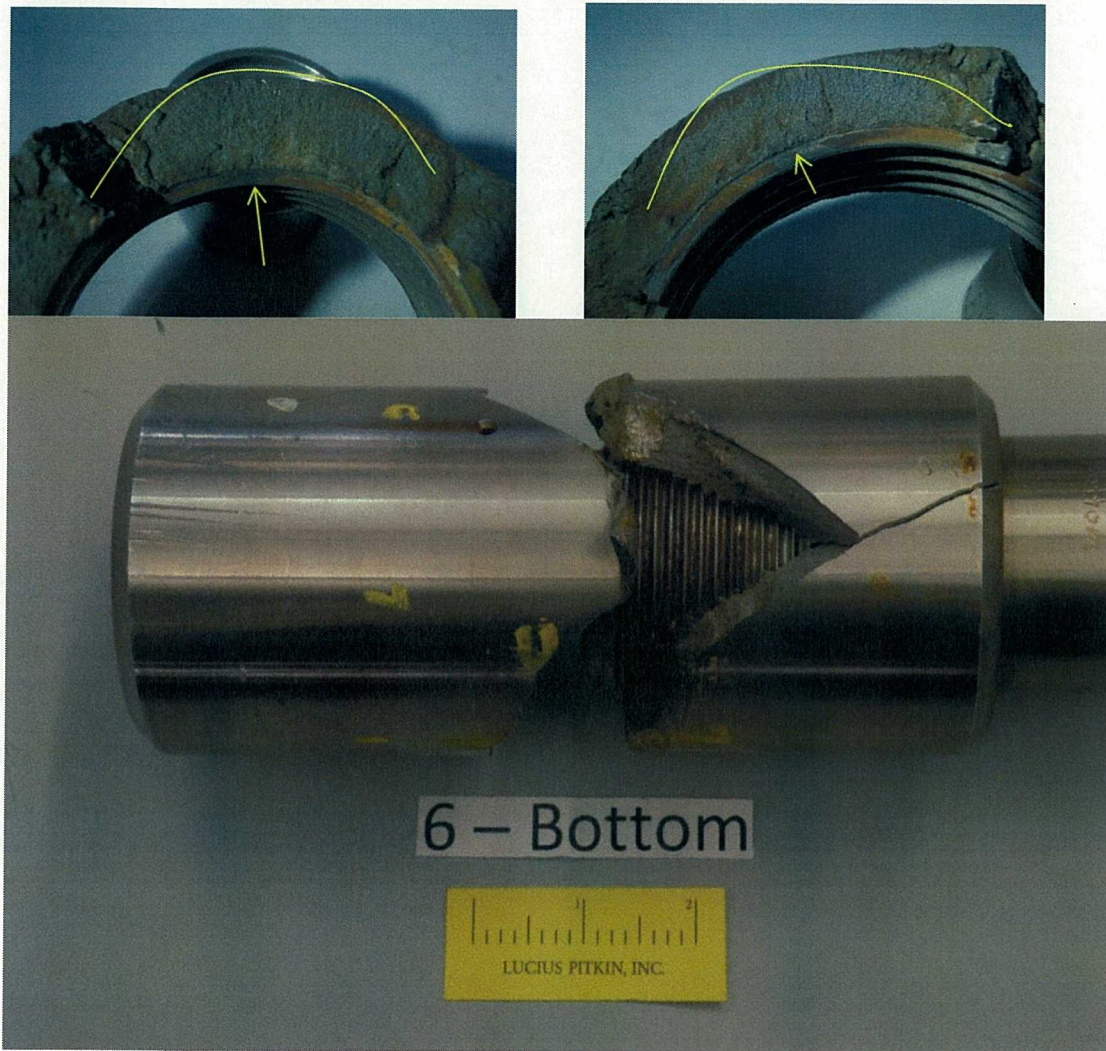
Work to restore P-7C began immediately under WO #286627. During disassembly, it was determined that line shaft coupling #6 had failed. The failure of coupling #6 was similar in nature to the failure of coupling #7 in September, 2009. As can be seen in Figure #1 (page 4), couplings #6 and #7 are above the water line when the pump is not running. This means that when P-7C is in standby, coupling #6 and #7 have the chance to dry out. Coupling #5 may also be dry, depending on lake levels. As is discussed in the metallurgical analysis from LPI (Attachment V), surface deposits of contaminants were found in the area of the fracture surface. Energy Dispersive X-Ray Spectroscopy (EDS) was performed on the surface deposits which were determined to contain oxides, chlorides and sulfides.

Shown below is a picture of the failed coupling and a close up of the fracture surfaces. Coupling #6 is the second coupling below the stuffing box and is subject to wet/dry cycles.

Figure 3: Failed Coupling #6 from P-7C Service Water Pump, Fracture Surfaces

Test	Parameters
Visual and Photographic Examination	Visual examination of the 2011 coupling failure indicates stress corrosion cracking (SCC), initiating from two locations from the interior of the coupling to the exterior perpendicular to the axis of the coupling. The crack initiation sites were one thread apart vertically, and not associated with the vent hole. The SCC propagated in an elliptical fashion through the thickness of the coupling. Final fracture was due to overload of the remaining material.
Surface Hardness Testing	Surface hardness of the failed coupling averaged 33.3 Rockwell C. This exceeds the maximum specified hardness of 32 Rc. Couplings #5 and #7 averaged 29.6 and 31.4 respectively.
Dimensional Examination	Coupling OD and length are within specified dimensions and tolerance. Eccentricities of coupling were checked and coupling 4 had the highest at 7 mils.
Compositional Analysis of Surface Deposits	EDS of surface deposits indicates presence of chlorides, sulfides and oxides

Magnetic Particle Examination	MT examination shows cracks through the failed coupling #6, and indications of a crack in coupling #7 at the thread root closest to the vent hole, but not through the vent hole.
Tensile Testing	Ultimate Tensile Strength – 155 ksi Yield Strength – 140.6 ksi
Charpy V-Notch Testing	Charpy Impact testing indicates that the failed coupling had low impact toughness and leads the material to be vulnerable to SCC
Through Thickness Hardness Testing	Through thickness hardness test of failed coupling 6 ranged from 31.5 to 32.7. For 5 and 7 values were less than 32.
Compositional Analysis	Compositional Analysis confirms the couplings are made of 416 Stainless Steel
Scanning Electronic Microscopy	SEM examination revealed the fracture surface morphology to exhibit a rock-candy appearance, characteristic of intergranular stress corrosion cracking (IGSCC).

Palisades SWS pump P-7C coupling #6 failed in August, 2011. The failure is determined, based on metallurgical evaluation, to be the result of intergranular stress corrosion cracking (IGSCC). The 2009 failure of the #7 coupling on the same pump (P-7C) was determined under CR-PLP-2009-04519 to also be a result of IGSCC. LPI's independent examination of the 2009 failed coupling 09-P7C-7F concurs with the failure mode as documented in the 2009 event RCE.

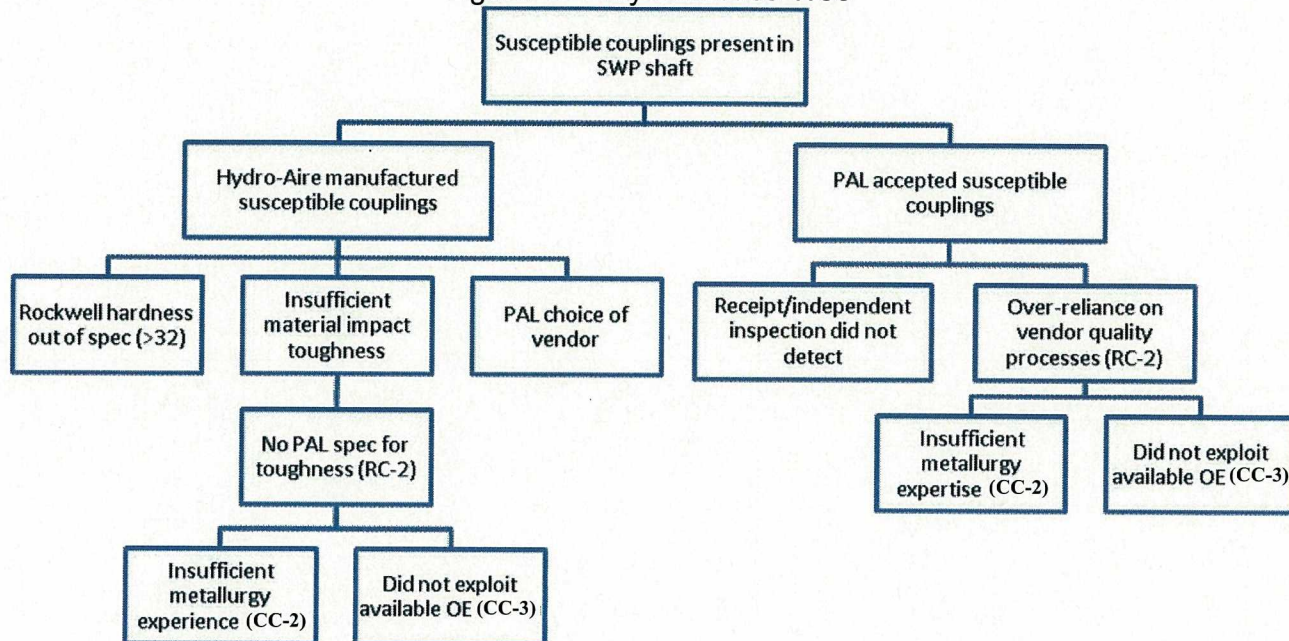
Figure 4: Why Staircase Tree

The team began with a simple why staircase tree that laid out three necessary and sufficient requirements for pump shaft coupling failure, namely:

Technical details of coupling material deterioration and failure appear elsewhere in this report, and form the basis for the material related cause (**RC₁**, **CC₁**). The O&P evaluation will focus on "why" the failure was able to occur. An underlying premise is that while qualified vendors may be expected to ensure product quality and suitability for service, the burden is on the nuclear licensee to manage its relationships with such third parties. The team concluded that Palisades did not do so effectively.
