Attachment V: LPI Report

Lucius Pitkin, Inc. Consulting Engineers

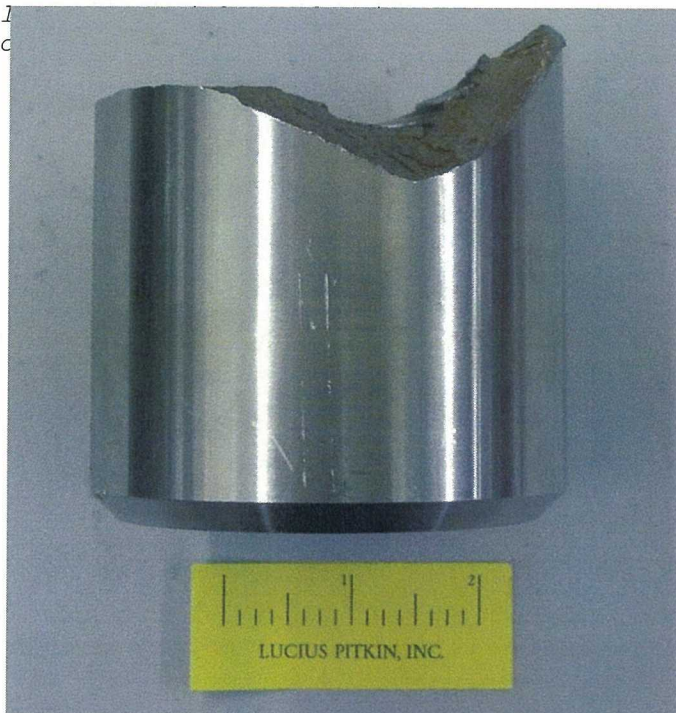
Advanced Analysis
Fitness-For-Service
Failure
Nondestructive

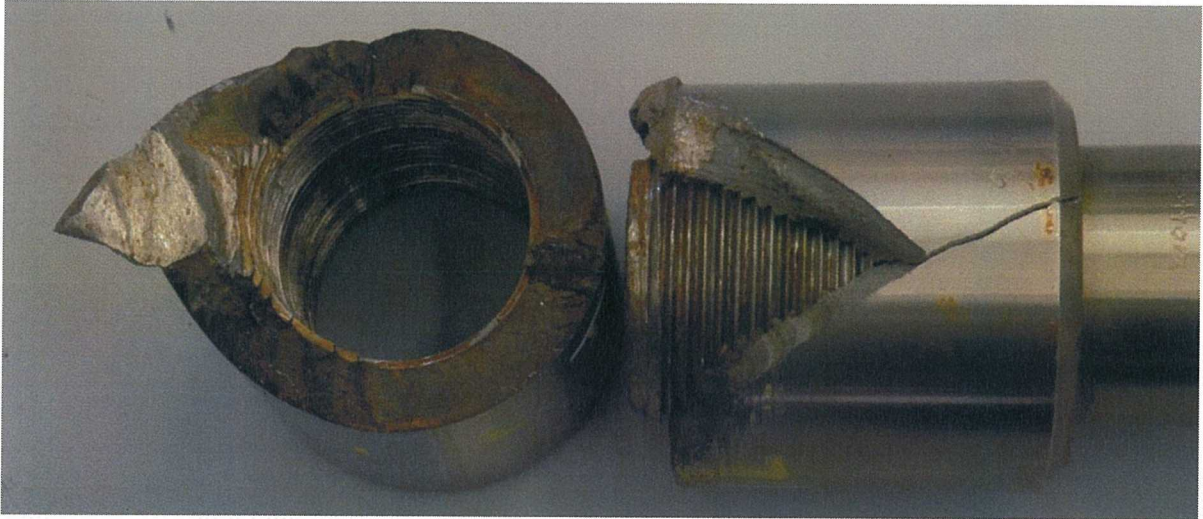
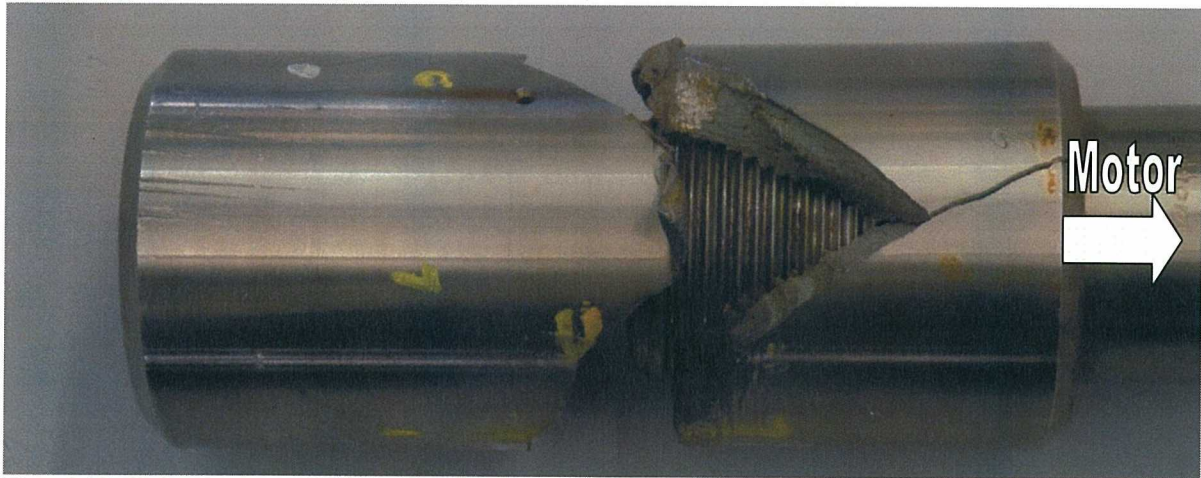
Figure 0-2: As-Received 11-P7C-6F

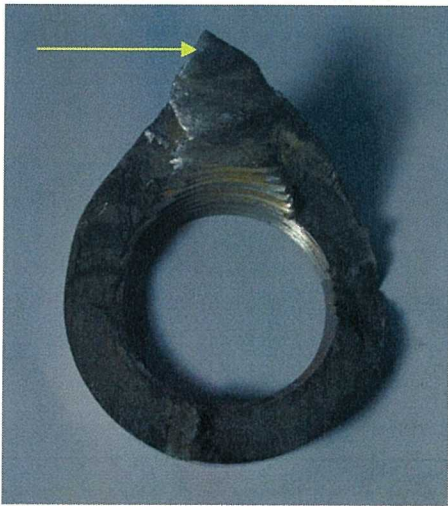
Fracture surface was removed from the bulk of the coupling for analysis.

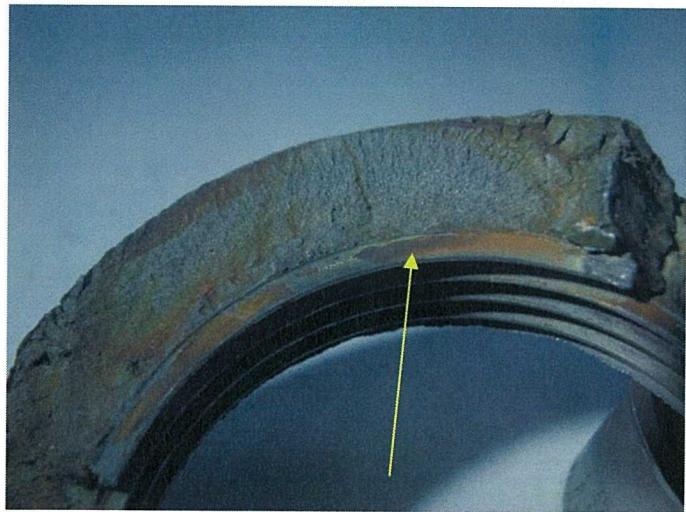
Elliptical pattern of crack on flat fracture surface, relative to coupling axis. Also, red/brown corrosion

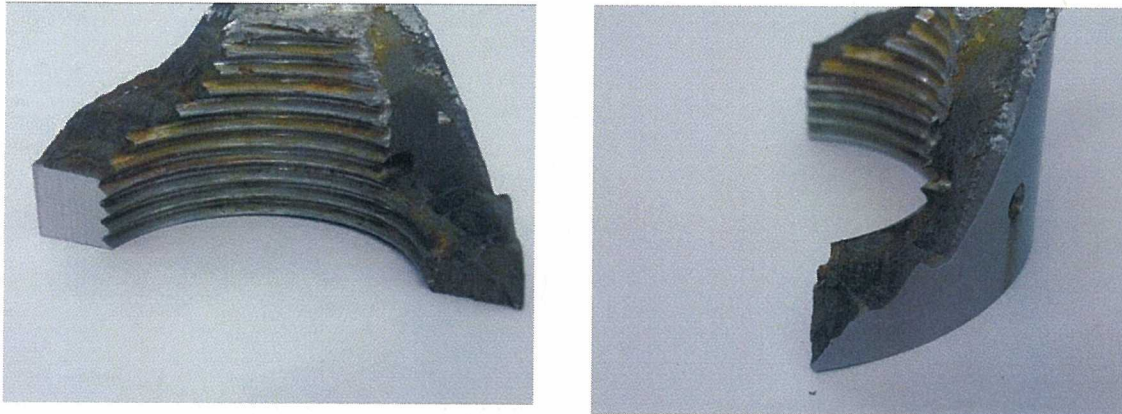
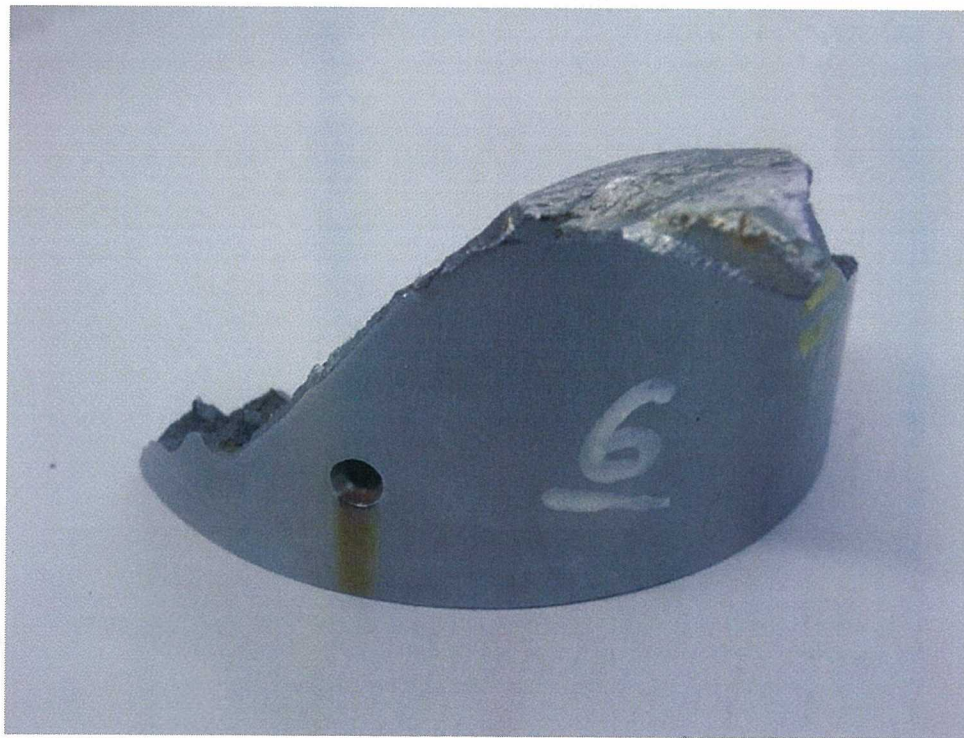
Figure 0-4: 11-P7C-6F showing Corrosion Deposit

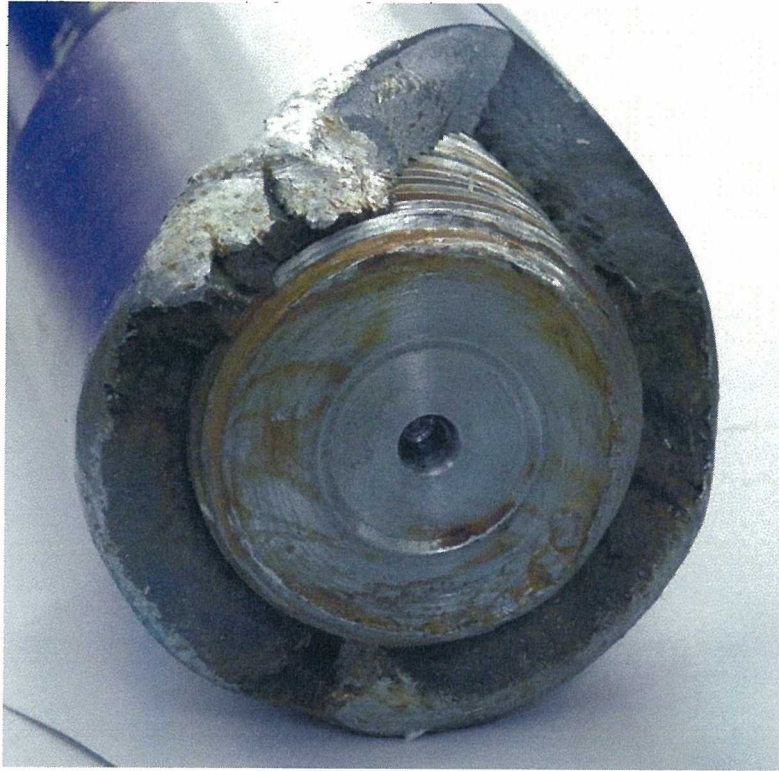
Half of coupling 11-P7C-6F remaining on shaft No. 6 exhibited damage on its fracture surface from contact with the mating coupling half and shaft 5, which occurred after fracture event.

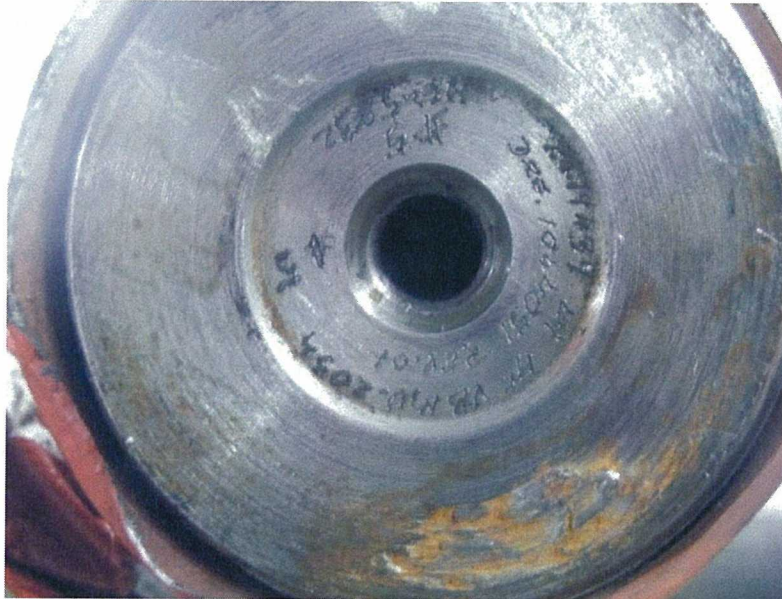
End of shaft No. 5 exhibited gouging damage post 11-P7C-6F final failure.

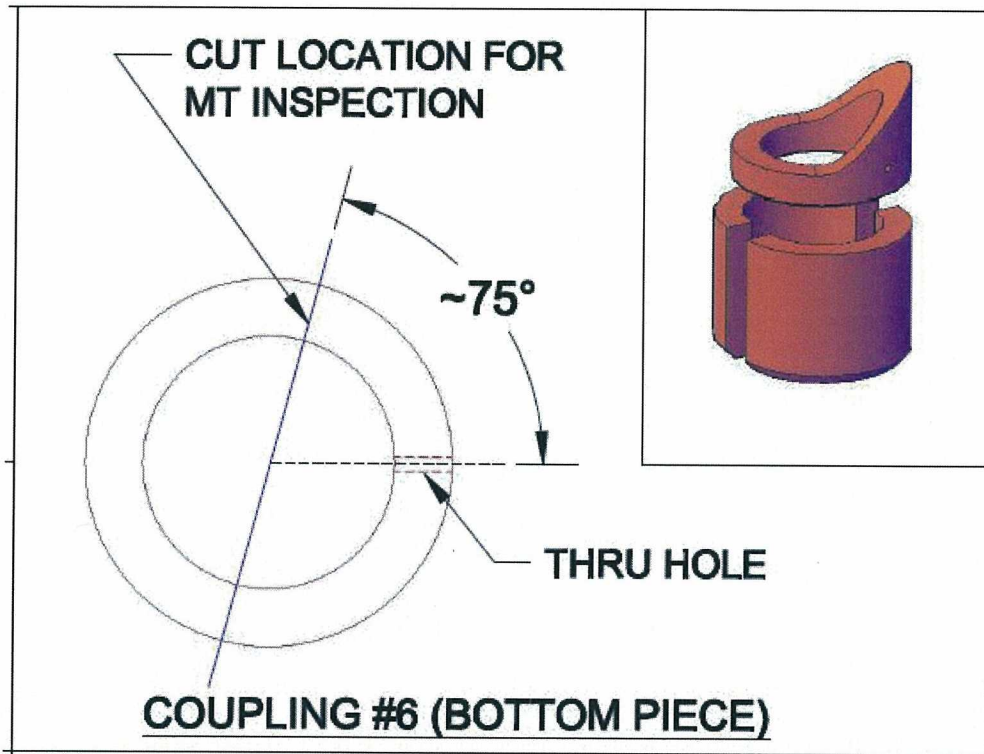
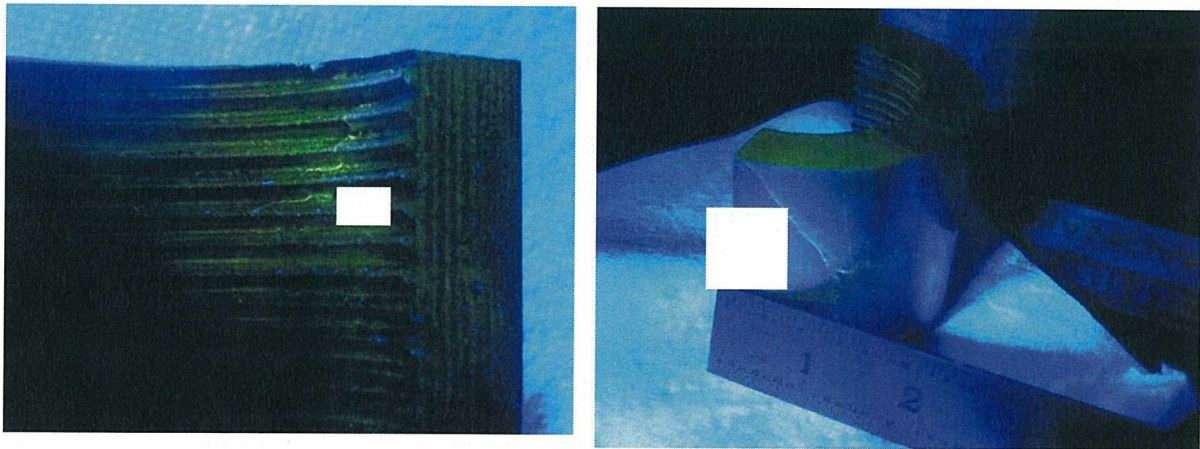
After fracture surface was sectioned, a remaining portion of coupling 11-P7C-6F was MT inspected. Arrows show location of indications.

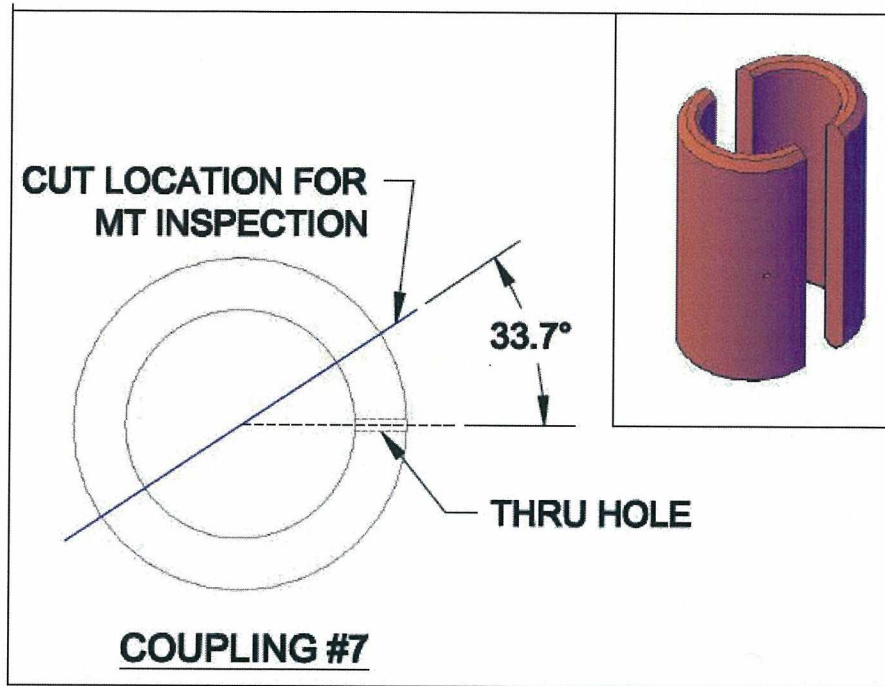
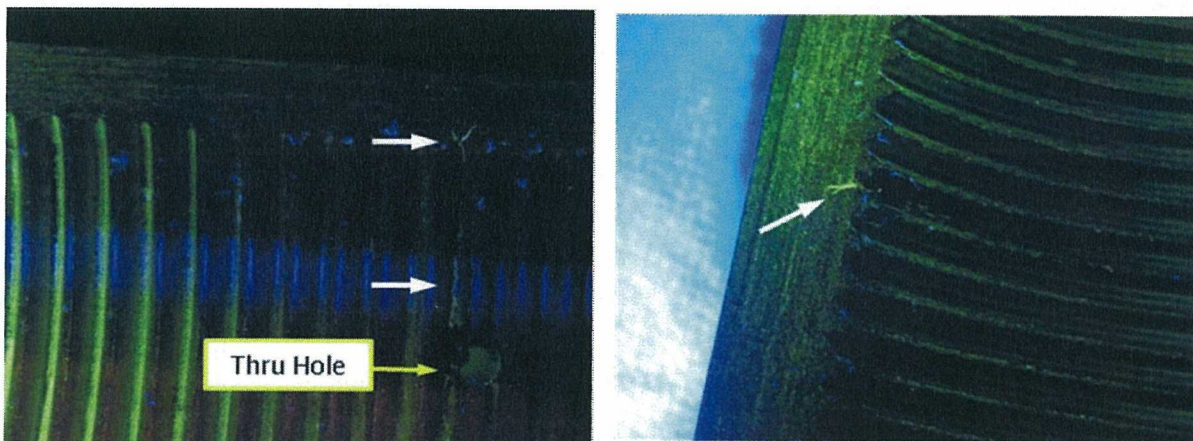
Top sketch show the cut line for coupling 11-P7C-7. Fluorescent MT examination of this coupling reveals an indication, shown by a well-defined fluorescent line, initiating from a thread root and propagating in the radial direction. The left and right images show the same indication on the two sections of this coupling after cutting in half longitudinally. Arrows show location of the indication.

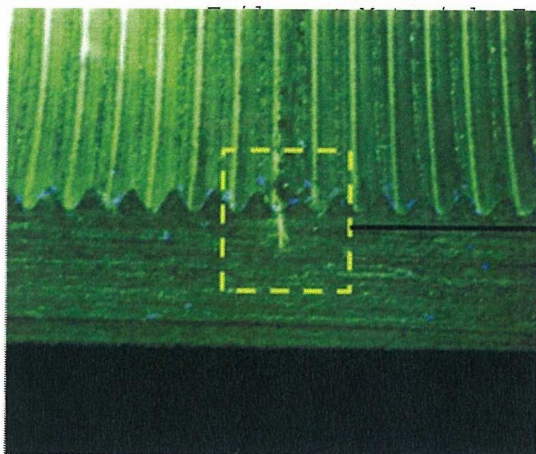
Advanced Analysis
Fitness-For-Service

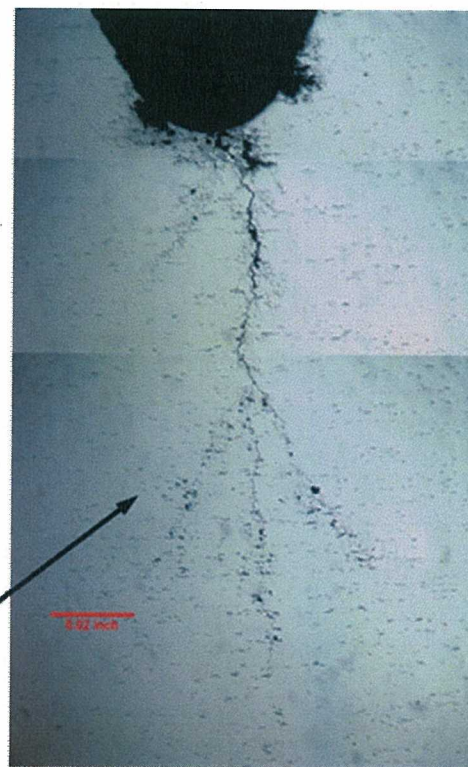
Branched cracking, characteristic of stress corrosion cracking (SCC), initiated from a thread root

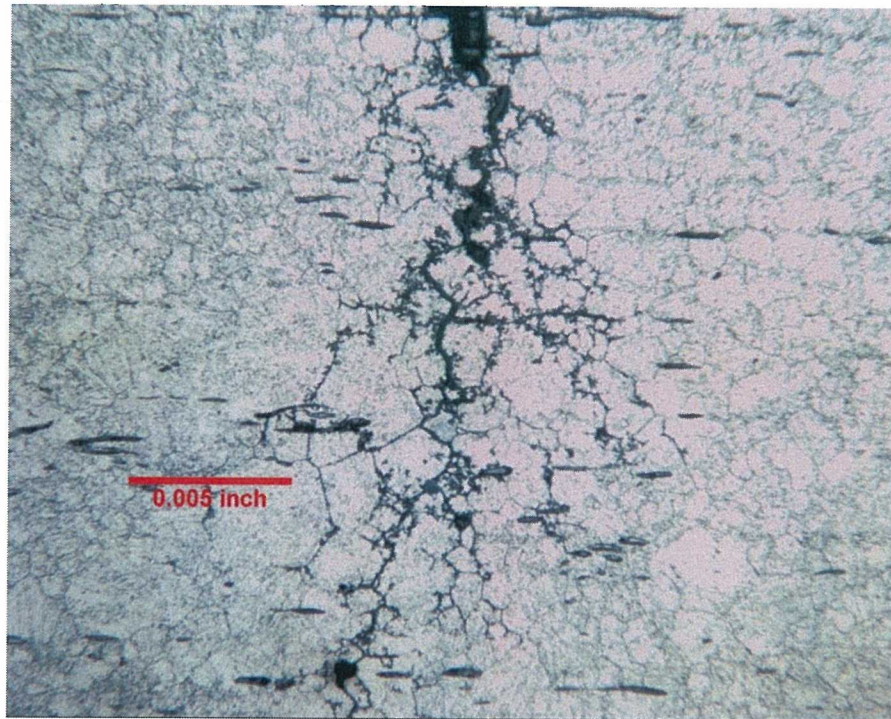
Etched specimen containing indication in coupling 11-P7C-7, showing microstructural features that reveal the intergranular nature of the branched cracking. Viewed at 200x.

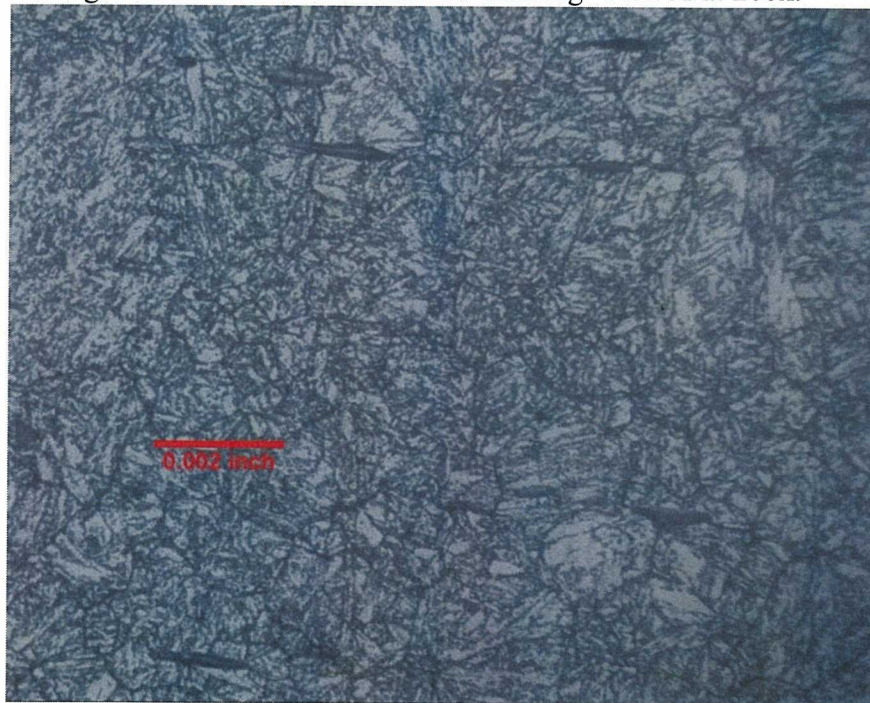
General microstructure of coupling 11-P7C-7 is tempered martensite. Specimen etched and viewed at 400x.

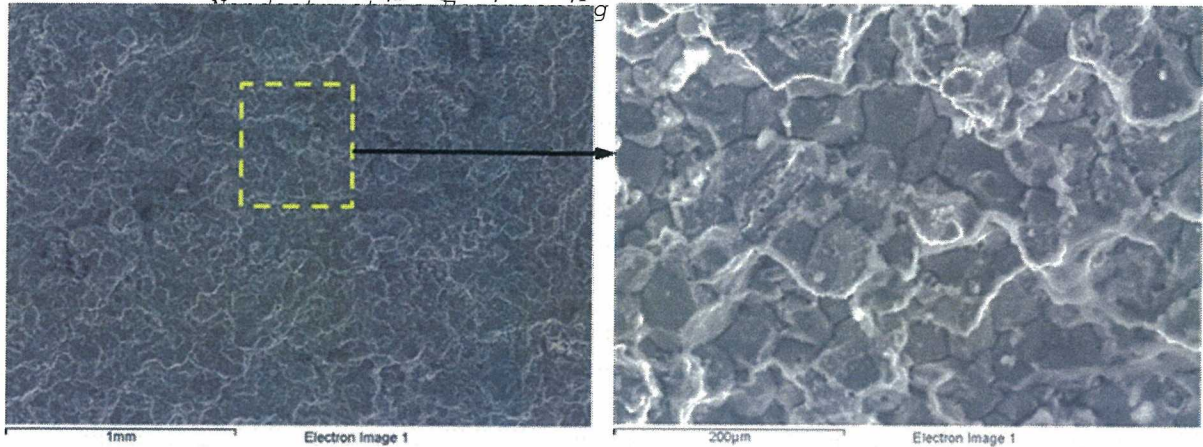
Fracture surface morphology exhibited a rock-candy appearance, characteristic of intergranular stress corrosion cracking. This is typical of a quench and tempered steel, such as a 400 series martensitic steel.

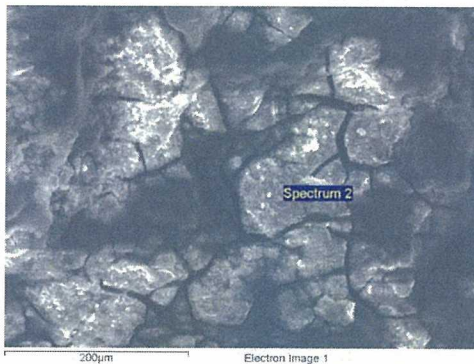
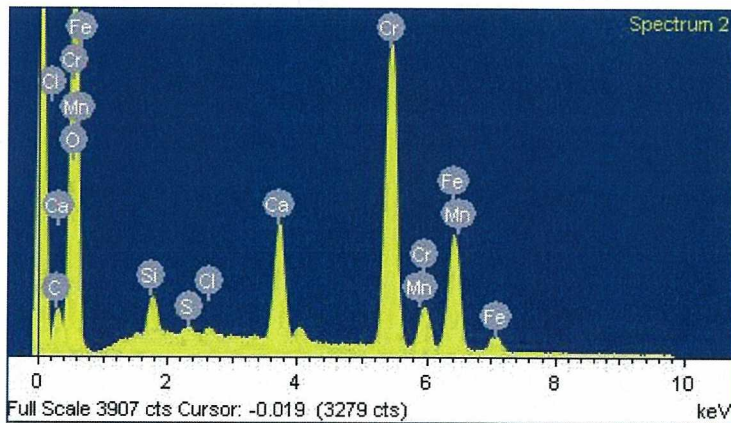
Element	Weight%
O	40.1
Si	1.7
S	0.3
Cl	0.3
Ca	5.9
Cr	29.5
Mn	0.4
Fe	Bal.
