4.0 DISCUSSION OF RESULTS/EVALUATION

In August 2011, a Type 416 stainless steel (SS) coupling fractured in Service Water System (SWS) pump P-7C at Palisades Nuclear Plant (PLP). A previous coupling fracture occurred in the same pump in 2009. As a result of the recent failure, some couplings extracted from all three pumps at the PLP site were examined by magnetic particle testing that revealed four additional cracked couplings from pumps P-7C and P-7B, but not P-7A.

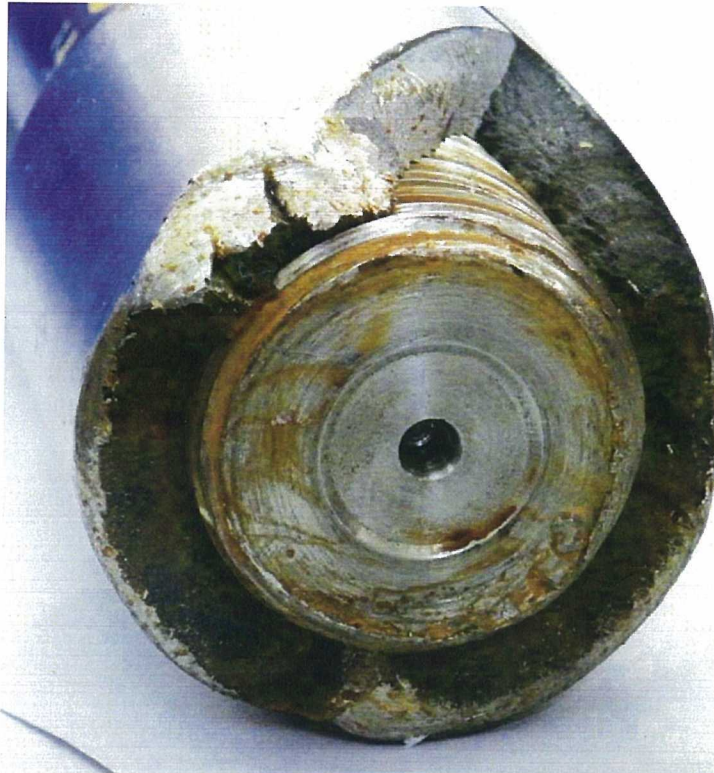
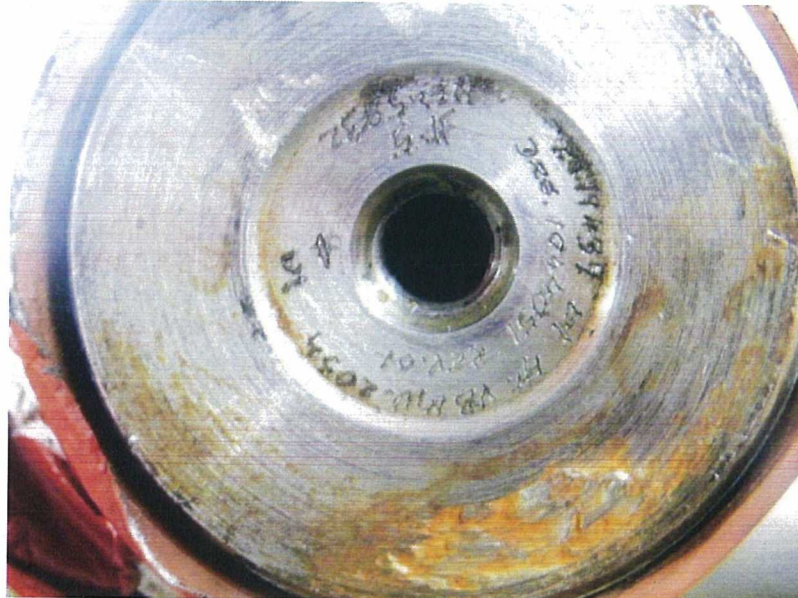
Figure 3-7: Ends of Shaft 5 and 6 Coupled by 11-P7C-6F

Half of coupling 11-P7C-6F remaining on shaft No. 6 exhibited damage on its fracture surface from contact with the mating coupling half and shaft 5, which likely occurred after fracture event.

End of shaft No. 5 exhibited gouging damage likely from post 11-P7C-6F final failure.

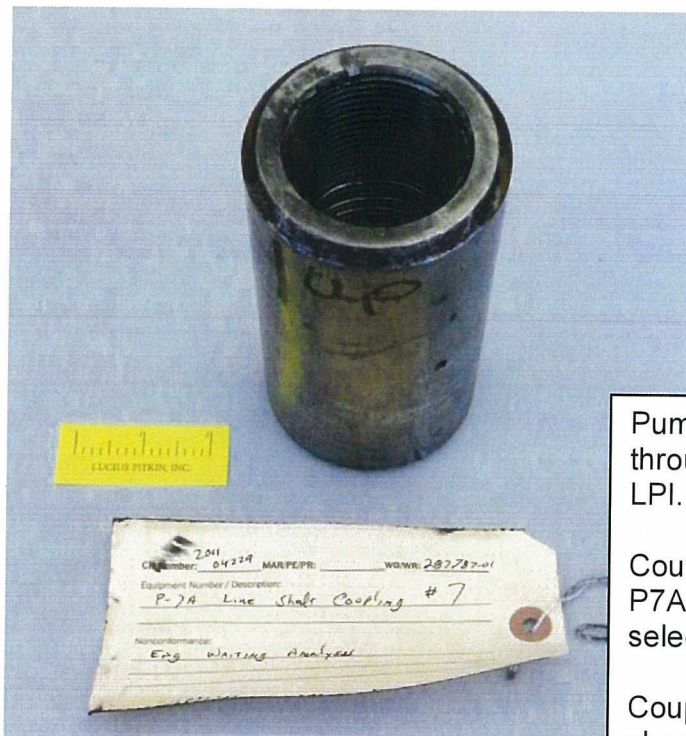
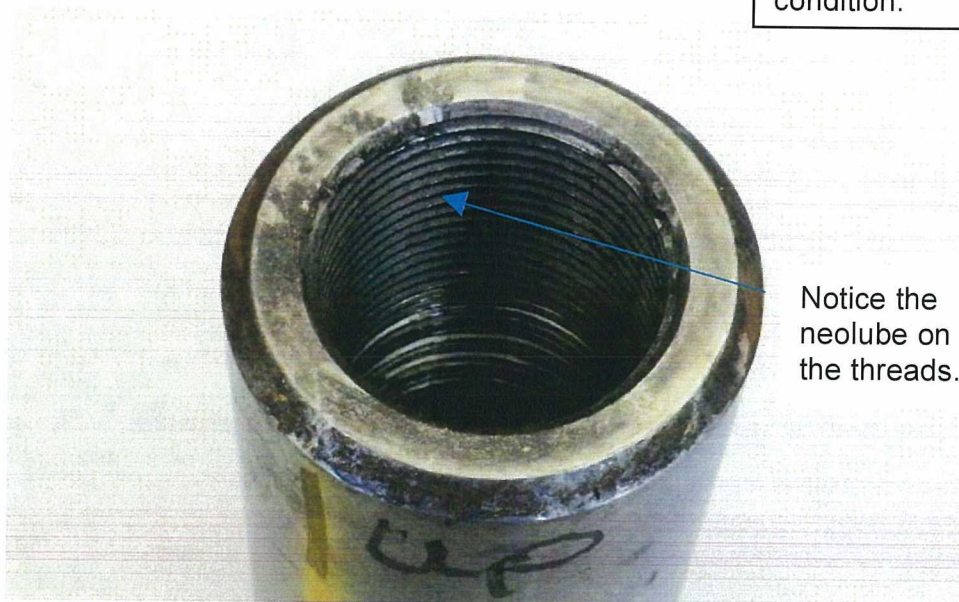
Figure 3-8: As-Received Coupling No. 11-P7A-7

Coupling No. 7 (11-P7A-7) shown in its as-received condition.

Notice the neolube on the threads.

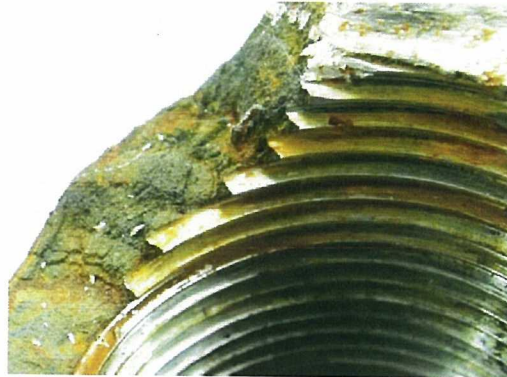
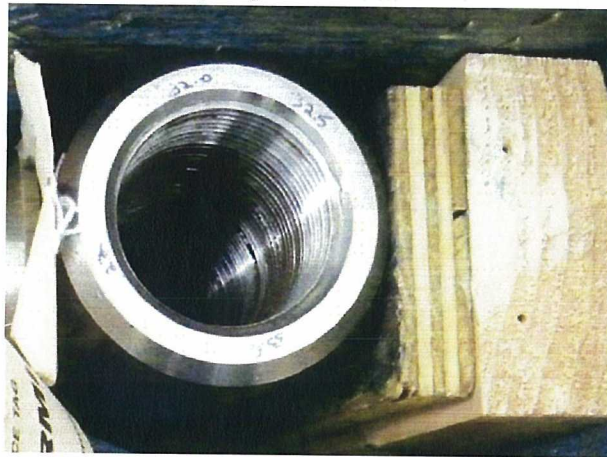
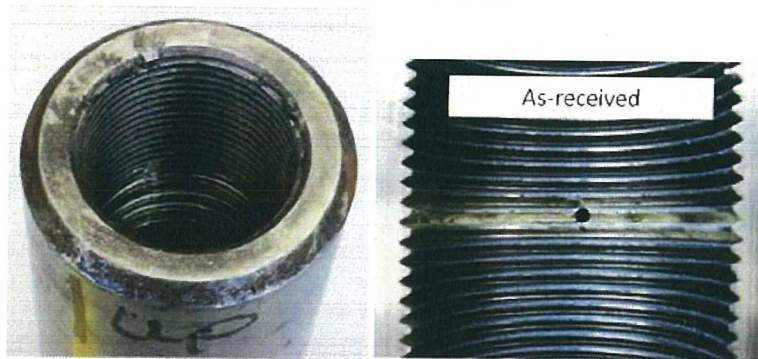
Figure 3-9: Contrast Thread Coating (As-Received) on P-7C Failed and Cracked Couplings to P-7A Coupling

Coupling No. 11-P7C-6F

11-P7C-7K in the as-received condition does not exhibit the same level of neolube on threaded surface as 11-P7A-7

11-P7A-7 in the as-received condition exhibits significant amounts of neolube on thread surface

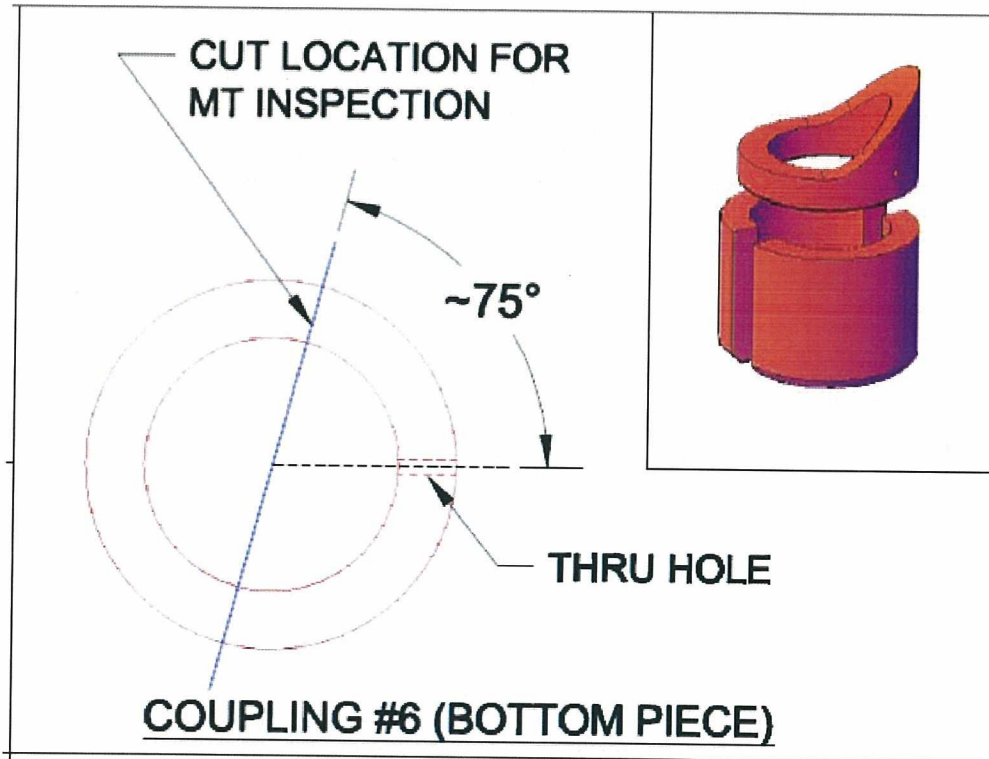
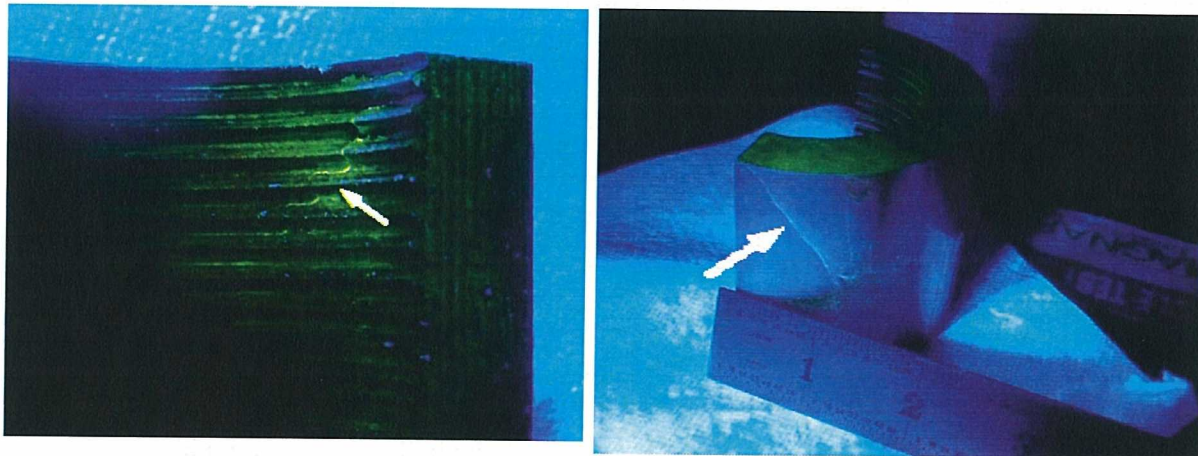
Figure 3-16: MT Highlighting Un-Opened Fracture on Coupling 11-P7C-6F

After fracture surface was sectioned, a remaining portion of coupling 11-P7C-6F was MT inspected. Arrows show location of indications.

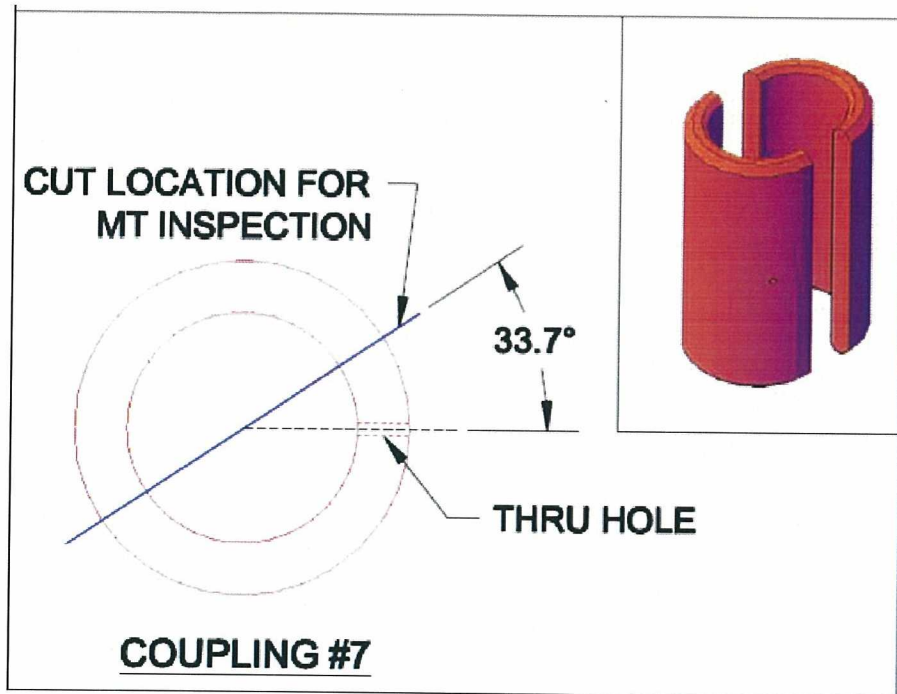
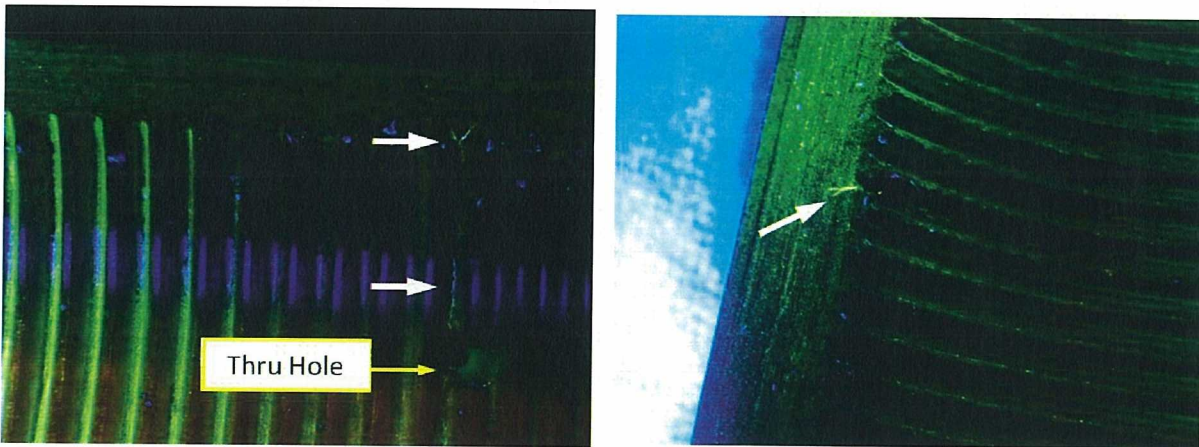
Figure 3-17: MT Highlighting Crack on Coupling 11-P7C-7K

Top sketch show the cut line for coupling 11-P7C-7. Fluorescent MT examination of this coupling reveals an indication, shown by a well-defined fluorescent line, initiating from a thread root and propagating in the radial direction. The left and right images show the same indication on the two sections of this coupling after cutting in half longitudinally. Arrows show location of the indication.

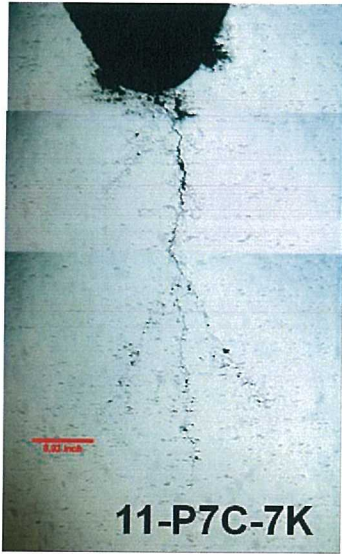
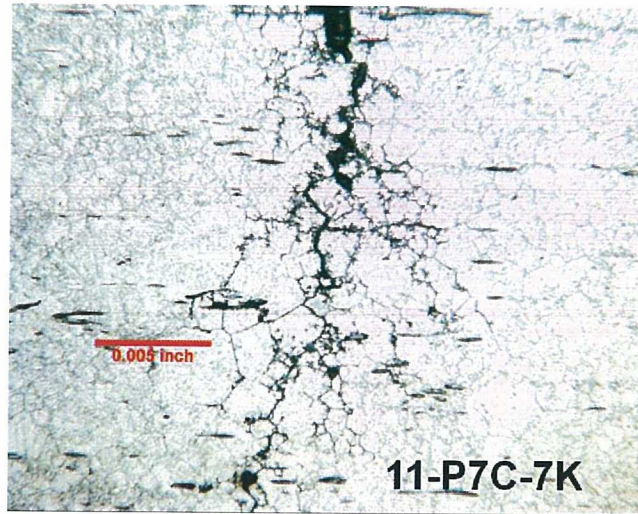
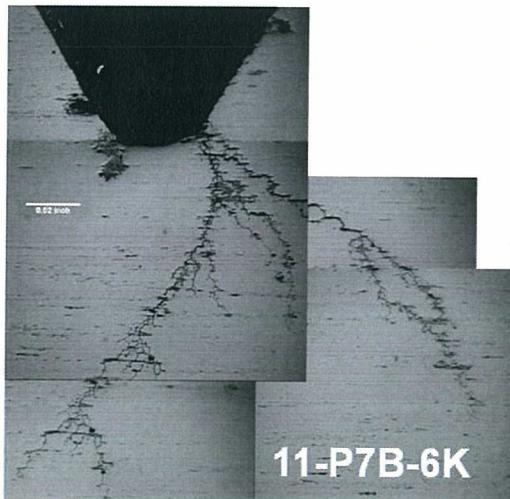
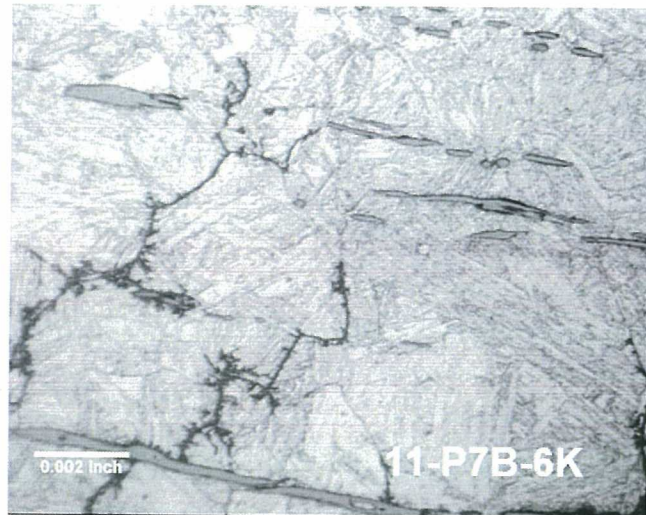
Figure 3-20: As-polished (left) and Etched (right) Microscopy

Images of SCC cracks in coupling 11-P7C-7K (top) and 11-P7B-6K (bottom) showing the network of cracks that follow the prior austenite grain boundaries.

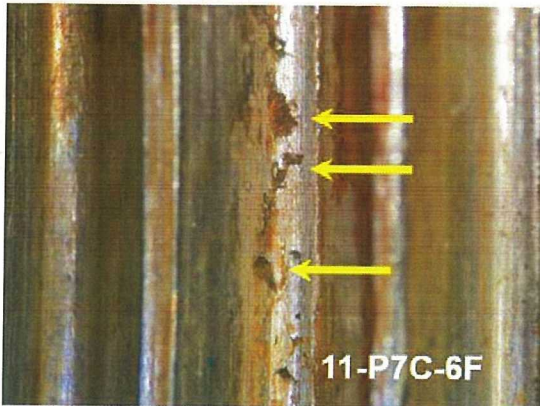
11-P7C-6F
Pitting at root near middle of fractured Coupling No. 6 (Stereomicroscopy 15X)

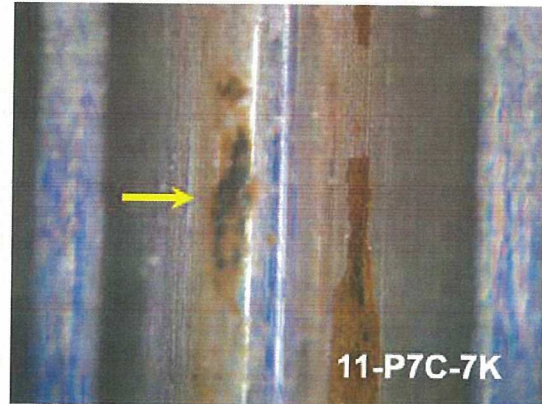
11-P7C-7K
Pitting near the root and near middle of Coupling No. 7 (Stereomicroscopy 40X)

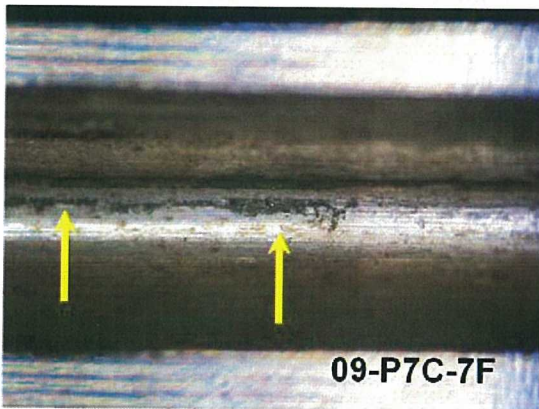
09-P7C-7F
Pitting near root at middle of fractured Coupling No. 7 from 2009 event (Stereomicroscopy 30X)

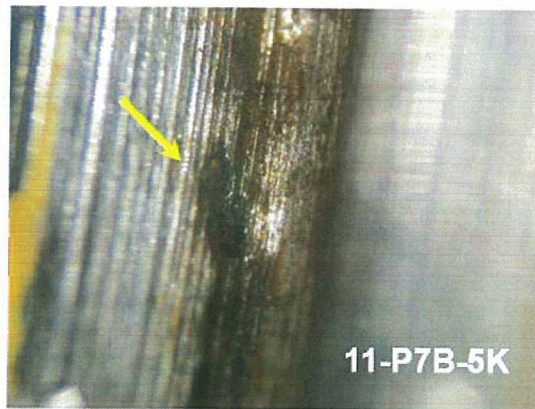
11-P7B-5K
Pitting near root at middle of Coupling No. 5 (Stereomicroscopy 40X)

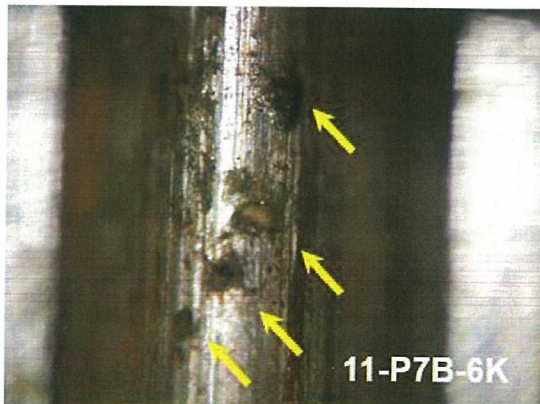
11-P7B-6K
Pitting at root near middle of Coupling No. 6 (Stereomicroscopy 50X)

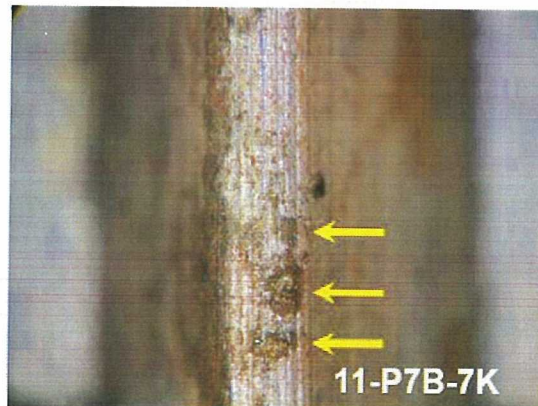
11-P7B-7K
Pitting at root near middle of Coupling No. 7 (Stereomicroscopy 50X)

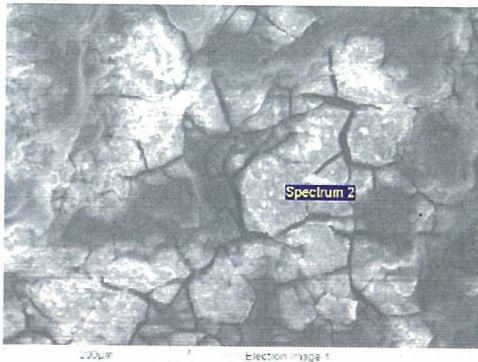
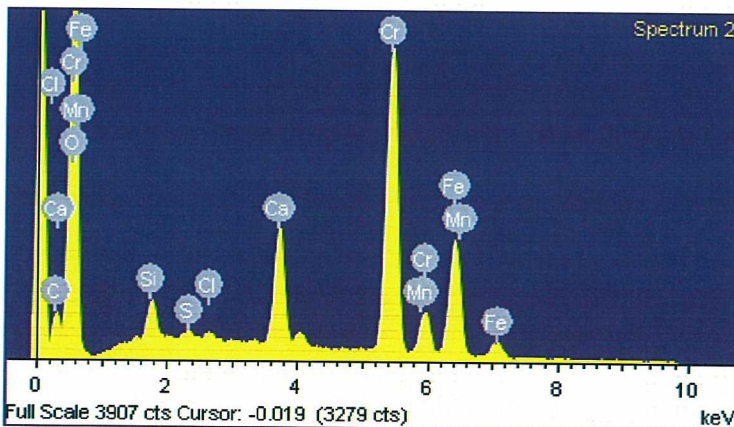
Figure 3-23: EDS of Coupling 11-P7C-6F Surface Deposit – Spectrum 2

Element	Weight%
O	40.1
Si	1.7
S	0.3
Cl	0.3
Ca	5.9
Cr	29.5
Mn	0.4
Fe	Bal.

EDS analysis of fracture surface revealed the presence of corrosive agents (chlorides, oxides and sulfides), consistent with stress corrosion cracking. The high chromium level in the spectrum is likely attributed to local chromium carbides in the EDS sampling volume.

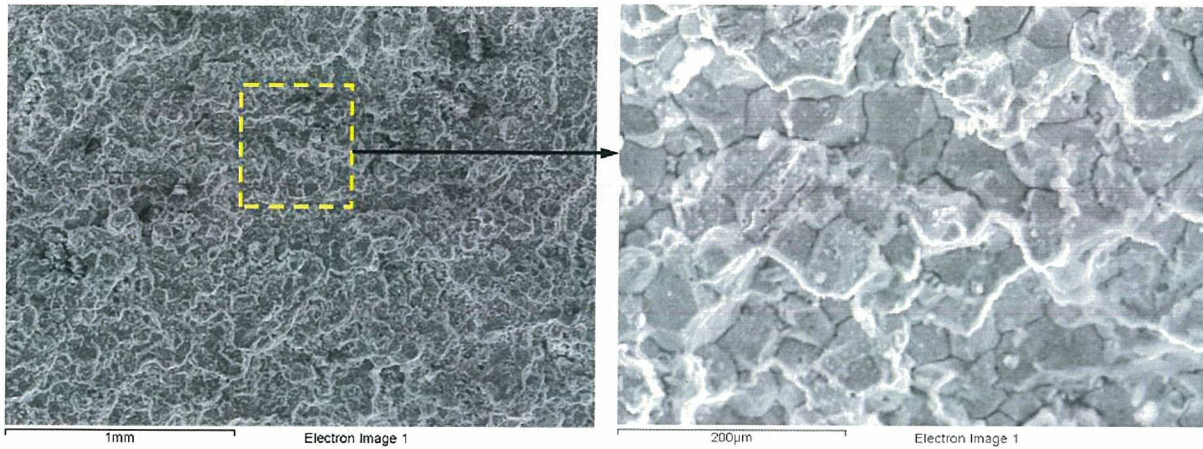
Figure 3-25: SEM of Coupling 11-P7C-6F Surface

Fracture surface morphology exhibited a rock-candy appearance, characteristic of intergranular stress corrosion cracking. This is typical of a quench and tempered steel, such as a 400 series martensitic steel.

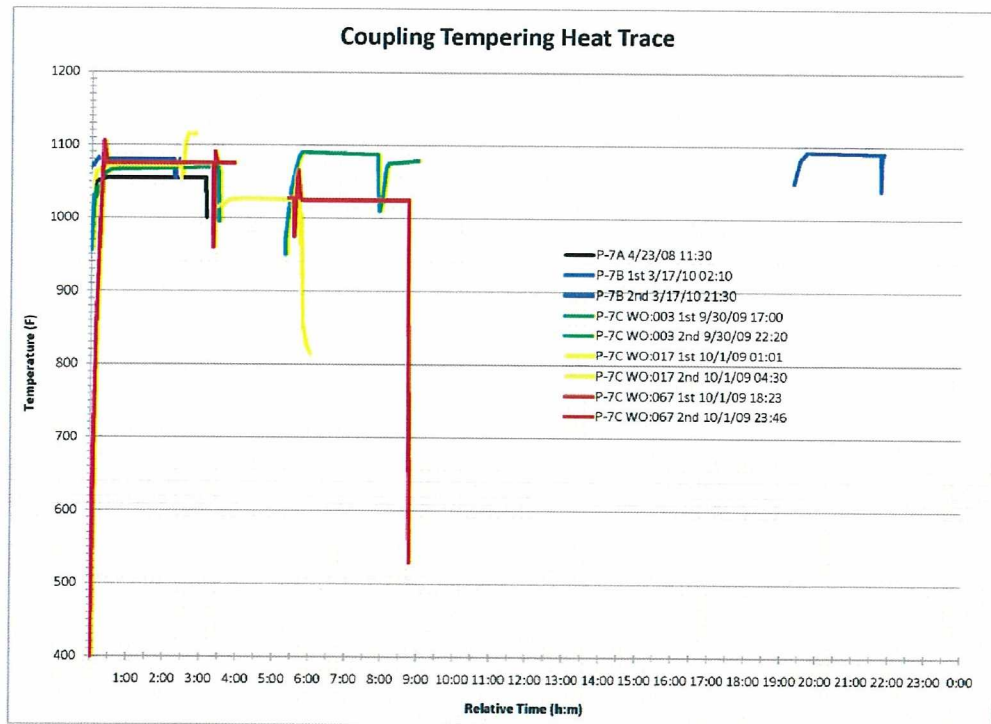
Figure 4-2: Tempering Heat Traces

Referring to the heat traces in Figure 4-2, the couplings were tempered in the range of 1025°F to 1090°F. This range encompasses a double temper. The double temper was performed to attain the specified hardness of 28 to 32 HRC. The first temper is in the range of 1050°F to 1080°F. Based on the first tempers, the austenitizing temperature of 1870°F (see Figure 4-1), not only exceeds the recommended maximum of 1850°F (as discussed above) but is on the wrong side of the recommended range.

Referring again to Figure 4-2, notice that the couplings extracted from P-7A were single tempered whereas the couplings installed and extracted from P-7B and P-7C were double tempered. Although double tempering could be beneficial, the second temper of the P-7C couplings under Hydro-Aire work order (WO) 202017 (yellow line) and 202067 (red line) were at approximately 1025°F, which is in the range that should be avoided.

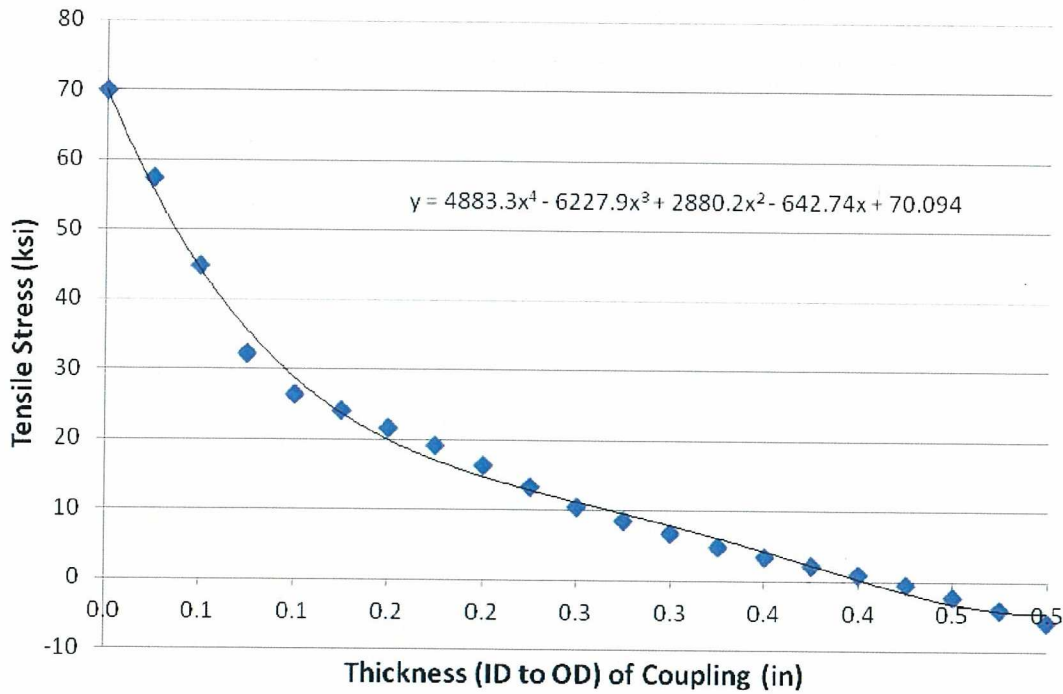
Figure 4-12: Tensile Stress Distribution Across Wall Thickness of Coupling – LC2
(Based on three threads reacting out applied load)

- 2) LC2: This load combination results in high stress concentrations at the thread root of the coupling at the contact plane of the two shafts. Axial tensile stresses at the thread root are over 10 times greater than LC1 with stresses on the order of 60 to 70 ksi. The stress distribution at the middle thread root across the coupling wall for this load combination root is presented in Figure 4-12.

The Figure 4-12 stress distribution is based on reacting the applied shaft end compression load from the applied motor torque across three threads³ per shaft end. Considering the two shafts meeting approximately in the center of the coupling, the three threads below the centerline react the lower shaft compression loading, the three threads above the centerline react the compression loading in the upper shaft. However, tolerances in machining of the threads could translate into different load and stress distribution across the threads. If the load is distributed to fewer or greater number of threads than the three assumed, then the tensile stress at the thread root could range according to the load distribution to the threads.

For example, if the shaft bearing loads were distributed across six threads instead of three, the maximum tensile stress would be on the order of 30 ksi. Based on the FEA and depending on the number of threads sharing the load, it is not un-reasonable for tensile stresses to range from approximately 20 ksi to 80 ksi at the thread root.
