Root Cause Evaluation – Plant Trip During Panel ED-11-2 Maintenance, Rev 2

Root Cause Evaluation Report

On September 25, 2011, at 1506, while performing maintenance activities on DC electric distribution panel D-11-2, a short circuit condition occurred resulting in reactor trip.

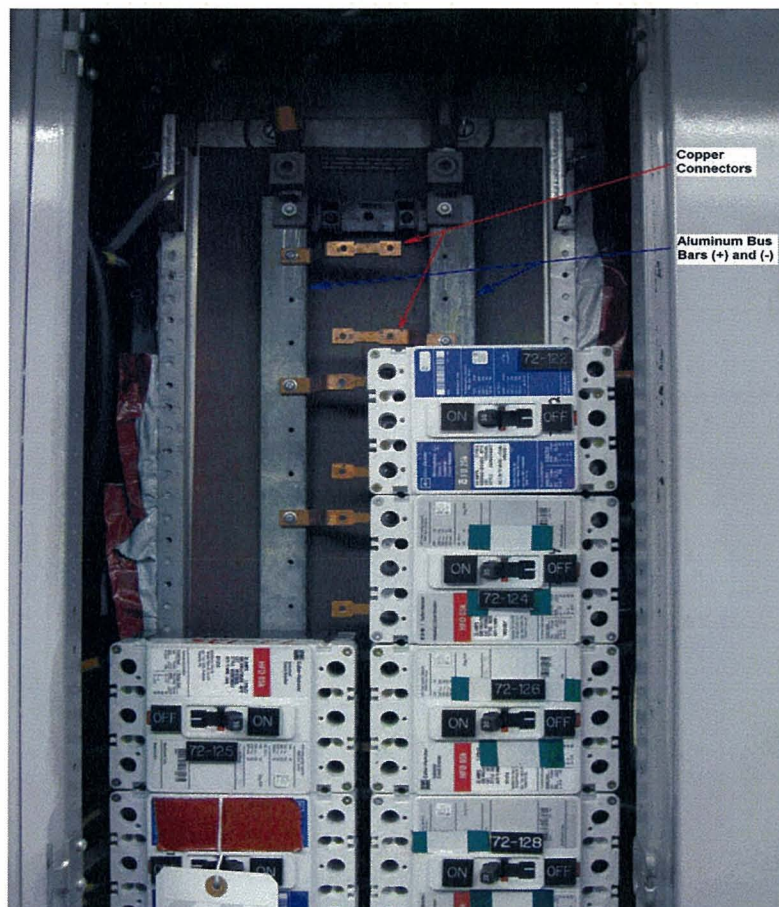
Discovery of cross-threaded bus connectors and a bus connector air gap during troubleshooting under WO291194 on 09/25/11 suggested that the breaker replacement workmanship during 1R21 could have been substandard. An examination of the two removed connectors that was done for this root cause evaluation found that the threads had been partially stripped, either by repeated use or by over-torquing the bolts in the relatively softer metal of the connectors. There was no evidence of damage on the tops of the connectors, such as scoring or gouging, to show that workers had found difficulty replacing the bus connector bolts which should have caused them to stop work and ask for help.

Following the removal of all four breakers, evidence of cross-threading damage was also found on the bus connector for 72-120. With concurrence from engineering, maintenance management and electrical maintenance supervision, the crew reached a decision to remove the bus connectors for both breakers 72-119 and 72-120 from the energized bus and to return them to the maintenance shop where the damaged threads could be repaired by retapping. The work could then be performed away from the energized bus and free from the risk of small metal particles falling into the bus or into other breakers. The following picture shows the two bus connectors that were to be removed:

- An examination of the two removed connectors found that the threads had been partially stripped by over-torquing the bolts in the relatively softer metal of the connectors.

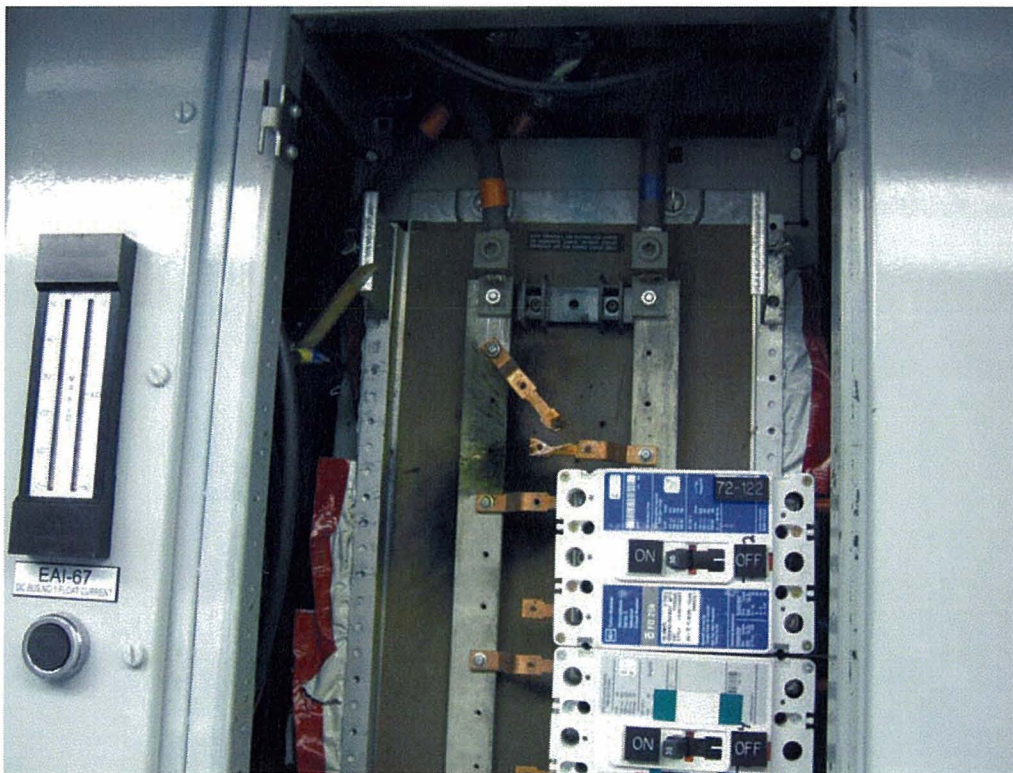
As the connectors were being removed, the worker holding the connector was startled, by an apparent flash or spark, into an involuntary motion that caused him to release the connector. Fortunately, the involuntary motion was such that no electrical shock occurred. The end of the connector, which had by now been loosened at its bus end, was able to swing down and contact the bus connector below it resulting in a short circuit between the positive and negative bus sections. The following picture was taken shortly after the short circuit occurred:
