ATTACHMENT D General Visual Examination Checklist

IP2-GEG-3113
Rev. 1
Rev. Date: 03-10-2000

Component or Zone Number: IWE-046-006

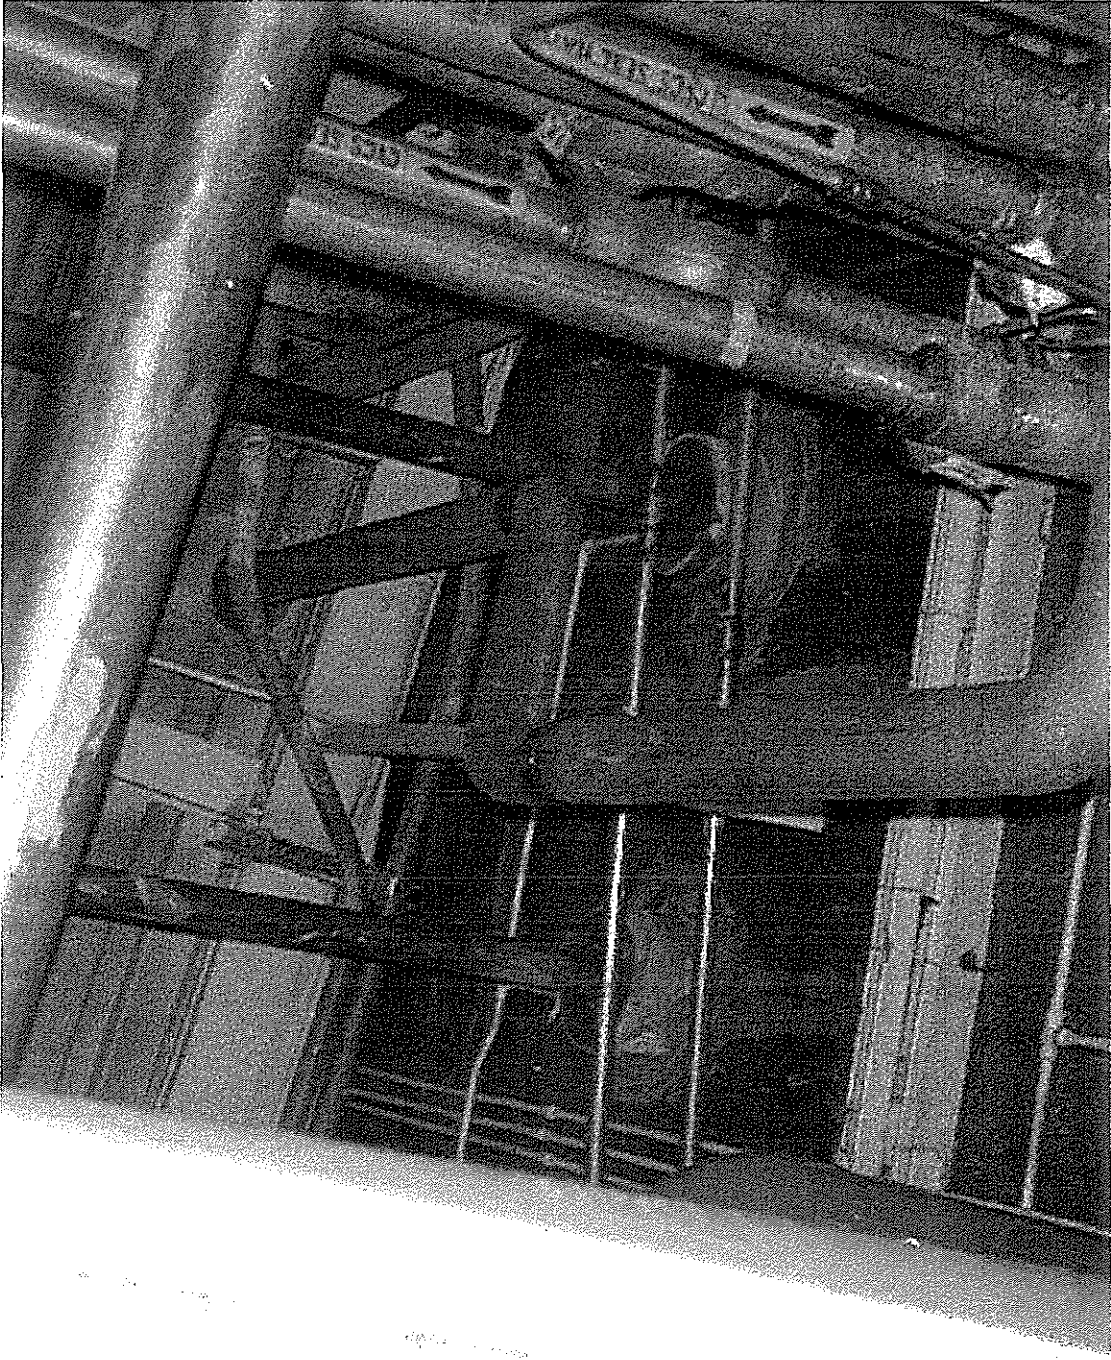
00031619.jpg

Item No.	Description	Photo
01	Mechanical penetration nos. MP-AA, MP-BB, MP-CC and MP-DD, MP-Q showed surface rusting on the end plates. Penetrations with hot piping will experience service that will not promote an active corrosive environment. Rust staining is classified as ASTM D610, Grade 1 -2. (between 1/3 and 1/2 of the end plate circumference.)	00031619.jpg, 00031620.jpg and 00031628.jpg

Item No.	Discussion	Acceptable	Additional Eval. Req'd.
01	<p>The corrosion on the 3/4" thick penetration head plates has resulted from high temperatures, which have burned off the coating and allowed corrosion of the plate. (MP-AA, BB, CC & DD are for Steam Generator Blowdown lines with process temperatures of 568°F. MP-Q is for a Safety Injection line with process temperature of 250°F.) The corrosion is powdery in form and does not exhibit flaking or pitting which would indicate a more severe condition. During plant operation the piping temperatures will be sufficiently high as to preclude moisture from the head plates and thus the plates will only be subject to corrosion during plant outages. These times are sufficiently short and the corrosion rates sufficiently low as to not result in significant loss of material (i.e., well less than 10% as discussed in IWE-3512.3). Corrosion on the penetration sleeves is general surface corrosion that has not resulted in any significant loss of material. Examination at the next regular inspection period is sufficient to monitor these conditions.</p>	✓

MP-AA (RIGHT) and MP-BB (LEFT)

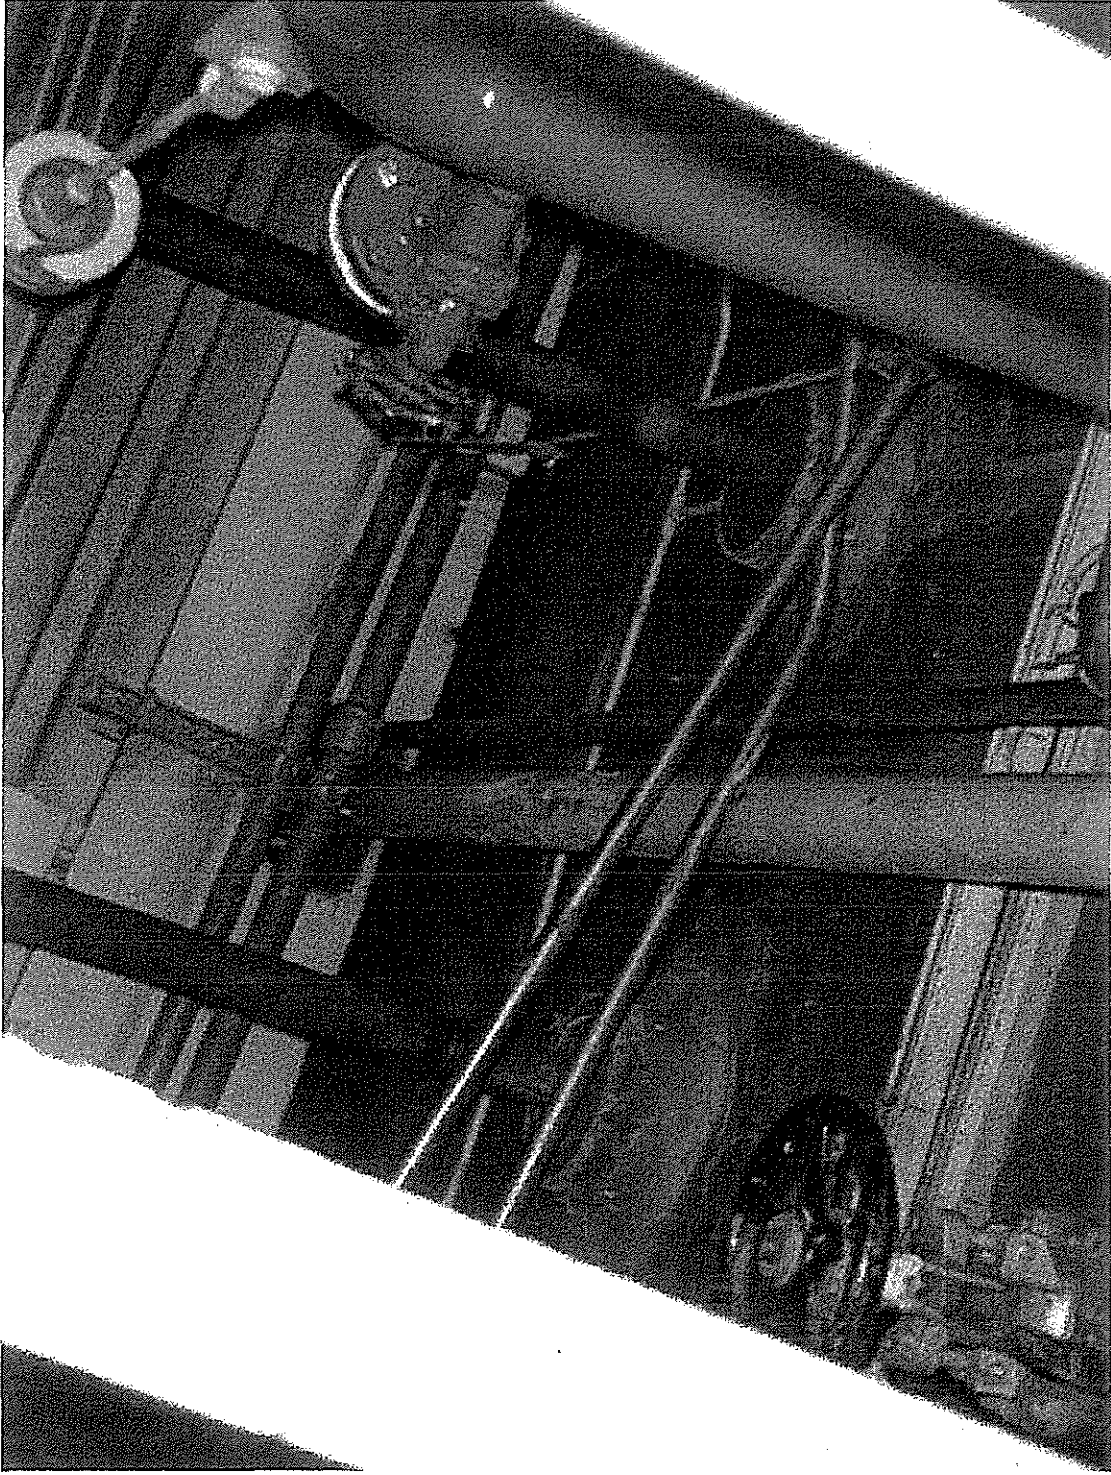
00031620.jpg

MP-CC (RIGHT) and MP-DD (LEFT)

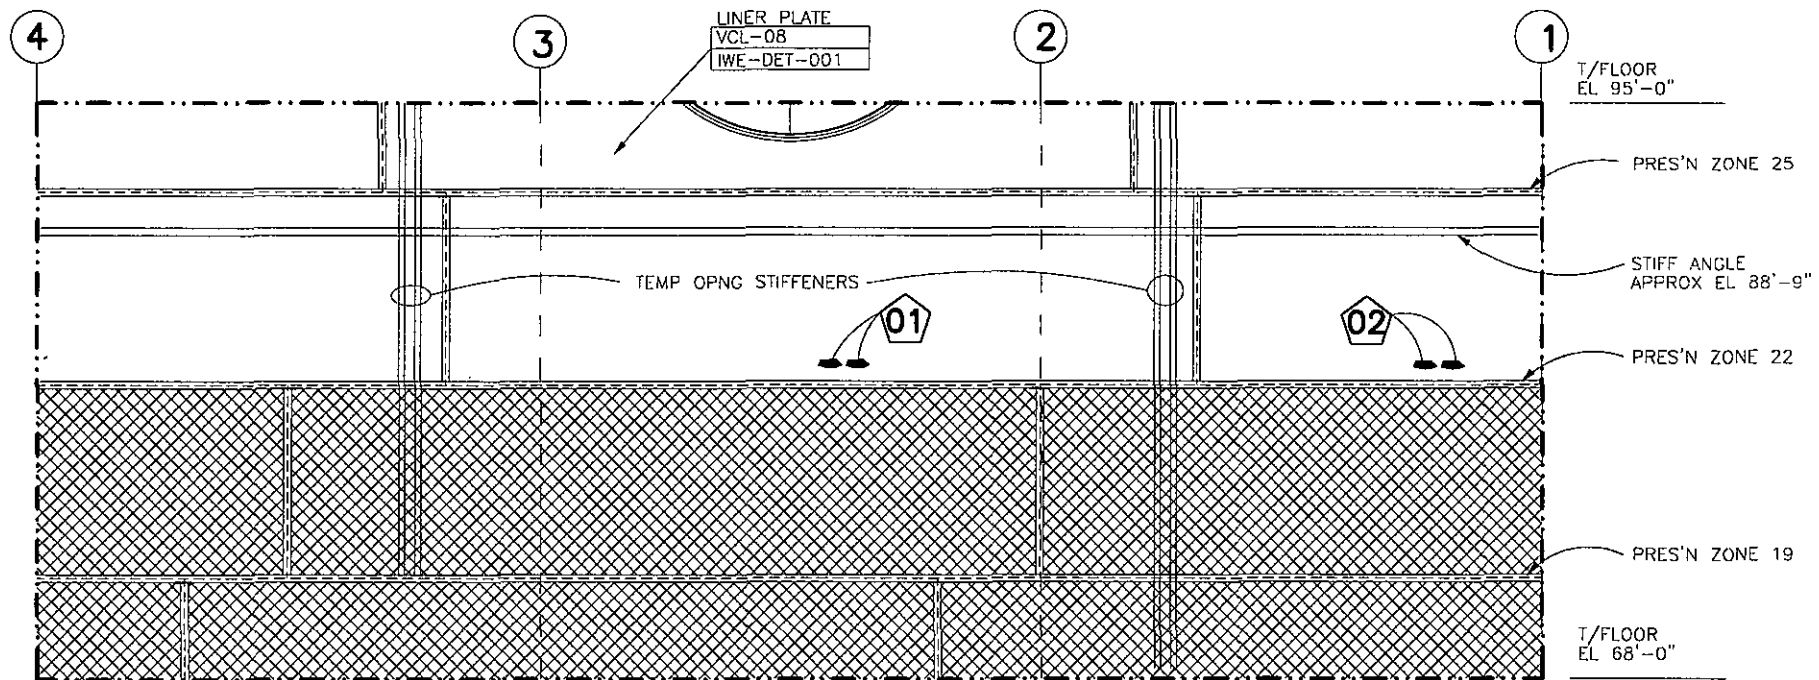
LINER INSPECTION ZONE IWE-068-001
 (INTERIOR DEVELOPED VIEW, LOOKING INSIDE OUT)

Item No.	Description	Photo
01	Two areas approximately 1"x1" located 12" above insulation halfway between Col. 2-3 show mechanical nicks in topcoat. Primer intact.	None
02	Two areas approximately 1"x1" located 8" above insulation between Col. 1-2 show mechanical nicks in topcoat. Primer intact.	None

Item No.	Discussion	Acceptable	Additional Eval. Req'd.
01, 02	The nicks in the coating are mechanical damage that has removed the top coat. Since the primer is intact, the liner will be protected and there is no significance to this condition.	✓

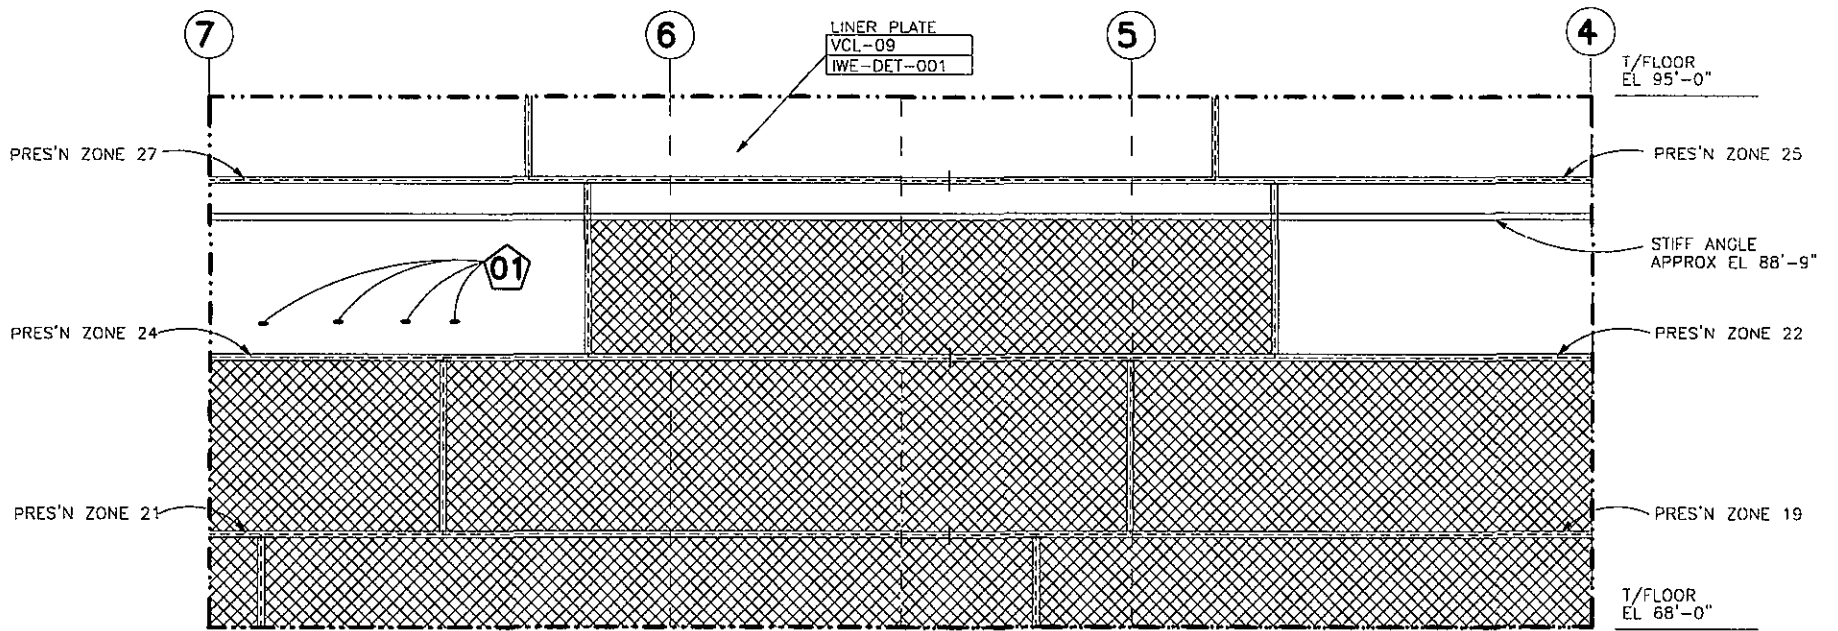
LINER INSPECTION ZONE IWE-068-002
 (INTERIOR DEVELOPED VIEW, LOOKING INSIDE OUT)

Item No.	Description	Photo
01	Four (4) areas approximately 3" in length between Col.6-7 show touch-up coat checking and peeling. Primer intact. Checking classified as ASTM D660, Mosaic Grade 8.	None

Item No.	Discussion	Acceptable	Additional Eval. Req'd.
01	The coating deterioration is limited to the top coat. Since the primer is intact, the liner will be protected and there is no significance to this condition.	✓

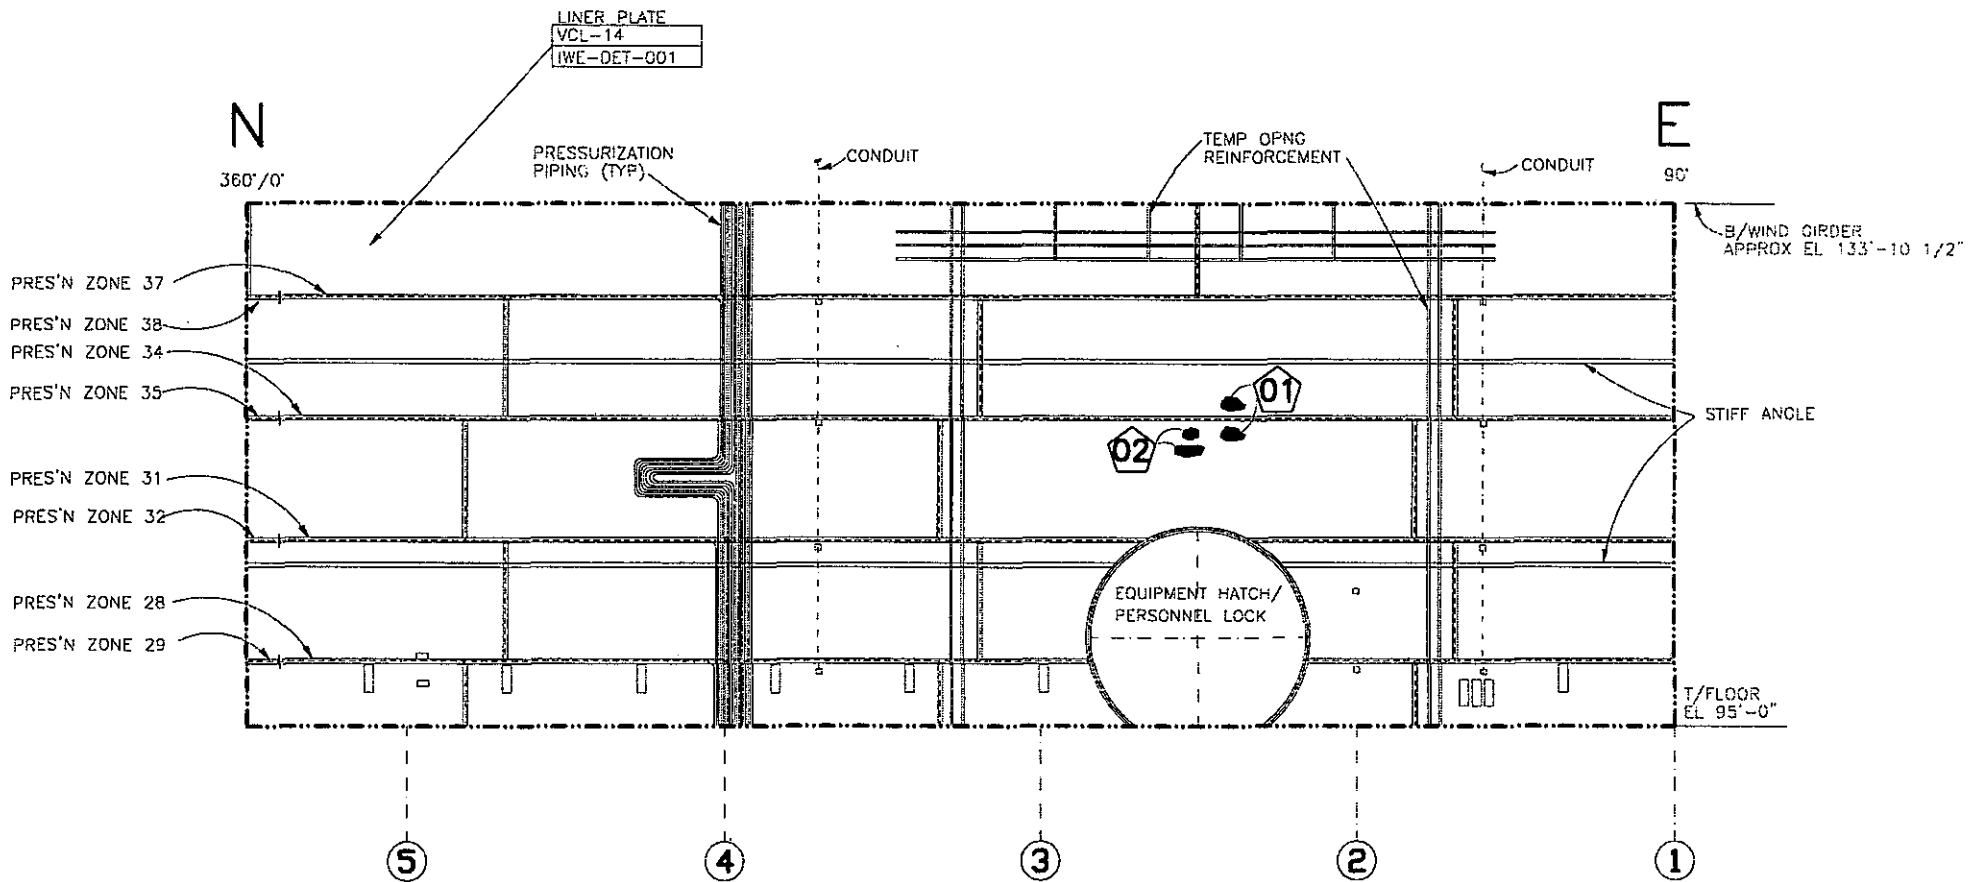
LINER INSPECTION ZONE IWE-095-001
(INTERIOR DEVELOPED VIEW, LOOKING INSIDE OUT)

Item No.	Description	Photo
01	Coated 3" round liner attachment above equipment hatch shows minor rusting. Rusting is classified ASTM D610, Grade 5, (3% of surface rusted). Also, area below attachment shows top coat delamination, checking and peeling. Primer intact in both areas. Checking to ASTM D660, Mosaic, Grade 8.	None
02	Two coated areas above equipment hatch show grinding depressions in liner plate. Coating intact.	None

Item No.	Discussion	Acceptable	Additional Eval. Req'd.
01	Neither the rusting of the attachment nor the coating deterioration has degraded the liner. The primer was observed to be intact and thus the liner is protected. Examination at the next regular inspection period is sufficient to monitor this condition.	✓	
02	The subject depressions do not reflect ongoing degradation of the liner. Based on the fact that they are coated and the coating is intact, they apparently remain from original construction or from some previous plant activity.	✓
