IP3-RPT-STR-03517  
IWL Inspection report

## Indian Point 3

### Attachment 6.5

### Interior Pictures

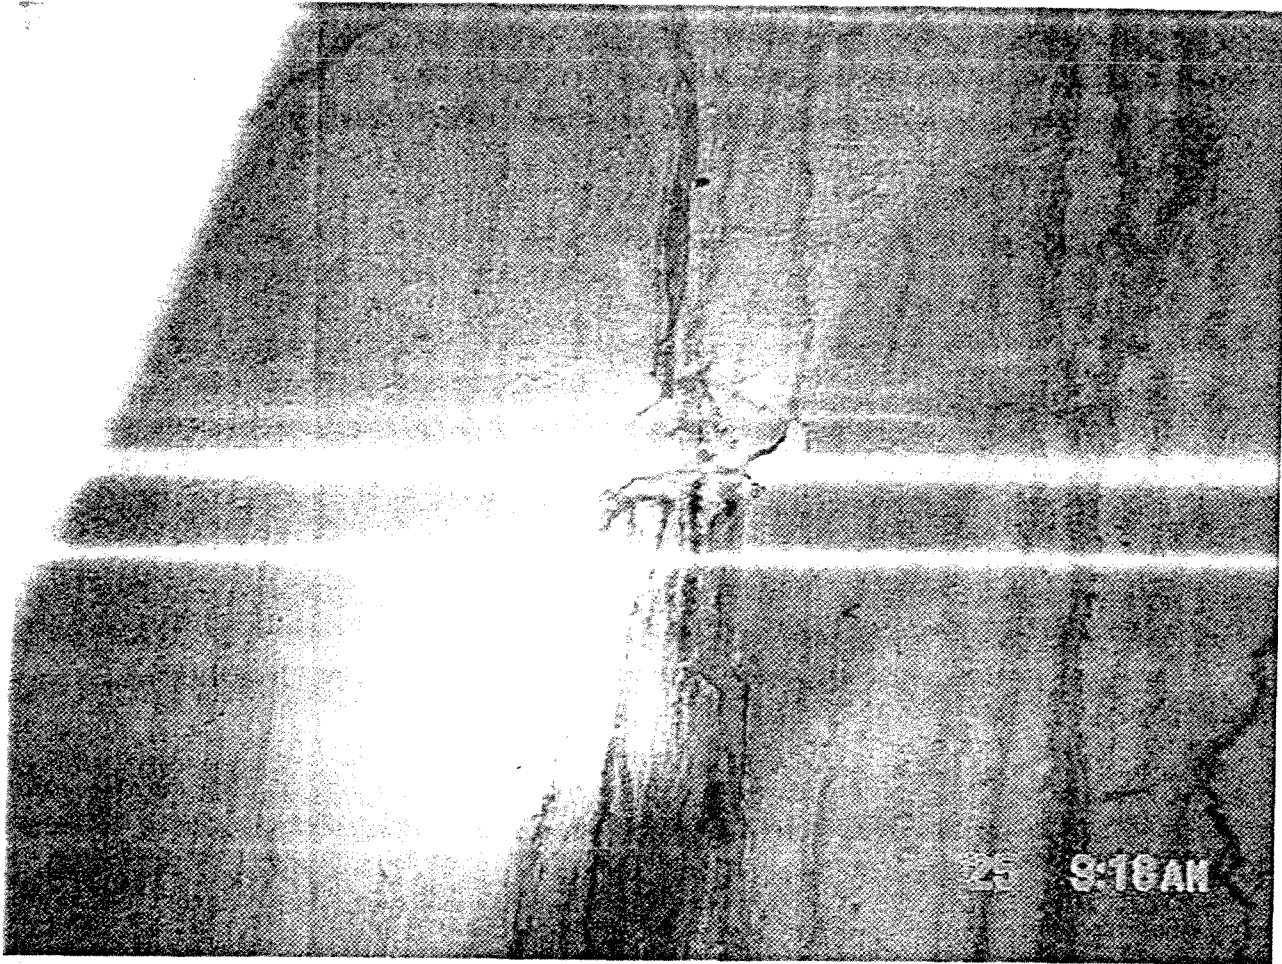
IP3 ASME Section XI, IWL Concrete Containment Inspection	No: IP3-RPT-STR-03517, Rev: 0
	Picture <u>69</u>

BEFORE FLAKING OFF  
1/2"-4" coner. patch

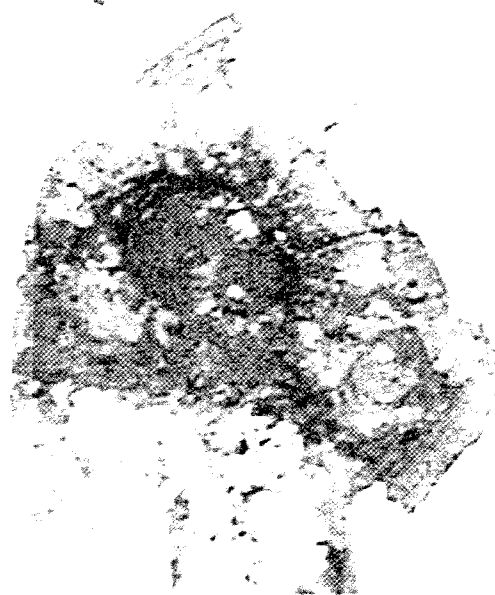
IP3 ASME Section XI, IWL Concrete Containment Inspection	No: IP3-RPT-STR-03517, Rev: 0 Picture <u>72</u>
--	--

*AFTER REMOVING FLAKING  
PATCH & EXPOSING REPAIRED AREA*
