**ENTERGY NUCLEAR NORTHEAST  
Engineering Report Cover Sheet**

**IP2 ASME SECTION XI,  
IWL CONCRETE CONTAINMENT INSPECTION  
FOR 2005**

<b>IPEC</b>	IP-RPT-06-00019	REV. 0
		Page 3 of 16	
	IP2 ASME Section XI, IWL Concrete Containment Inspection for 2005

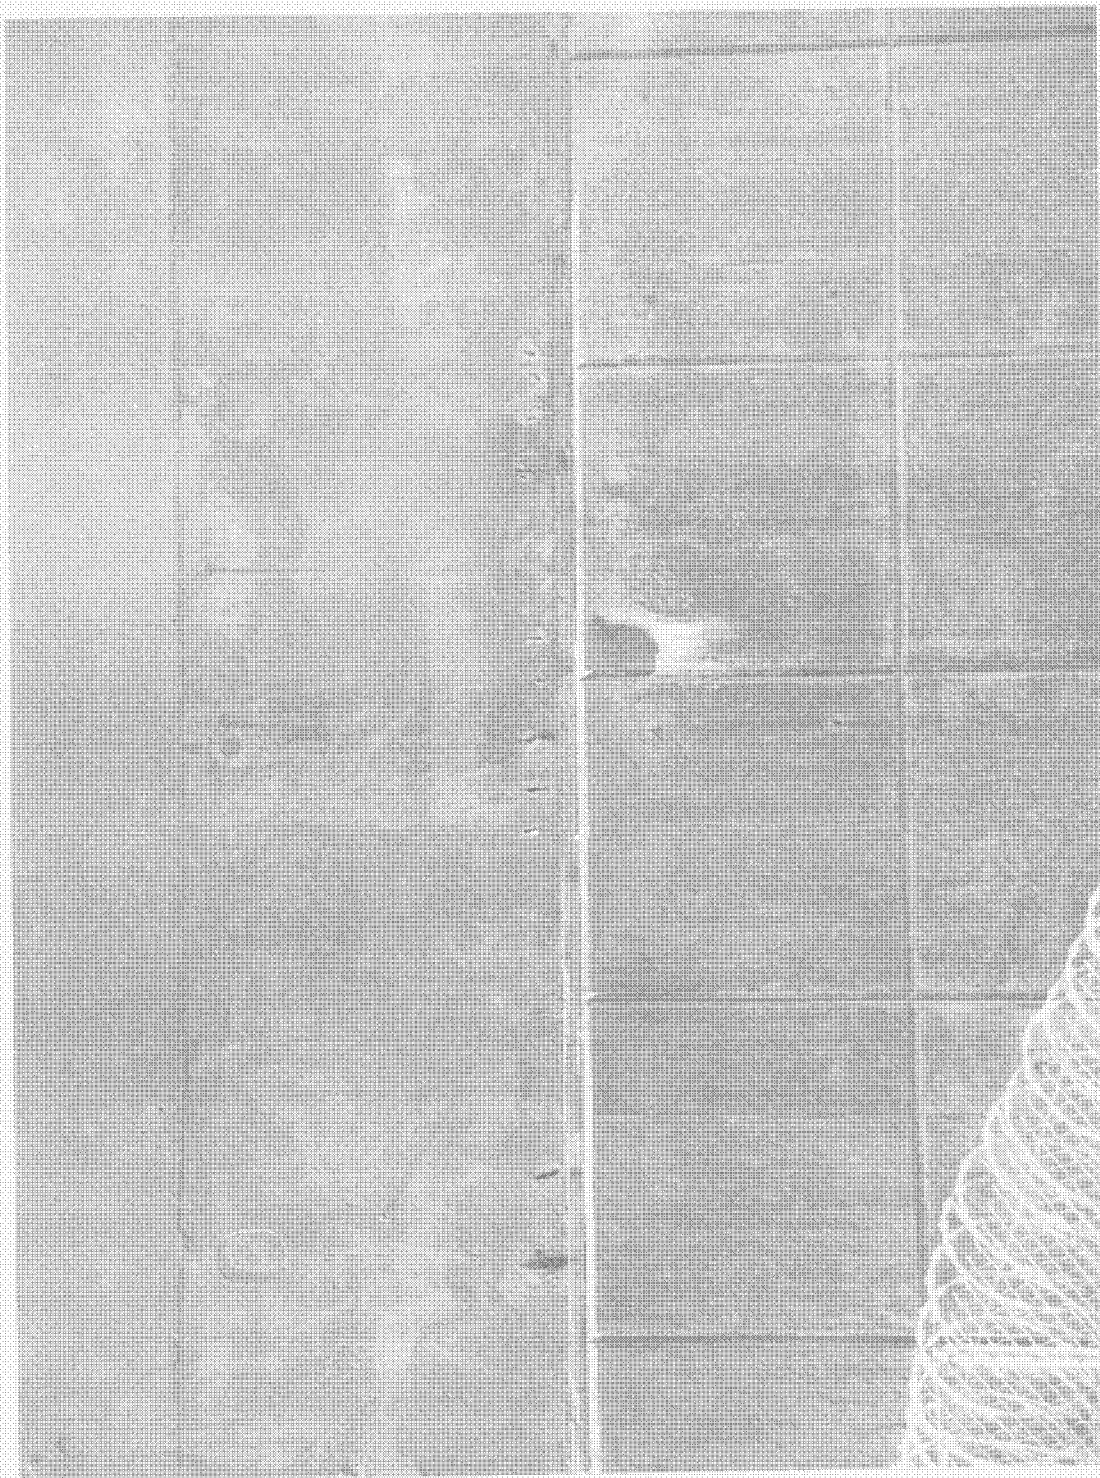
6	Rusted bar exposed over 6" span at El. 51.	<i>[Handwritten Signature]</i>
7	Ribs of some embedded steel (scrap?) exposed at the surface at El. 44. Additional pitting has developed since previous inspection.	<i>[Handwritten Signature]</i>
8	Vertical rebar exposure with rust mark maximum 9" at 10 locations over 20' width at basement junction. This area has remained unchanged with the exception of random pitting since the previous inspection. See photo U2-015101	<i>[Handwritten Signature]</i>

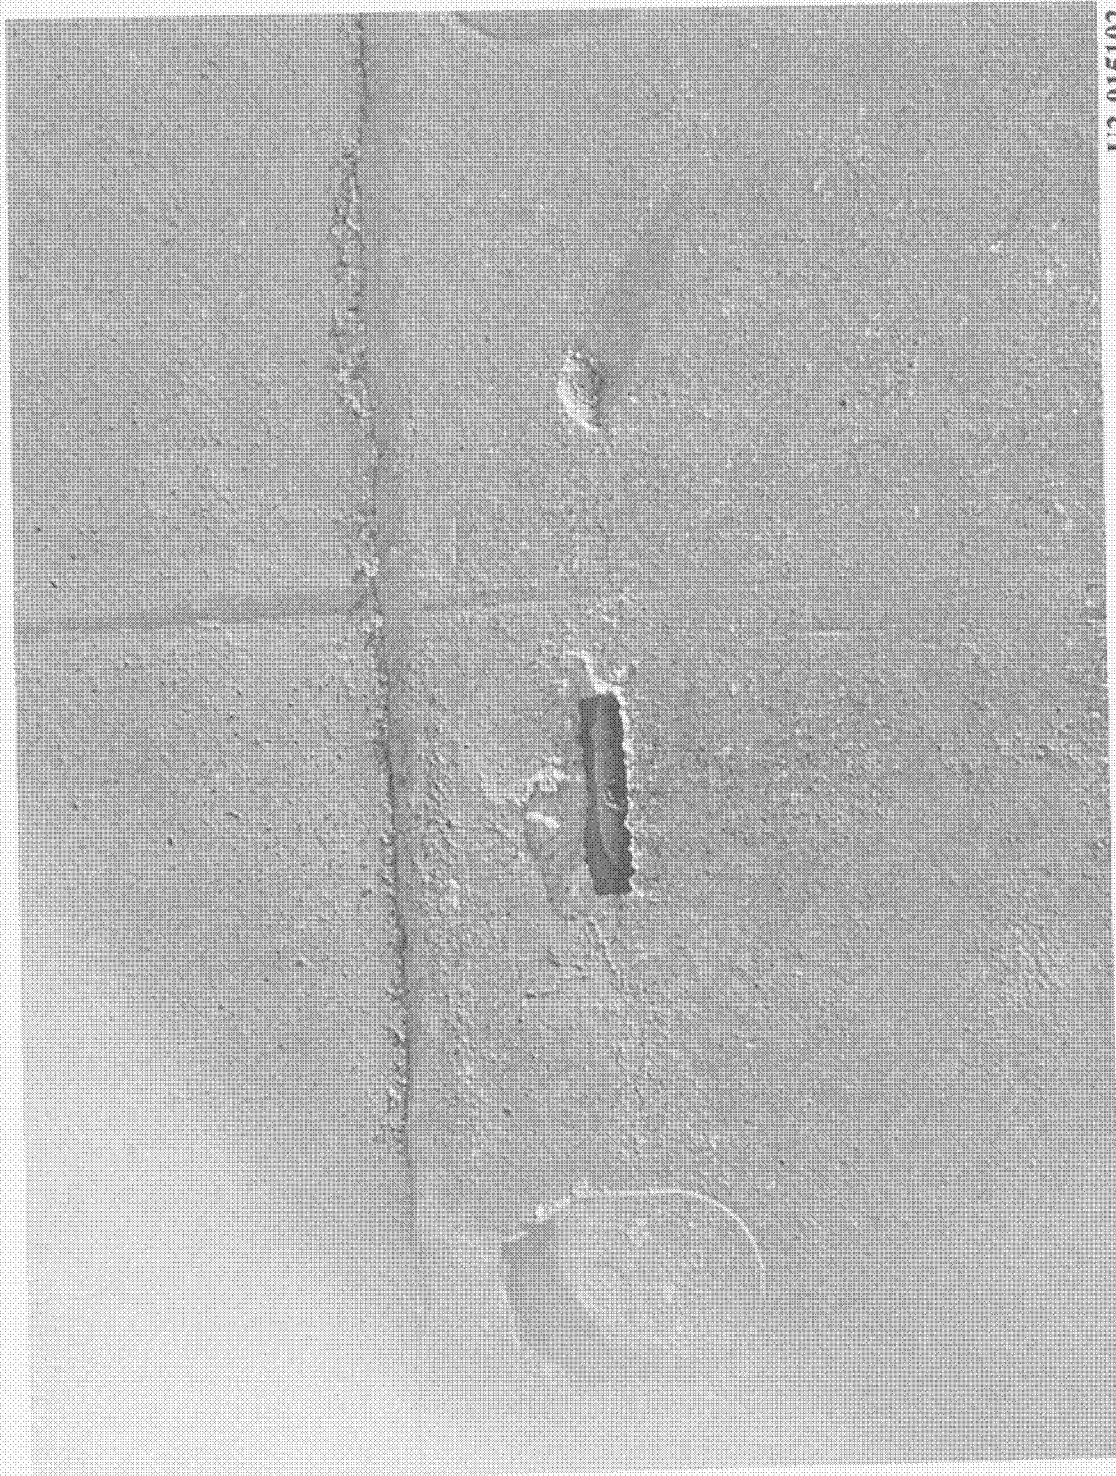
No.	Comment	Initials
1	Cadmium exposure due to spalling 9" x 3", insufficient concrete cover (less than 1/2"). Since previous inspection, additional spalling with loss of concrete has occurred. See photo U2-015102	<i>[Handwritten Signature]</i>
2	One form tie hole not filled and one partially filled. These holes have remained in the same condition since previous inspection.	<i>[Handwritten Signature]</i>
3	Scrap steel exposed at the surface. Since previous inspection, an additional well defined crack approx. 6" long and less than 1/4" wide has developed.	<i>[Handwritten Signature]</i>
4	Leaching from 9" dia. patch at top of basement at junction of wall. This area has remained unchanged since previous inspection. See photo U2-015101	<i>[Handwritten Signature]</i>
5	Leaching over a length of 20' close to joint from grout patch. This area has remained unchanged since previous inspection.	<i>[Handwritten Signature]</i>

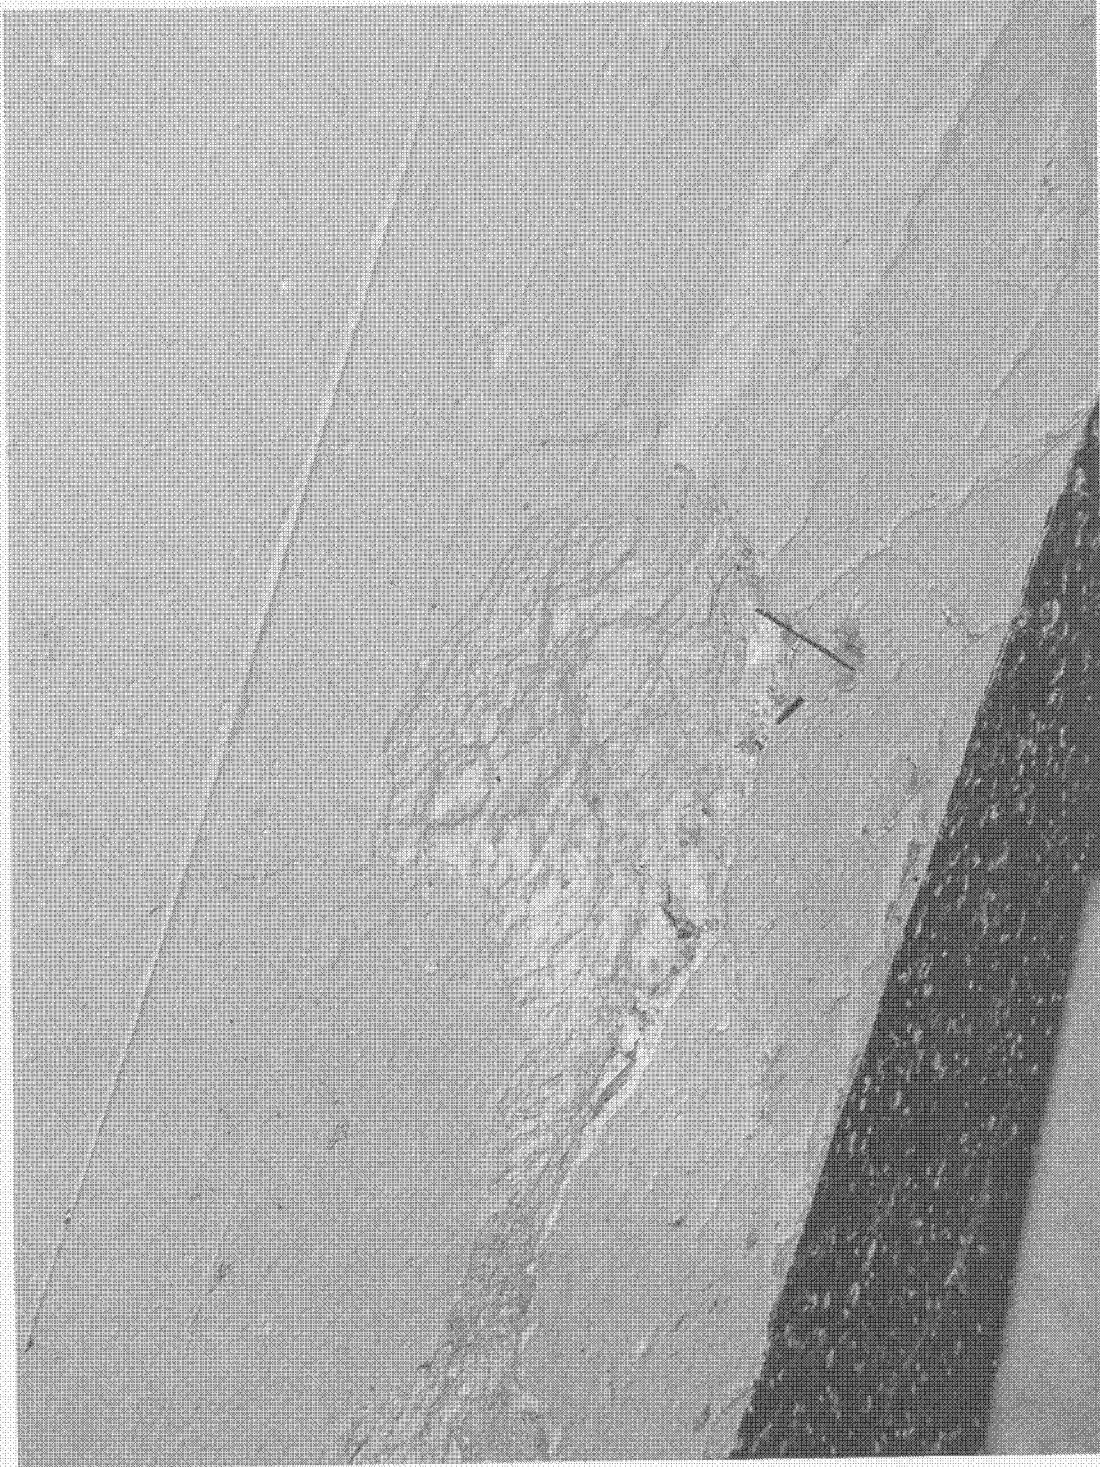
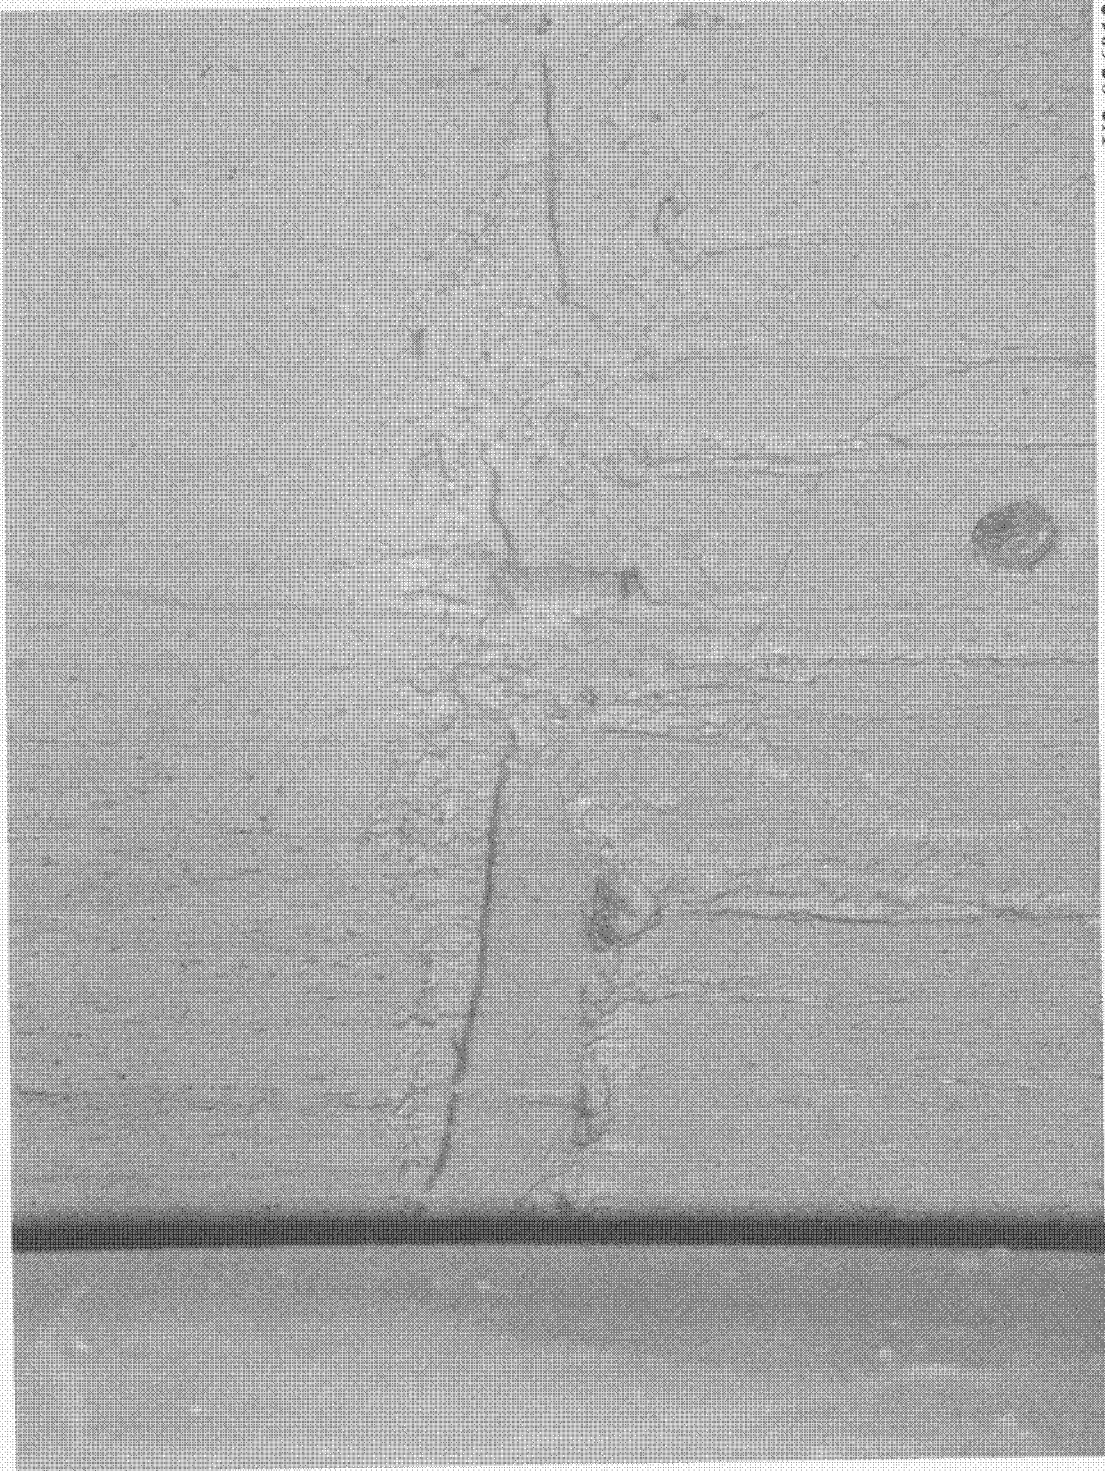
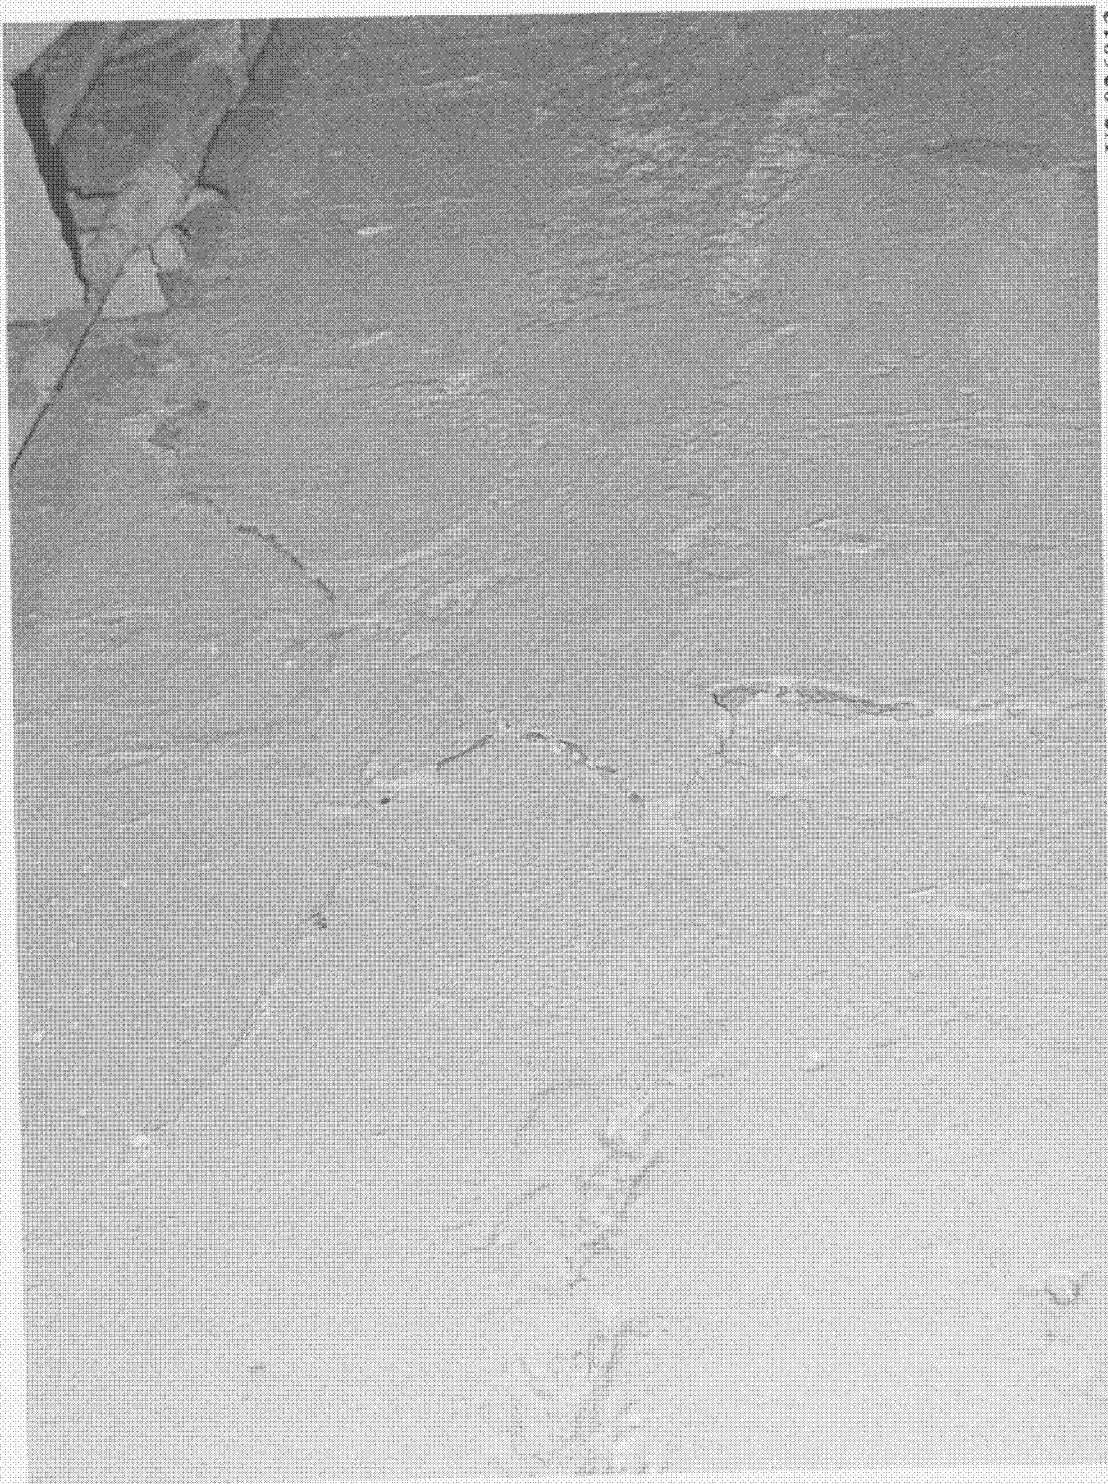
- For Component VCC- 05, Inspection zone 002, from 043' to 068', everything stayed the same when compared to the 2000 inspection. The ¾" diameter reinforcing steel projecting out of the containment wall behind Rack 15, which also displays some rust and staining is not a structural bar and has no structural significance.

No.	Comment	Initials
1	A spalled area approximately 10" long was found at the floor line directly below penetration MP-H. This area appears to have some unconsolidated concrete ("honeycomb") from the original placement of the concrete. This area has remained unchanged since previous inspection. See photo U2-026011	WJF
2	A crack with apparent delamination was found around the lower left edge of penetration MP-G. This area has remained unchanged since previous inspection. See photo U2-026012	WJF
3	A delamination was found at approx. El. 49' directly below penetration MP-F. The area was estimated to be 18" wide by 12" high by sounding the concrete (tapping the surface with a metal object). This area has remained unchanged since previous inspection. See photo U2-026013	WJF
4	This area was examined from the floor level at El. 43'. The examination distances were a maximum of 20 feet. While this distance exceeds the limits for direct visual examination, it was too short for use of the binoculars due to their minimum focal length. Lighting levels using the flashlight exceeded the 50 foot-candle requirement. The upper 5 feet of this zone were not visible for inspection by direct line of sight due to piping and structural steel obstructions. Area has been coated.	WJF

5	There are a number of areas within this zone where the coating is flaking and peeling. There is no evidence that this is due to degradation of the concrete substrate. It is a coatings related issue and not containment degradation.	WJF
6	Rebar sticking out (roughly 3/4" dia. bar) with rust and staining at El. 46 behind Rack 15.	WJF
