ENN NUCLEAR MANAGEMENT MANUAL	ENGINEERING STANDARD	ENN-EP-S-003 Revision 0
		IWL Visual Containment Inspection	Page 14 of 15

**Attachment 7.2  
CONTAINMENT INSERVICE INSPECTION  
RECORD OF VT-3 / GENERAL VISUAL EXAMINATION**

IPEC Unit: 2 Interval Period: 1<sup>st</sup>/2<sup>nd</sup> Inspection Inspection Report No.: IP2-O5-IWL-001

IWL VISUAL CONTAINMENT INSPECTION  
 Indian Point Unit No. 2

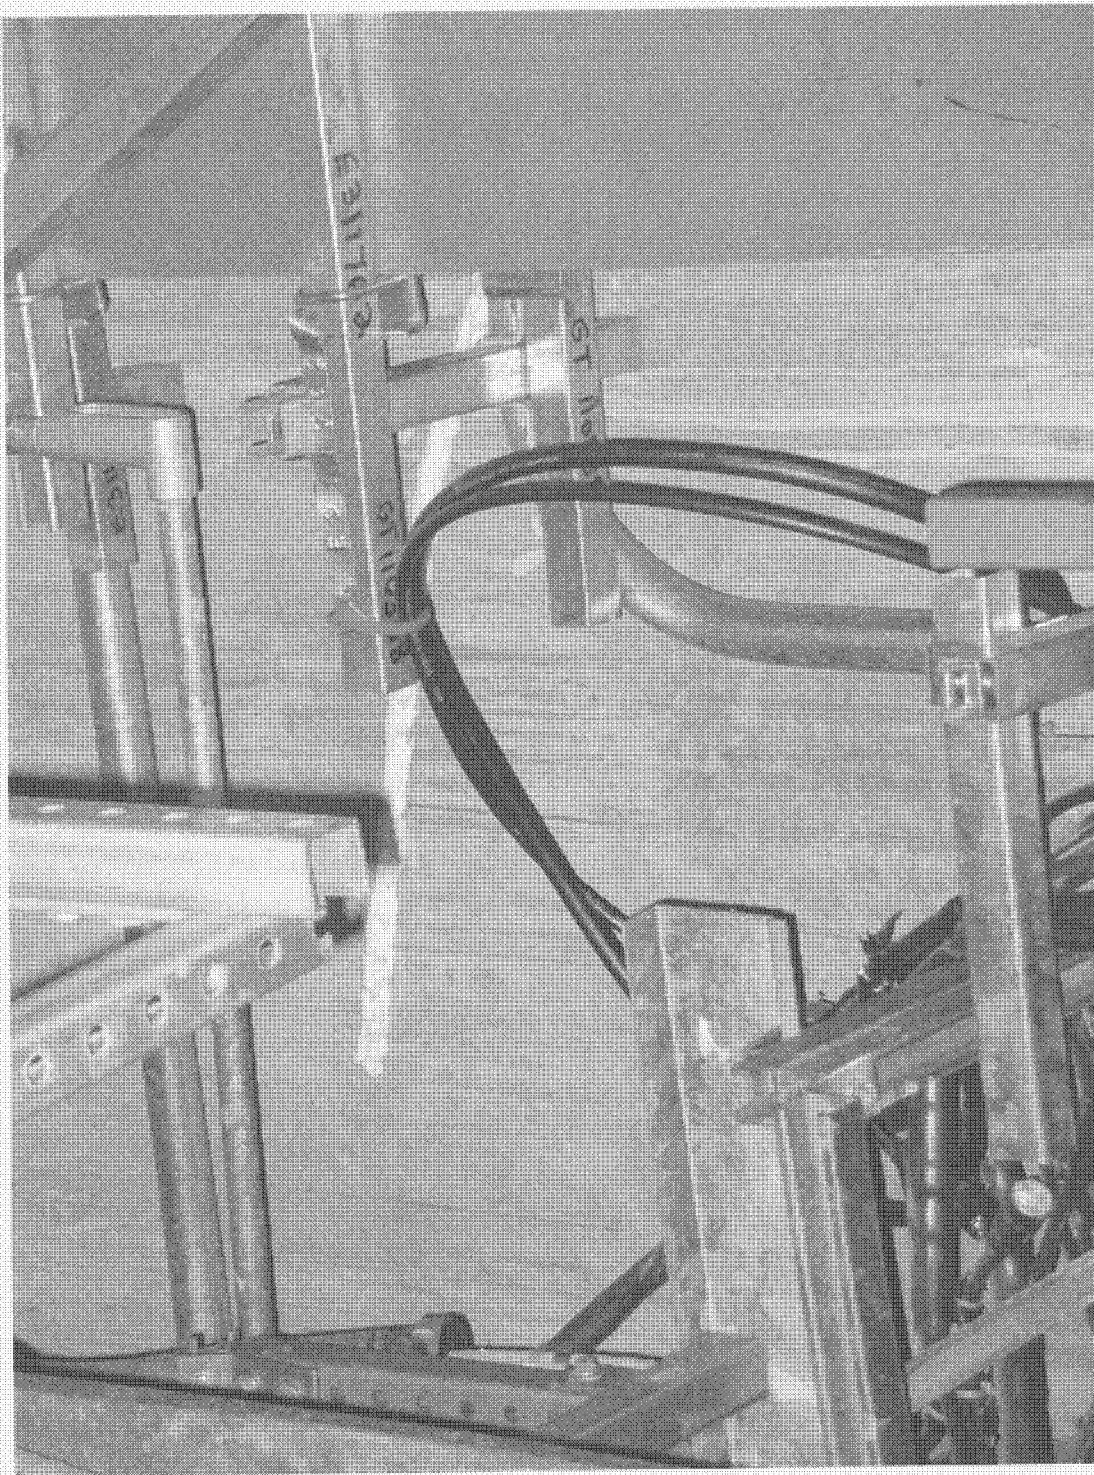
U2-035204

No.	Comment	Initials
1	Two pieces of embedded steel appearing to be cadweld splices are exposed at the surface of the concrete. Slight corrosion is evident but no streaking or staining of the concrete. This area has remained unchanged since previous inspection.	<i>WDF</i>
2	A small surface defect (approx. 2' dia) and several unfilled form tie holes were noted but are insignificant relative to containment structural integrity. These areas have remained unchanged since previous inspection. See photo U2-035208	<i>WDF</i>
3	Caulk, possibly covering a crack, diagonally approx. 10' long. See photos U2-035204, U2-035205, and U2-035206	<i>WDF</i>
4	This area was examined from the floor level at El. 46'. The examination distances were a maximum of 20 feet. While this distance exceeds the limits for direct visual examination, it was too short for use of the binoculars due to their minimum focal length. Lighting levels using the flashlight exceeded the 50 foot-candle requirement. Approximately 10% of this zone was not visible for inspection by direct line of sight due to various obstructions.	<i>WDF</i>

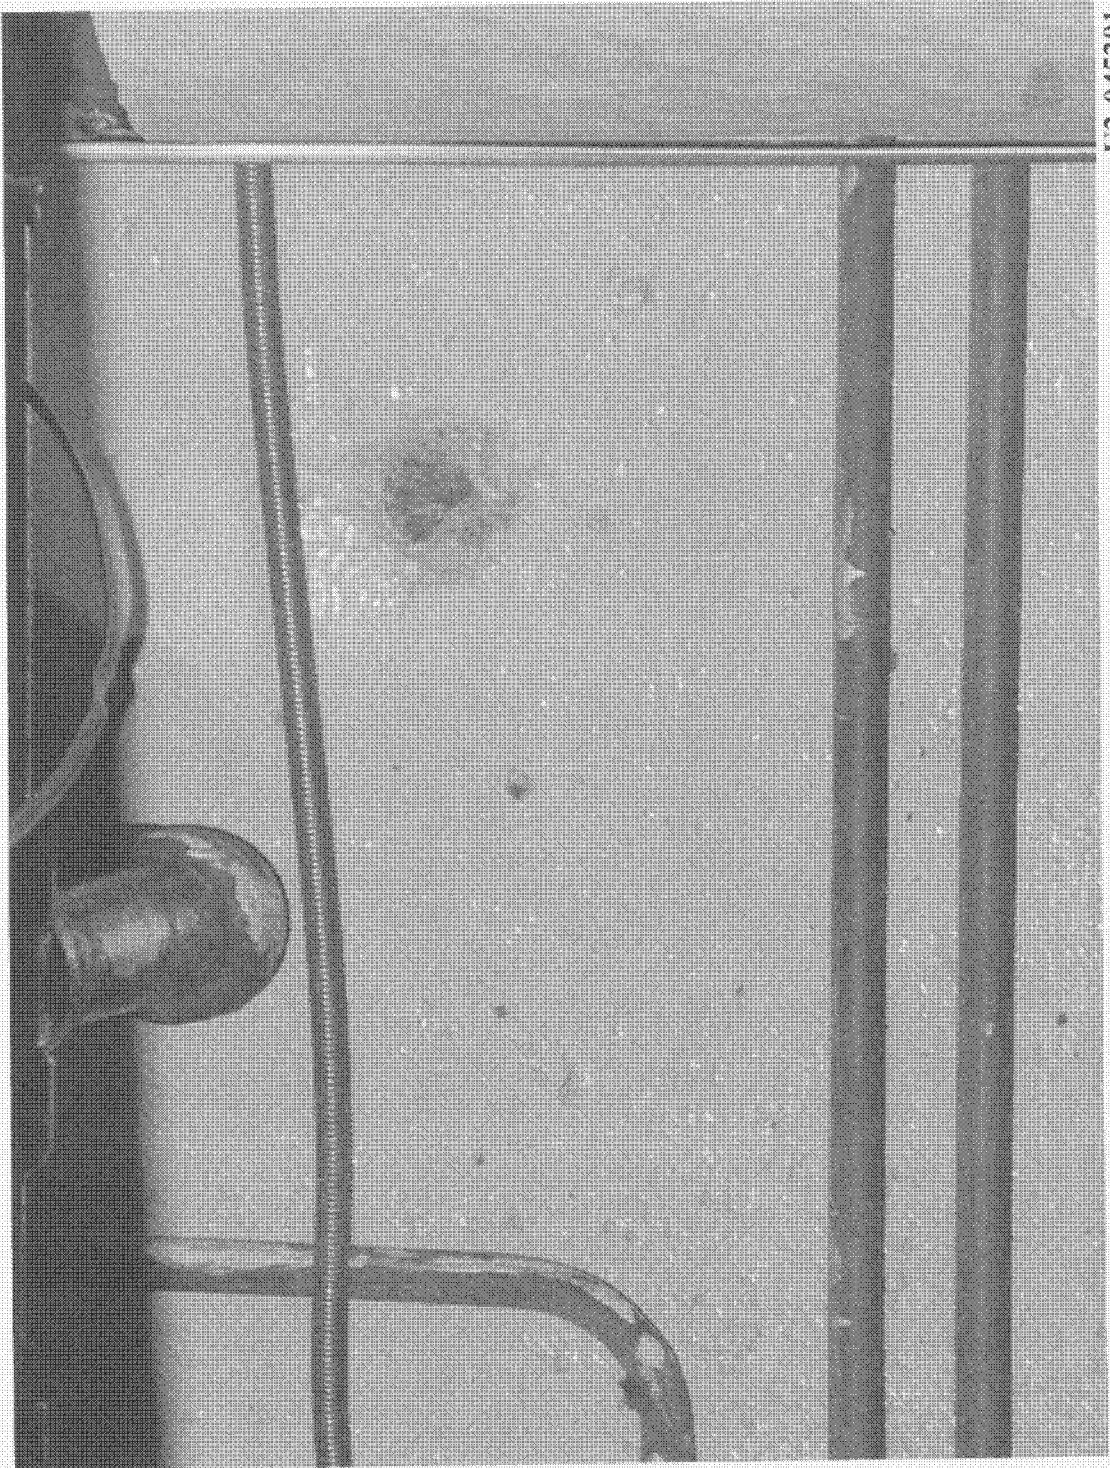
No.	Comment	Initials
1	This area was examined from the catwalk at approx. El. 51' due to radiological contamination of the floors in this area. The examination distances were a maximum of 30 feet. While this distance exceeds the limits for direct visual examination, it was too short for use of the binoculars due to their minimum focal length. Lighting levels using the flashlight exceeded the 50 foot-candle requirement. Approximately 50% of the concrete surface was not visible for inspection by direct line of sight due to obstructions.	<i>WJF</i>
2	Several form tie holes were found not filled. These have remained unchanged since previous inspection and are not significant relative to containment structural integrity.	<i>WJF</i>
3	New spalling (approximately 2" dia) has occurred. See photo U2-045201	<i>WJF</i>
4	Popouts (3"-9" in size) and joint spalling. Upon further review, it was found that this area has been coated with a sealant for fire barrier 1A/74A. Dowcorning 3-6548 silicone foam appears to have shrank and separated. See photos U2-045202 and U2-045203	<i>WJF</i>
