IWL Visual Containment Inspection

•							
IPEC Unit: 2 Interval	Period: 1st/2nd Inspe	ection	Ins	pectio	n Repo	ort No.:	:IP2-O5-IWL-001
Component No.: VC	C - 24 Zone No	:001			Orawin	g No.:	
Description: El. 128 –	El. 148		Wor	k Orde	r No:	IP2-0	3-29683
Equipment Used: Celes	stron Giant 20x80 Bir	noculars		Limita	tions:	<u>Acces</u>	ssible areas only
Record	ding Condition		RI	NRI	NI	N/A	Comments
Leaching or chemical atta	ck			\boxtimes			5
Abrasion or erosion degra	dation				\boxtimes		
Pop outs and voids			\boxtimes				3
Scaling					\boxtimes		
Spalls				\boxtimes			2
Corrosion staining on con-	crete surfaces						1,3,4
Cracks					\boxtimes		
Exposed reinforcing steel			\boxtimes				1,3,4
Deteriorating of concrete of	coating, if applicable					\boxtimes	
Excessive corrosion of the surfaces	e exposed embedded	metal			\boxtimes		
Detached embedment or l	loose bolts				\boxtimes		
Other					\boxtimes		
(Note: Sketches or pictures many Company Compa	Date:	<i>6/2/05</i> Ex	amino	ed By:	DRI Print/S		NUTA Date: 6/2/01

IWL VISUAL CONTAINMENT INSPECTION Indian Point Unit No. 2

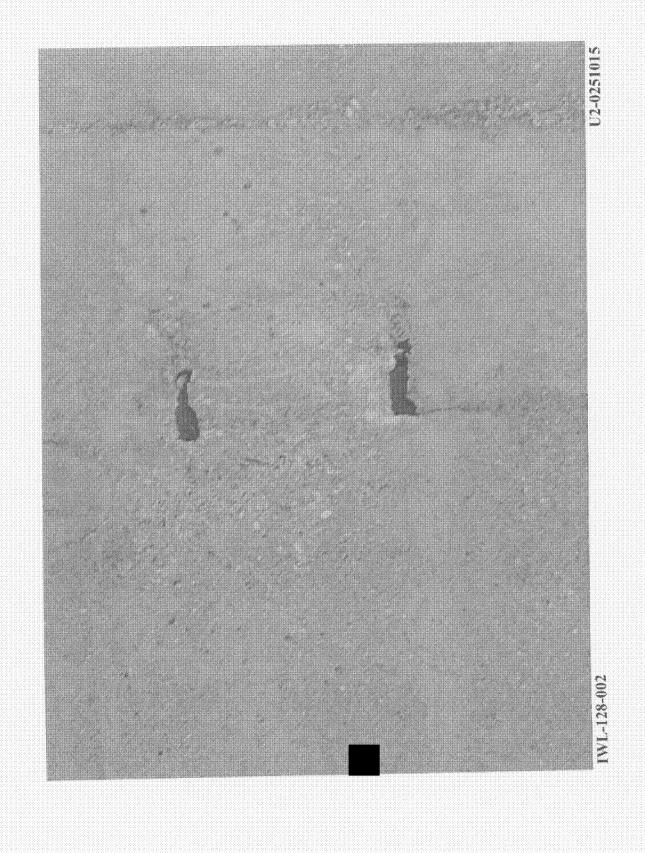
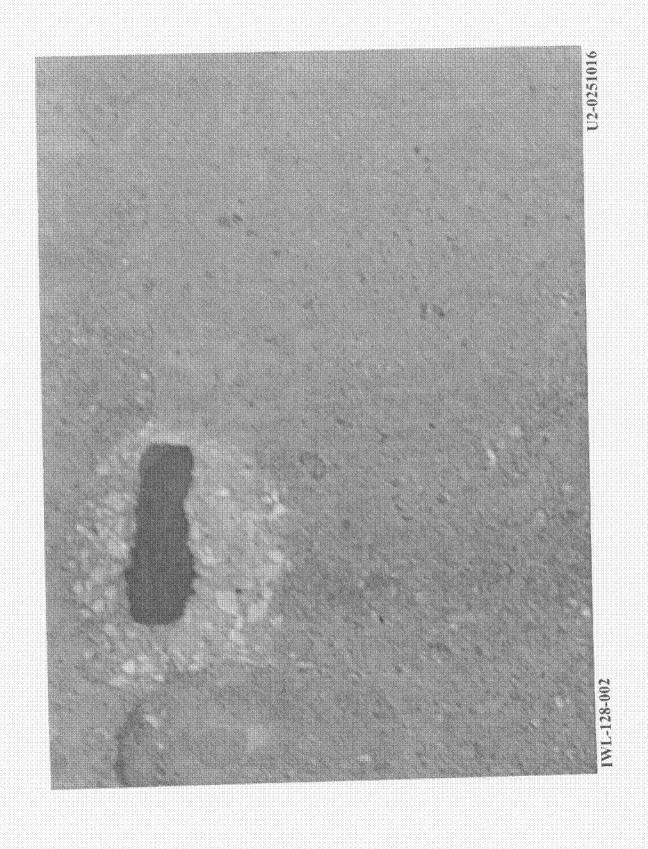
No.	Comment	Initials
1	Cadweld exposed (approx. 6" long) & corroded with rusting and staining due to loss of concrete cover at El. 144.	nof
2	Cadweld exposed & corroded with rusting and staining due to loss of concrete cover. Since previous inspection, pattern cracking surrounding the exposed cadweld has occurred. See photo U2-0251015	ngf
3	Cadweld exposed & corroded with rusting and staining due to loss of concrete cover. Since previous inspection, pattern cracking surrounding the exposed cadweld has occurred. Also, the portion of concrete directly above the cadweld has fallen off. See photo U2-0251015	ugf
4	A small area of concrete has cracked and is likely to spall off. This area has remained unchanged since previous inspection.	nof
5	The concrete has cracked & bulged in a small area that is likely to spall off. This area has remained unchanged since previous inspection.	nef
6	The concrete has joint cracking along El. 128.	ng

7	Bugholes appear between El. 128 and El. 133.	NOS
8	Cadweld exposed (approx. 4" long) with rusting and staining due to spalling at El. 129. See photo U2-0251016	not
9	Small area of concrete ready to fall off at El. 144.	ng
10	Joint spalls and cracks appear along El. 133.	not

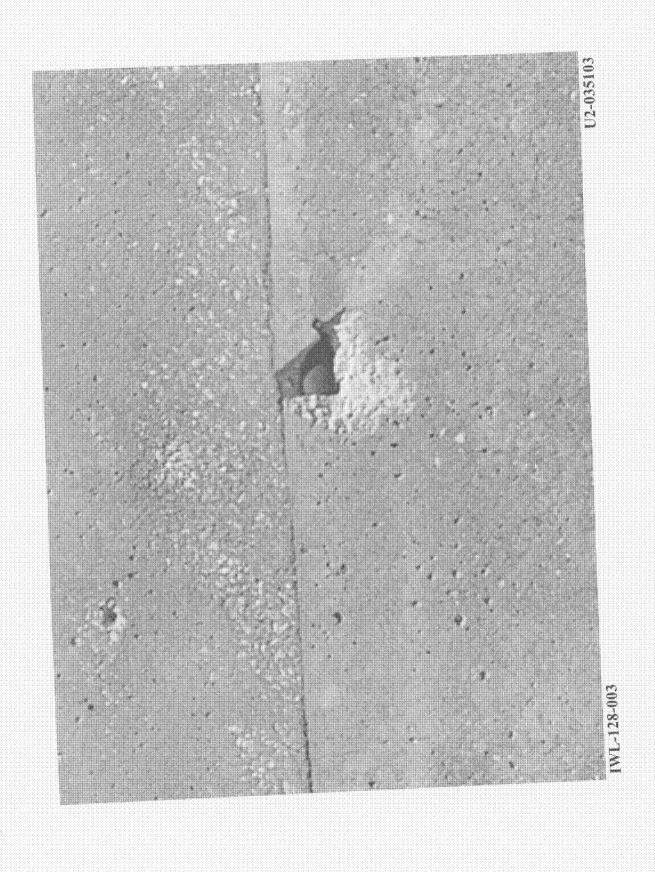
No.	Comment	Initials
140.		initials
1	Band of concrete surface containing 9 popouts/spalls (ranging from 2"-8" dia.) centered on the zone between El. 108 and El. 148. Also, numerous bugholes (some with visible rust and staining) and general pattern cracking appear within this band.	Med
2	General joint cracking, local scaling, and pattern cracking between El. 128 and El. 133.	Mof
3	General joint cracking, local incipient spalls, and bugholes between El. 133 and El. 138.	rugf
4	A 2" diameter popout exposing rebar appears with abrasion and a small spall just below. Minor rusting and staining appear in this area. See photo U2-035103	nof
5	General joint cracking and pattern cracking between El. 143 and El. 148.	nof

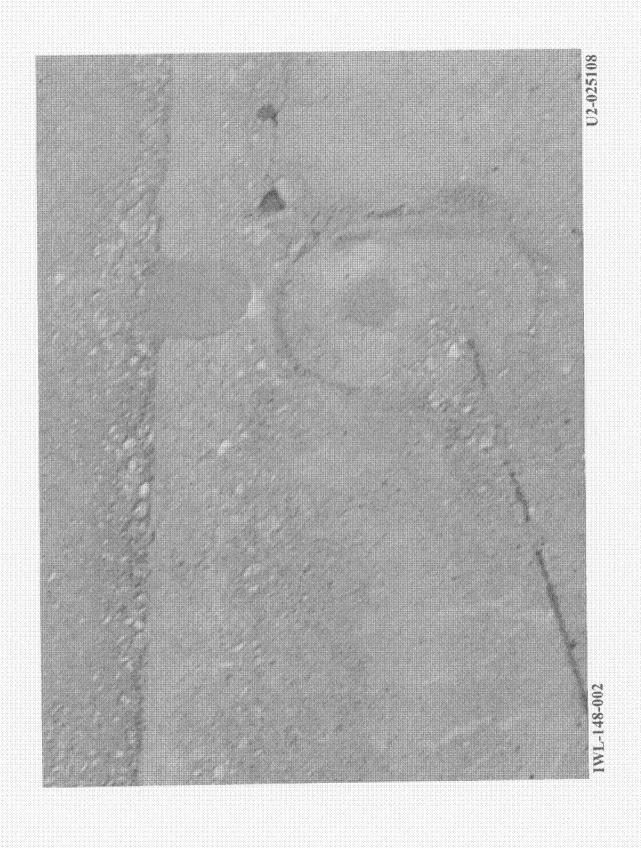
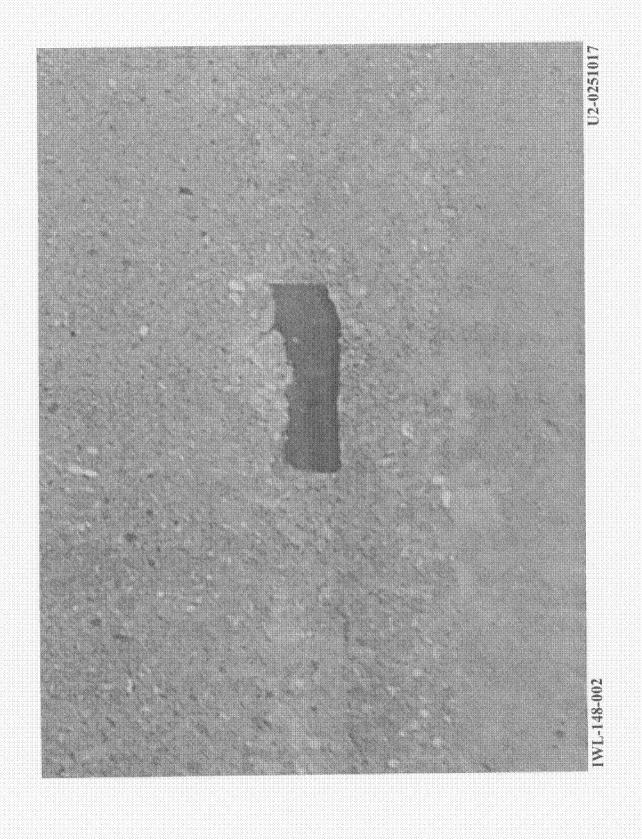
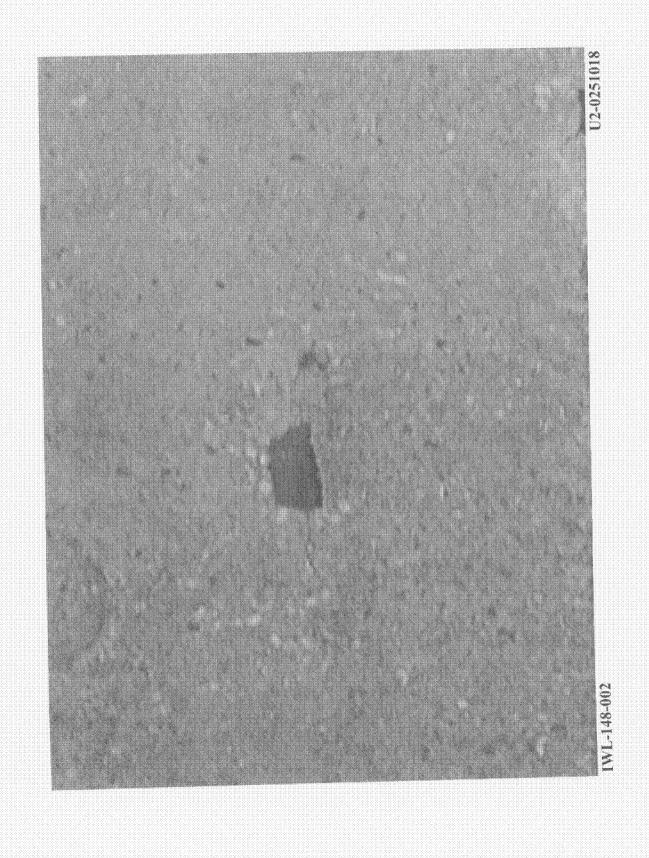
No.	Comment	Initials
1	Exposed steel is corroded with staining and appears to be rebar. This has remained unchanged since previous inspection. See photo U2-025108	ug
2	A piece of steel, not reinforcing steel, is exposed at the concrete surface on a diagonal line approximately 3' long with minor staining. This has remained unchanged since previous inspection. See photo U2-025108	nof
3	A small spot of steel is exposed and corroded with staining. It does not appear to be reinforcing steel, and has remained unchanged since previous inspection.	nef
4	Exposed cadweld approximately 8" long due to inadequate concrete cover at El. 156.	ugf
5	Cadweld exposed & corroded due to loss of concrete cover. Additional spalling has occurred since previous inspection. See photo U2-0251017	Neg
6	A joint spall, cracking, and small popouts appear at El. 148 centered in zone 002.	ngl
7	A crack with popout (approximately 4" wide) appears at El. 157.	ng

8	Cadweld exposed & corroded due to loss of concrete cover. This has remained unchanged since previous inspection. See photo U2-0251018	not
9	Pitting/abrasion appears in small area at El. 154.	ng
10	The concrete has joint cracks and pitting/abrasion along El. 158.	not
11	Grout is about to fall at El. 155.	ng

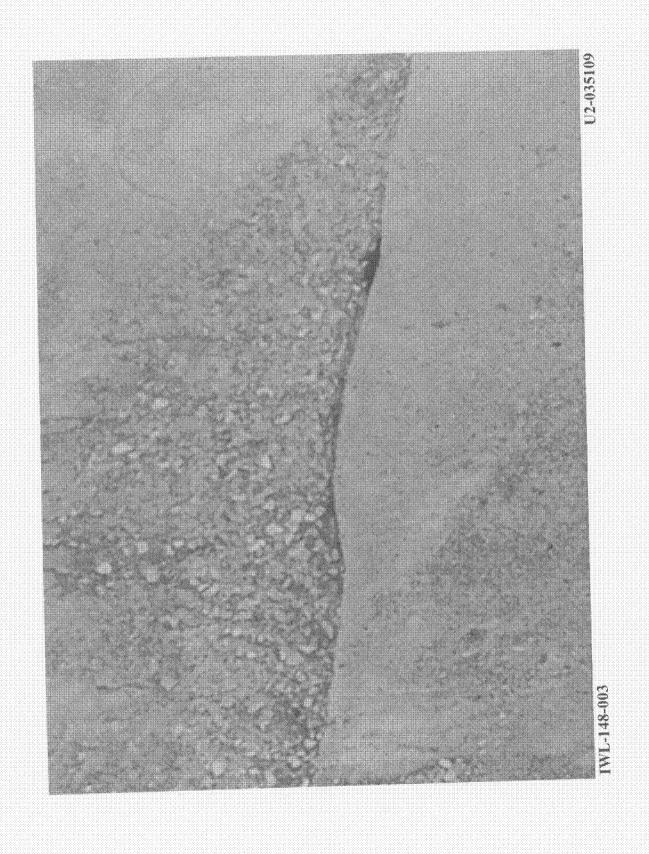
No.	Comment	Initials
1	General pattern cracking and discoloration between El. 148 and El. 153.	ruf
2	General pattern cracking and bugholes between El. 153 and El. 158.	nuf
3	Patch of small spalls with visible rust and staining at El. 155.	Med
4	A small spot of steel is exposed and corroded with staining. It is not immediately apparent whether it is reinforcing steel but it is similar in appearance to cadwelds exposed in other areas. This area has remained unchanged since previous inspection.	wof
5	Two small spots of steel are exposed and corroded with staining. It is not immediately apparent whether they are reinforcing steel but it is similar in appearance to cadwelds exposed in other areas.	Med
6	A 6" long crack exists at bottom of scaling area (El. 158) approximately 15' from right boundary. See photo U2-035109	Med
7	Located between El. 163 and El. 168, centered in zone, minute leaching is visible from grouted hole with surrounding pattern cracking and bugholes.	ugf
