STATION/UNIT:	: IPEC / Indian Point No. 2	COMPONENT NO.:	VCC – 34
ZONE No:	005

IWL Visual Containment Inspection

IPEC Unit: 2 Interval Period: 1st/2nd Inspection	Ins	pectio	n Repo	ort No.	: IP2-O5-IWL-001	
Component No.: VCC - 35 Zone No: 006		Drawing No.:				
Description: El. 148 – El. 168	Wor	k Orde	er No:	IP2-0	3-29683	
Equipment Used: Celestron Giant 20x80 Binoculars		Limita	tions:	<u>Acces</u>	ssible areas only	
Recording Condition	RI	NRI	NI	N/A	Comments	
Leaching or chemical attack	\boxtimes				4	
Abrasion or erosion degradation			\boxtimes			
Pop outs and voids		\boxtimes			1	
Scaling			\boxtimes			
Spalls	\boxtimes				2,3,4	
Corrosion staining on concrete surfaces					2,3,4	
Cracks			\boxtimes			
Exposed reinforcing steel					2,3,4	
Deteriorating of concrete coating, if applicable				\boxtimes		
Excessive corrosion of the exposed embedded metal surfaces			\boxtimes			
Detached embedment or loose bolts			\boxtimes			
Other			\boxtimes			
(Note: Sketches or pictures may be attached to clarify Inspection areas Examined By:	Examine	ed By:	DRA Print/S	Go G Signatur	TO NUTA Date: 6/2/ NUTA Date: 6/2/ re/Level

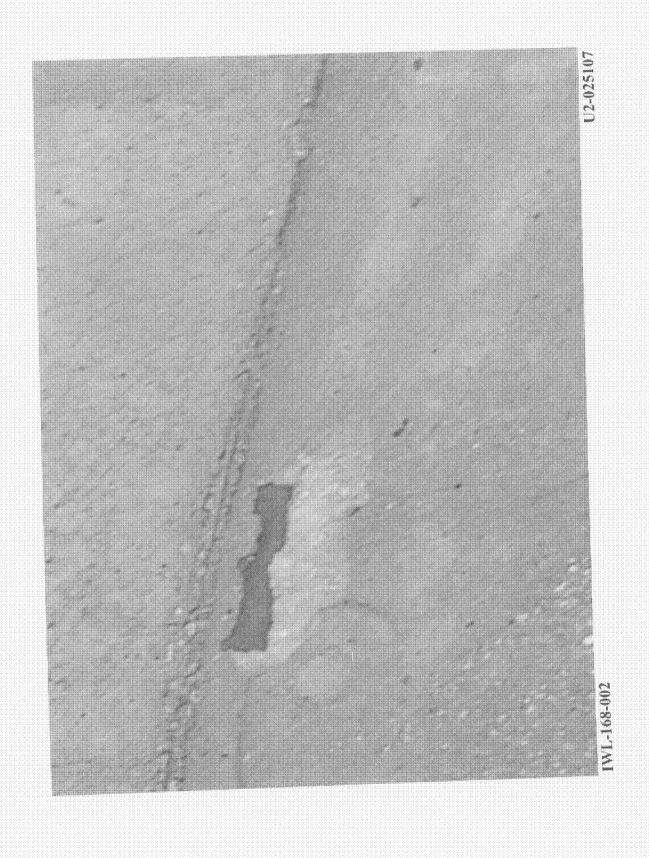
No.	Comment	Initials
1	A small spot of steel is exposed and corroded with staining. It is not known whether this is reinforcing steel. This area has remained unchanged since previous inspection.	ug
2	A small spot of steel is exposed and corroded with staining. It is not known whether this is reinforcing steel. This area has remained unchanged since previous inspection.	Kuf
3	The concrete has cracked & bulged in a small area that is likely to spall off. By comparison to other similar areas it is believed to be a cadweld or reinforcing steel which is corroded due to insufficient concrete cover. This area has remained unchanged since previous inspection.	Med
4	Patch of shallow popouts just below El. 188.	Wef
5	A popout exposing a cadweld with rust and staining (approx. 8" long) is visible. See photo U2-025107	ligh
6	Leaching has occurred 6" long.	Nef
7	A joint spall and some pitting/abrasion is visible at El. 173.	Mig

8	Area of light abrasion approximately 4' long was spotted between El. 168 and El. 178	mof
9	General pattern cracking, bugholes, and leaching between El. 168 and El. 178.	Med
		U

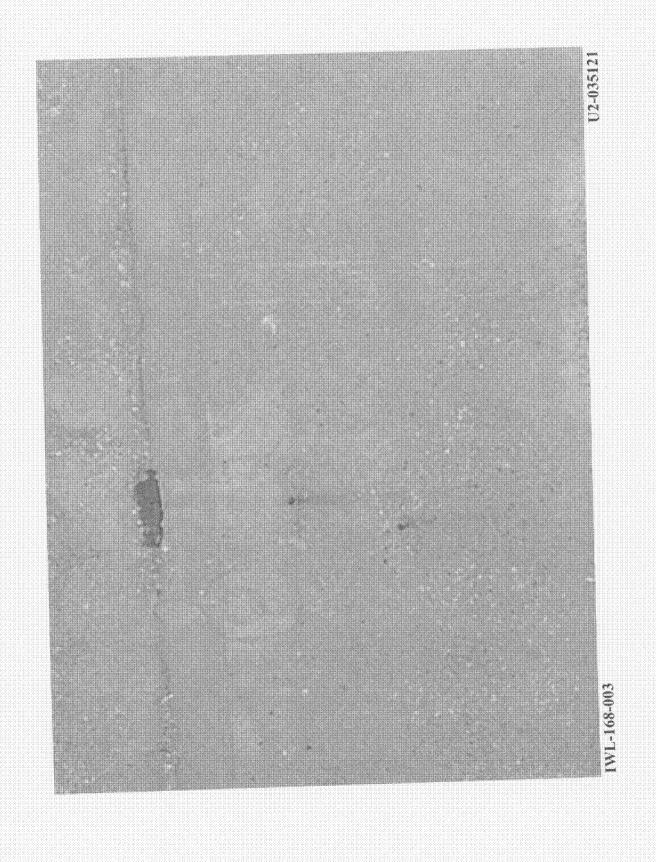
No.	Comment	Initials
1	General joint cracking, minor leaching, and pattern cracking between El. 168 and El. 173.	Mes
2	Bugholes with visible rust at El. 174 approximately 10 feet from left boundary.	nof
3	General joint cracking, bugholes, and spalls between El. 173 and El. 178.	not
4	General pattern cracking, minor joint cracking, and light spalling between El. 178 and El. 183.	West
5	9"x3" concrete spall exposing cadweld sleeve with staining due to insufficient concrete cover. This spall remains unchanged since previous inspection.	nef
6	2 voids exposing 1" corroded steel with staining remain unchanged since previous inspection. See photo U2-035121	ung
7	9"x3" concrete spall exposing cadweld sleeve with staining due to insufficient concrete cover has had additional spalling since previous inspection. See photo U2-035121	nof
8	Joint crack with spalling is visible just below El. 188.	uel
