ATTACHMENT 83 OF 19-RPT-06-10019 REV. O PAGE 56 OF 138

IWL Visual Containment Inspection

IPEC Unit: 2 Interval Period: 1st/2nd Inspection Component No.: VCC - 17 Zone No: 006	_ Ins		n Repo Orawin		: IP2-O5-IWL-001
	\A/				
Description: El. 88 – El. 108	_ wor	K Orae	er No:	IP2-0	3-29683
Equipment Used: Celestron Giant 20x80 Binoculars		Limita	tions:	Acces	ssible areas only
Recording Condition	RI	NRI	NI	N/A	Comments
Leaching or chemical attack					2
Abrasion or erosion degradation		\boxtimes			2
Pop outs and voids			\boxtimes		
Scaling			\boxtimes		
Spalls	10		\square		
Corrosion staining on concrete surfaces	10		\boxtimes		
Cracks	10	\boxtimes			1,2
Exposed reinforcing steel			\boxtimes		
Deteriorating of concrete coating, if applicable	10			\boxtimes	
Excessive corrosion of the exposed embedded metal surfaces					
Detached embedment or loose bolts					
Other			\boxtimes		
(Note: Sketches or pictures may be attached to clarify inspection areas an Examined By: (April 1) Date: (April 2) Date: (April			Print/S	oignatui	re/Level

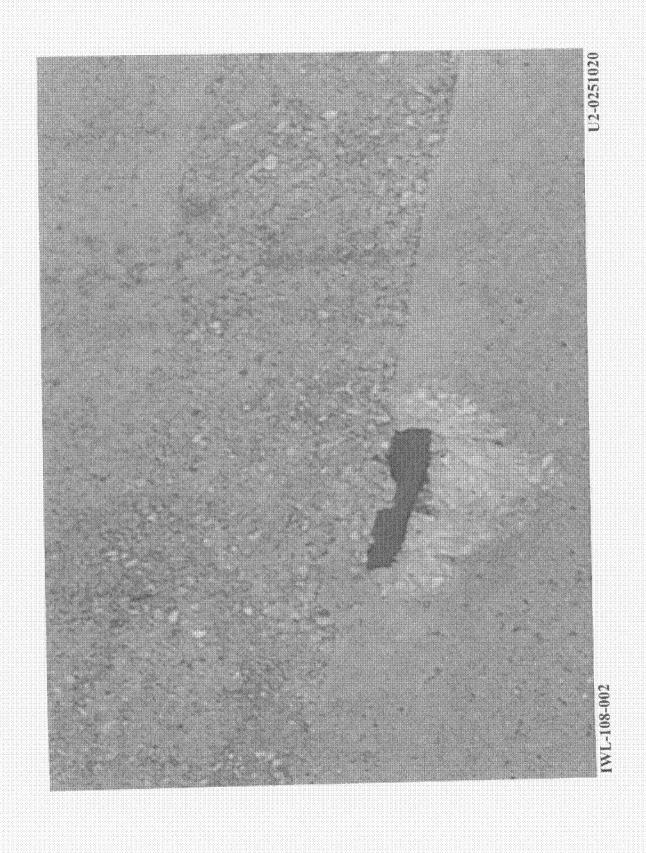
Comment	Initials
Exposed cadweld (approx. 9" long) with corrosion and staining apparently due to inadequate cover. Since previous inspection, the exposed cadweld has remained unchanged, but the concrete directly above is ready to fall. See photo U2-0251020	ingl
A small spot of corrosion appears on the concrete surface. It is not apparent whether this is reinforcing steel, a cadweld or miscellaneous steel. Unchanged since previous inspection.	nof
A small spot of corrosion appears on the concrete surface. It is not apparent whether this is reinforcing steel, a cadweld or miscellaneous steel. Since previous inspection, additional degradation has occurred. This area now has some abrasion, leaching, honeycomb, and 8 popouts (2 roughly 1" dia. and 6 smaller).	nof
Minor rust and joint cracking appears along El. 117.	ng
The concrete directly above (comment 4) has pattern cracking and bugholes.	ref
Leaching is evident approximately 18" long extending downward from the construction joint. This remains unchanged from previous inspection.	ngf

The concrete has spalled along the joint at El. 122 and rusting is visible.	Med
	Exposed cadweld (approx. 9" long) with corrosion and staining apparently due to inadequate cover. Since previous inspection, the exposed cadweld has remained unchanged, but the concrete directly above is ready to fall. See photo U2-0251020 A small spot of corrosion appears on the concrete surface. It is not apparent whether this is reinforcing steel, a cadweld or miscellaneous steel. Unchanged since previous inspection. A small spot of corrosion appears on the concrete surface. It is not apparent whether this is reinforcing steel, a cadweld or miscellaneous steel. Since previous inspection, additional degradation has occurred. This area now has some abrasion, leaching, honeycomb, and 8 popouts (2 roughly 1" dia. and 6 smaller). Minor rust and joint cracking appears along El. 117. The concrete directly above (comment 4) has pattern cracking and bugholes. Leaching is evident approximately 18" long extending downward from the construction joint. This remains unchanged from previous inspection.

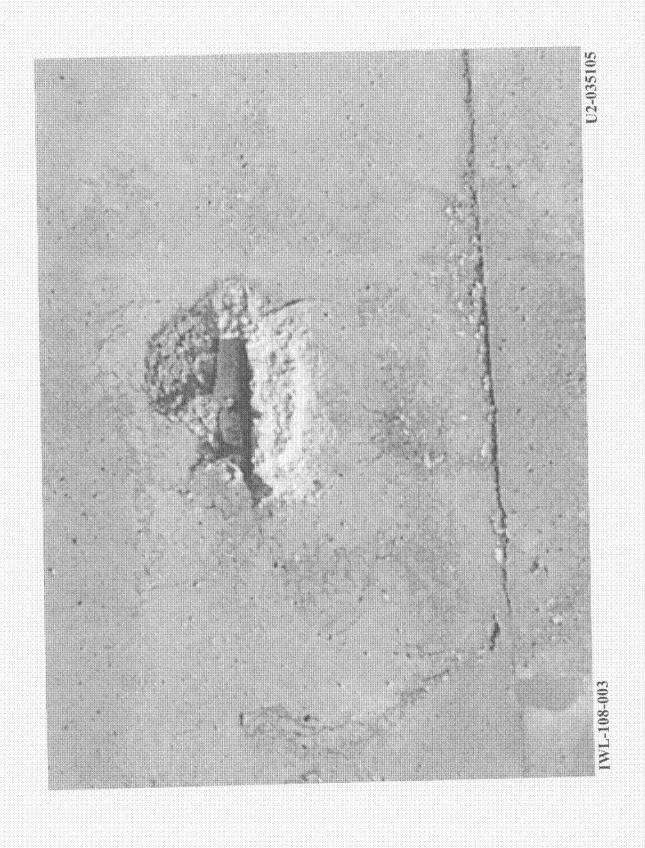
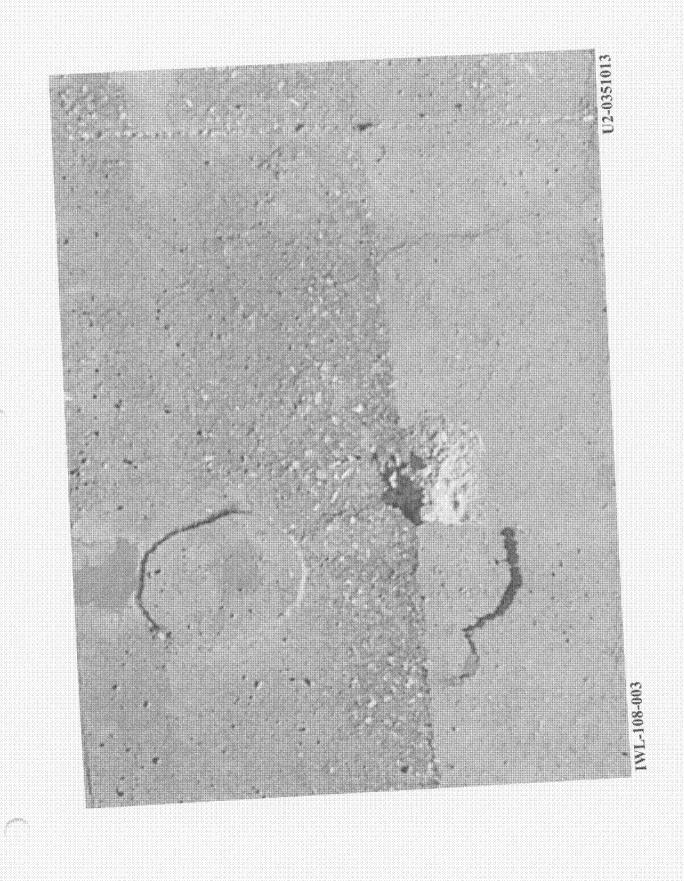
No.	Comment	Initials
1	6" diameter of concrete about to spall. Cadweld exposure 6" long with concrete spall. These areas have remained unchanged since previous inspection.	Med
2	6" concrete spall with additional concrete popouts and a slightly larger hole since previous inspection.	Med
3	6" concrete about to spall. This area has remained unchanged since previous inspection.	ng
4	Corrosion staining from 1 1/2" void hole. This hole has remained unchanged since previous inspection.	Nef
5	4 bug holes along a minor horizontal crack about 20 mils wide with minor staining. These holes have remained unchanged since previous inspection. See photo U2-035106	Med
6	3" concrete hole (spall) with an additional 6 inches of concrete about to spall and expose reinforcing steel with minor staining. This area has remained unchanged since previous inspection. See photo U2-0351013	nof
7	8" concrete area spalled, exposing cadweld with rust and staining since previous inspection. See photo U2-035105	nof

8	Band of concrete surface containing 9 popouts/spalls (ranging from 2"-8" dia.) centered on the zone between El. 108 and El. 148. Also, numerous bugholes (some with visible rust) and general pattern cracking appear within this band.	nof

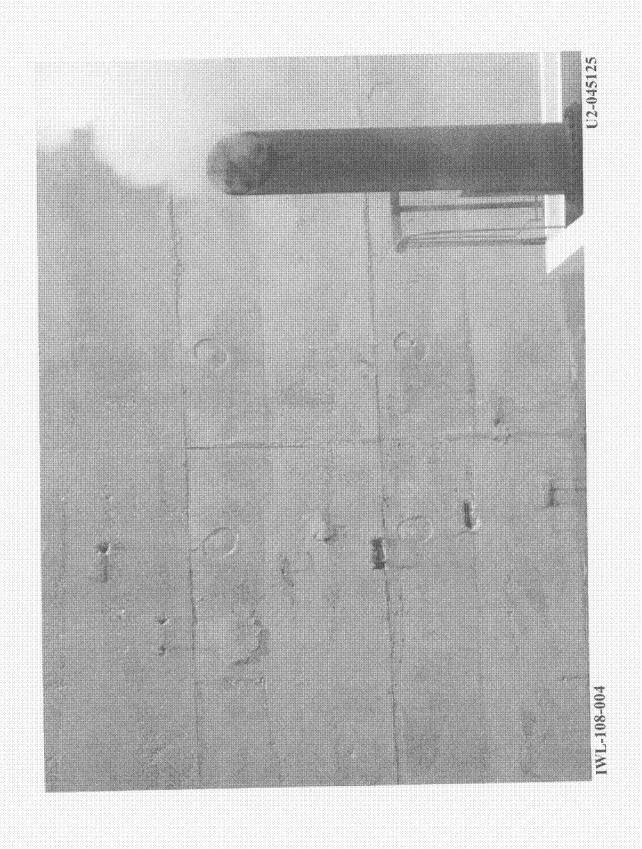
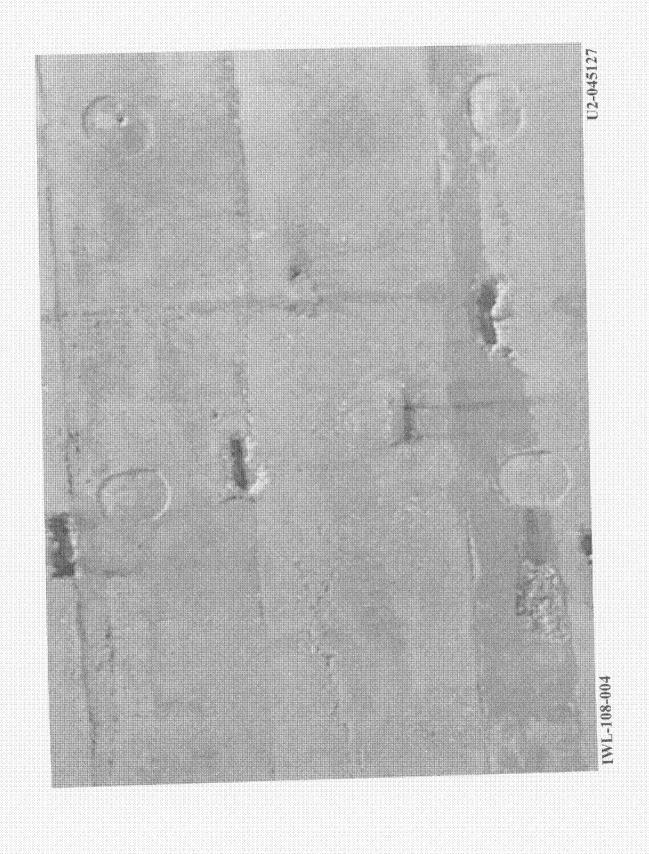
No.	Comment	Initials
1	1 ½" rebar exposed with rusting and staining due to spall. Since previous inspection, some additional minor spalling has occurred at El. 109. See photo U2-045125	No
2	Concrete spall, 8" concrete about to popout. Since previous inspection, additional rebar has been exposed, along with rusting and staining. See photo U2-045125 and U2-045127	nof
3	Light spalling occurs with minor rust visible near El. 108.	ugf
4	10"x4" concrete spall exposing rebar over 8" length with some rusting and staining. This area has remained unchanged since previous inspection. See photo U2-045125	nof
5	A 2" concrete spall has occurred and two 6" concrete areas are about to spall. These areas have rusting and staining, but remained unchanged since previous inspection. See photo U2-045125	nef
6	Rebar (rusty) exposed at 2 locations spaced 9" and a 2" hole exposing rebar appear. These areas have remained unchanged since previous inspection. See photo U2-045125	nof

7	General bugholes appear over area (some with rust).	Not
8	2" hole, exposing rebar with rusting and staining. This area has remained unchanged since previous inspection.	Med
