## IP3 ASME Section XI, IWL Concrete Containment Inspection for 2005

IP-RPT-06-00013

## Attachment 7.2 of ENN-EP-S-003, Rev. 0 CONTAINMENT INSERVICE INSPECTION RECORD OF VT-3 / GENERAL VISUAL EXAMINATION

STATION/UNIT	: IPEC / Indian Point No. 3	COMPONENT NO. :	VCC - 47
ZONE No:	005

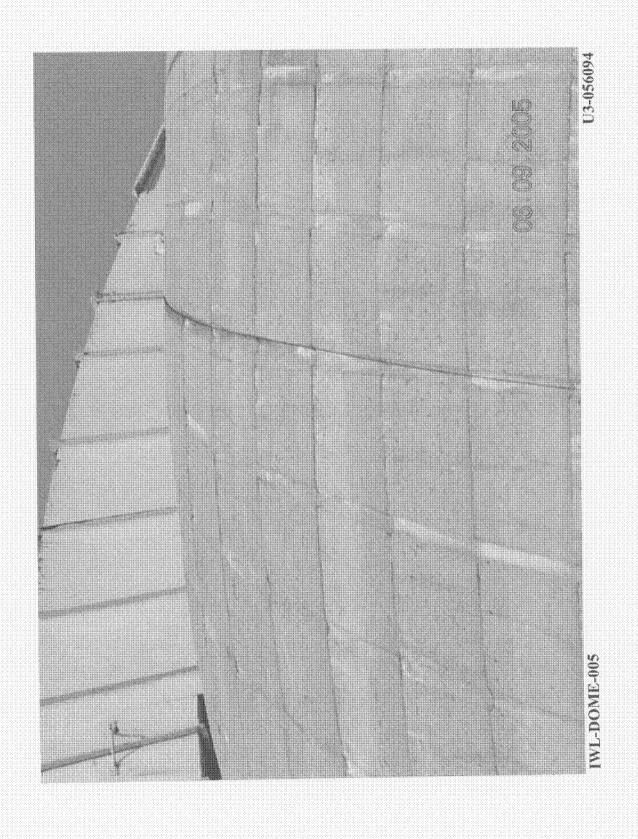
8	Steel cable rusting along a vertical joint. See photos U3-056094 and U3-056095	PAB

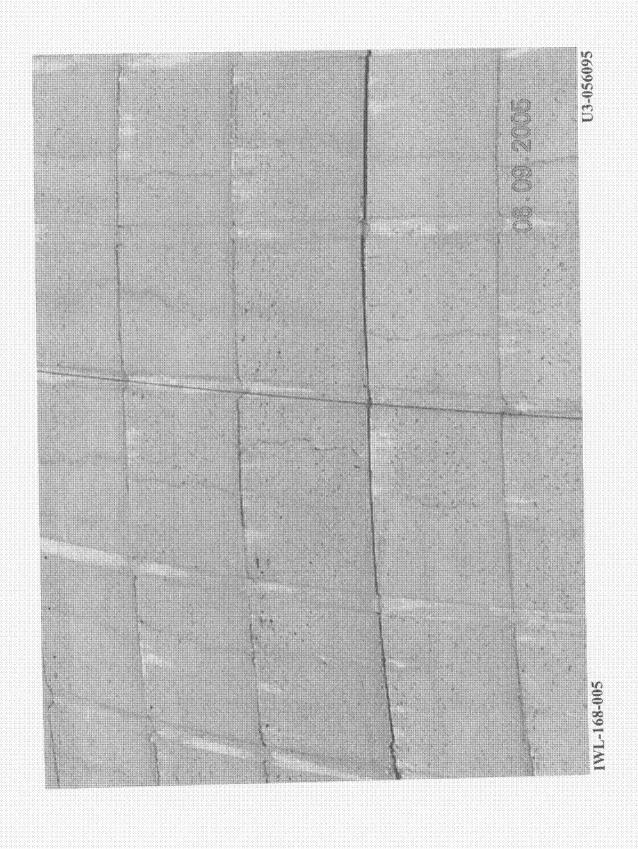
No.	Comment	Initials
1	First two rows of dome: Minor cracking due to shrinkage; popouts; leaching; scaling and spalling; all non-active, minor.	Pas
2	Vertical cracks 5' long and 5' o/c along the first row of the dome. See photo U3-056095	PB PB
3	Third and fourth rows of dome: Joint cracking; spalling; staining from duct support steel; vertical cracks 5' long and 5' o/c; small popouts with rust and staining.	PMS
4	Fifth and sixth rows of dome: Joint cracking; vertical cracks; minor spalling; bugholes; staining from lightning arrester support. See photo U3-056031	PMB
5	Seventh and eighth rows of dome: Joint crack and spall approximately 5' long adjacent to duct support; spall areas less than 5" in size; pitting/abrasion; bugholes; two small popouts with rust and staining.	PMB
6	Ninth and tenth rows of dome: Leaching; pattern cracking; joint spalls and cracking; staining.	PB.
7	Eleventh thru thirteenth rows of dome: Small spall areas; popouts adjacent to duct; rust and staining.	P.M.B
