CONTAINMENT INSERVICE INSPECTION RECORD OF VT-3/GENERAL VISUAL EXAMINATION

Plant: IPEC - Unit 3 **Interval Period:** 1st/3rd Inspection **Inspection Report No.:** IP3-09-IWL-001
Component No: VCC-10 **Zone No:** 004 **Drawing No.:** ISI-IWL-001
Description: El. 68' - El. 88' **Work Order No:** 138856
Equipment Used: Celestron Giant 20x80 Binoculars **Limitations:** Accessible areas only

IP3 ASME Section XI, IWL Concrete Containment Inspection for 2009

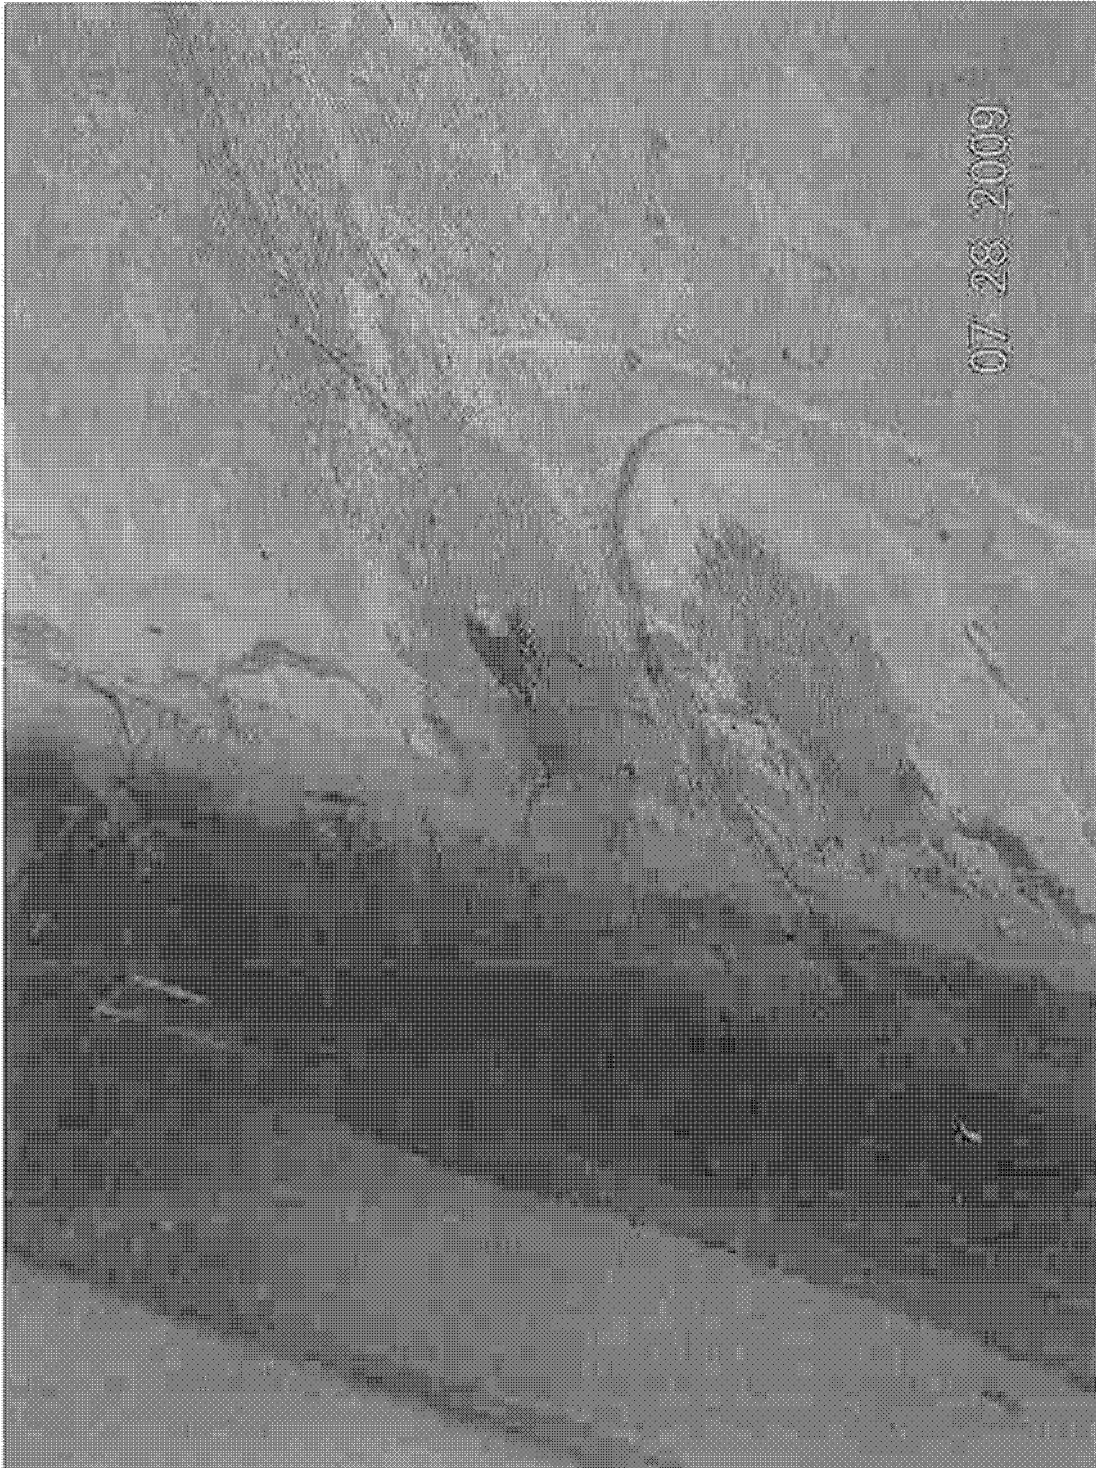
U3-047281

| No. | Comment | Initials |
|---|--|---|
| 3 | 1-1/2" dia. pop-out with rust staining, visible between Fan House and Containment. See photo U3-047281. | PMB |

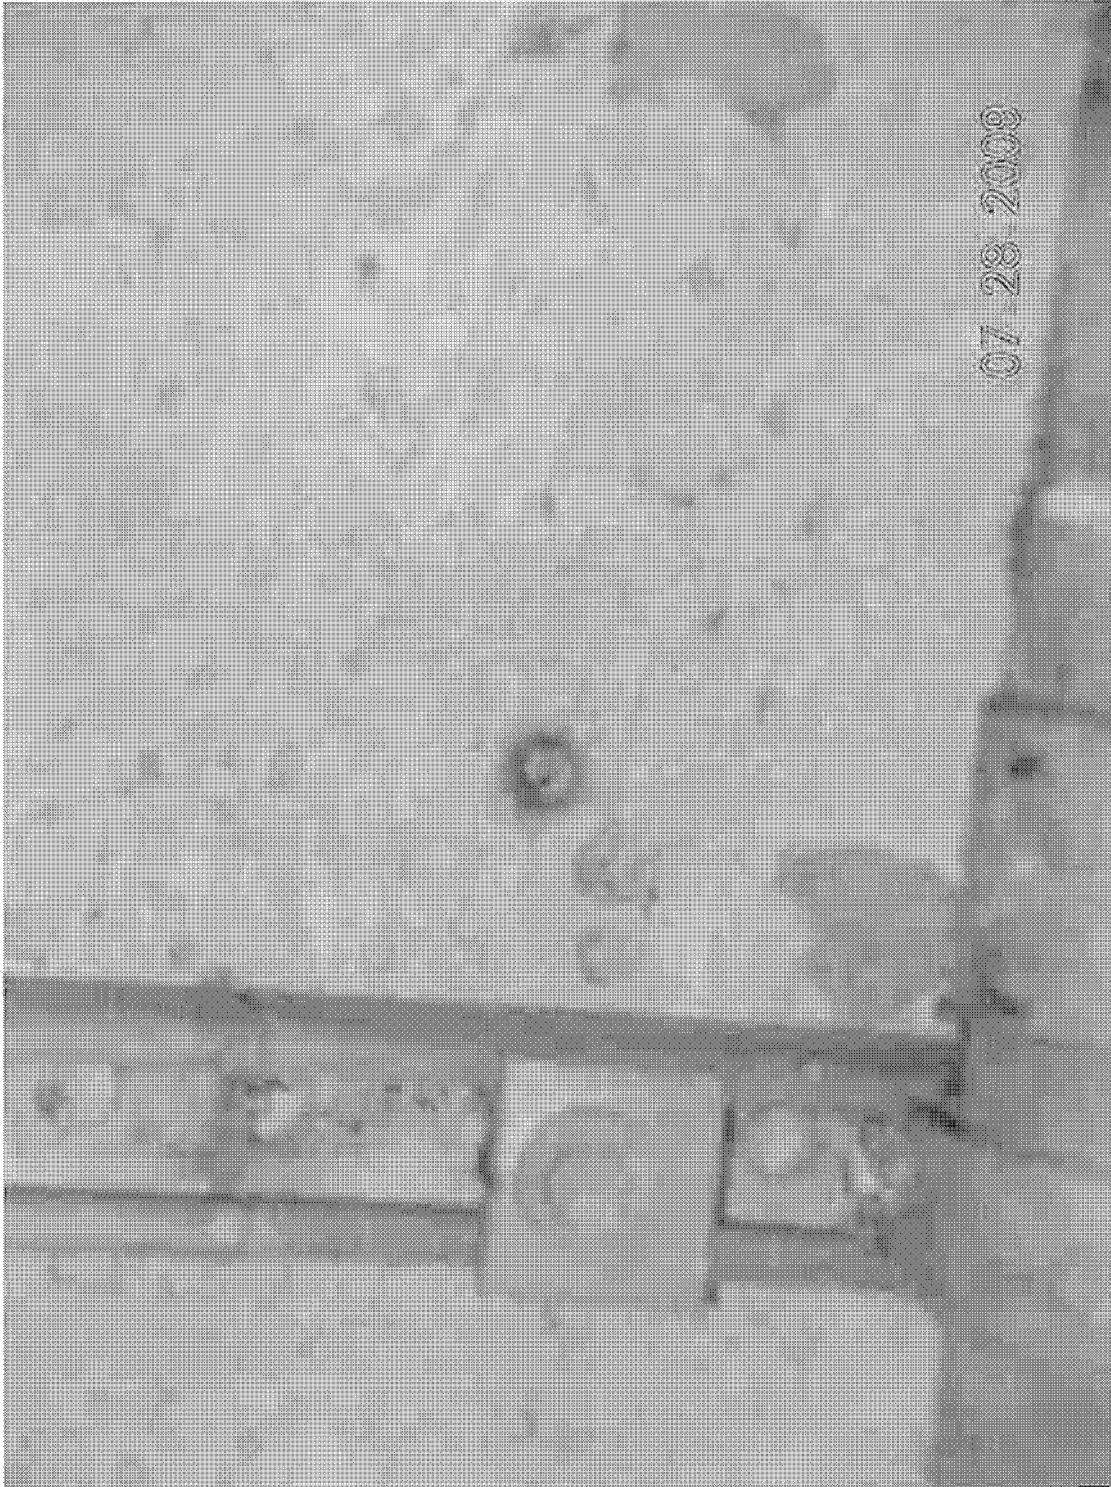
U3-047282

| No. | Comment | Initials |
|---|--|---|
| 4 | 2" dia. pop-out exposing steel with surface corrosion, visible between Fan House and Containment. See photo U3-047282. | PMB |

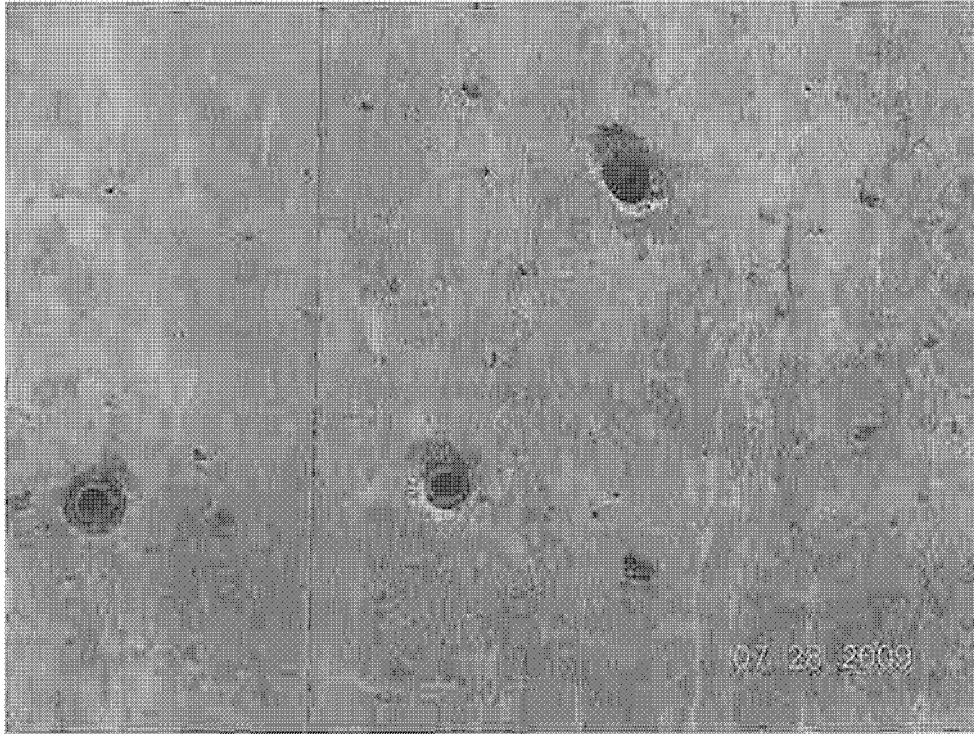
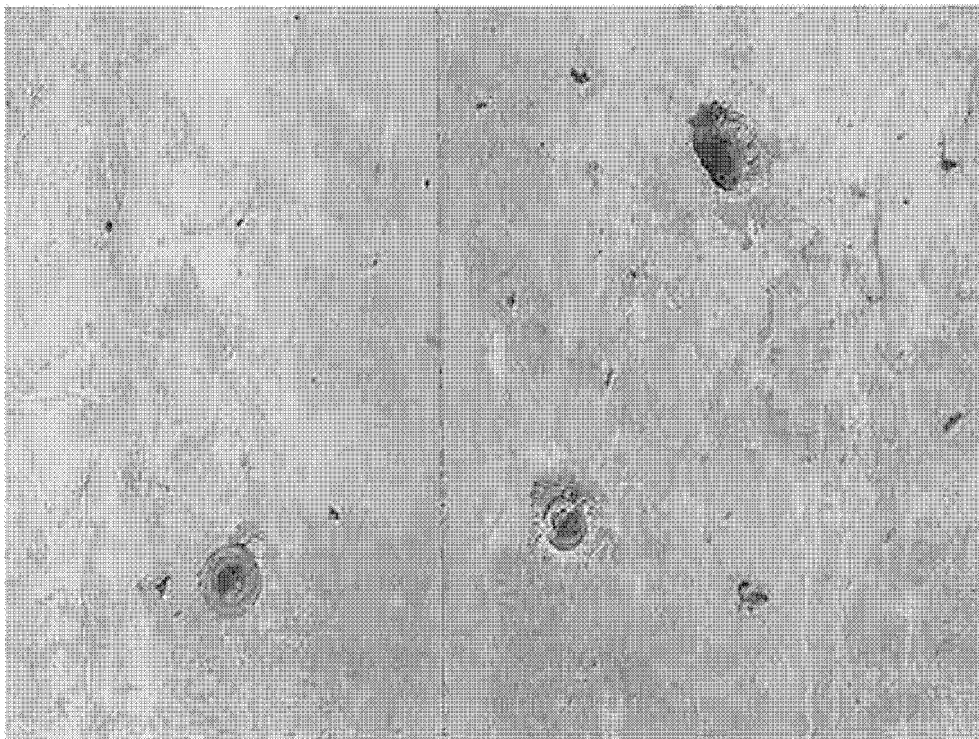
U3-067283

| No. | Comment | Initials |
|---|--|---|
| 4 | Three 1" pipe inserts previously identified in 2001 with no change. See photo U3-067283. | <i>PMB</i> |

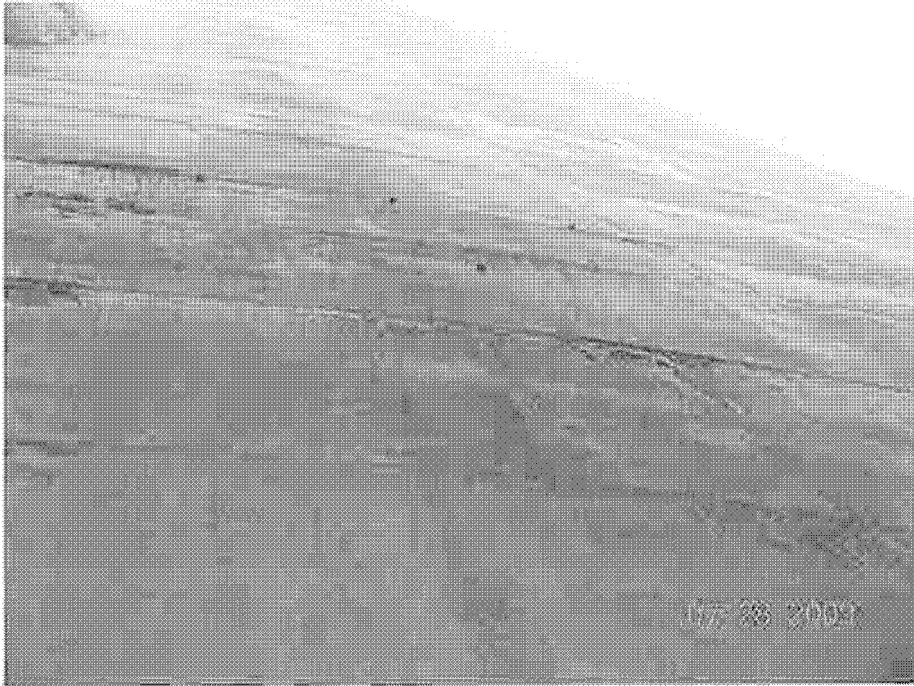
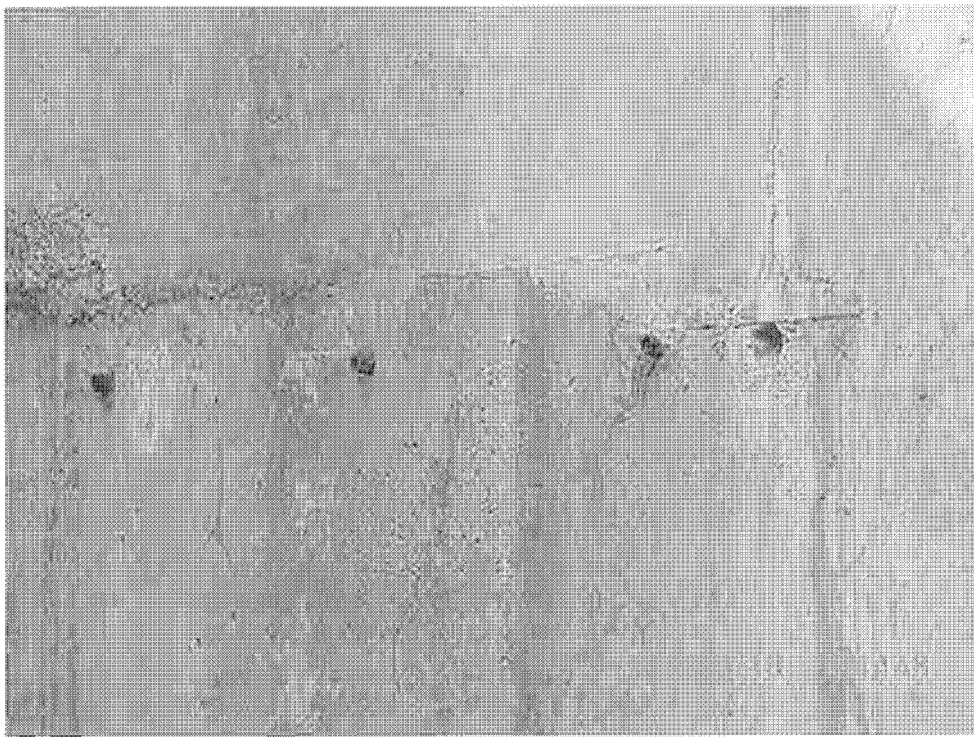
U3-067284

| No. | Comment | Initials |
|---|--|---|
| 3 | Sixteen 1" dia. pipe inserts protruding 1" from containment surface located under the equipment hatch. Identified previously in 2001. See photo U3-067284. | <i>PMB</i> |

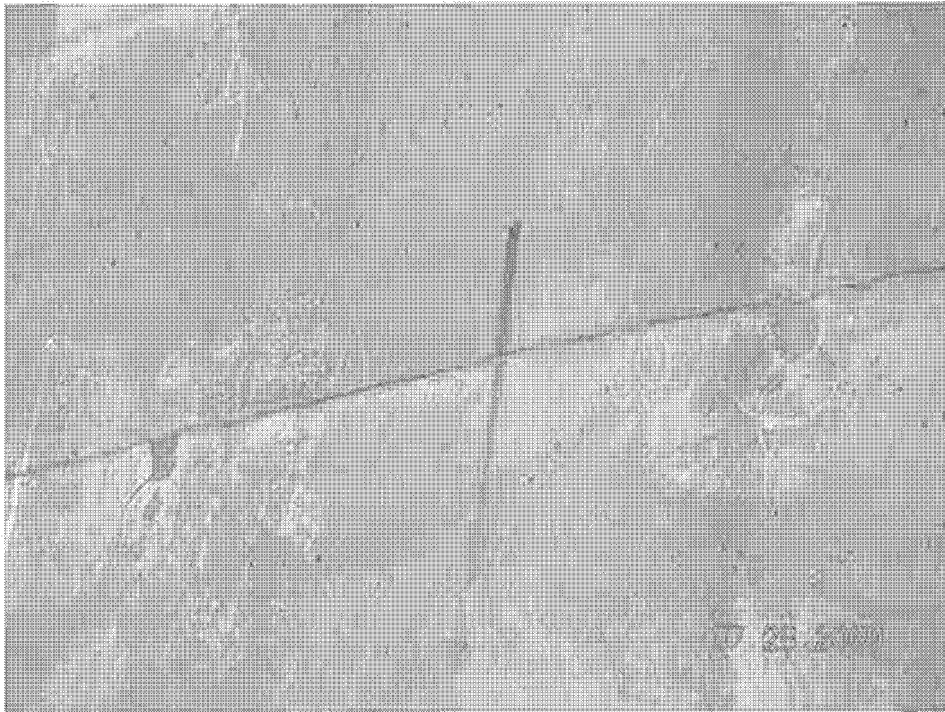
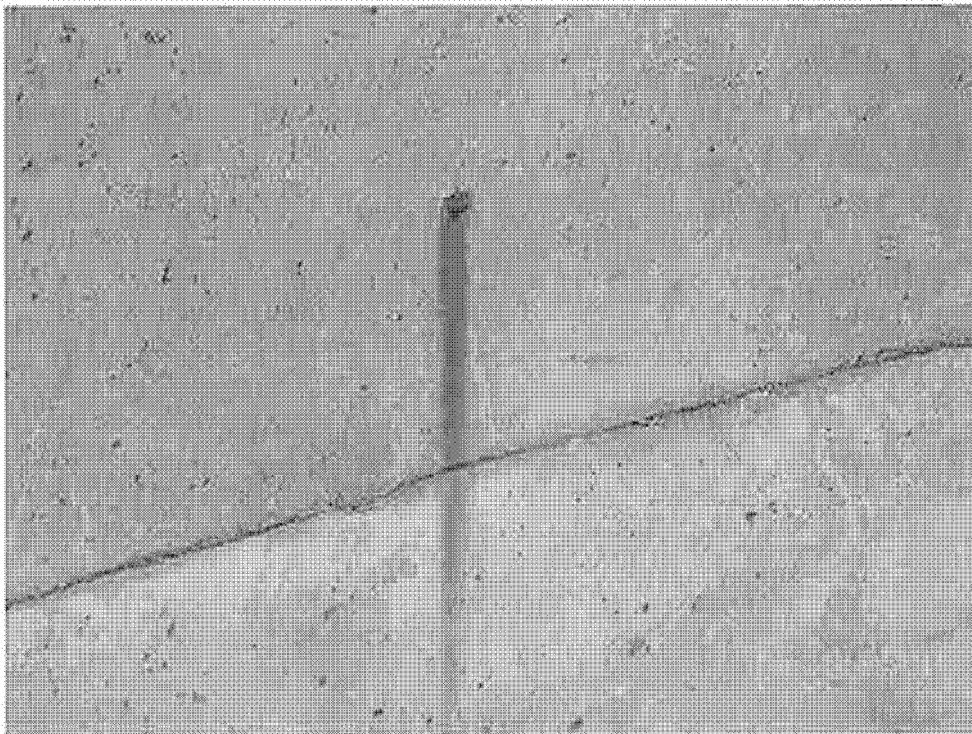
| No. | Comment | Initials |
|---|--|---|
| 1 | Exposed metal tip, roughly 1-1/2" dia., flush to concrete surface with a 5' long rust streak at El. 95. Update: Condition was found to be the same since the previous inspection and then coated in 2009 to prevent further corrosion. See photo U3-067281 and indication #1 of Attachment 8.5 for before and after photo. | PMB |

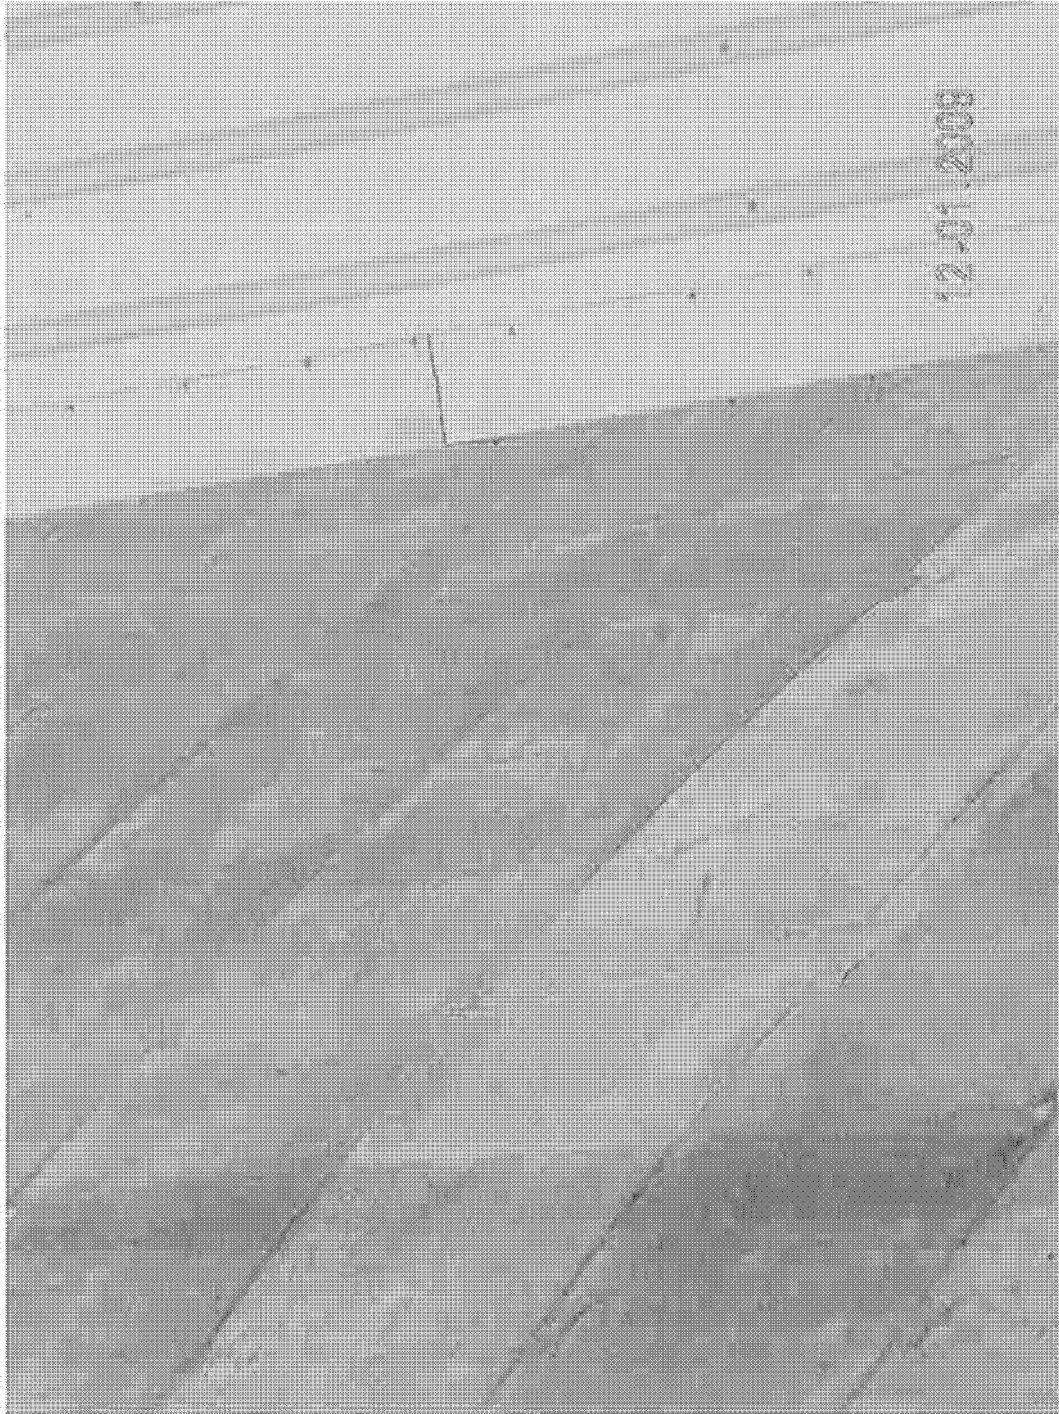
U3-021211

| No. | Comment | Initials |
|---|---|---|
| 2 | Minor spalls, approximately 1-3" long and less than 1/4" wide, some exposing small areas of rebar (previously identified). See photo U3-021211. | PMB |

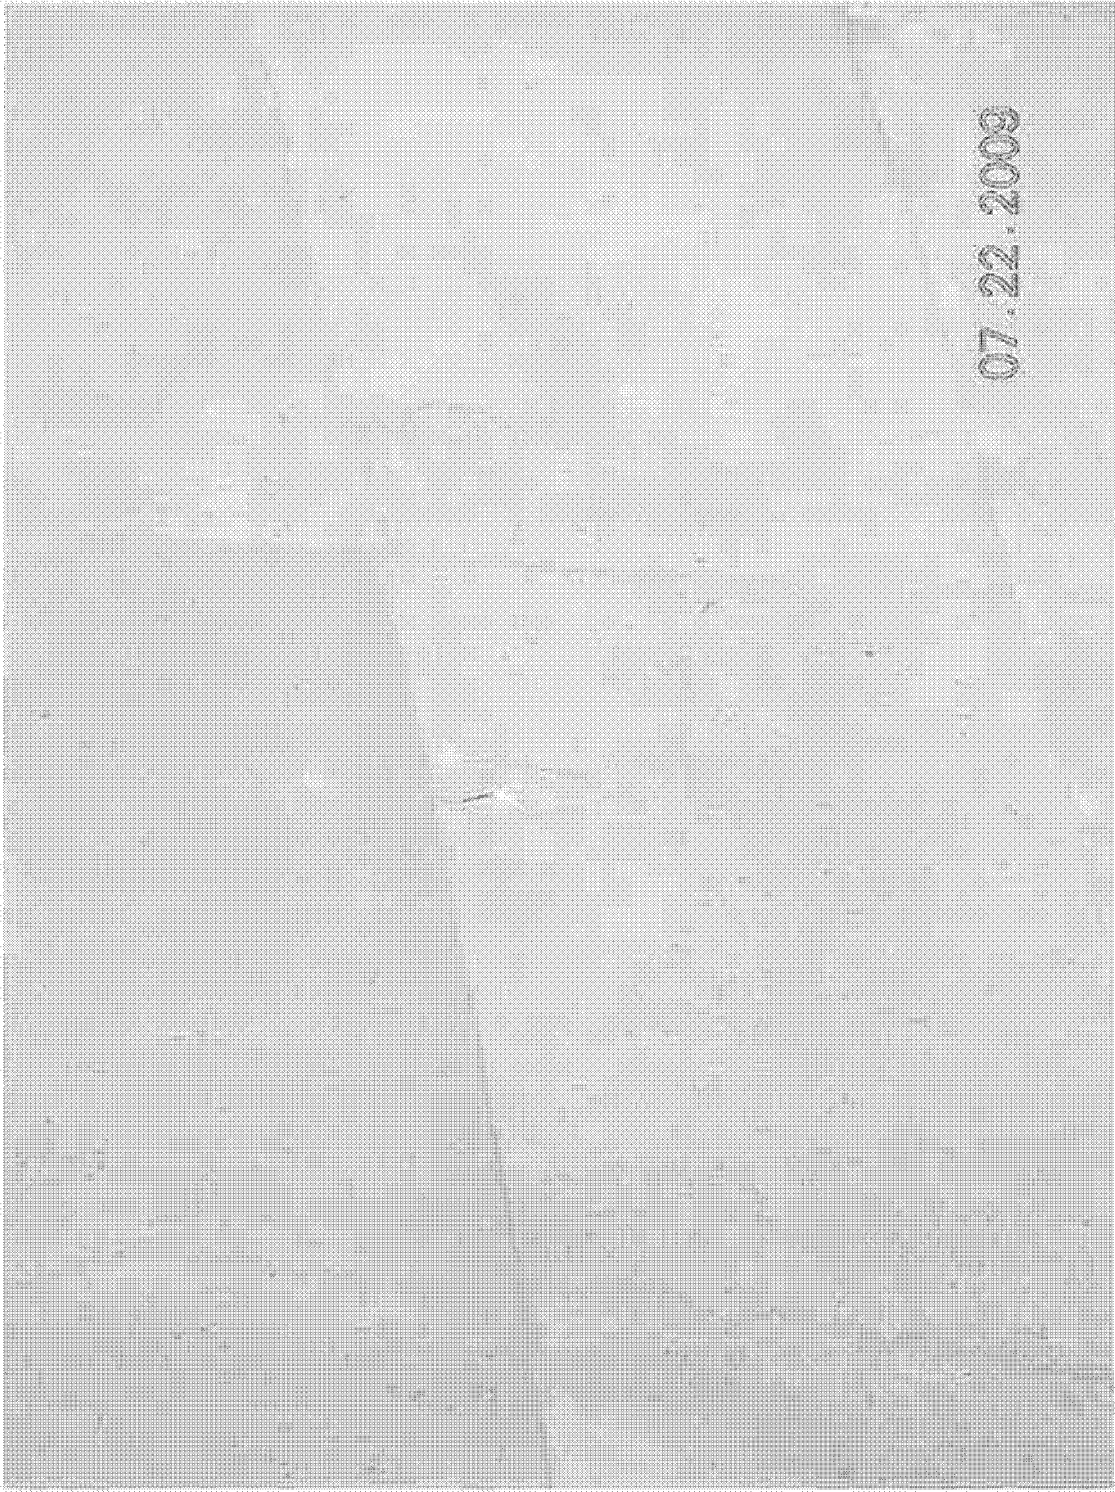
U3-027223

| No. | Comment | Initials |
|---|---|---|
| 4 | Concrete separated indicating potential future spall of 6" x 3" area at El. 113'. See photo U3-027223. | PMB |
