<b>IPEC</b>	IP-RPT-09-00069	REV. 0
		Page 190 of 192	
IP3 ASME Section XI, IWL Concrete Containment Inspection for 2009

**Indian Point 3  
Nuclear Power Plant**

**Unit 3 Dome Ring  
Inspection and Load Test Report**

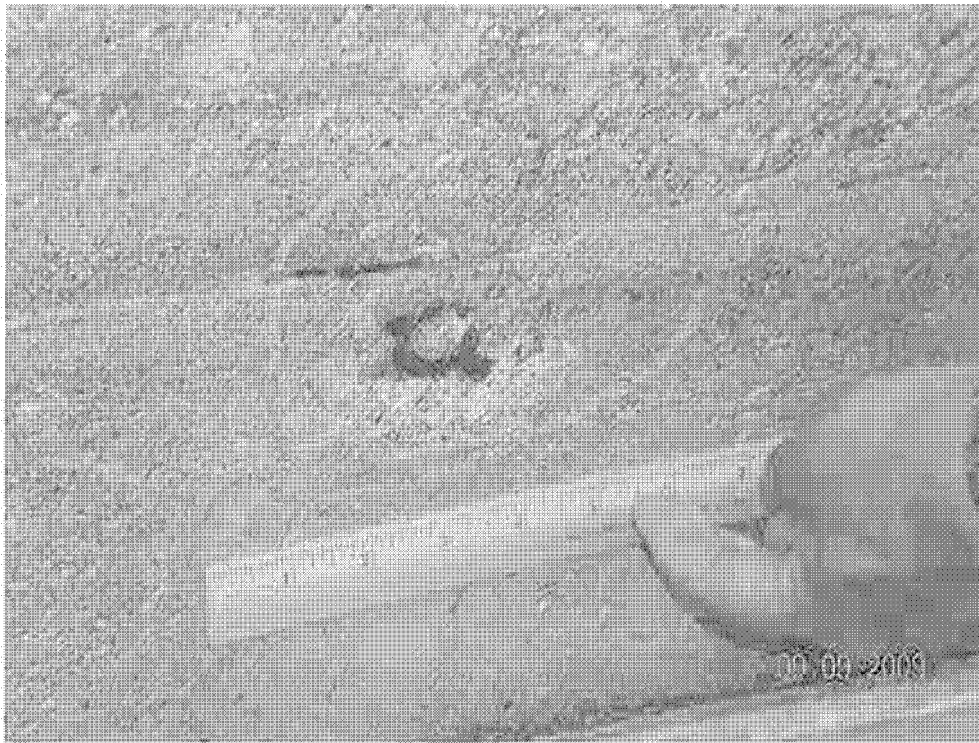
Indication: Small exposed metal insert with minimal rust and staining.  
Location: Zone 6, approx. elevation 113'-0", just to the right of the hatch.

NO VANTAGE POINT FOR AFTER PHOTO. CONFIRMED WITH PERSON-IN-CHARGE THAT COATING WAS APPLIED.

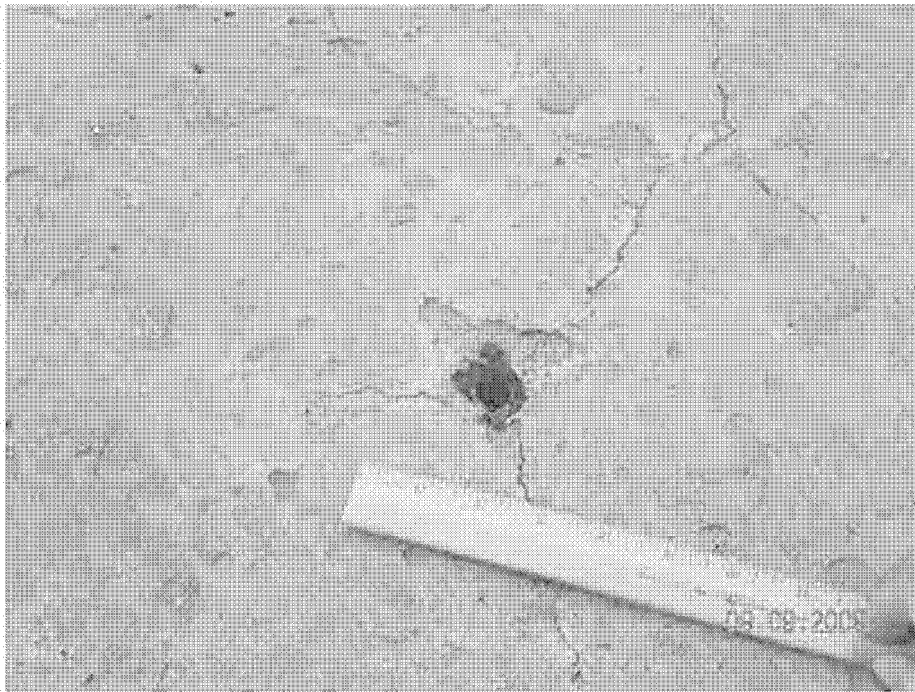
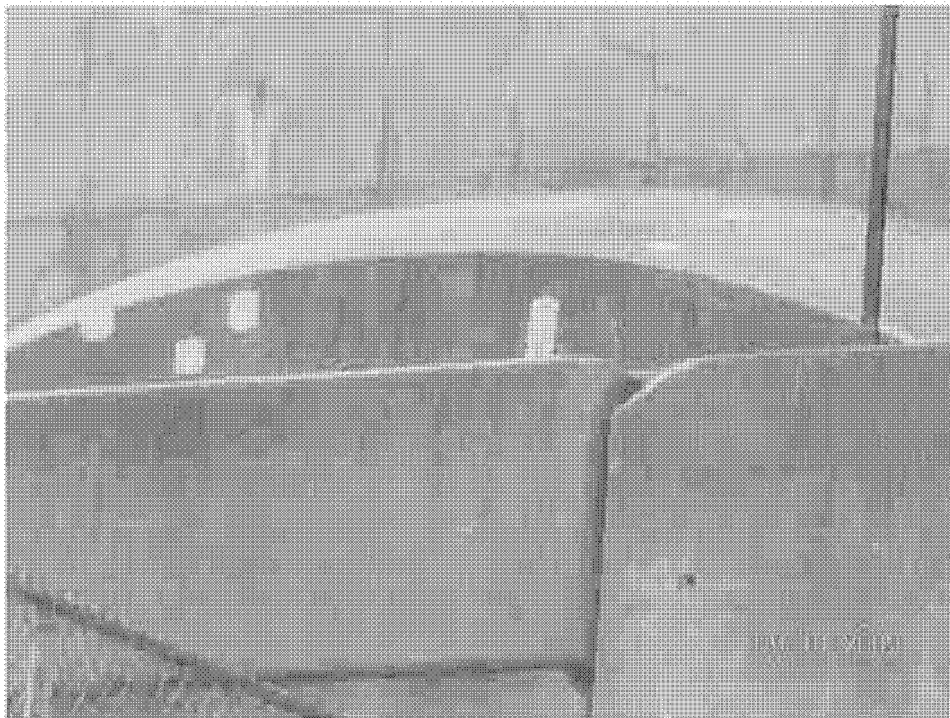
INDICATION #8

Indication: Anchor hole, approx. 5/8" dia., with minimal rust and staining.  
Location: Zone 6, approx. elevation 113'-0", on the hatch.

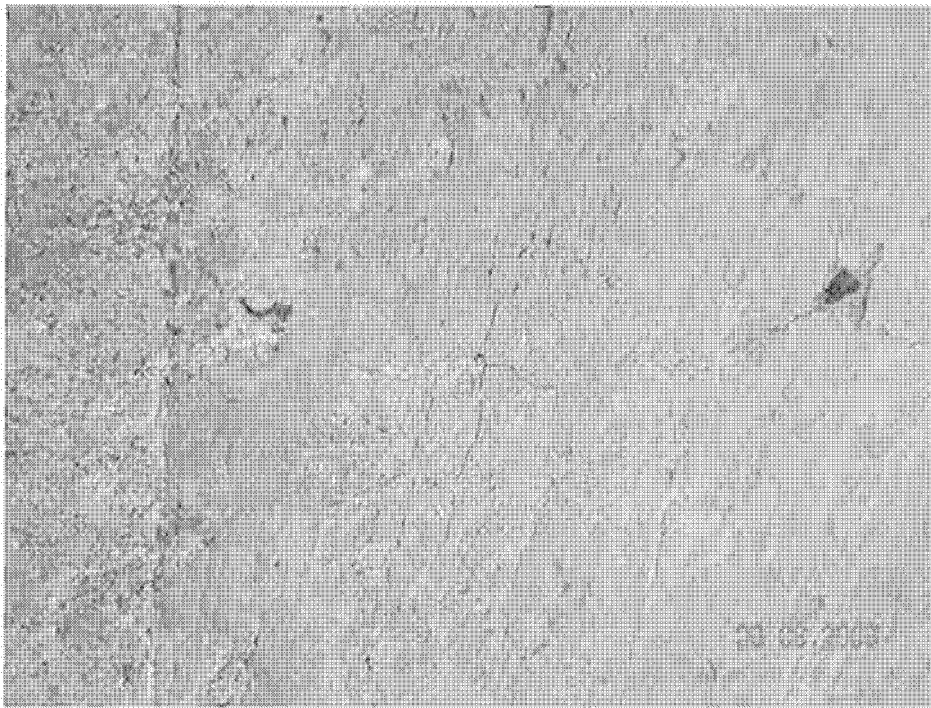
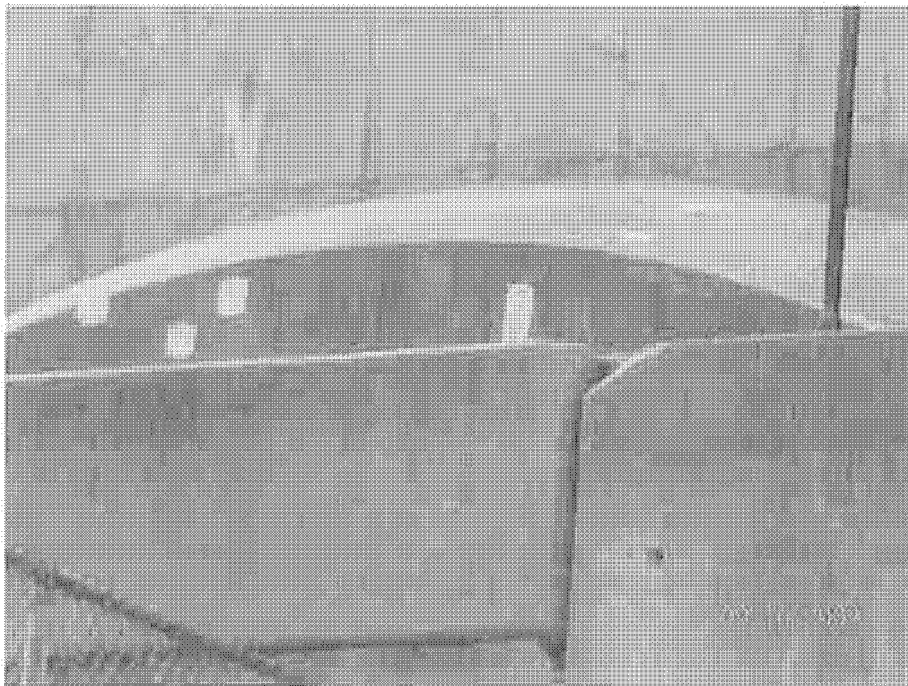
INDICATION #9

Indication: Two small exposed metal inserts with minimal rust and staining.  
Location: Zone 6, approx. elevation 113'-0", on the hatch.

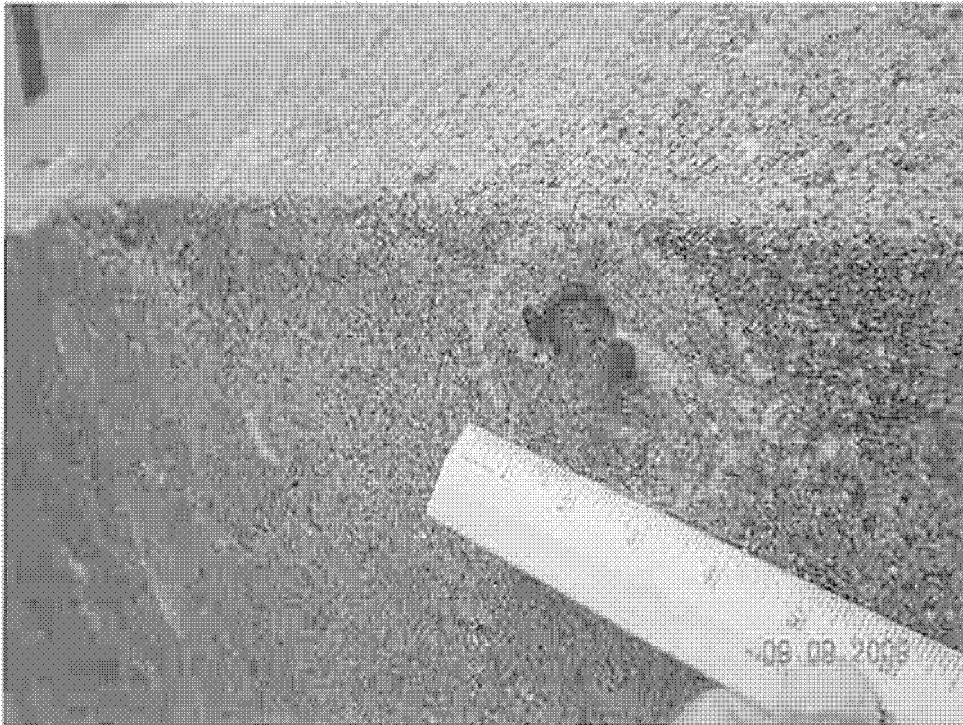
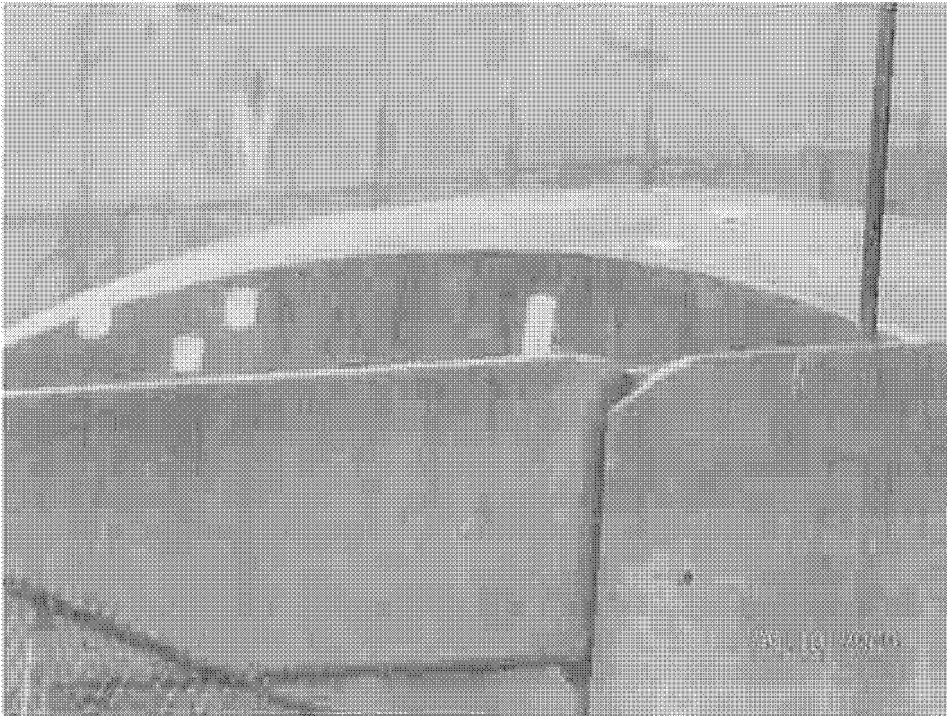
INDICATION #10

Indication: Two small nails with minimal rust and staining.  
Location: Zone 6, approx. elevation 113'-0", on the hatch.

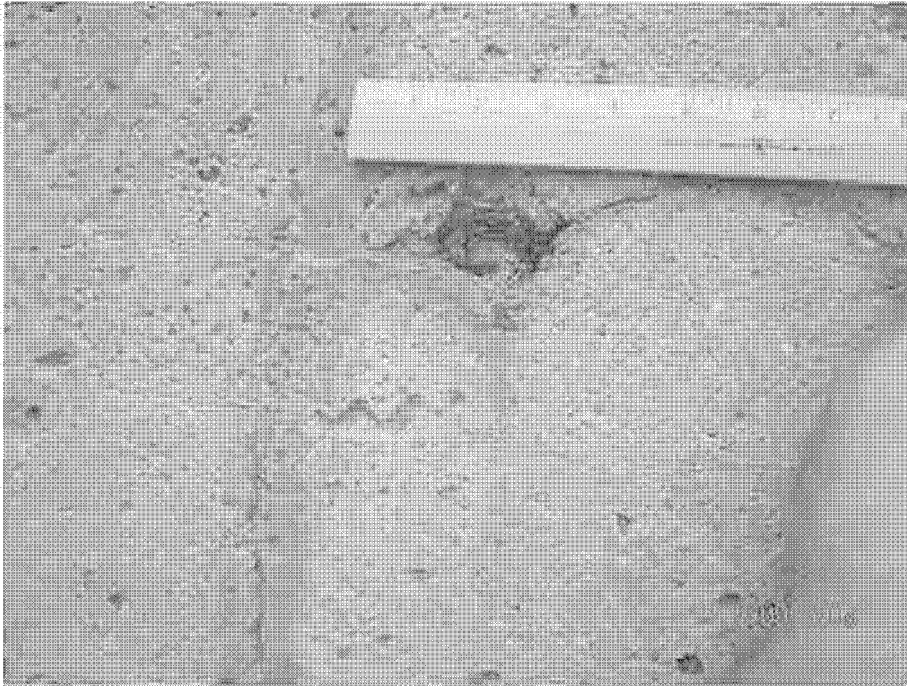
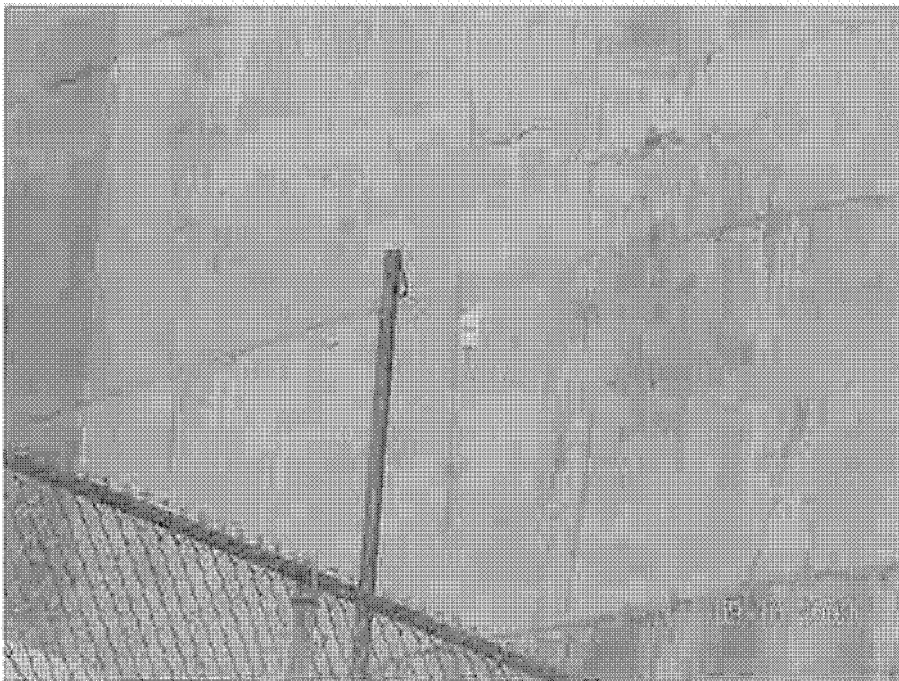
INDICATION #11

Indication: Exposed metal insert, approx. 1 ¼" dia., with rust and staining.  
Location: Zone 5, approx. elevation 120'-0", to the left of and above the hatch.

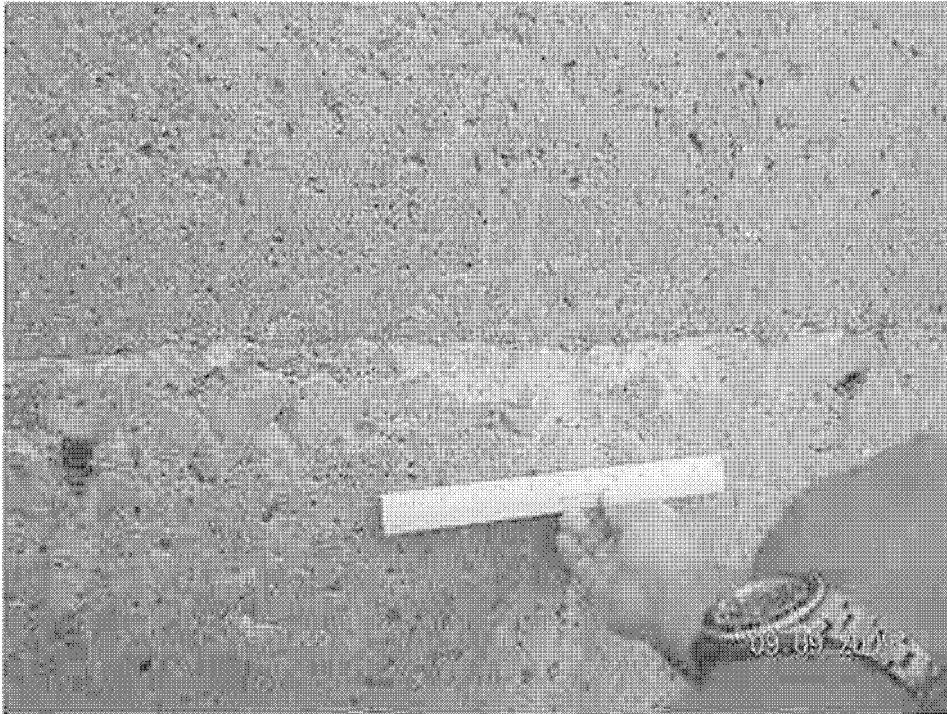
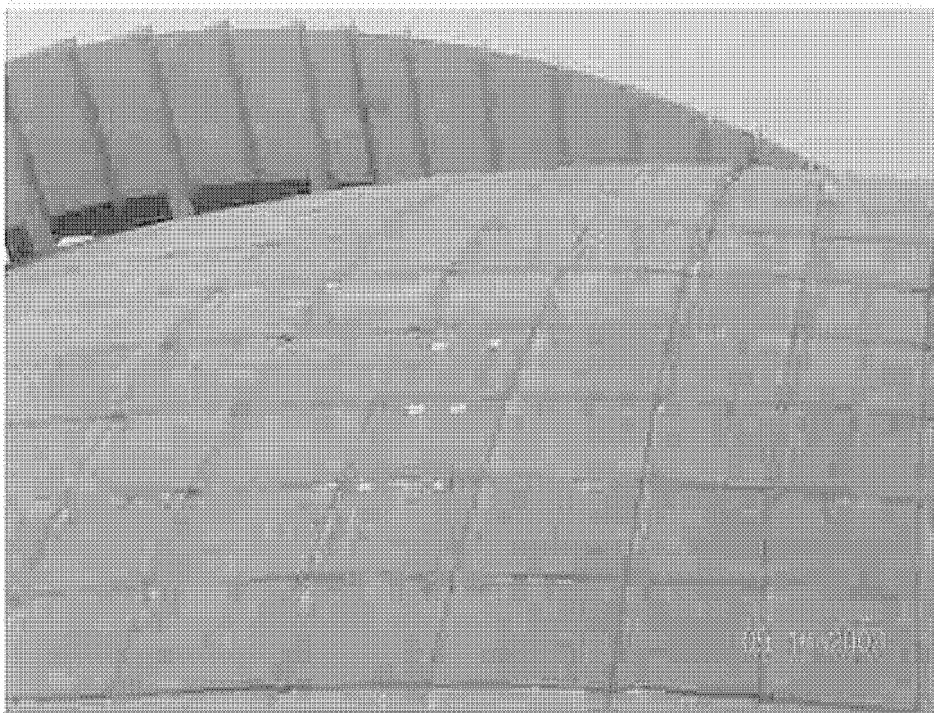
INDICATION #12

Indication: Two 1/2" dia. anchor sleeves with minimal rust and staining.  
Location: Zone 5, dome, approx. 15' right of vent.

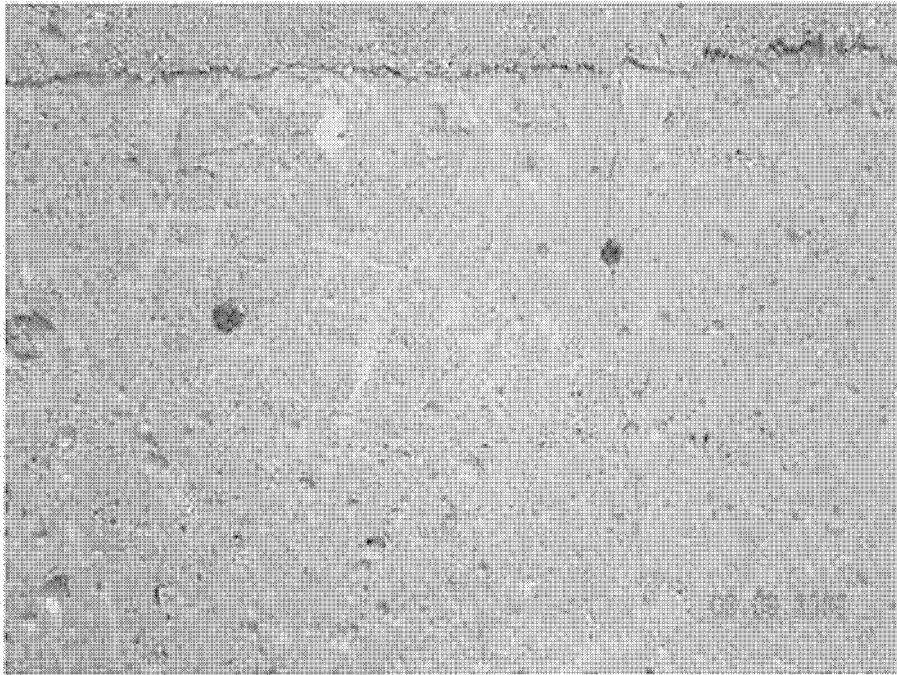
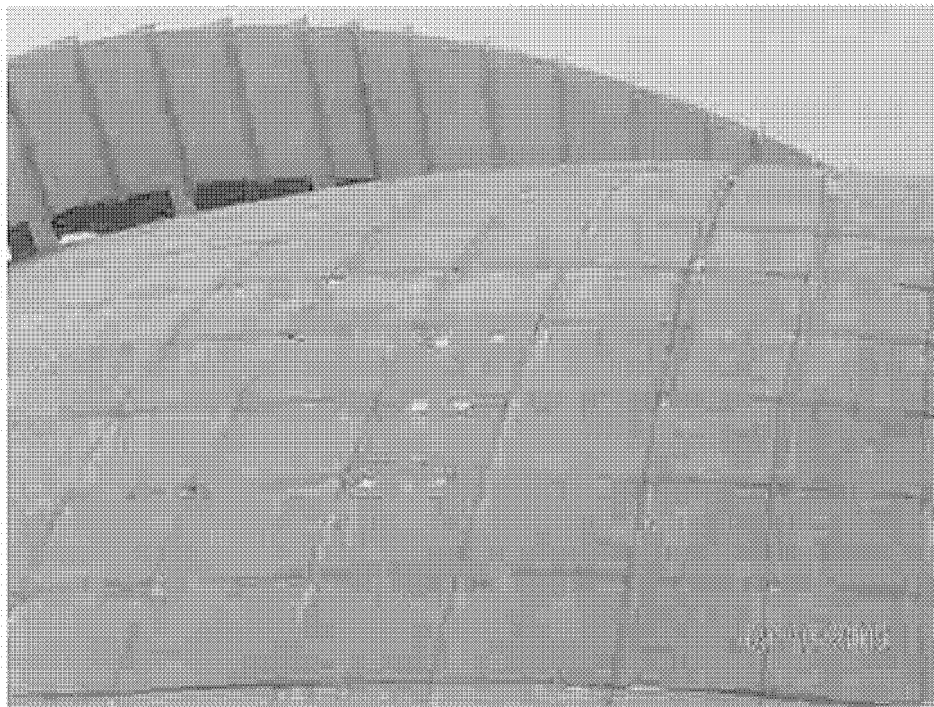
INDICATION #13

Indication: Two ½" dia. anchor sleeves with minimal rust.  
Location: Zone 5, dome, approx. 15' right of vent.

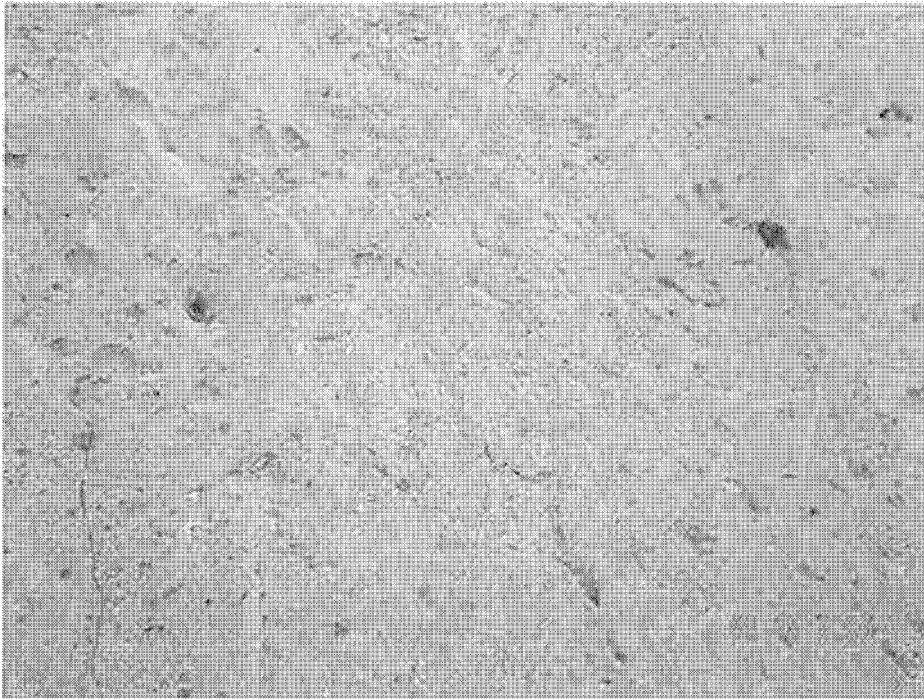
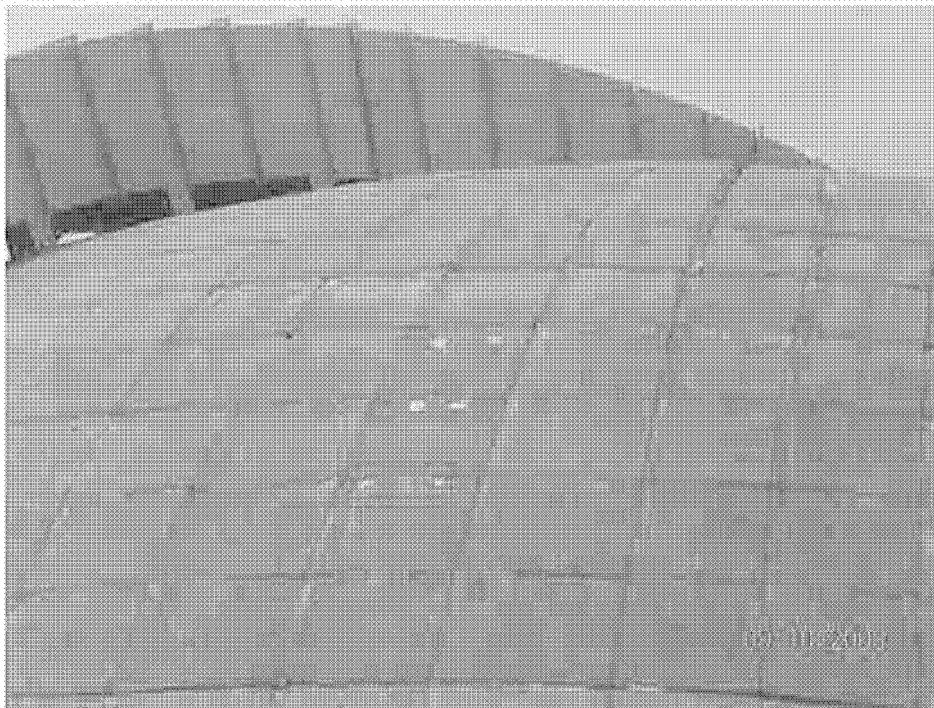
INDICATION #14

Indication: Two 1/2" dia. anchor sleeves with minimal rust.  
Location: Zone 5, dome, approx. 15' right of vent.

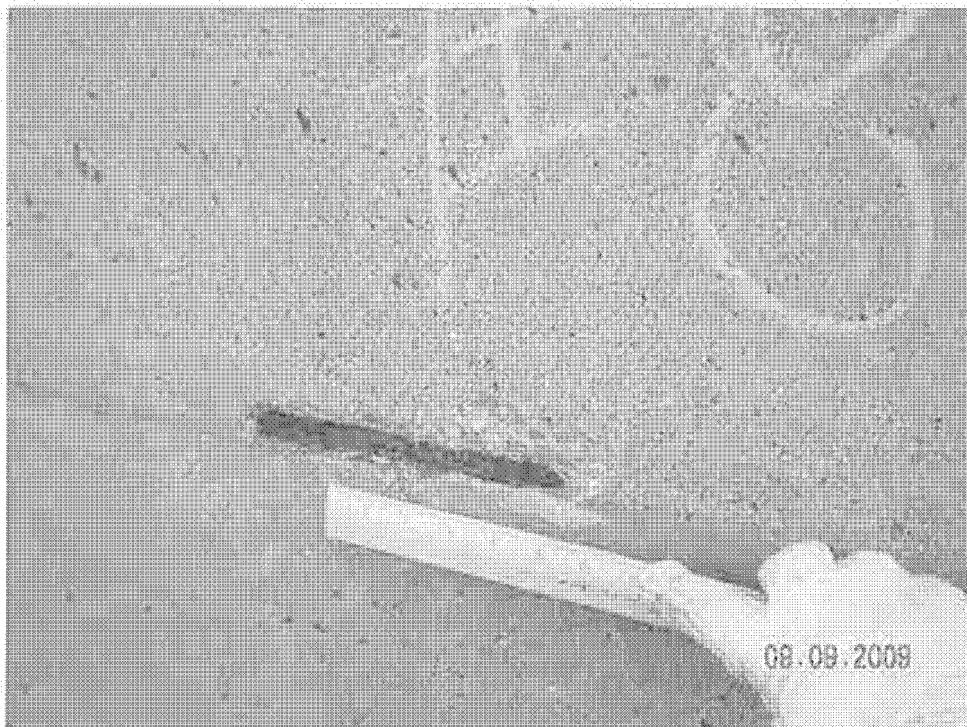
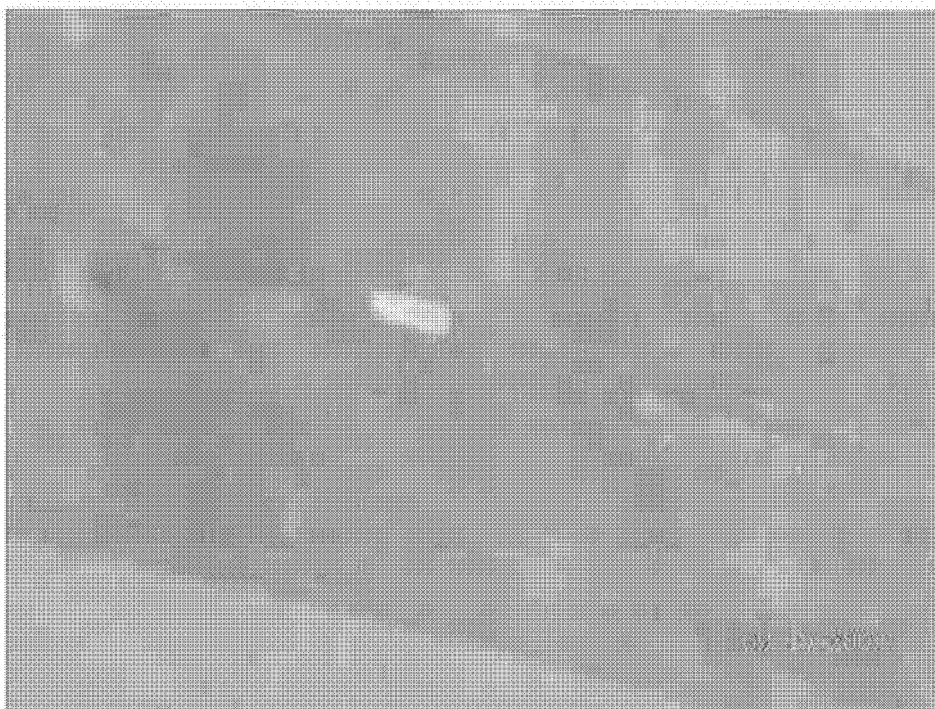
INDICATION #15

Indication: Flat bar steel insert, approx. 7" long, with minimal rust and staining.  
Location: Zone 3, elevation 118'-0", visible from transformer yard.

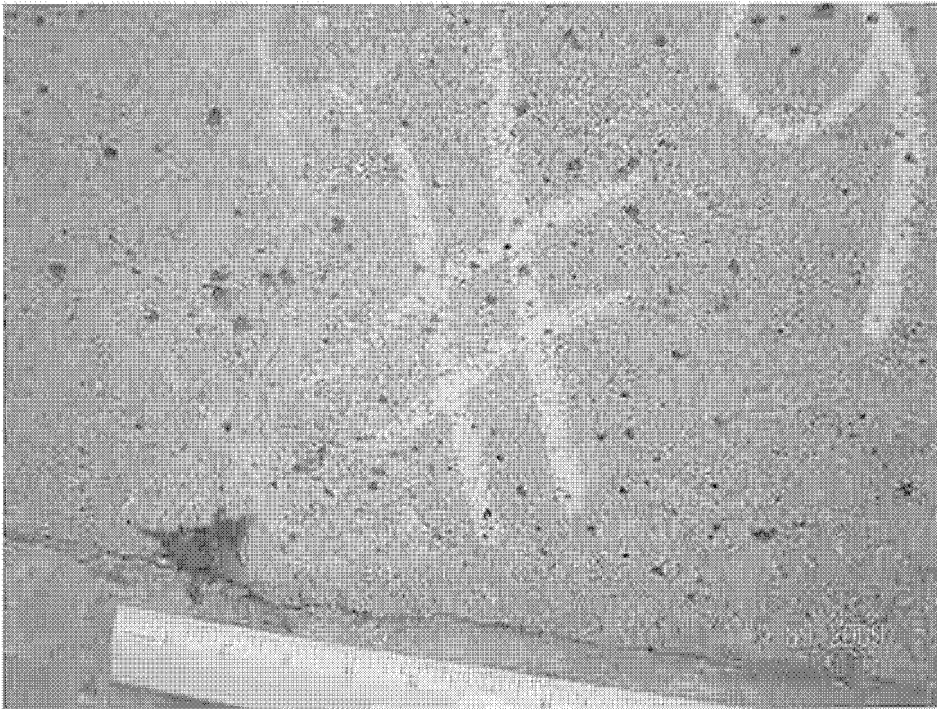
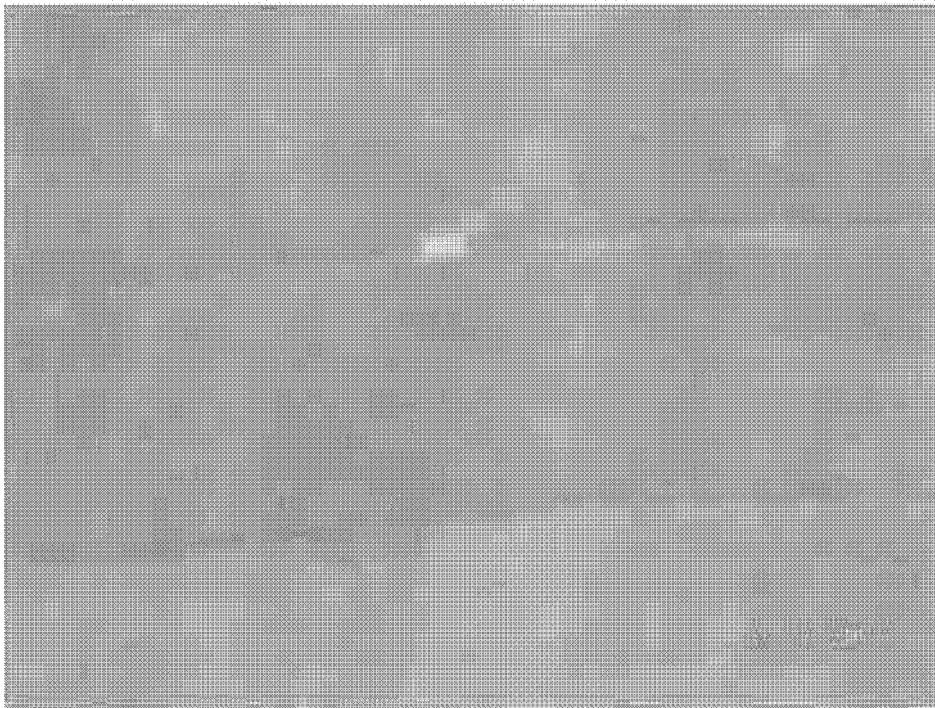
INDICATION #16

Indication: Metal insert, 1 ½" x 1", with minimal rust and staining.  
Location: Zone 3, elevation 128'-0", visible from transformer yard.

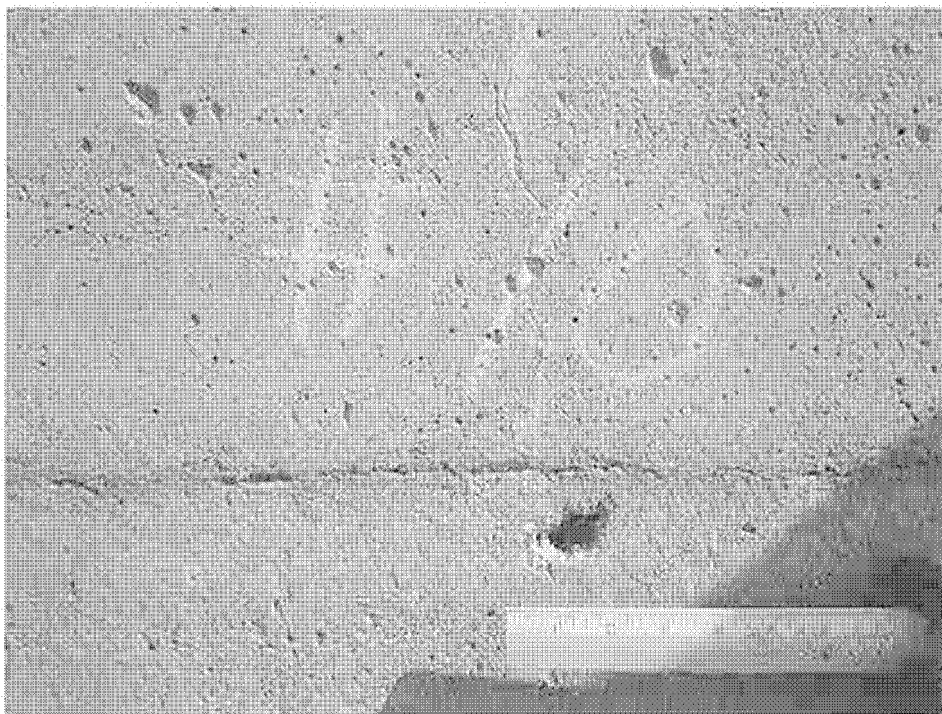
INDICATION #17

Indication: Exposed steel, approx. 1" dia., with minimal rust & staining.  
Location: Zone 2, elevation 153'-0", visible from Turbine Roof

DUE TO ACCESS LIMITATIONS, ONLY A PRIME COAT COULD BE APPLIED  
TO THE INDICATION.

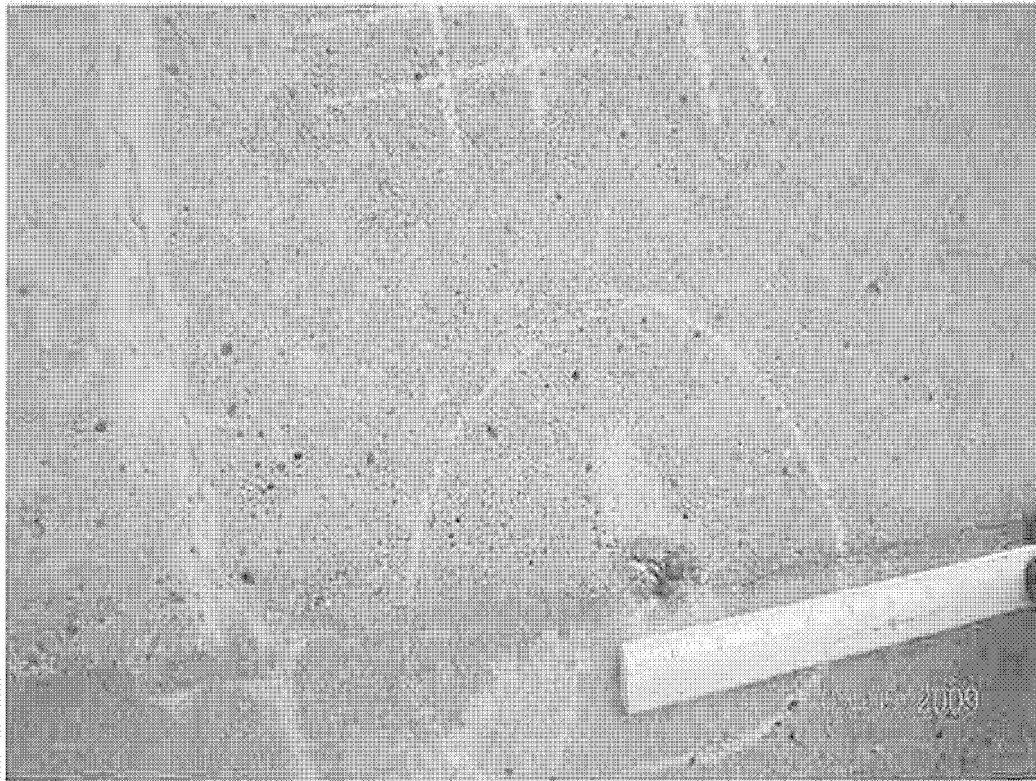
INDICATION #18

Indication: Exposed steel, approx. ½" dia., with minimal rust & staining.  
Location: Zone 2, elevation 138'-0", visible from Turbine Roof

DUE TO ACCESS LIMITATIONS, ONLY A PRIME COAT COULD BE APPLIED  
TO THE INDICATION.

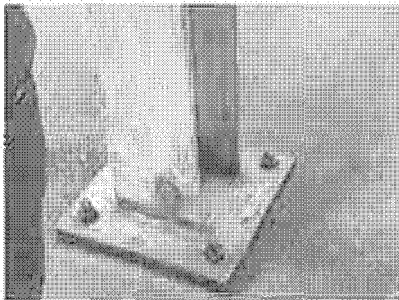
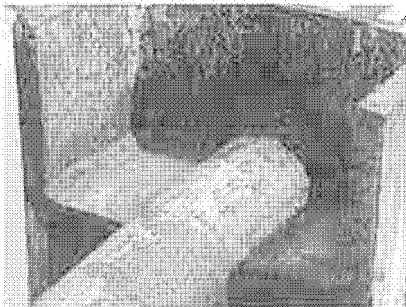
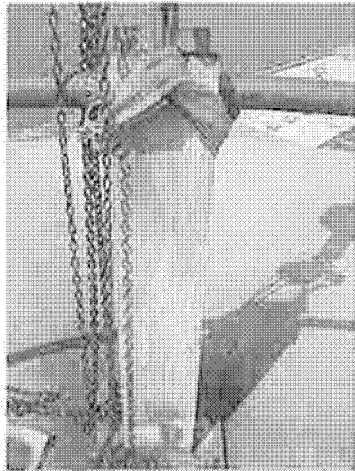
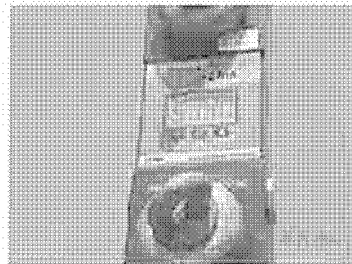
Results of the visual inspection revealed that the ring support structure was in good condition with light to moderate surface corrosion on all of the components. There was no significant loss of material observed as a result of the corrosion. The anchors were tight and in good condition with no evidence of concrete cracking in the vicinity of the anchors. Some localized pitting was observed near the welds that attached the gusset plates to the wide flange and pipe ring sections. None of the observed degradation would result in any significant reduction in the structural capacity of the components that comprise the ring support system.

cracking were observed in any of the structural components when exposed to the 5140 lb load. Only one location was tested since the visual inspection indicated this was representative of the entire structure.
