CONTAINMENT INSERVICE INSPECTION RECORD OF VT-3/GENERAL VISUAL EXAMINATION

Plant: IPEC – Unit 3 Interval Period: 1st/3rd Inspection Inspection Report No.: IP3-09-IWL-001

IP3 ASME Section XI, IWL Concrete Containment Inspection for 2009

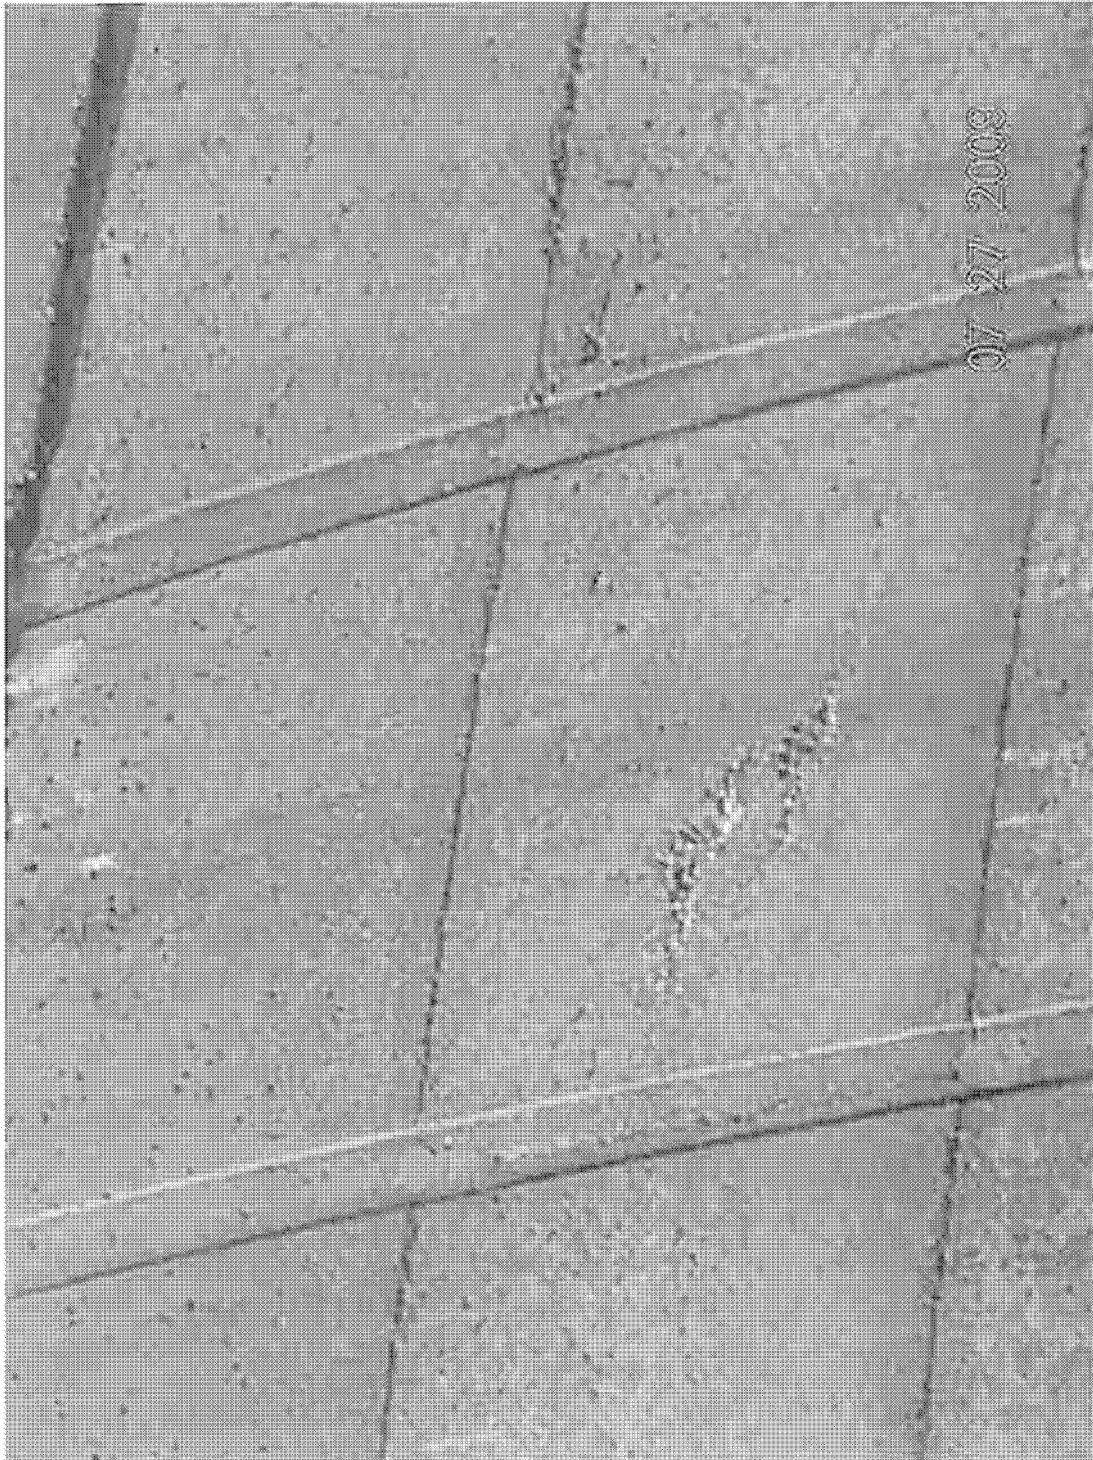
U3-017274

No.	Comment	Initials
1	Numerous bugholes, leaching, localized spall areas, joint spalls with exposed aggregate and pop outs – all minor and previously identified.	PMB
2	Horizontal cracks with spalling and a diagonal crack, approximately 3' long, with spalling (previously identified with no significant changes).	PMB
3	Exposed aggregate, 12" x 4" area, located 2 panels down and 1 to the right from the left lightning arrestor.	PMB
4	Exposed aggregate, 10" long x 2" wide (at widest location), located 5 th /4 th row down and third over from left border. Indication appears to be from original construction formwork spillage.	PMB
5	Spall, approximately 3" diameter x 1/2" deep, located 8 th row down and 7 th over from left border.	PMB
6	Two adjacent areas of exposed aggregate, approximately 12" x 4" and 9" x 2", located 5 panels up from spring line and 7 panels over from left border. See photo U3-017274. This photo represents a typical condition as described in the above comments.	PMB

7	Potential future spall, approximately 4" x 3" area, located 4 panels up from spring line and 9 over from left border.	PMB
8	Exposed aggregate, approximately 2' x 2" diagonal, located 2 panels up from spring line and 6 over from left border.	PMB
9	Exposed aggregate, approximately 6" x 8" area, located 2 panels down and 5 over from left border.	PMB

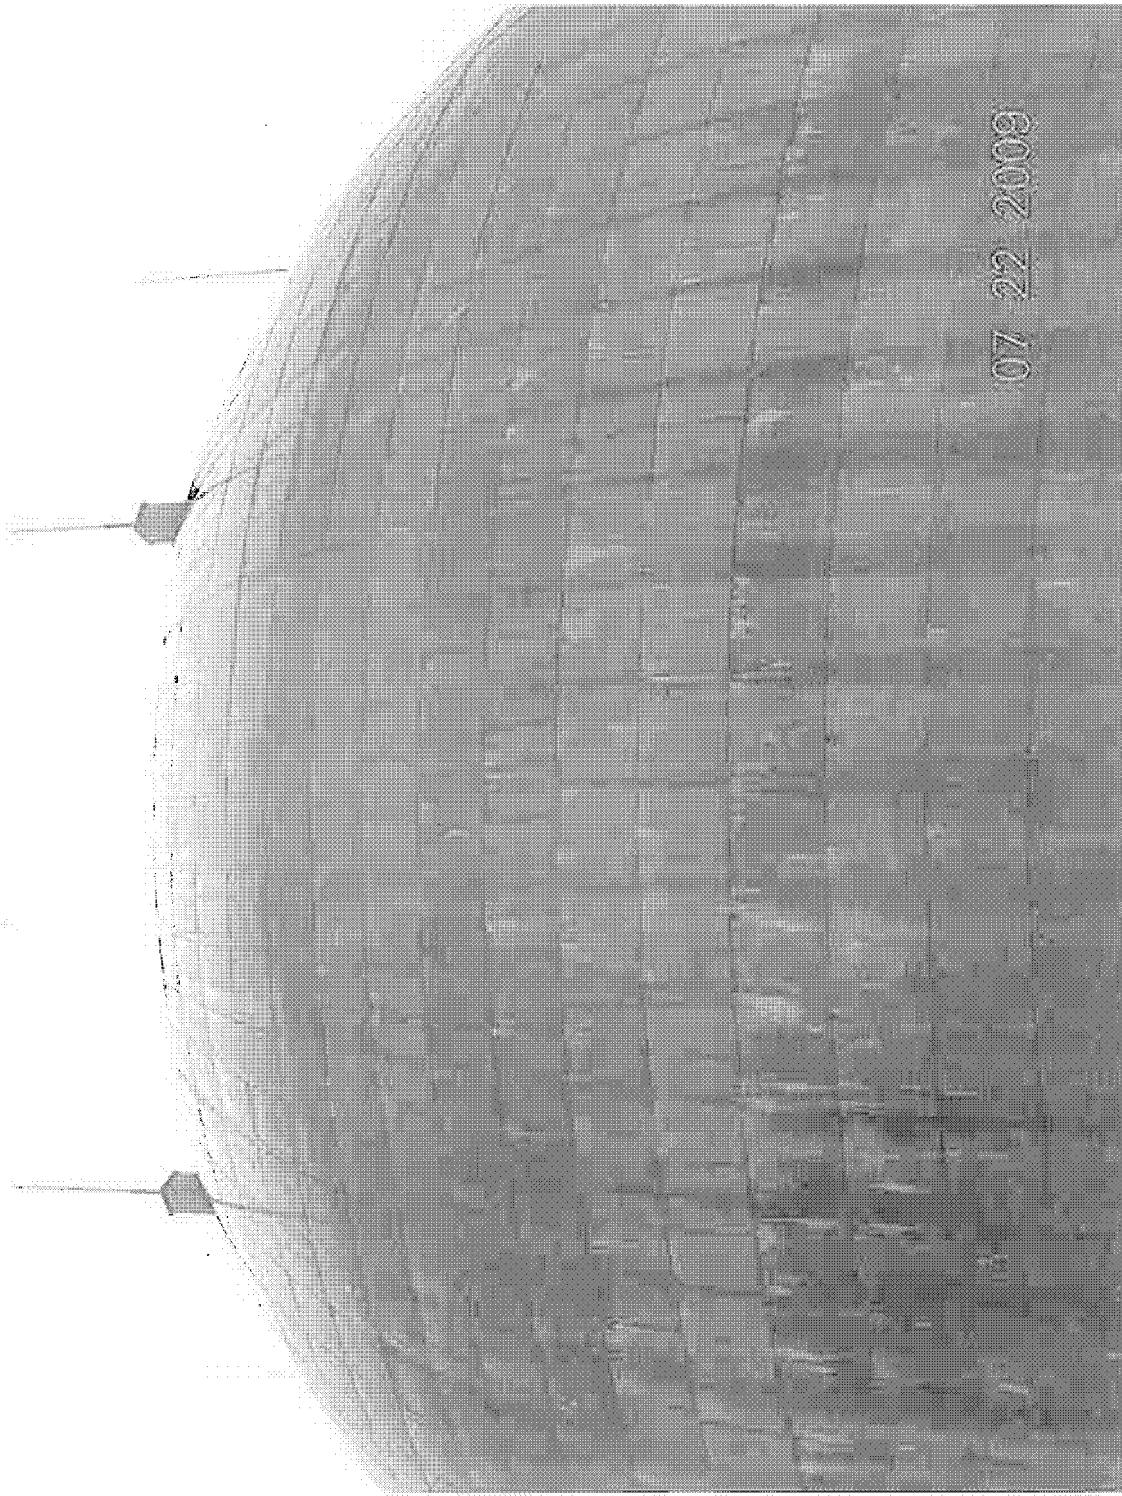
No.	Comment	Initials
1	Numerous bugholes, leaching and vertical cracking – all minor and previously identified.	PMB
2	Cracking and spalling with exposed aggregate at cylinder to dome interface (previously identified with no significant changes).	PMB
3	Joint cracking and spalling with exposed aggregate over 10' long section at El. 198 (previously identified with no significant changes).	PMB
4	Exposed aggregate, approximately 6" x 8" area, located 3 rd row up and 2 nd panel over from left boundary.	PMB
5	Joint spalling and separation near lightning arrestor. See photo U3-027228.	PMB
6	See photo U3-027227 for general view of dome in zone 2.	PMB

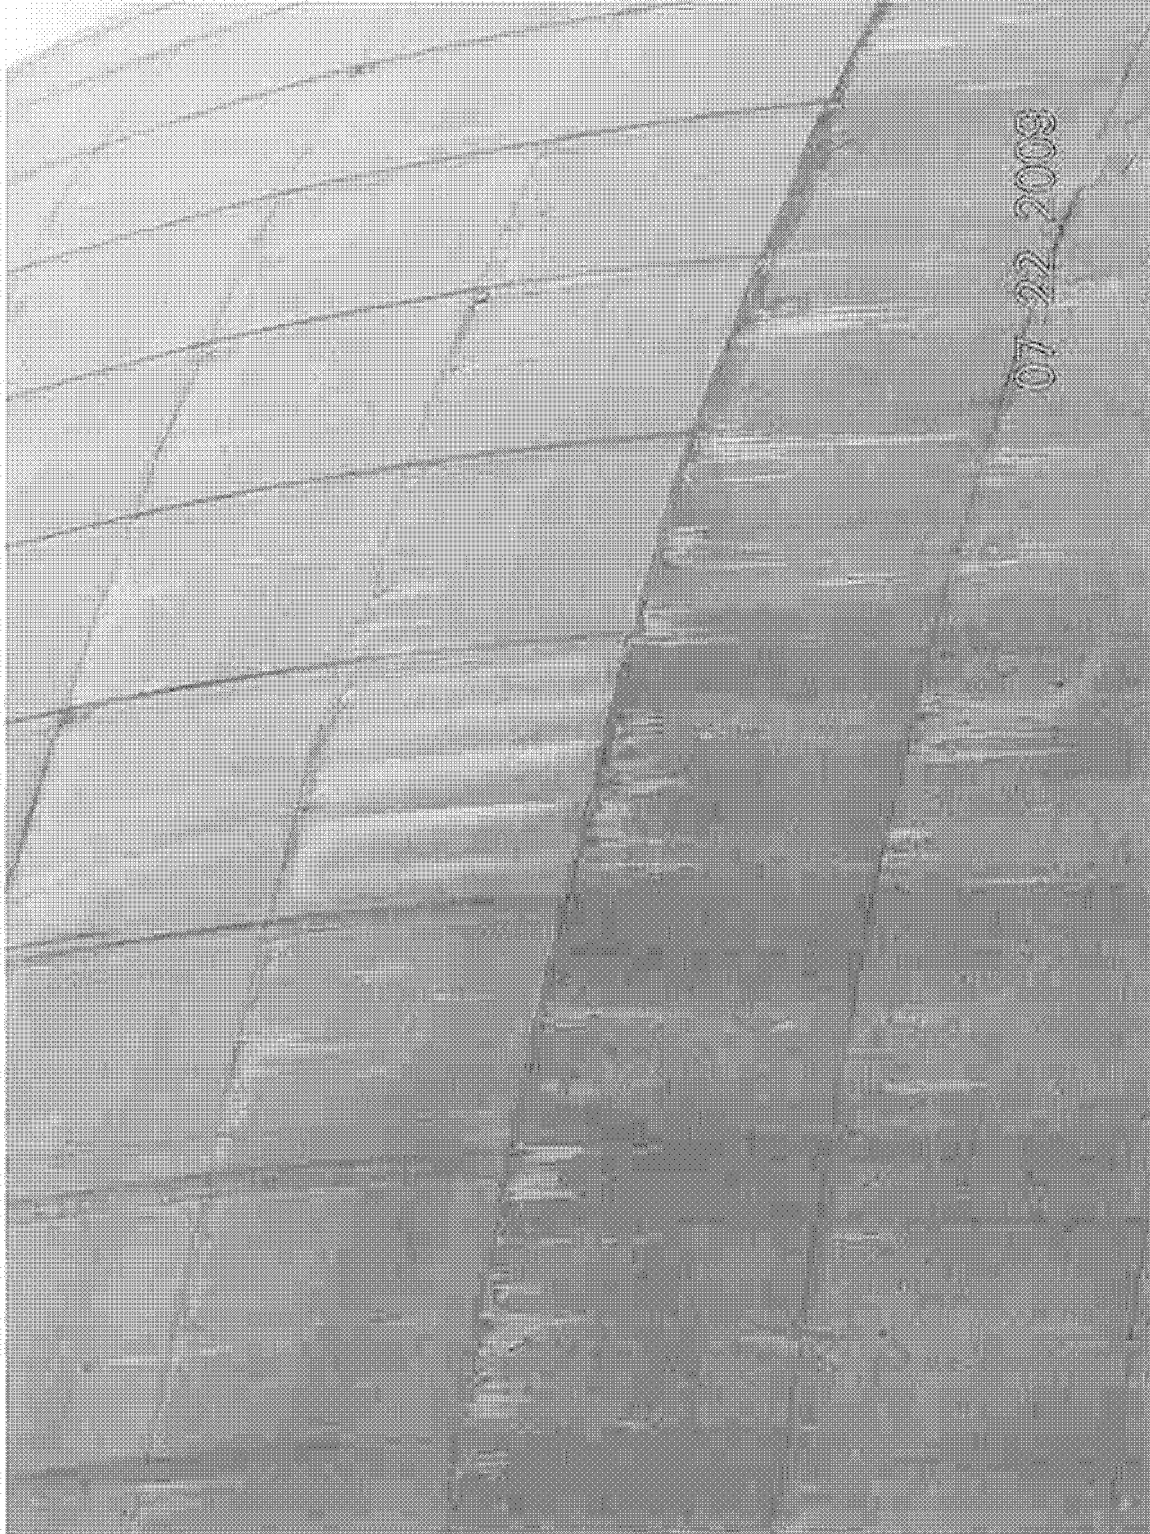
U3-037228

No.	Comment	Initials
1	Cracking and spalling with exposed aggregate at cylinder to dome interface.	PMB
2	Panel at spring line bordering zone 4 is wavy and appears to stick out. See photo U3-037228.	PMB
3	General inactive leaching consistent throughout containment. See photo U3-037228.	PMB

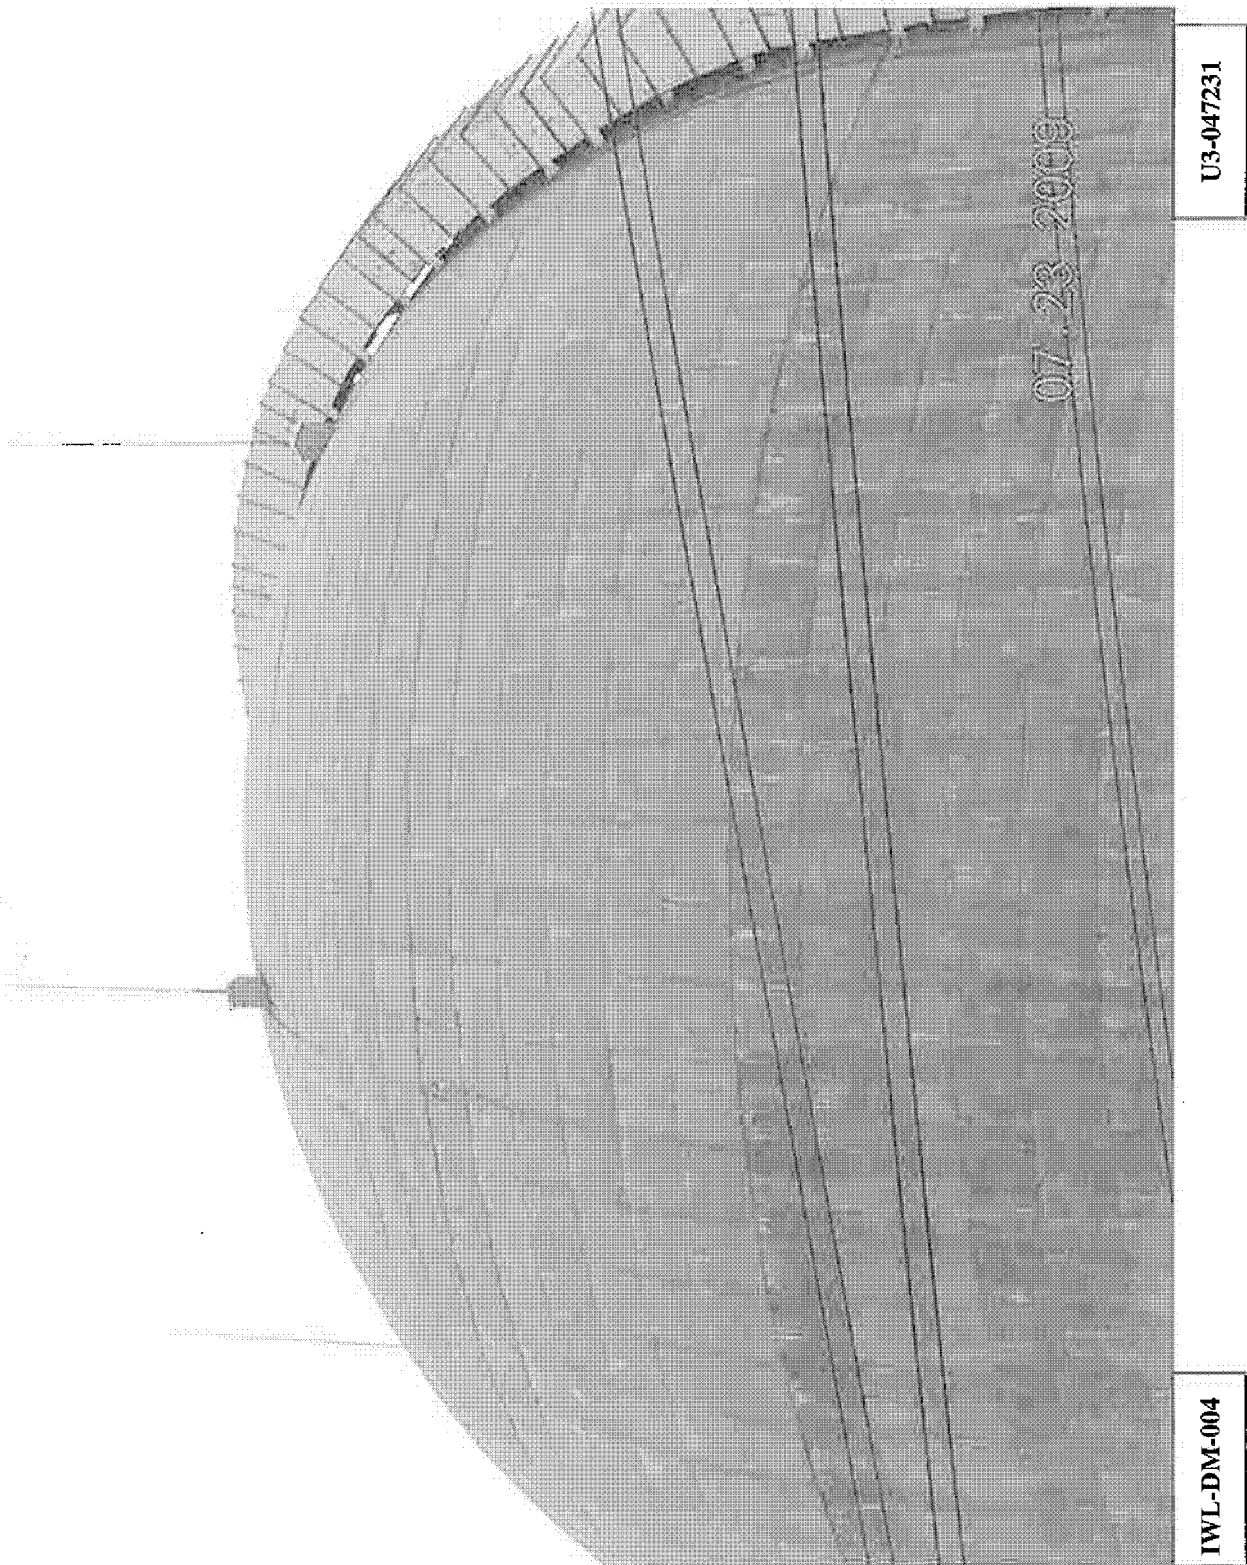
No.	Comment	Initials
1	Vertical spall at form joint with the following dimensions: 1' long x 1" wide x 1" deep (previously identified with no significant change).	PMB
2	Cracking and spalling with exposed aggregate at cylinder to dome interface (previously identified with no significant change).	PMB
3	Rust stains from lightning arresters (previously identified and all lightning arresters have been coated).	PMB
4	General inactive leaching consistent throughout containment. See photo U3-047231.	PMB

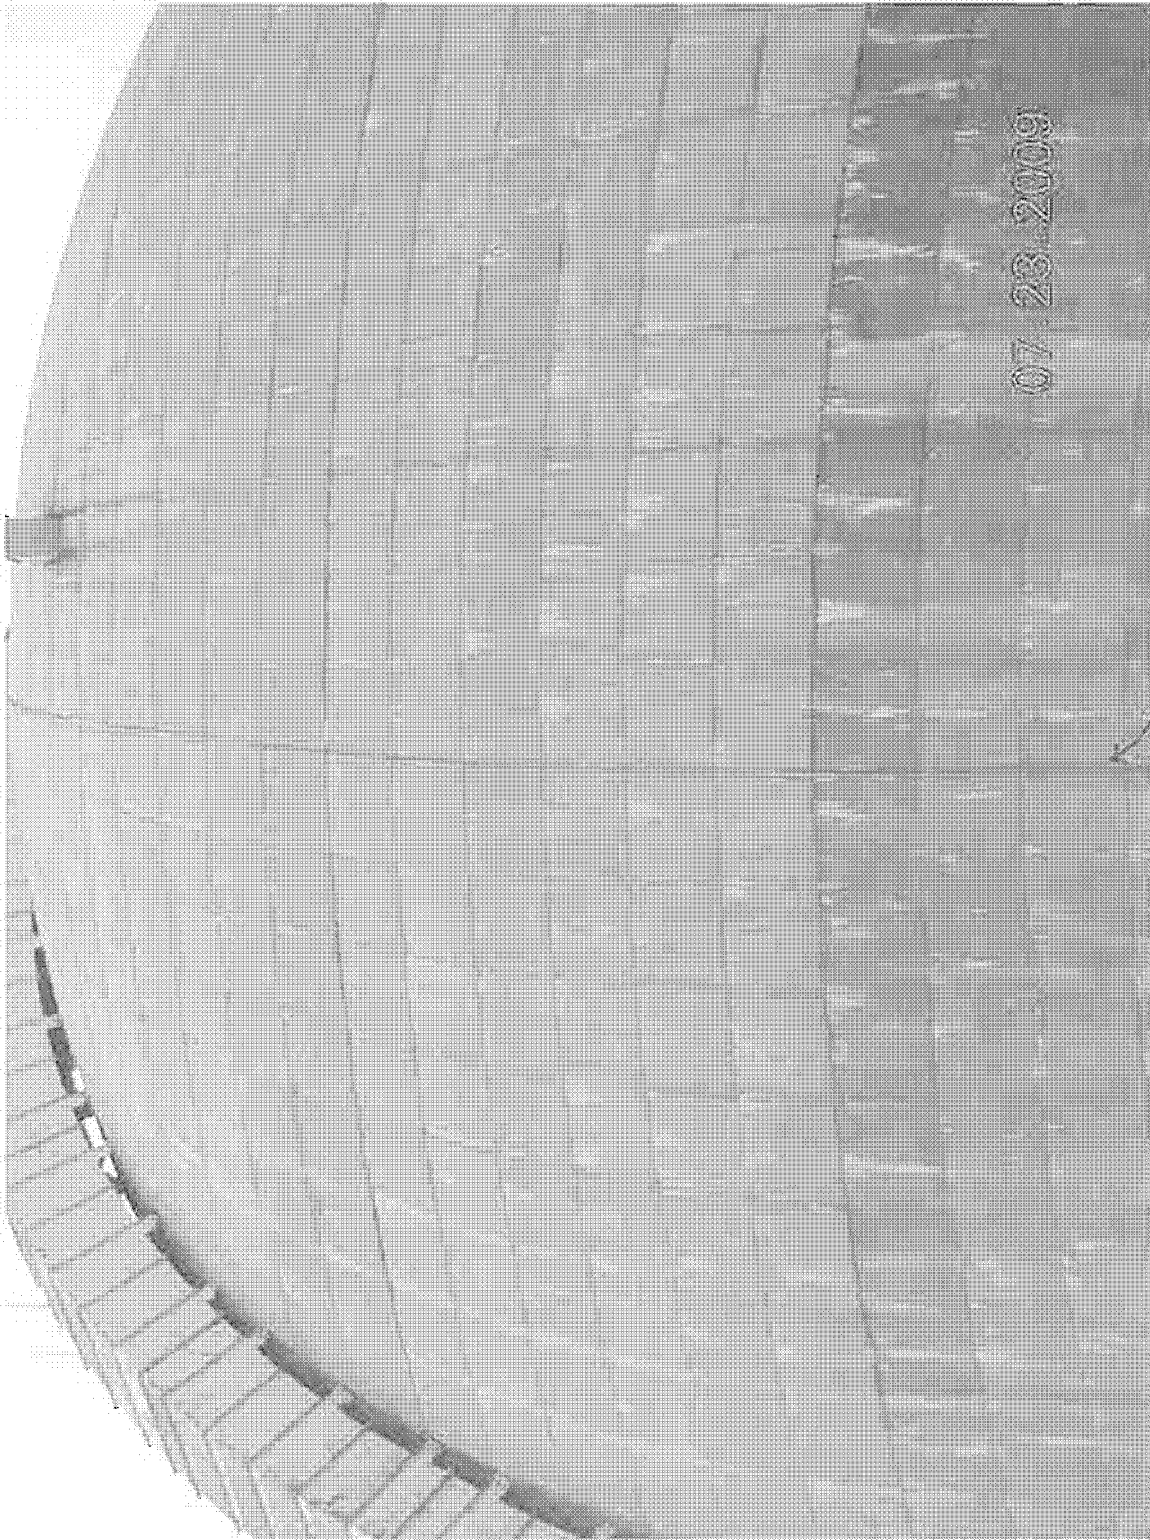
No.	Comment	Initials
1	First two rows of dome: Minor cracking due to shrinkage, pop outs, leaching, scaling and spalling – all minor, non-active and previously identified.	PMB
2	Vertical cracks 5' long and 5' o/c along the first row of the dome. This condition is consistent over the majority of the dome and previously identified with no significant change.	PMB
3	Third and fourth rows of dome: Joint cracking, spalling, staining from duct support steel and vertical cracks 5' long and 5' o/c – all minor and previously identified.	PMB
4	Fifth and sixth rows of dome: Joint cracking, vertical cracks, minor spalling, bugholes and staining from lightning arrester – all minor and previously identified.	PMB
5	Seventh and eighth rows of dome: Joint cracking and spall approximately 5' long adjacent to duct support, spall areas less than 5" in size, pitting/abrasion, and bugholes – all minor and previously identified.	PMB

6	Ninth and tenth rows of dome: Leaching, pattern cracking, joint spalls, cracking, and staining – all minor and previously identified.	PMB
7	Eleventh thru thirteenth rows of dome: Small spall areas, pop outs adjacent to duct and rust staining – all minor and previously identified.	PMB
8	Steel cable rusting along a vertical joint (previously identified). Cable removed during coating of vent duct.	PMB
9	Six 1/2" diameter pipe inserts sticking out approximately 1" from containment with minimal surface corrosion. All six were coated in 2009 to protect against future corrosion. Before and after photos can be found in Attachment 8.5.	PMB
10	See photo U3-057231 for general view of dome in zone 5.	PMB

STEEL CABLE REMOVED
