**Summary of Earthquake Information for the North Anna Nuclear Power Plant**  
**(Last Update: September 9, 2011)**

## **North Anna Independent Spent Fuel Storage Installation Response to Earthquake**

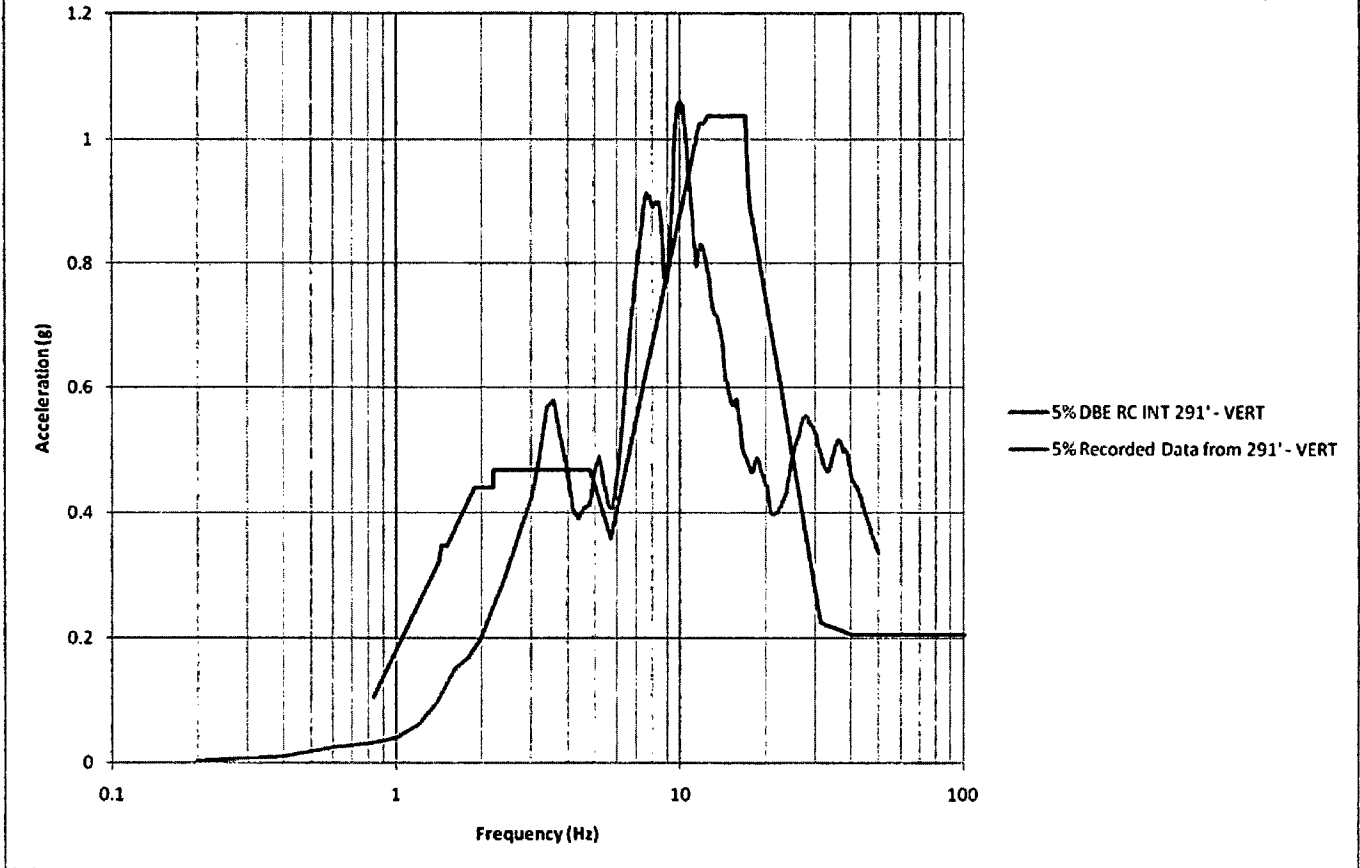
### Kinematics Data (at 5%) for Containment Elevation 291' - Vertical Direction

- Preliminary data provided by the licensee indicate that the DBEs at different elevation levels have been exceeded in both the horizontal and vertical directions at different frequencies (see attached sample figure).
- The licensee's inspections have not identified any safety related equipment which failed during the event except for the 2H EDG. When it became evident that the DBE had been exceeded, the licensee declared all the safety related equipment in both units inoperable and took action to place the units in cold shutdown.
- Preliminary data from the licensee's investigation with regards to the 2H EDG failure indicates that a cooling water system gasket may have been installed incorrectly.

The figure above, as submitted by the licensee, compares the observed ground motion in the vertical direction to the exceeded design motion at various frequencies. The blue curve is from the observed readings and the purple curve is the design spectrum at the same elevation level.
