SUBJECT: **R.E. Ginna Nuclear Power Plant**
Docket No. 50-244

Response to Request for Additional Information RE: The 2011 Steam Generator Tube Inspections – R.E. Ginna Nuclear Power Plant

**Response to Request for Additional Information Regarding the 2011 Steam
Generator Inspection Report**

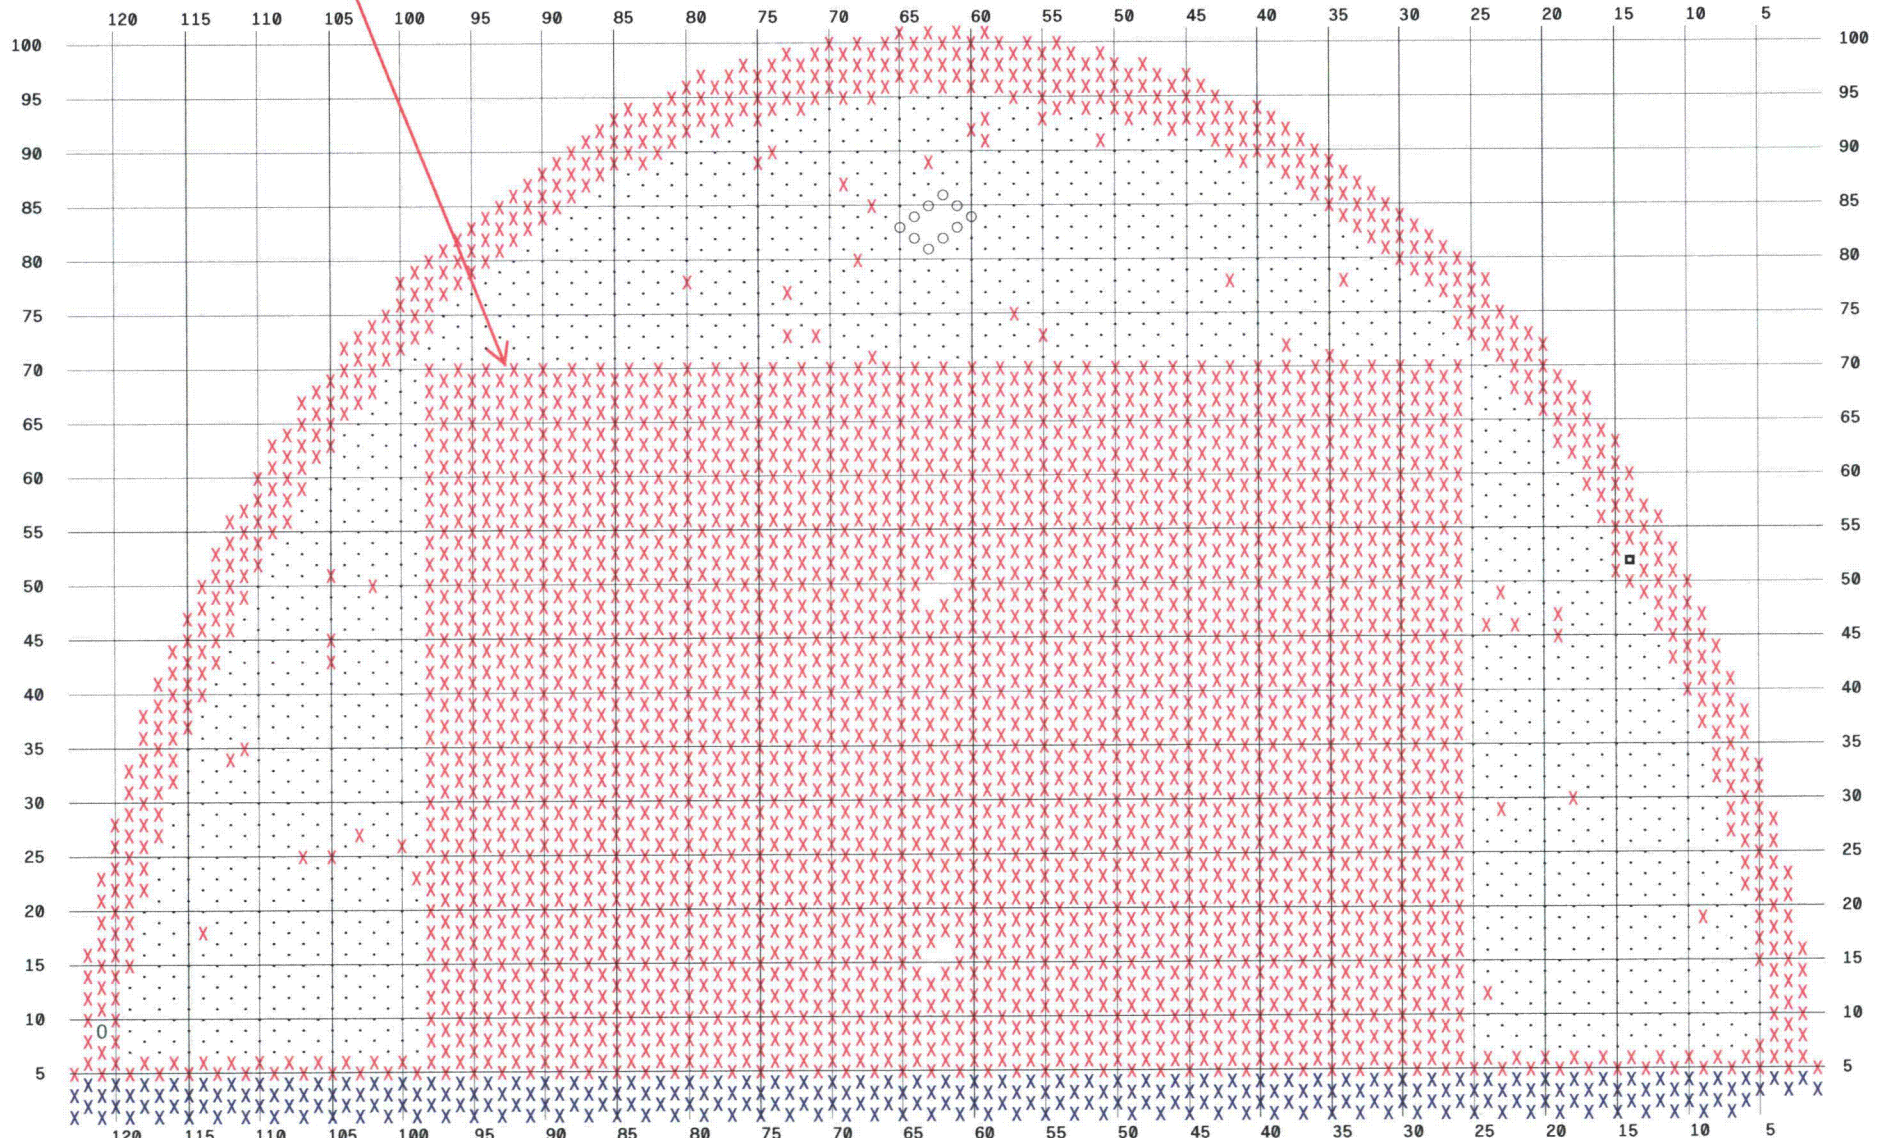
Central Box Area

The tubesheet map, Attachment 3, shows the examination area. The central box area is a large portion of the examination area, and was selected to bound the denting extent of condition.
