**From:** Khanna, Meena *in/ra*  
**Sent:** Wednesday, September 14, 2011 3:28 PM  
**To:** Boyle, Patrick -  
**Cc:** Martin, Robert; Kulesa, Gloria  
**Subject:** FW: One Pager on North Anna Earthquake Issue - Updated Sept. 9, 2011  
**Attachments:** One Pager on North Anna Earthquake Issue updated 9-9-2011 word doc.docx

**Summary of Earthquake Information for the North Anna Nuclear Power Plant**  
**(Last Update: September 9, 2011)**

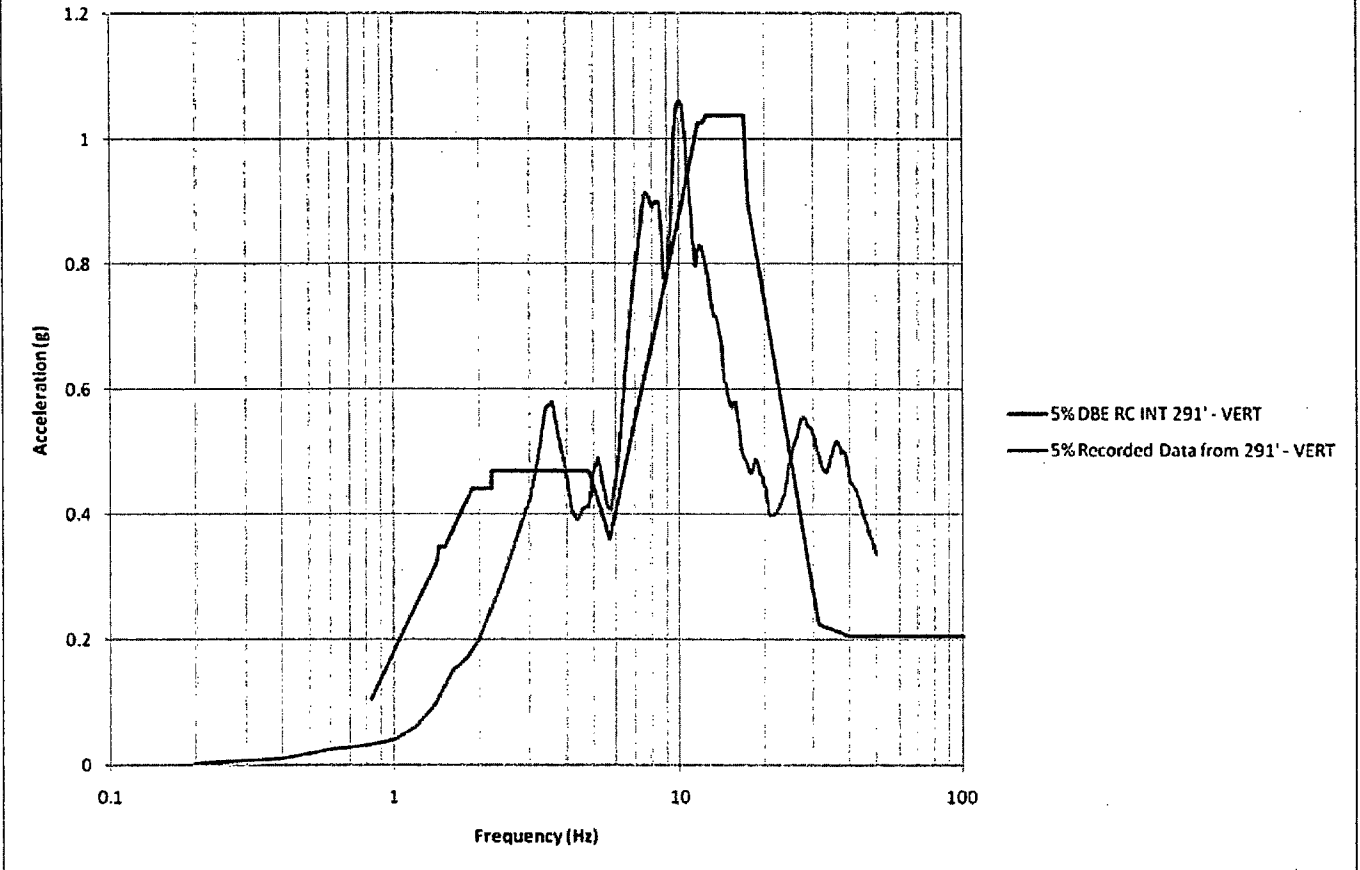
### Kinematics Data (at 5%) for Containment Elevation 291' - Vertical Direction

- Preliminary data provided by the licensee indicate that the DBEs at different elevation levels have been exceeded in both the horizontal and vertical directions at different frequencies (see attached sample figure).
- The licensee's inspections have not identified any safety related equipment which failed during the event except for the 2H EDG. When it became evident that the DBE had been exceeded, the licensee declared all the safety related equipment in both units inoperable and took action to place the units in cold shutdown.
- Preliminary data from the licensee's investigation with regards to the 2H EDG failure indicates that a cooling water system gasket may have been installed incorrectly.

The figure above, as submitted by the licensee, compares the observed ground motion in the vertical direction to the exceeded design motion at various frequencies. The blue curve is from the observed readings and the purple curve is the design spectrum at the same elevation level.
