UNITED STATES
NUCLEAR REGULATORY COMMISSION
REGION IV
1600 EAST LAMAR BLVD
ARLINGTON, TEXAS 76011-4511

March 12, 2012

Subject: FORT CALHOUN STATION – NRC SPECIAL INSPECTION REPORT
05000285/2011014; FINDING OF PRELIMINARY HIGH SAFETY
SIGNIFICANCE

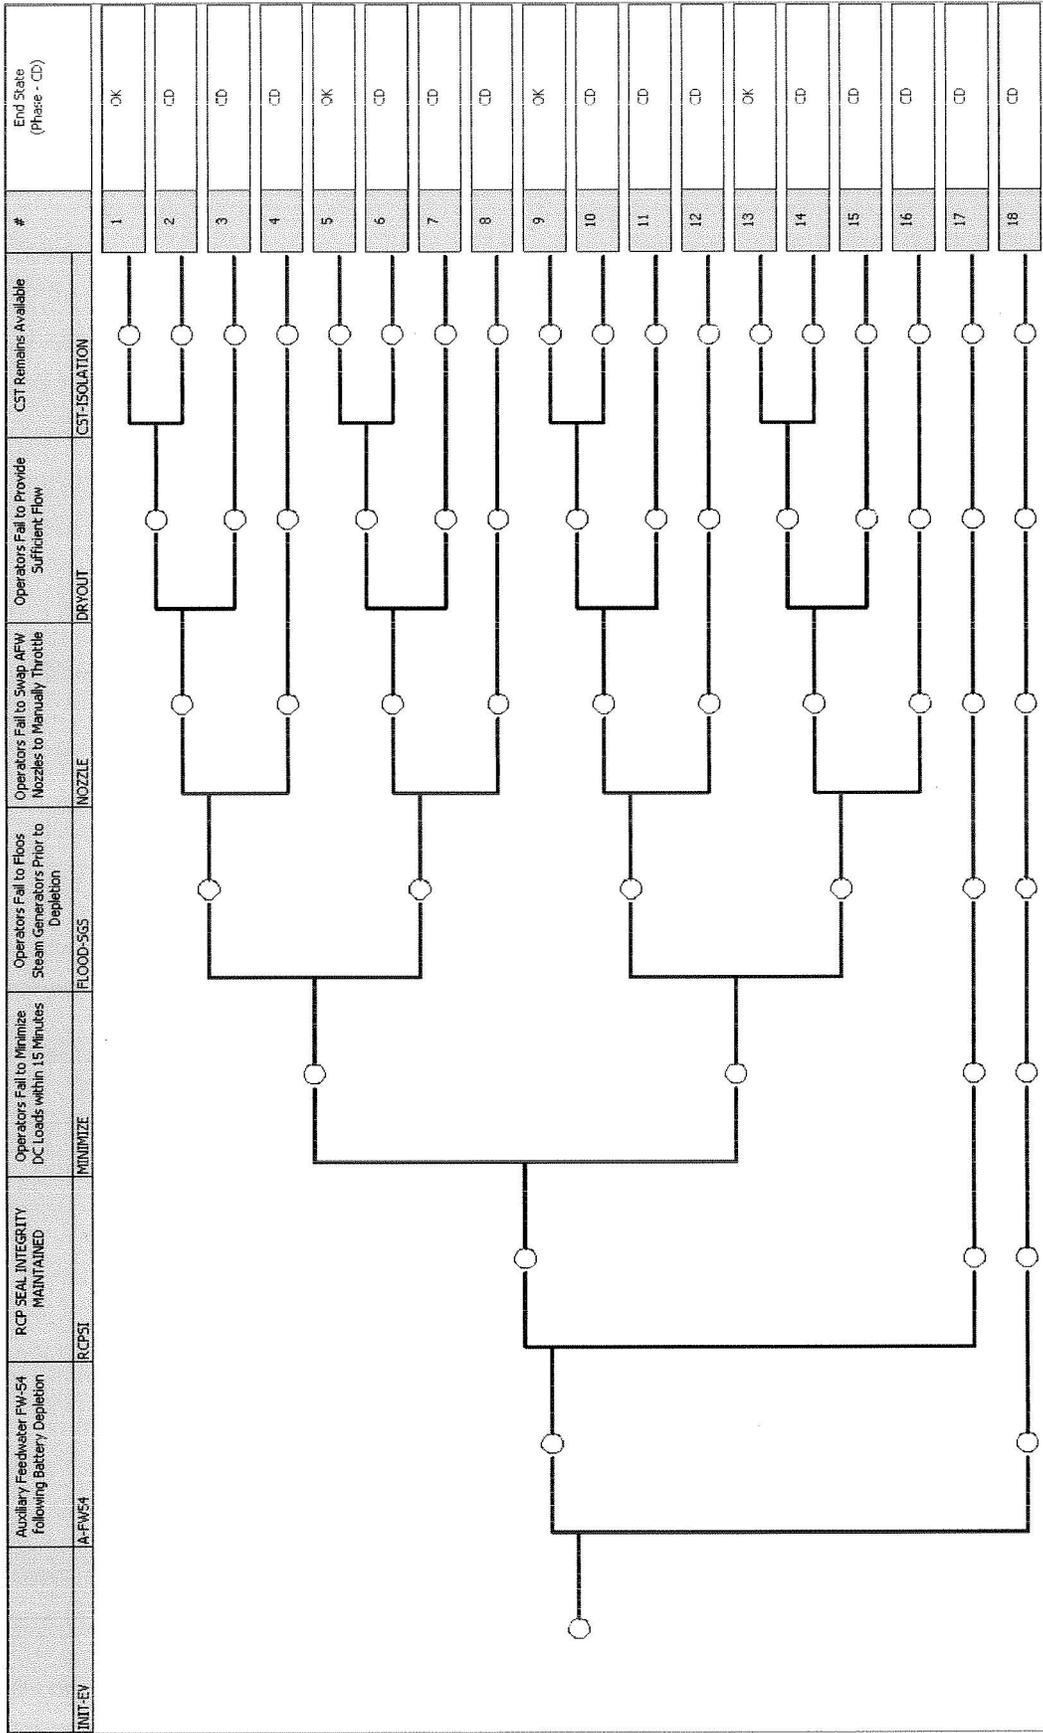
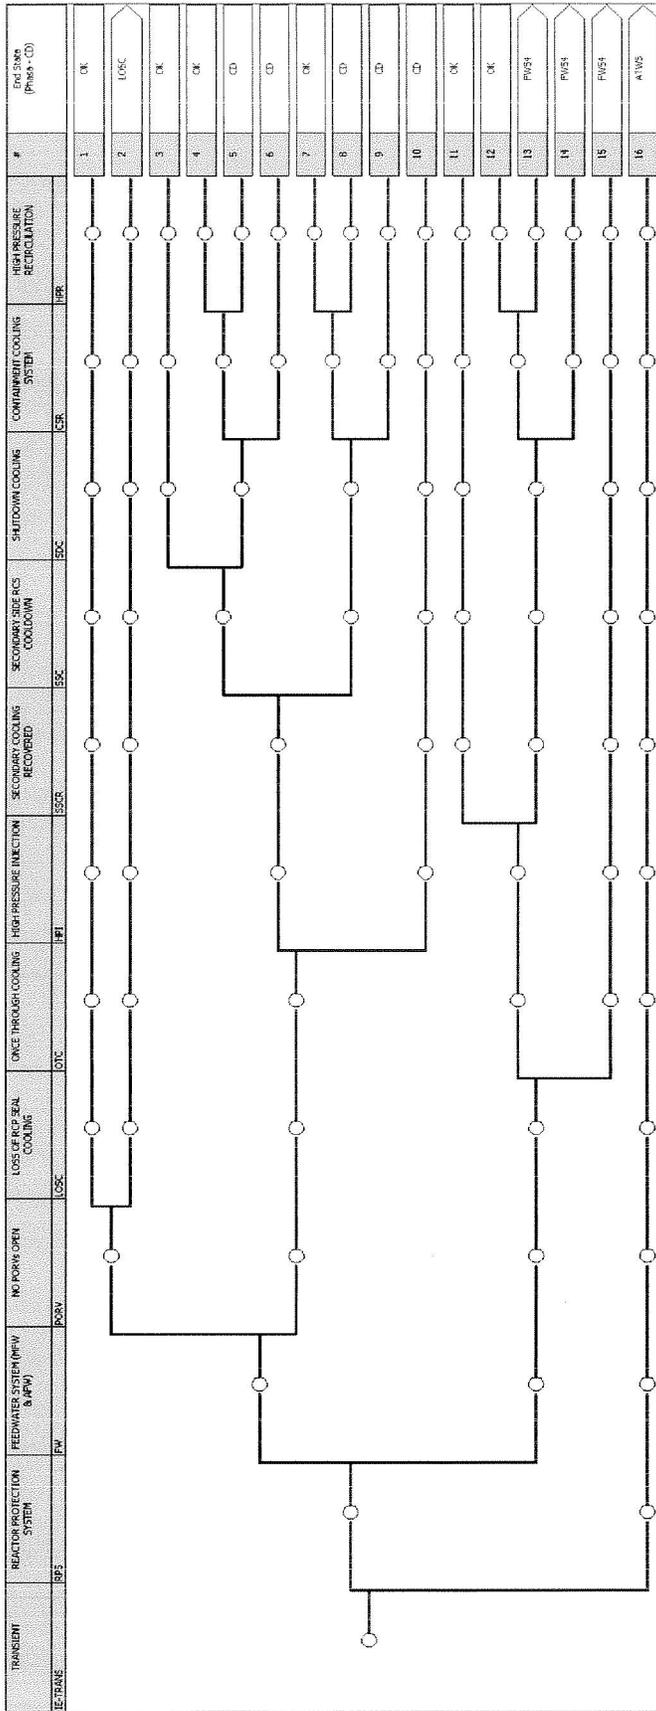
The analyst modified the SPAR model to include the attached Event Tree, "FW54 Cooling Following Battery Depletion." The analyst created a transfer to this tree from Event Tree, "Fort Calhoun PWR G Transient," for Sequences 13, 14, and 15.

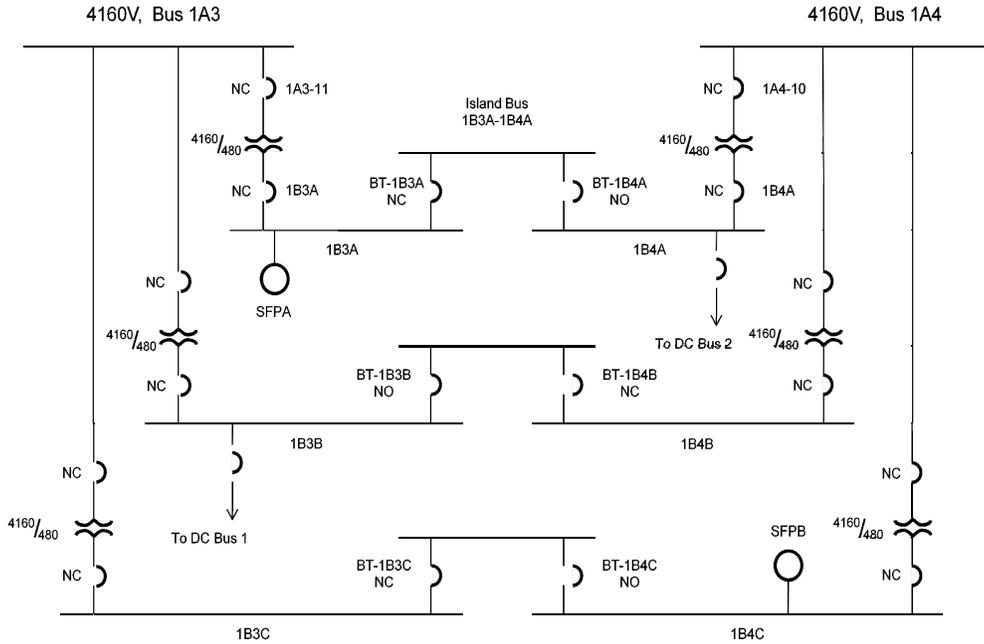
Figure 1: Simplified 480 Vac Distribution Diagram

The team reviewed modification EC 33464, "Replace AK-50 480 V Main and Bus-Tie Breakers With Molded Case Type or Equivalent," Revision 0, which replaced 12 General Electric AK-50 low voltage power circuit breakers with Nuclear Logistics Incorporated/Square-D Masterpact circuit breaker/cradle assemblies and digital trip devices in November 2009. The modification replaced six feeder circuit breakers and six bus-tie breakers. These breakers and their relation to the Fort Calhoun Station electrical distribution system are shown in Figure 1 of Attachment 4.
