Seismic Walkdown Checklist (SWC)

Equipment ID No. H21P081 Equip. Class¹ 18, Instrument Racks

Equipment Description Div 2 EECS Trip Unit Instrument Rack

Location: Bldg. AB Floor El. 659'-6" Room, Area A-34, Col. F-11

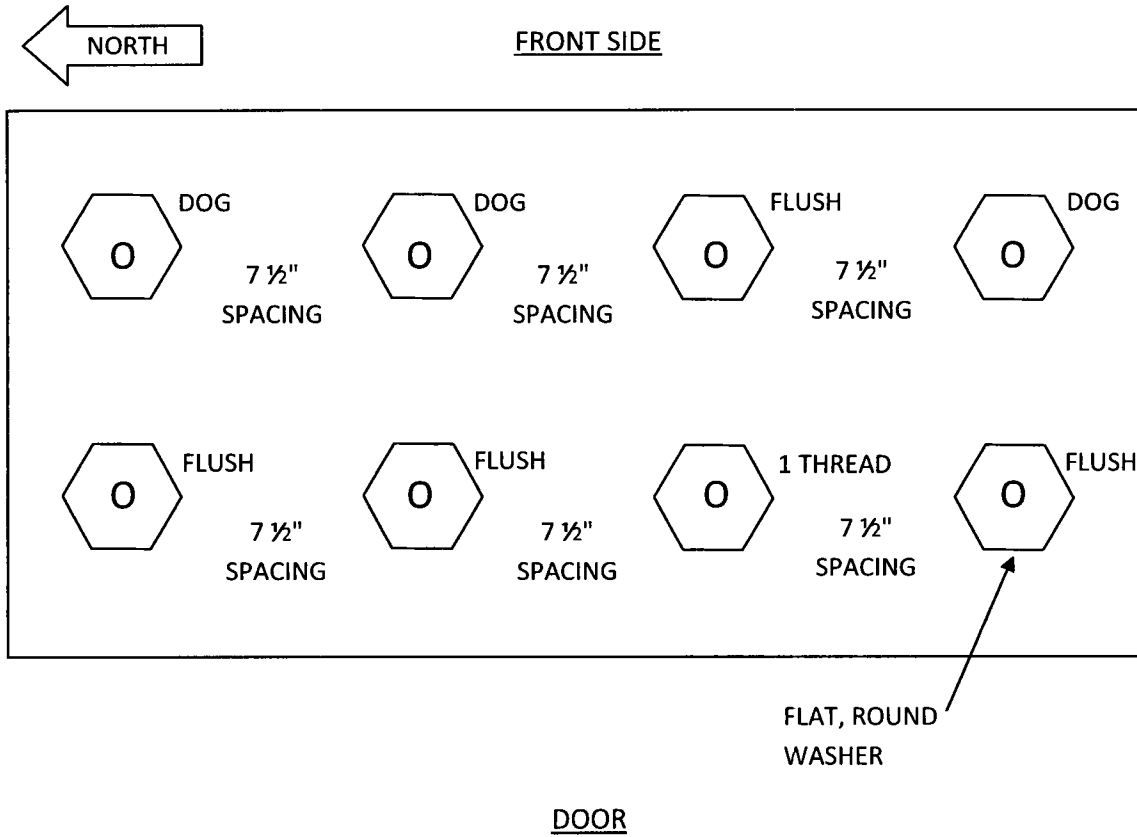
1. Is the anchorage configuration verification required (i.e., is the item one of the 50% of SWEL items requiring such verification)? Y N
2. Is the anchorage free of bent, broken, missing or loose hardware? Y N U N/A
There are no Bent, Broken, Missing or loose bolts. However, only one anchor bolt has full thread engagement per Fermi Spec. 3071-226, Rev. K, Section 3.3.5.4(b). See attached "Hand sketch". Card 12-27702 was initiated to resolve this matter.

6. Based on the above anchorage evaluations, is the anchorage free of potentially adverse seismic conditions? Y N U
All but the bottom three cabinet-to cabinet bolts in the northeast corner of H21P081 are viewable from the H21P083 side (see photo DSC01157). All anchor bolts were visible and only one anchor bolt had full thread engagement (at least one thread exposed from face of nut) per Spec. 3071-226. CARD 12-27702 was initiated.

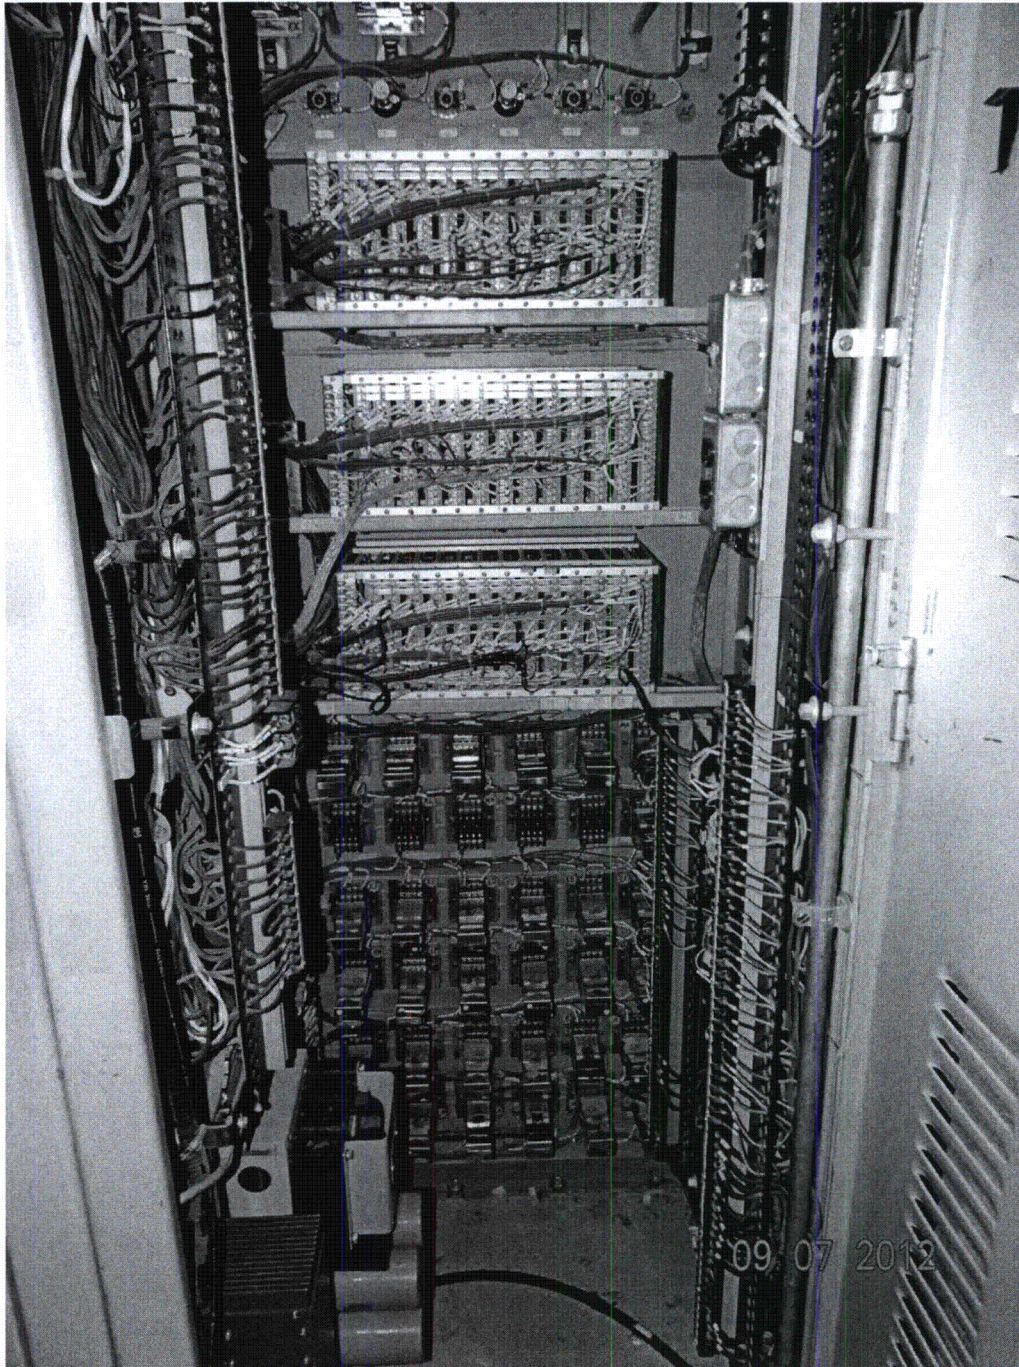
(DSC01157)

11. Have you looked for and found no other seismic conditions that could adversely affect the safety functions of the equipment? Y N U
Mounting of internal components, doors, etc. structurally adequate. All anchor bolts, except bolt in southeast corner, have beveled washers. Bolt in southeast corner has a flat, round washer. Per 1969 AISC specification, a beveled washer is required. Initiated CARD 12-27702 to resolve matter. (see photo DSC01157, 01176 & 01177)

"Inside Cabinet Components"

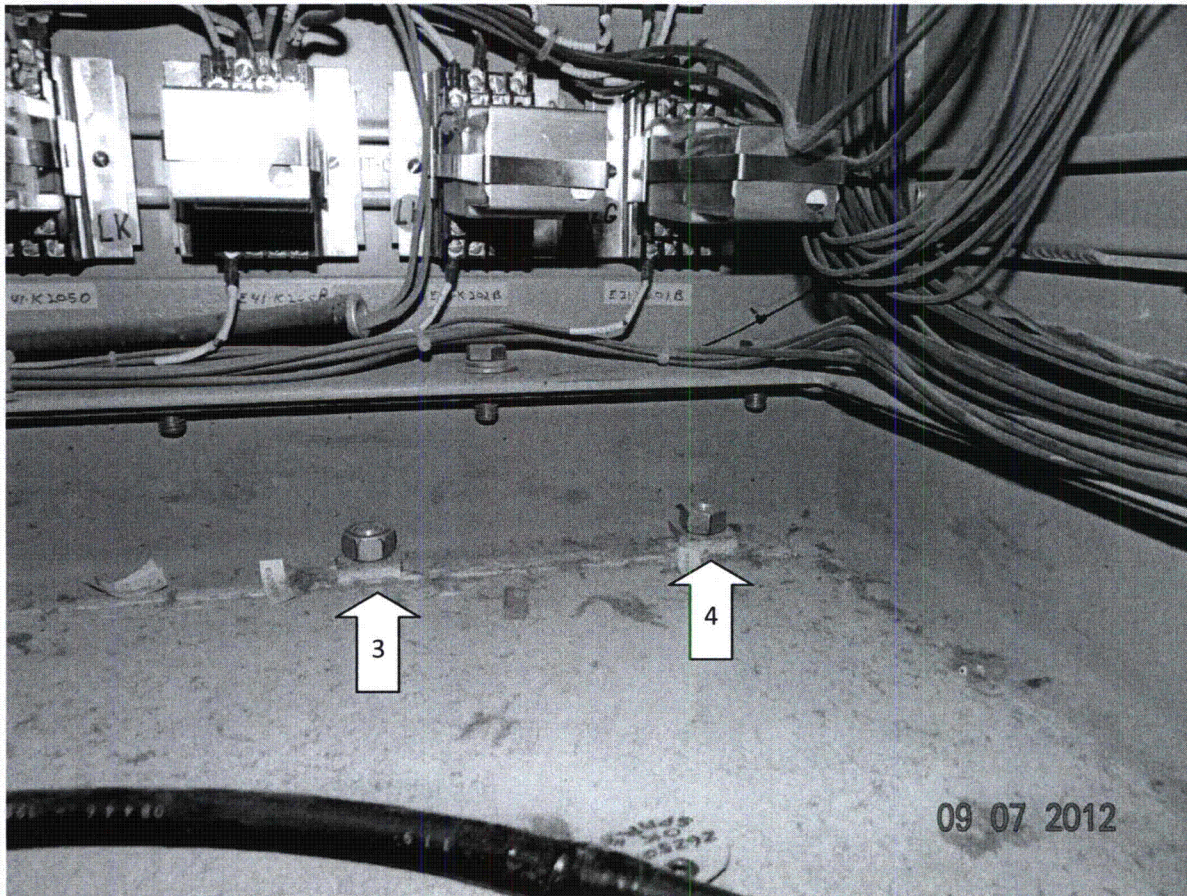
(DSC01158)

5. Is the anchorage configuration consistent with plant documentation? Y N U N/A
(Note: This question only applies if the item is one of the 50% for which anchorage configuration verification is required.)
Anchorage configuration is consistent with the following documents: I-2525-25, Rev. E (No postings). Calc. No. DC-1073, Rev. A (No postings). Calc. No. DC-5634 Vol. I, Rev. 0 (Two postings not applicable). TDEC 3526 "Seismic Qualification" Dated 12/11/1978 (No postings) and Calc. No. DC-5157 Vol. I, Rev. C (Five postings not applicable). (see photos DSC01158, 01159, 01162 & 01164)

"Bolt Configuration"

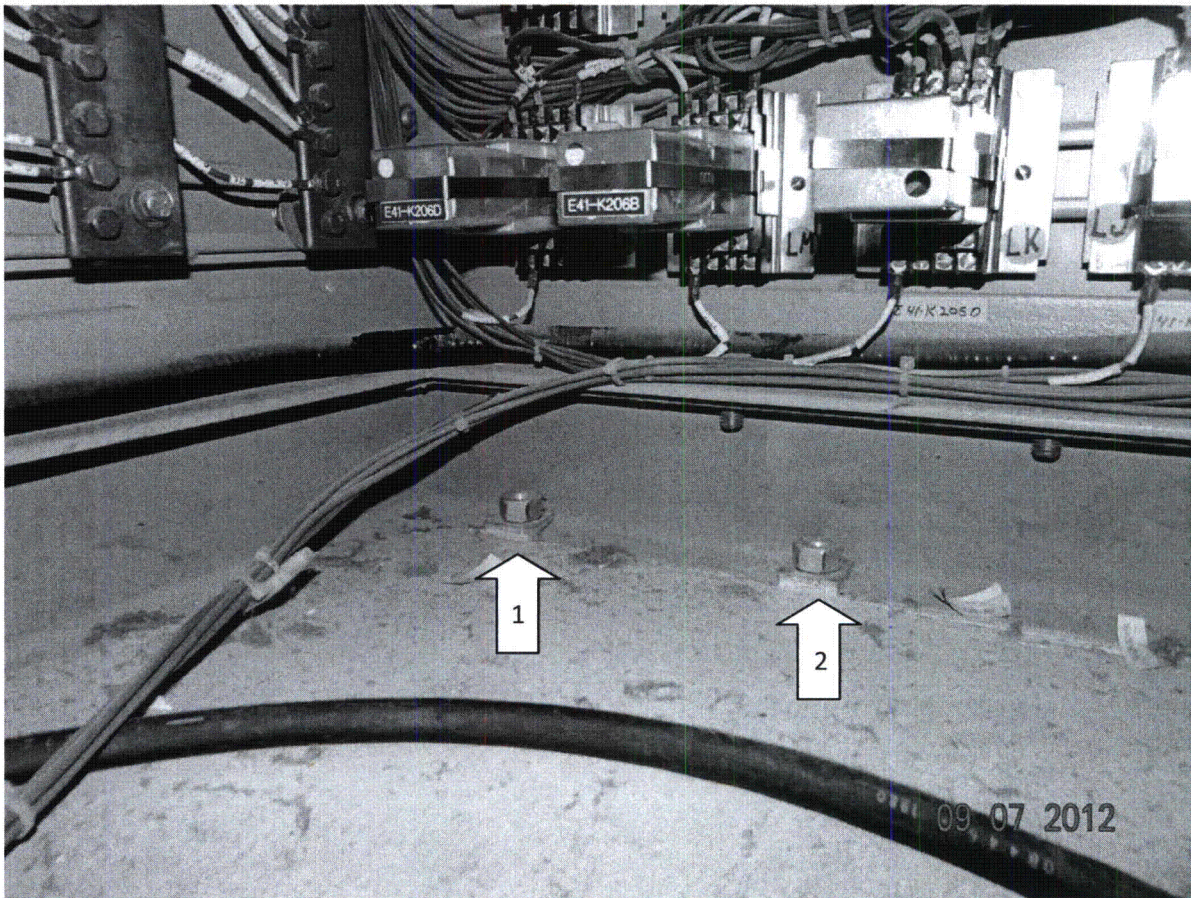
(DSC01159)

"Bolt Configuration"

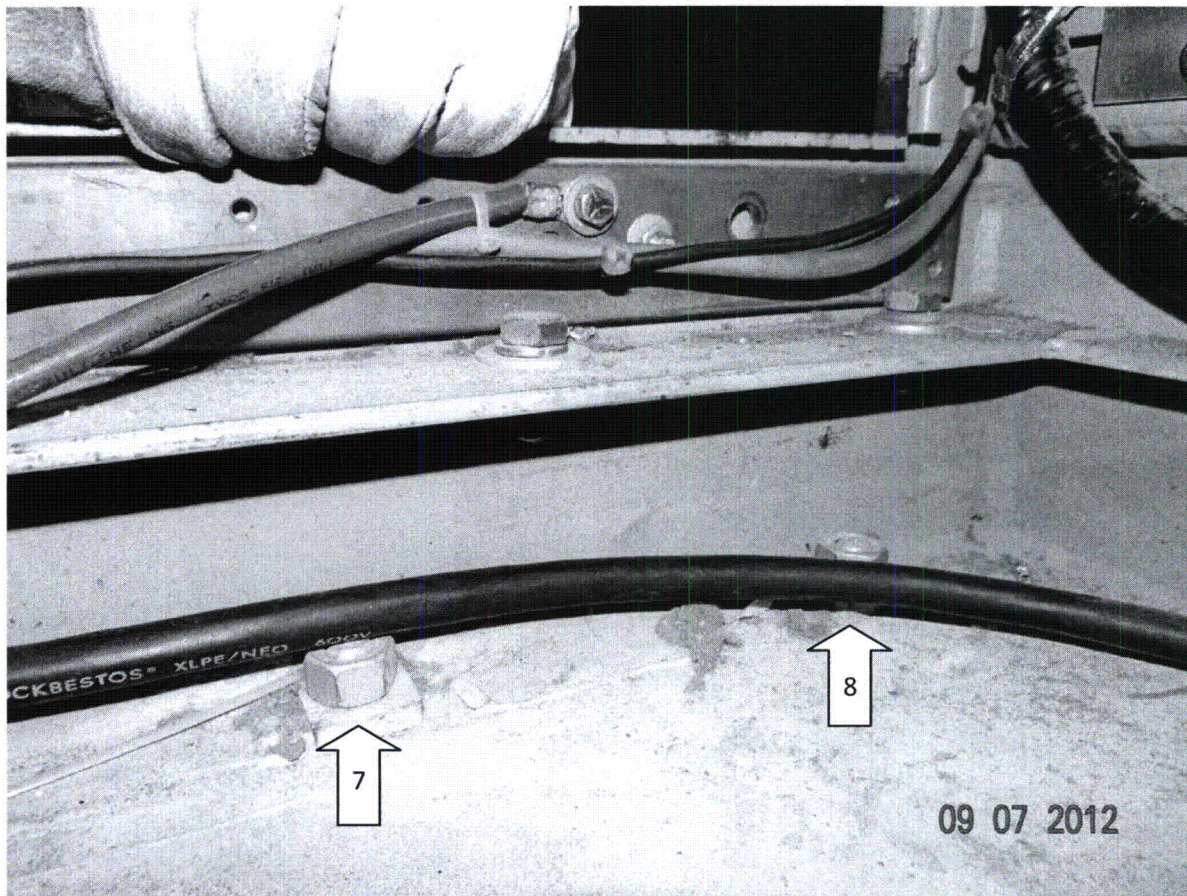
(DSC01162)

"Bolt Configuration near panel door"

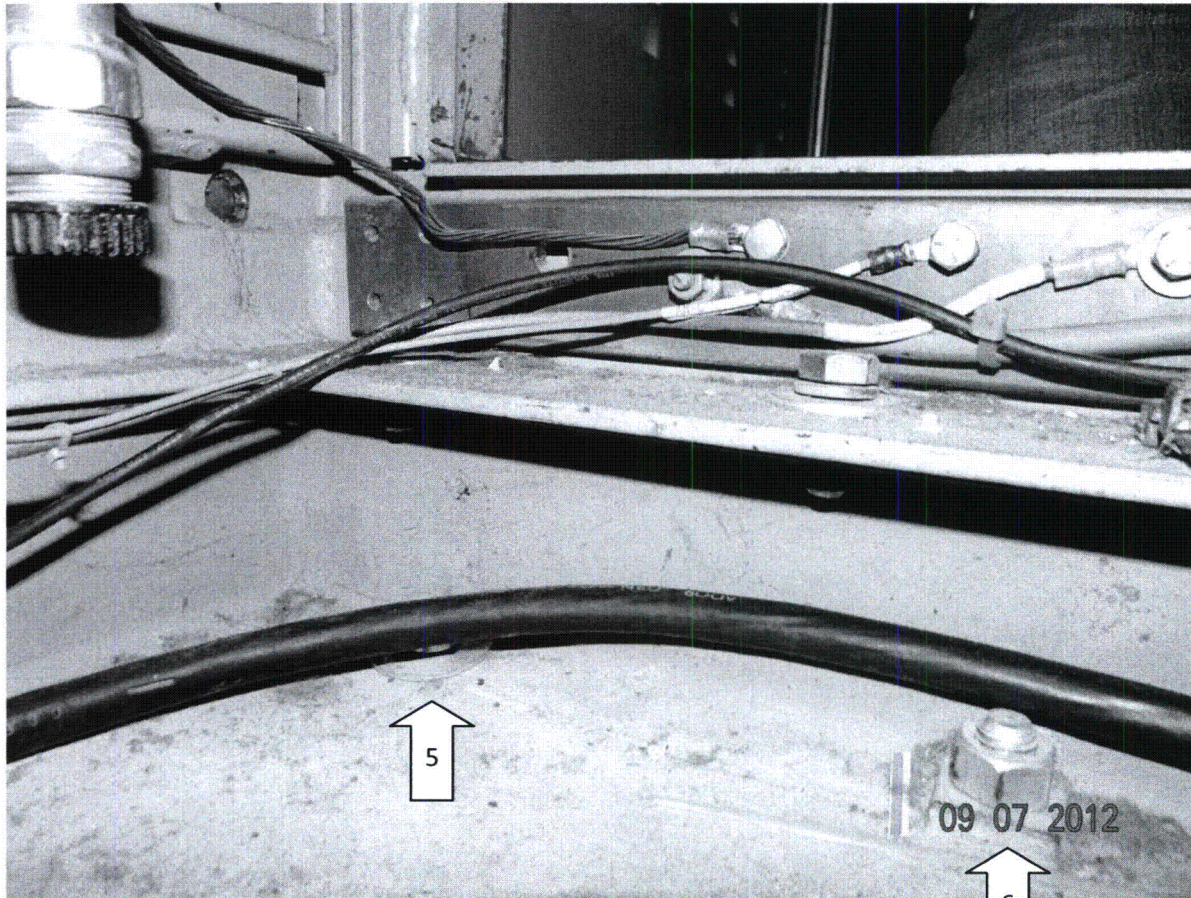
(DSC01164)

"Bolt Configuration near panel door"

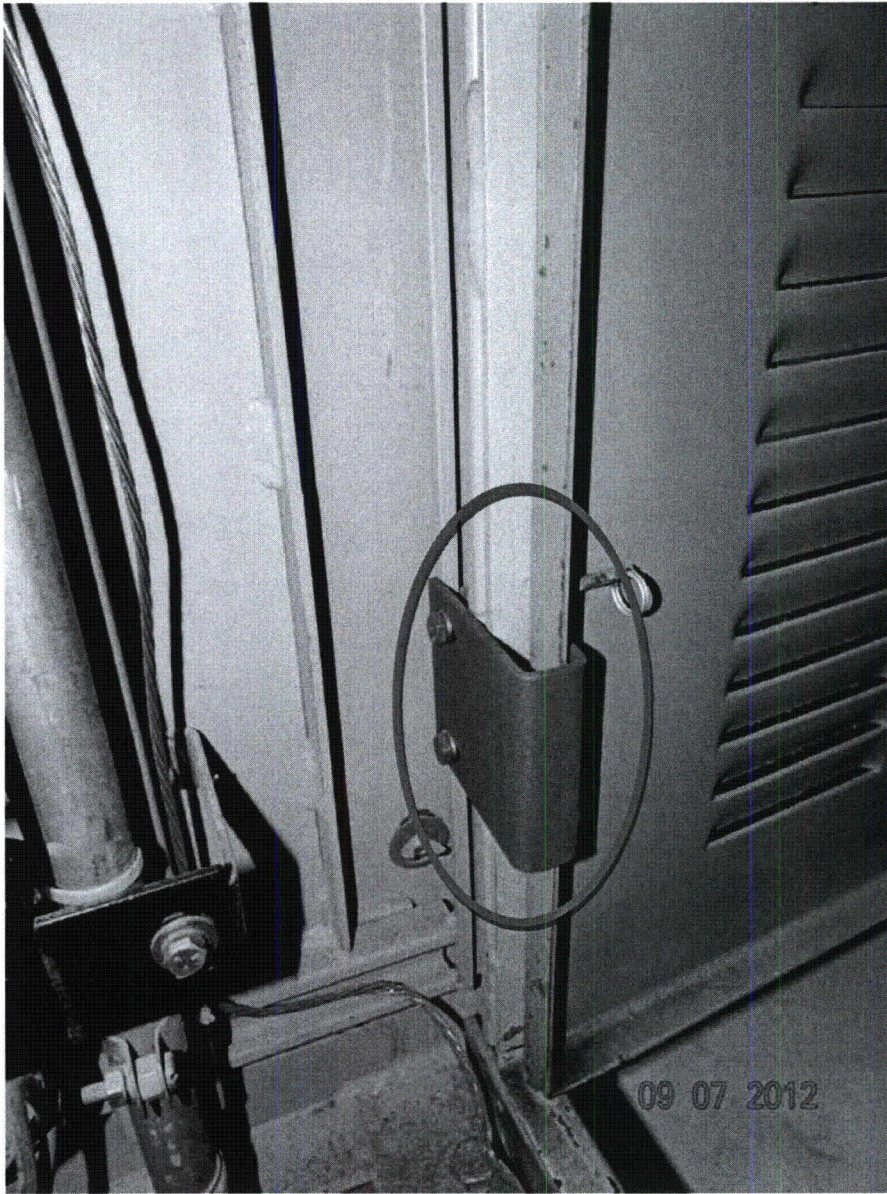
(DSC01176)

"Door hinge w/washer & lock-nut"

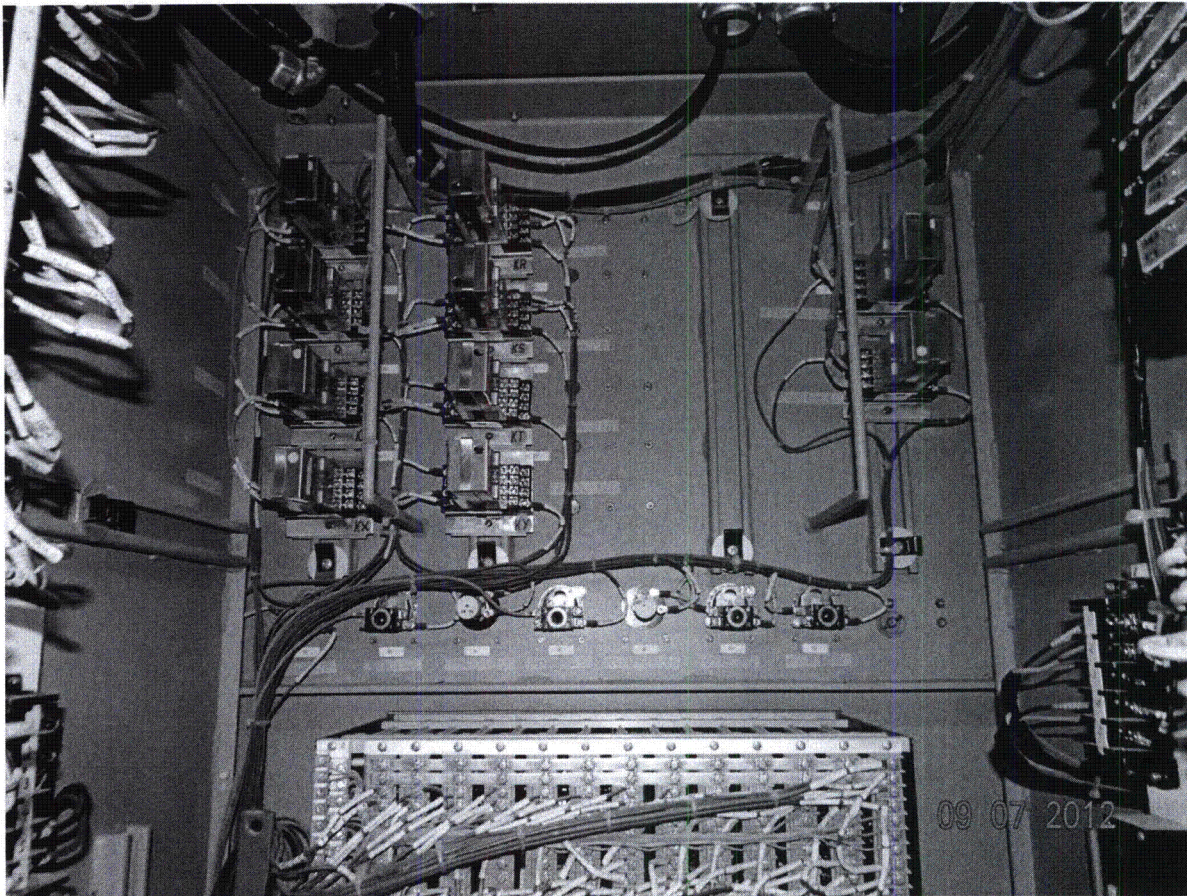
(DSC01177)

3. Is the anchorage free of corrosion that is more than mild surface oxidation? Y N U N/A
No corrosion or oxidation inside the cabinet. (see photo DSC01177)

"Flexible Wires & Internal Components"

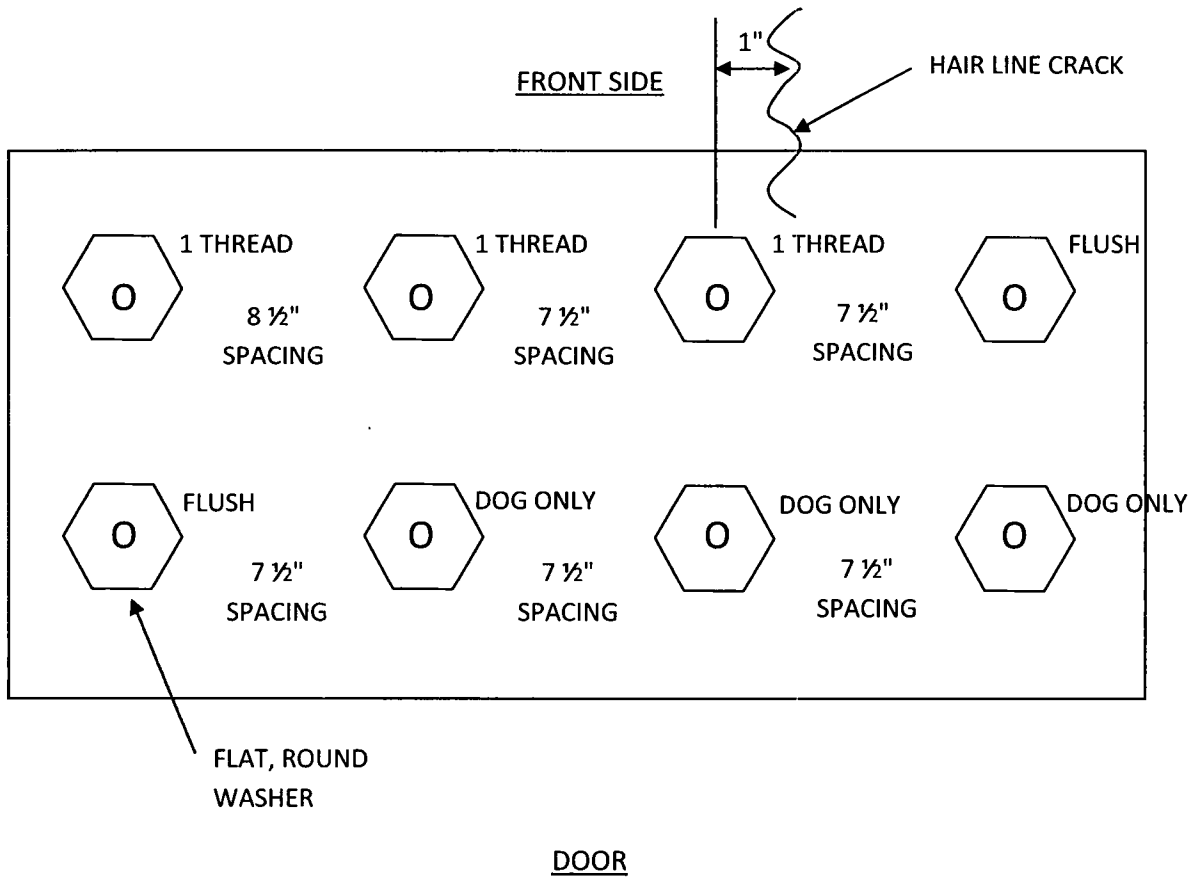
1. Is the anchorage configuration verification required (i.e., is the item one of the 50% of SWEL items requiring such verification)? Y N
2. Is the anchorage free of bent, broken, missing or loose hardware? Y N U N/A
No Broken, Missing or loose bolts. Thread engagement on five anchor bolts is less than one thread exposed from face of nut per Fermi Spec. 3071-226, Rev. K, Section 3.3.5.4(b). See attached "Hand sketch". Card 12-27702 was initiated to resolve this matter.

6. Based on the above anchorage evaluations, is the anchorage free of potentially adverse seismic conditions? Y N U
Item (2) - Five anchor bolts do not have full thread engagement per Fermi spec. 3071-226. Anchor bolt in northwest corner of cabinet has a flat washer instead of a beveled washer. See attached "Hand sketch". (see photo DSC01140). CARD 12-27702 was initiated. Bottom, southwest cabinet to cabinet bolt not visible due to wires in cabinet.

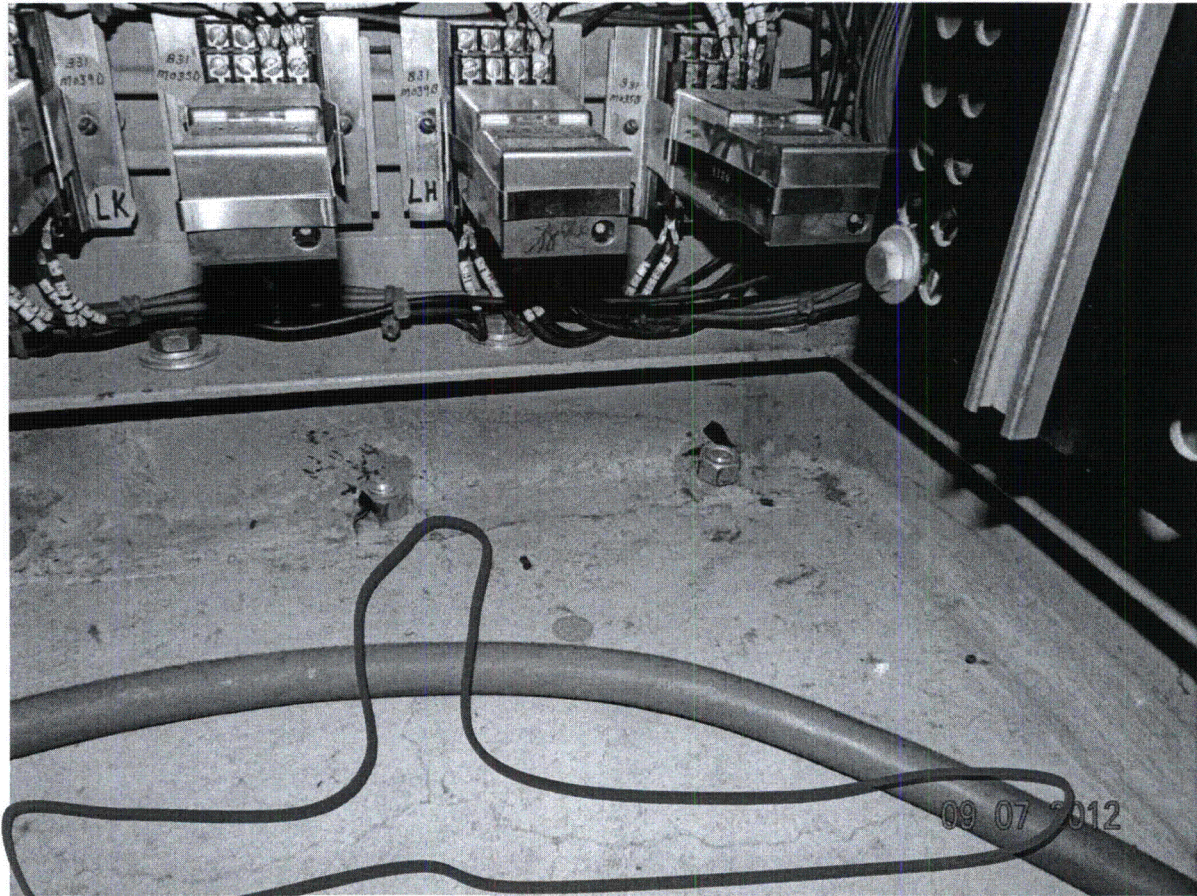
(DSC01136)

3. Is the anchorage free of corrosion that is more than mild surface oxidation? Y N U N/A
No corrosion or oxidation inside the cabinet.
4. Is the anchorage free of visible cracks in the concrete near the anchors? Y N U N/A
Minor hairline cracks visible within 1" of anchor bolt. See attached "Hand sketch". The cracks are "Shrinkage" cracks and not cause for concern (see photo DSC01136).

"Bolt to Concrete Floor"

Hairline Cracks on Floor

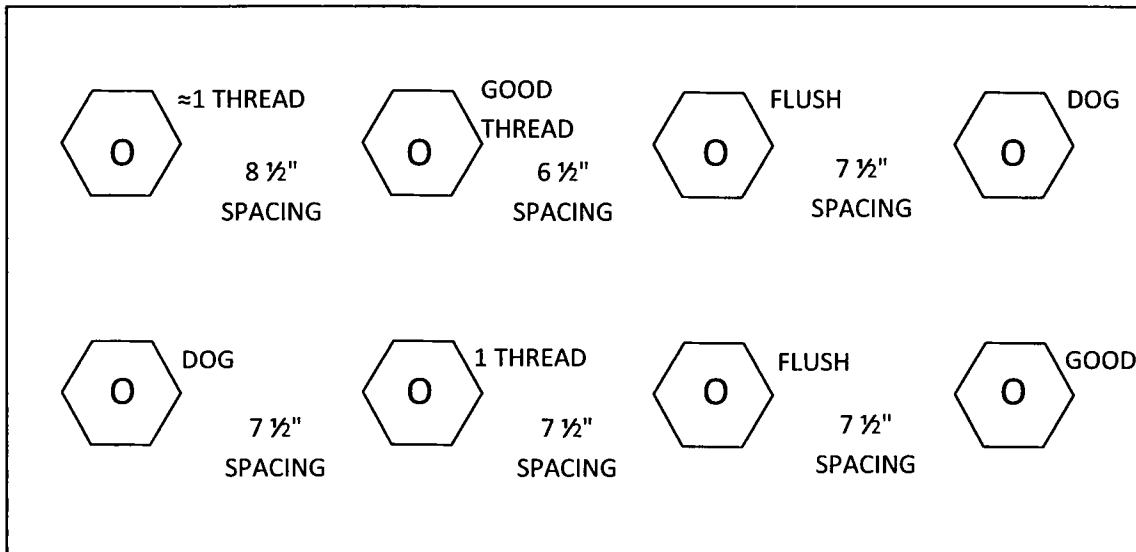
1. Is the anchorage configuration verification required (i.e., is the item one of the 50% of SWEL items requiring such verification)? Y N
2. Is the anchorage free of bent, broken, missing or loose hardware? Y N U N/A
All bolts correct size, acceptable spacing, and appear tight. Thread engagement on five anchor bolts is less than one thread exposed from face of nut per Fermi Spec. 3071-226, Rev. K, Section 3.3.5.4(b). See attached "Hand sketch". Card 12-27702 was initiated to resolve this matter.

6. Based on the above anchorage evaluations, is the anchorage free of potentially adverse seismic conditions? Y N U
Item (2) - Five anchor bolts do not have full thread engagement per Fermi spec. 3071-226. CARD 12-27702 was initiated to resolve this matter.

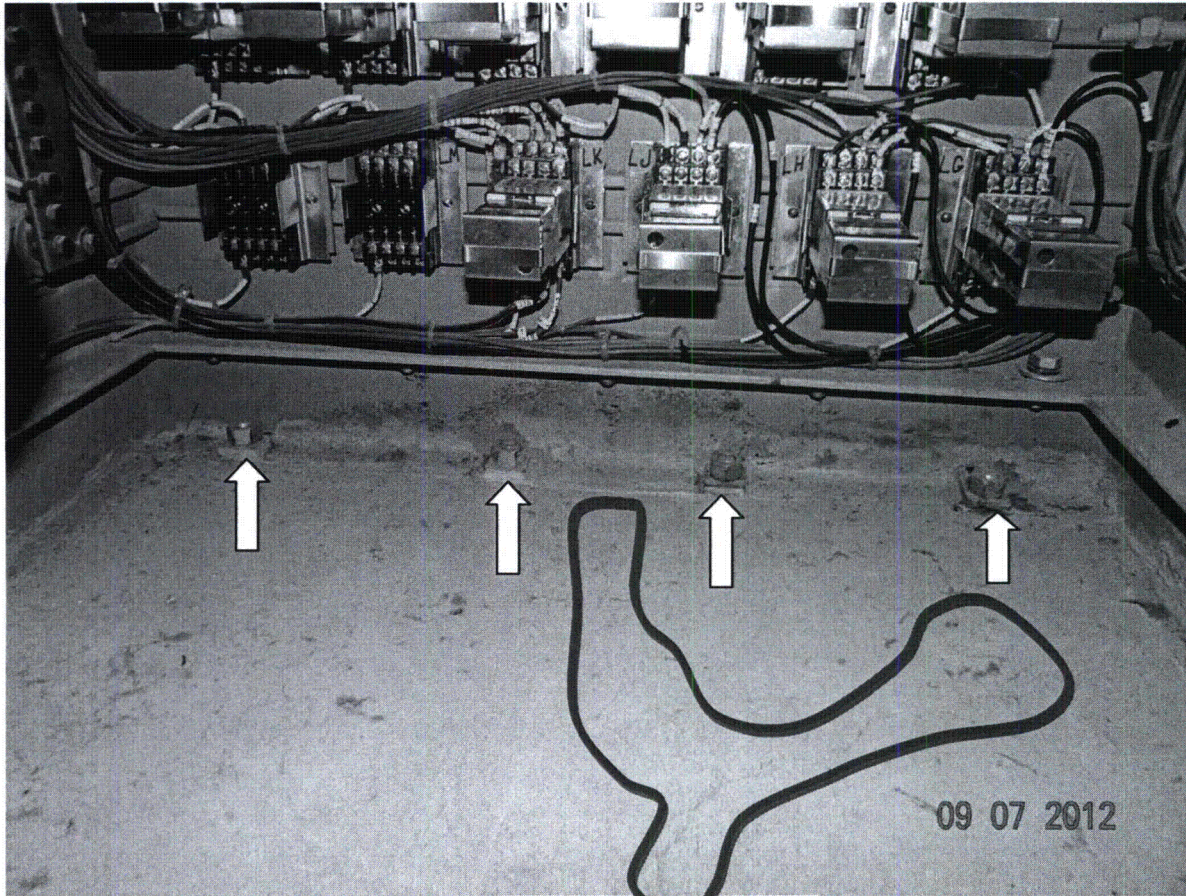
(DSC01116)

3. Is the anchorage free of corrosion that is more than mild surface oxidation? Y N U N/A
All bolts are corrosion-free or painted.
4. Is the anchorage free of visible cracks in the concrete near the anchors? Y N U N/A
Minor hairline cracks between anchors. The crack is a "Shrinkage" crack and not cause for concern. (see photo DSC01116)

"Shrinkage" crack

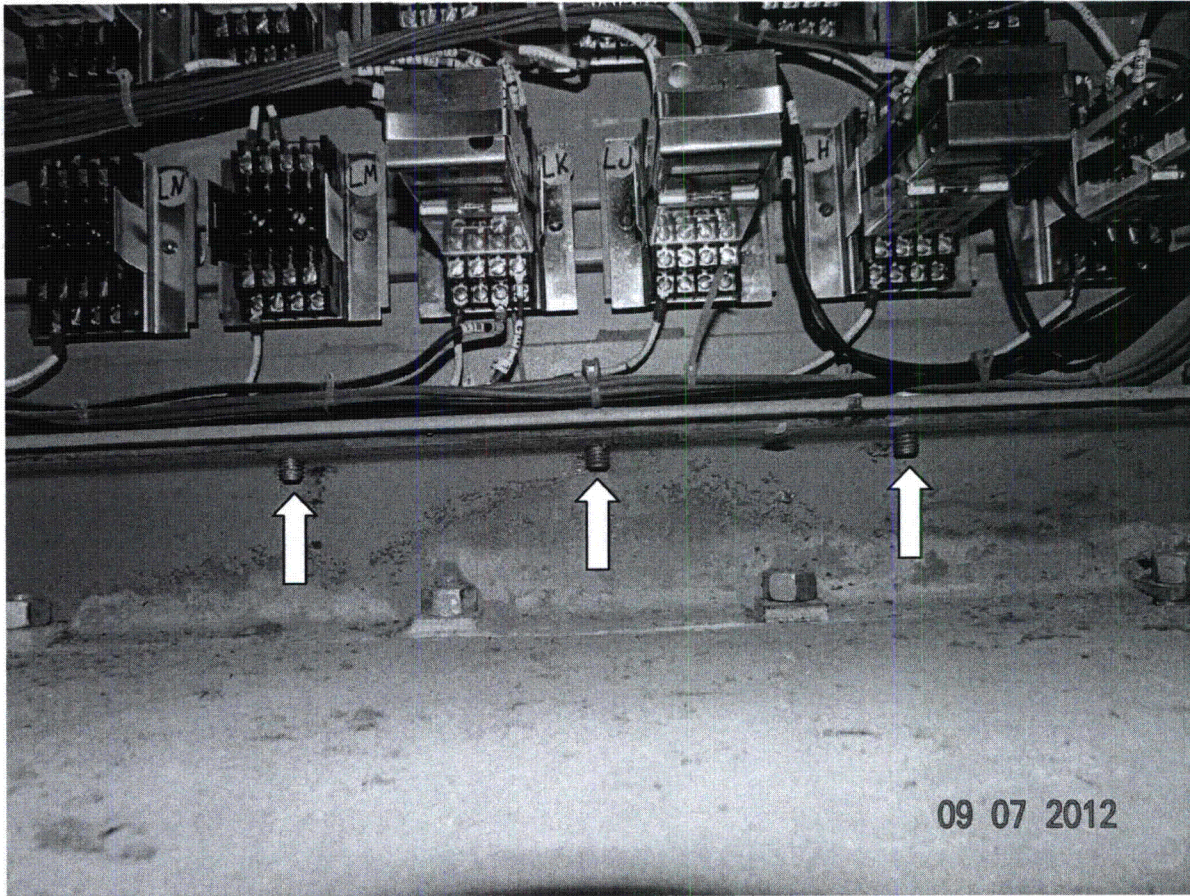
(DSC01118)

7. Are soft targets free from impact by nearby equipment or structures? Y N U N/A
Due to enclosed cabinet, no potential exists for impact with in the cabinet.
8. Are overhead equipment, distribution systems, ceiling tiles and lighting, and masonry block walls not likely to collapse onto the equipment? Y N U N/A
No ceiling tiles. Lights seismically supported and over 1'-0" away. Overhead systems and block walls are seismically supported.
9. Do attached lines have adequate flexibility to avoid damage? Y N U N/A
All Conduits are flex conduits with ample flexibility.
10. Based on the above seismic interaction evaluations, is equipment free of potentially adverse seismic interaction effects? Y N U
Adjacent cabinets are bolted together side by side to prevent banging into each other, thus cabinets are free of potentially adverse seismic interaction effects. (see photos DSC01118, 01126 & 01128)

"Connection between angle and Channel"

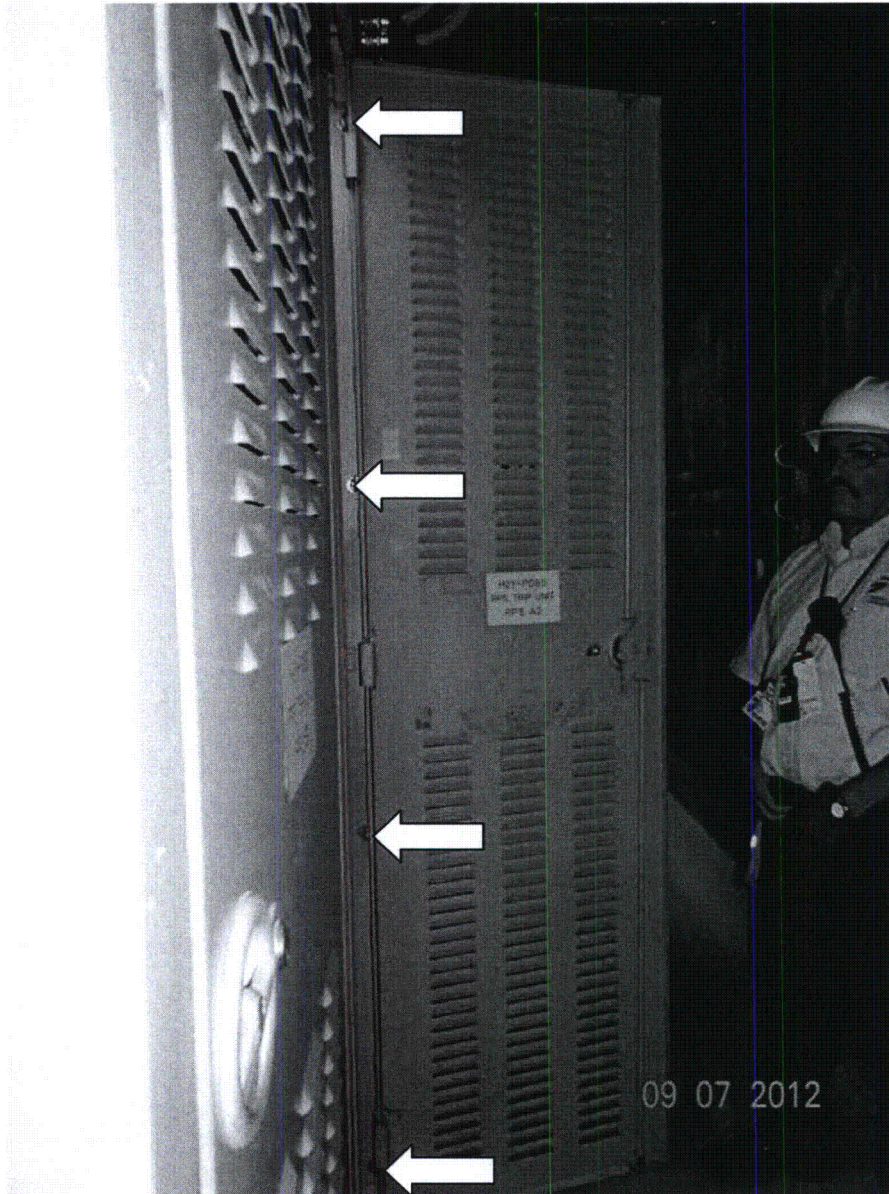
(DSC01126)

"Side to side panel bolting"

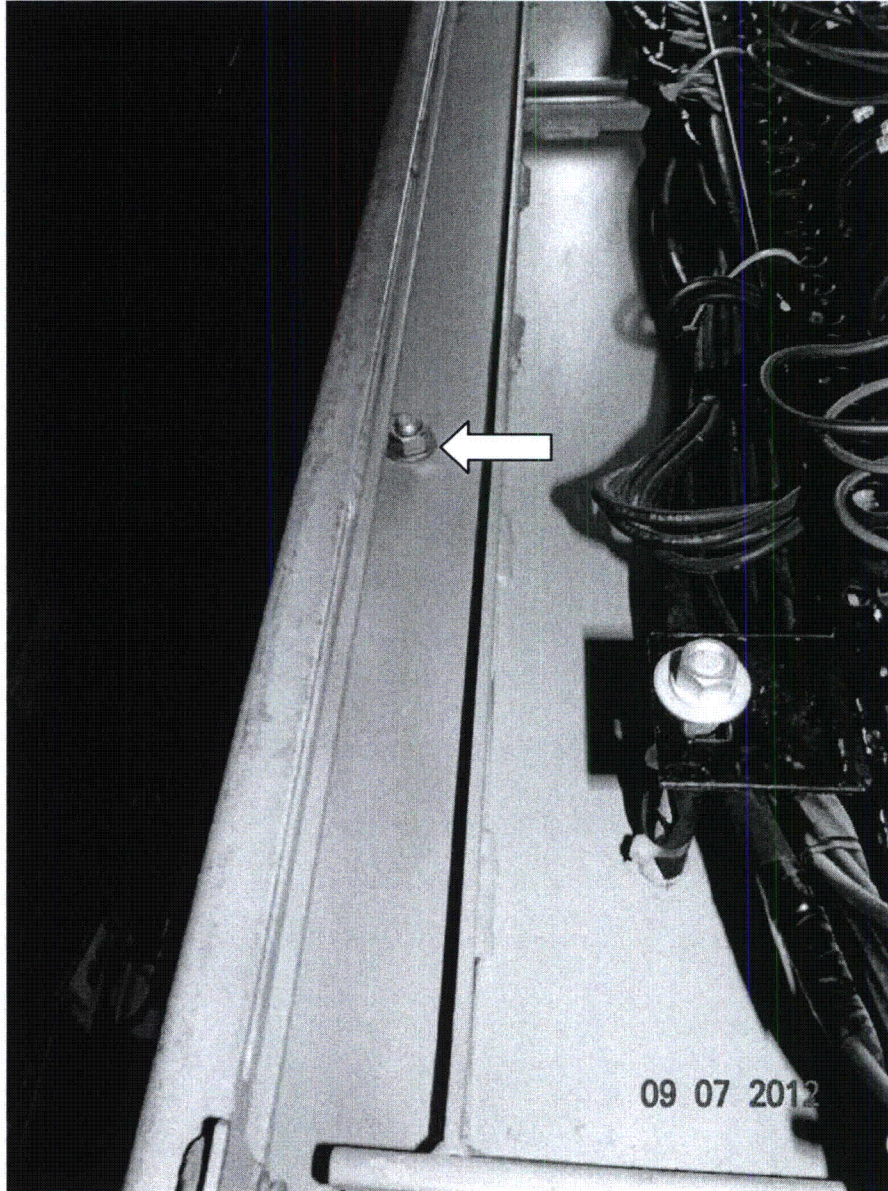
(DSC01128)

"Side to Side panel Bolt"

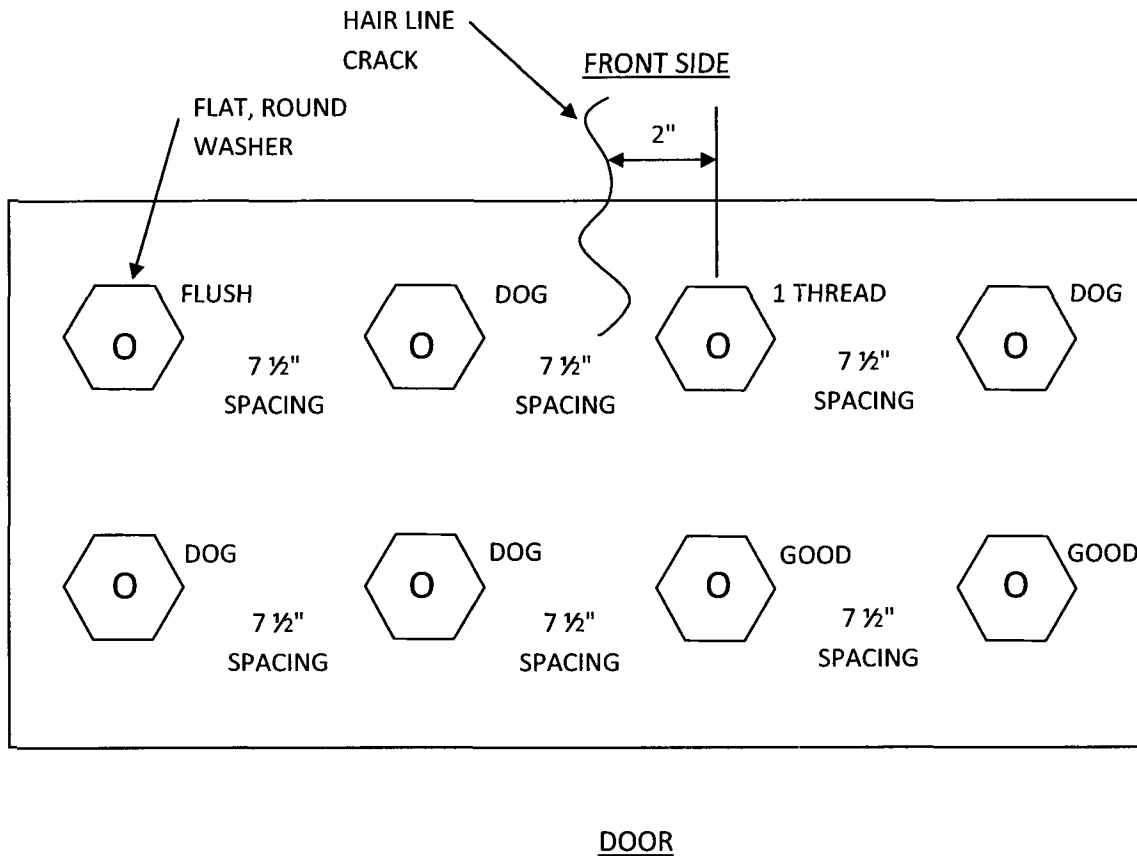
1. Is the anchorage configuration verification required (i.e., is the item one of the 50% of SWEL items requiring such verification)? Y N U
2. Is the anchorage free of bent, broken, missing or loose hardware? Y N U N/A
Thread engagement on some anchor bolts is less than one thread exposed from face of nut per Fermi Spec. 3071-226, Rev. K, Section 3.3.5.4(b). See attached "Hand sketch". Card 12-27702 was initiated to resolve this matter. Also, one bolt has a flat round washer instead of a square beveled washer (see photo DSC01090).

6. Based on the above anchorage evaluations, is the anchorage free of potentially adverse seismic conditions? Y N U
Item (2) - Some anchor bolts do not have full thread engagement per Fermi spec. 3071-226. & one bolt has a round washer instead of beveled washer. See attached "Hand sketch". CARD 12-27702 was initiated to resolve both issues (see photo DSC01090).

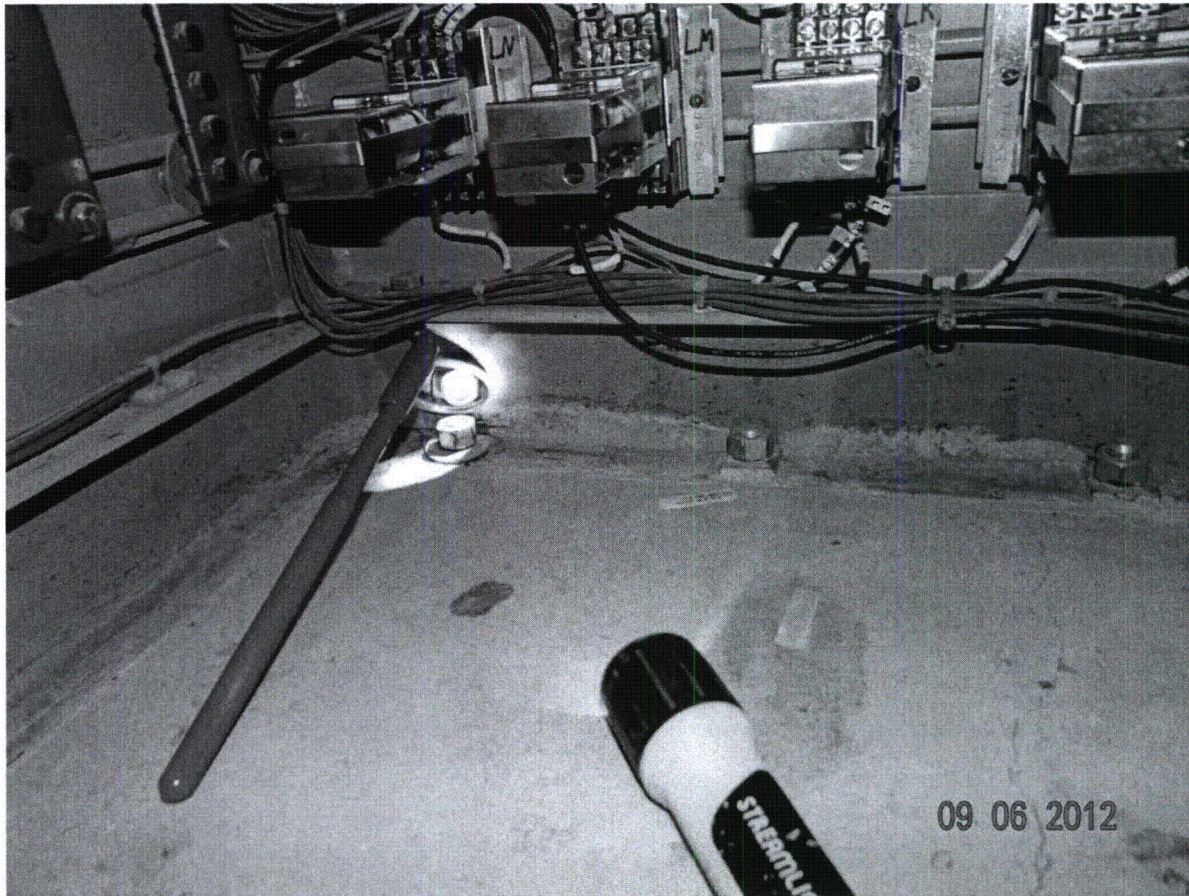
(DSC01090)

"Bolt Spacing and flat Round washer"

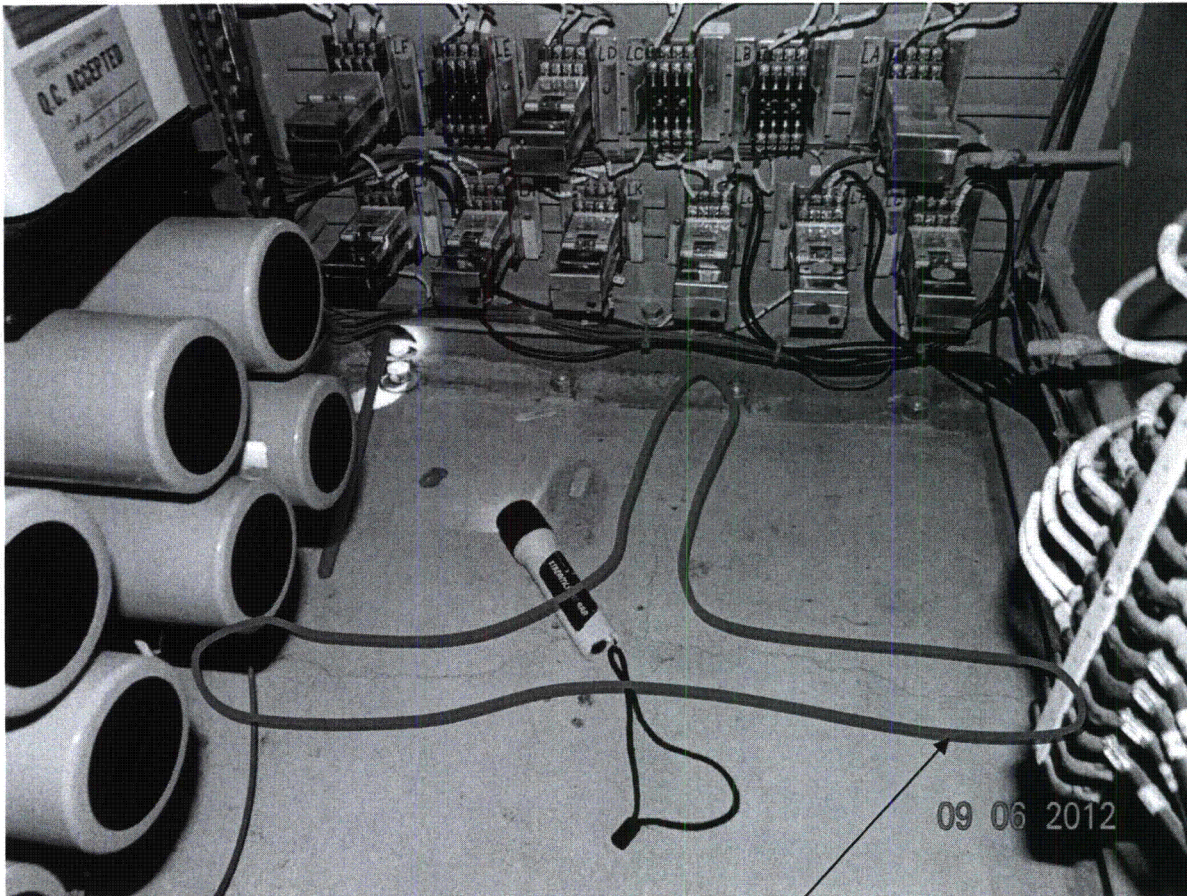
3. Is the anchorage free of corrosion that is more than mild surface oxidation? Y N U N/A
No corrosion or oxidation for the anchor bolts.
4. Is the anchorage free of visible cracks in the concrete near the anchors? Y N U N/A
Visible hairline cracks in the concrete inside the cabinet, within 2" of anchor bolt and also in front of cabinet. See attached "Hand sketch". The cracks are "Shrinkage" cracks and no impact on anchor capacity (see photo DSC01092).

(DSC01092)
"Hairline Cracks"

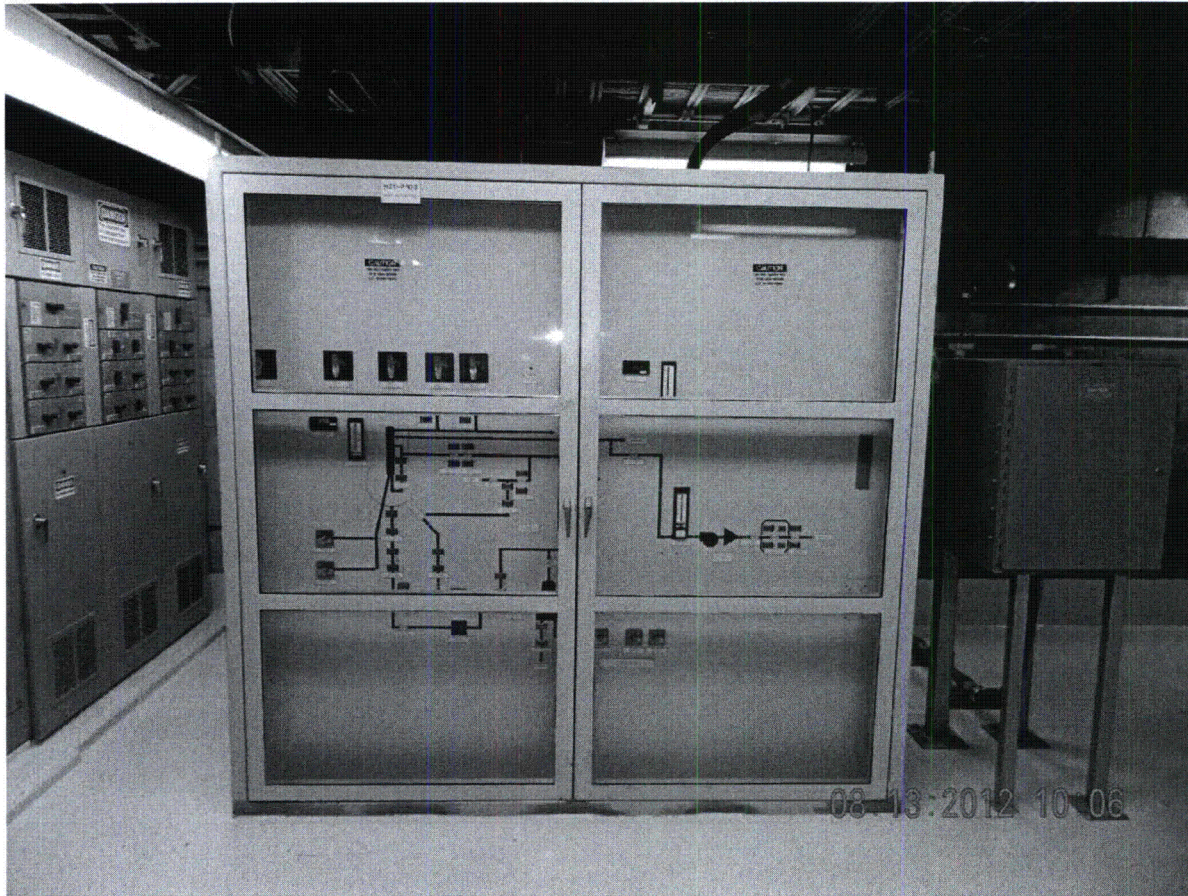
(Photo H21P100 (2))

6. Based on the above anchorage evaluations, is the anchorage free of potentially adverse seismic conditions? Y N U
Welds on front side visible, about 6" at five locations. Five plug welds at rear of cabinet at 22" centers (see Photo H21P100 (2)). The welded anchorage is free of adverse seismic conditions.

Welds along Front Bottom Edge of Panel
