Seismic Walkdown Checklist (SWC)

Equipment ID No. H21P081 Equip. Class¹ 18, Instrument Racks

Equipment Description Div 2 EECS Trip Unit Instrument Rack

Location: Bldg. AB Floor El. 659'-6" Room, Area A-34, Col. F-11

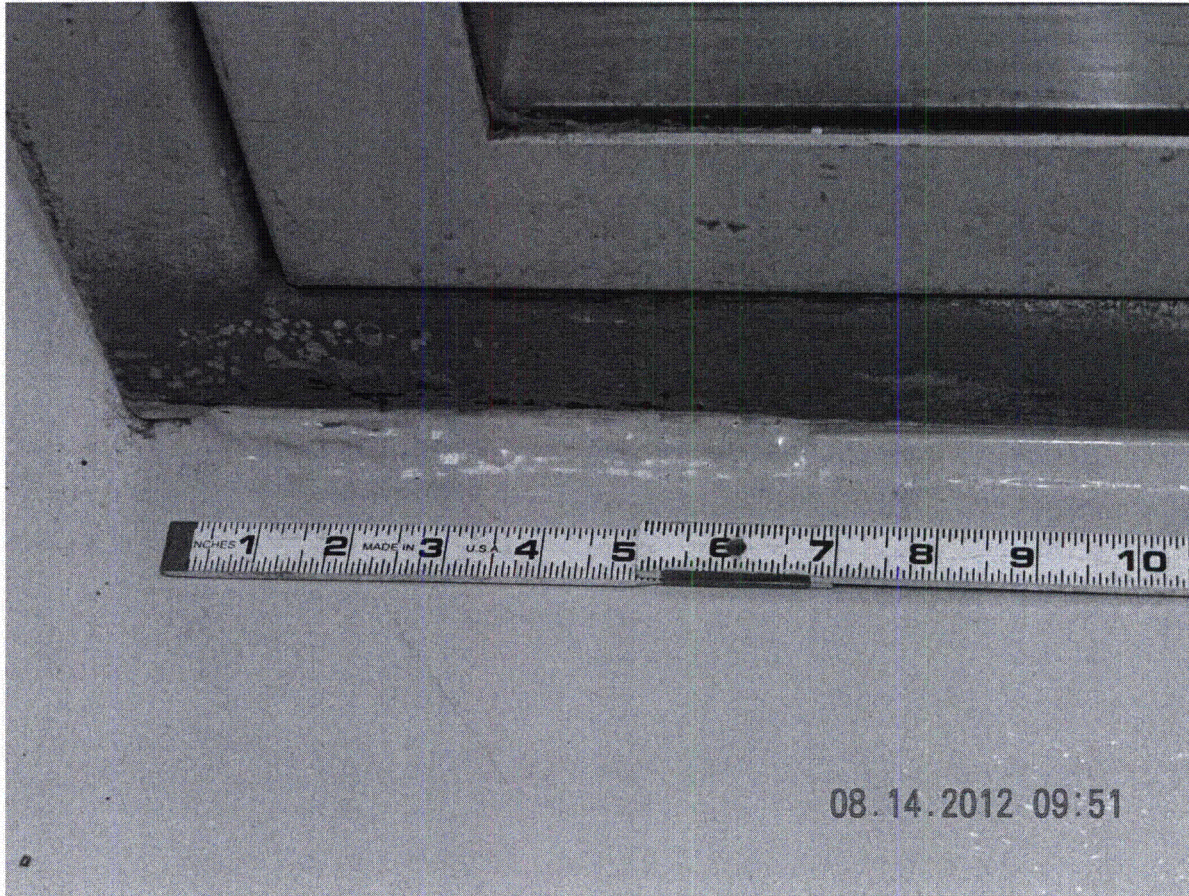
(Photo DSCN 0294)

4. Is the anchorage free of visible cracks in the concrete near the anchors? Y N U N/A
Concrete around embedded plates is free of cracks (see Photo DSCN 0294).

Concrete Floor Adjacent to Welds to Embedded Plates

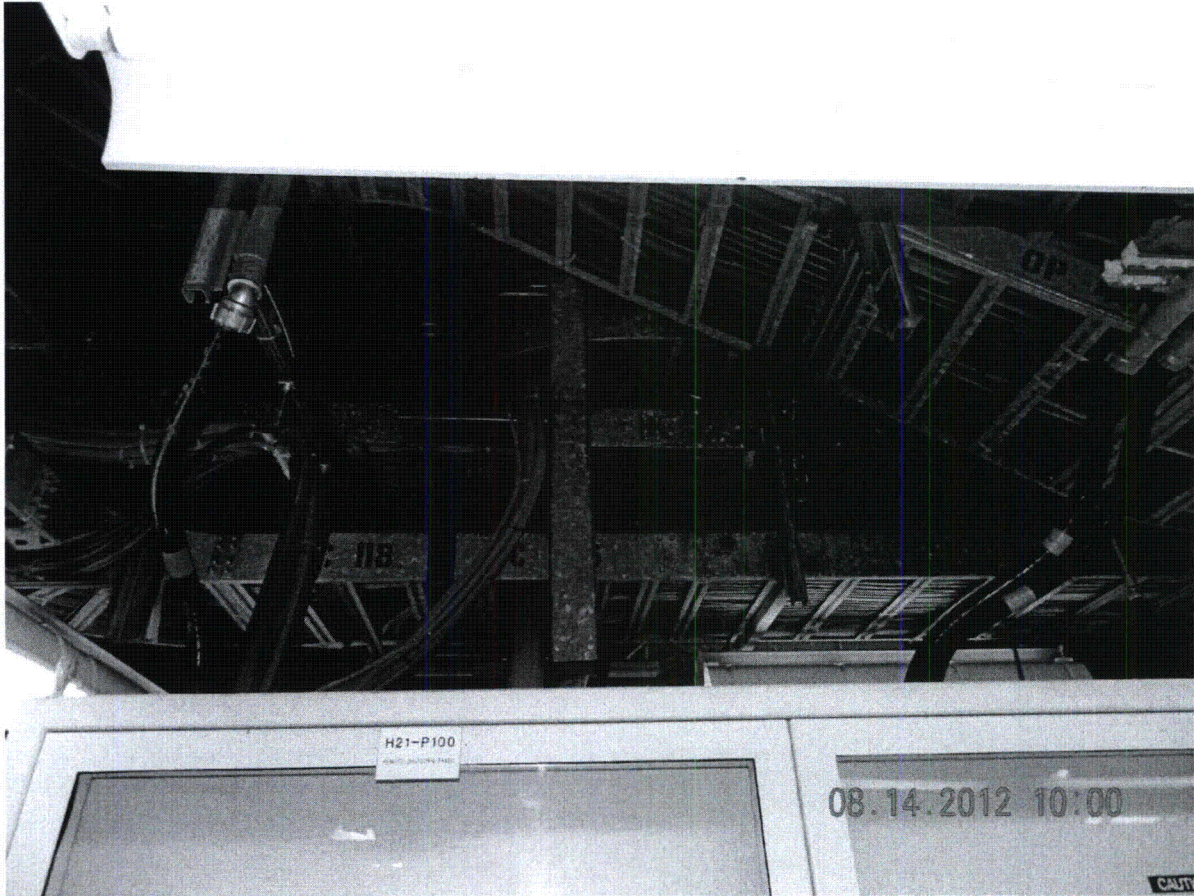
(Photo DSCN 0300)

9. Do attached lines have adequate flexibility to avoid damage? Y N U N/A
Top entry cables are looped to provide flexibility (see Photo DSCN 0300).
10. Based on the above seismic interaction evaluations, is equipment free of potentially adverse seismic interaction effects? Y N U
Adjacent switchgear cabinets, 72B-2A and R3101S001, are welded front and rear to embedded plates. Therefore, separation is acceptable. Panel H21P628 is approximately 10" away. Per EPRI guidance for rigidly supported equipment, only 2" of separation is required. Therefore, 10" of seismic separation is acceptable.

Electrical Cables above Panel

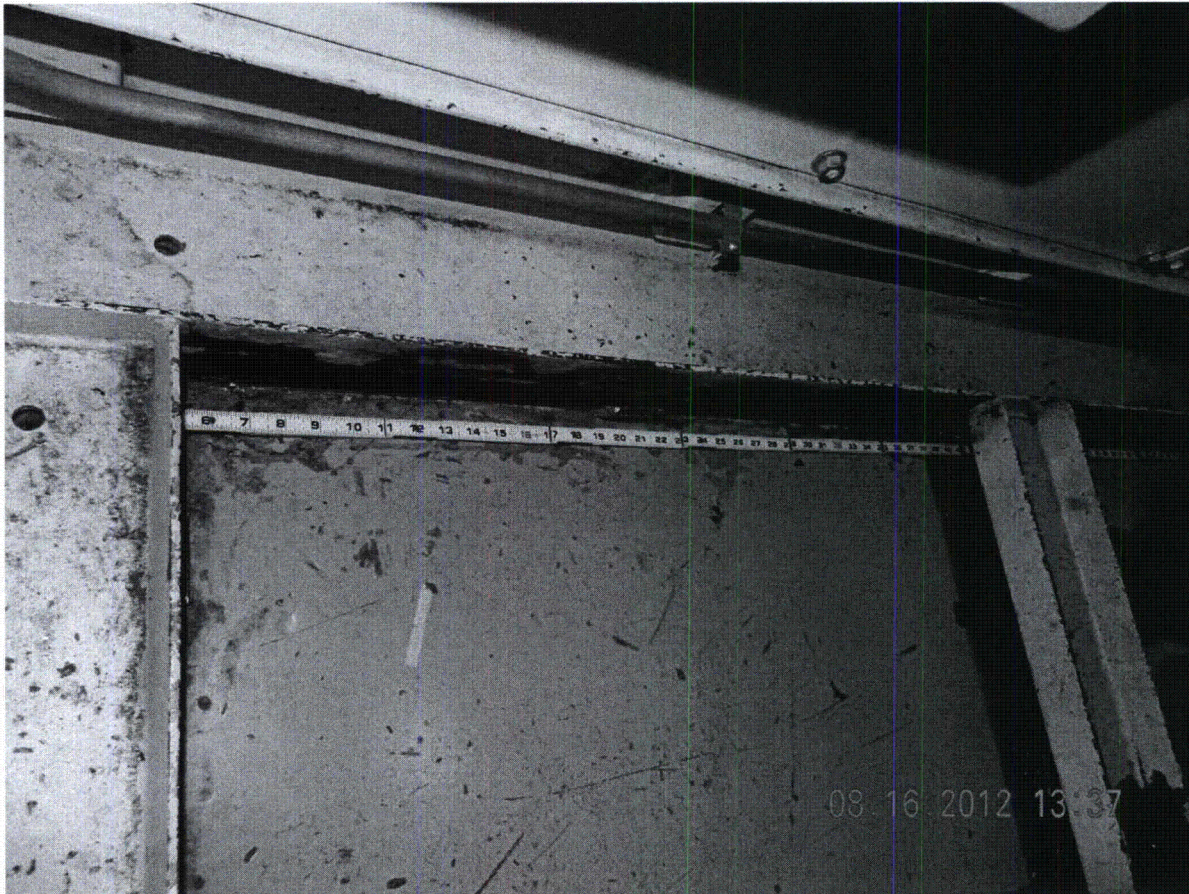
(DSCN0466)

2. Is the anchorage free of bent, broken, missing or loose hardware? Y N U N/A
All welds are complete. No bent, broken, missing or loose hardware was observed, although anchor bolts to floor are enclosed in steel and not observable. (SEE PICTURE DSCN0466) ~ DJK 10/11/12

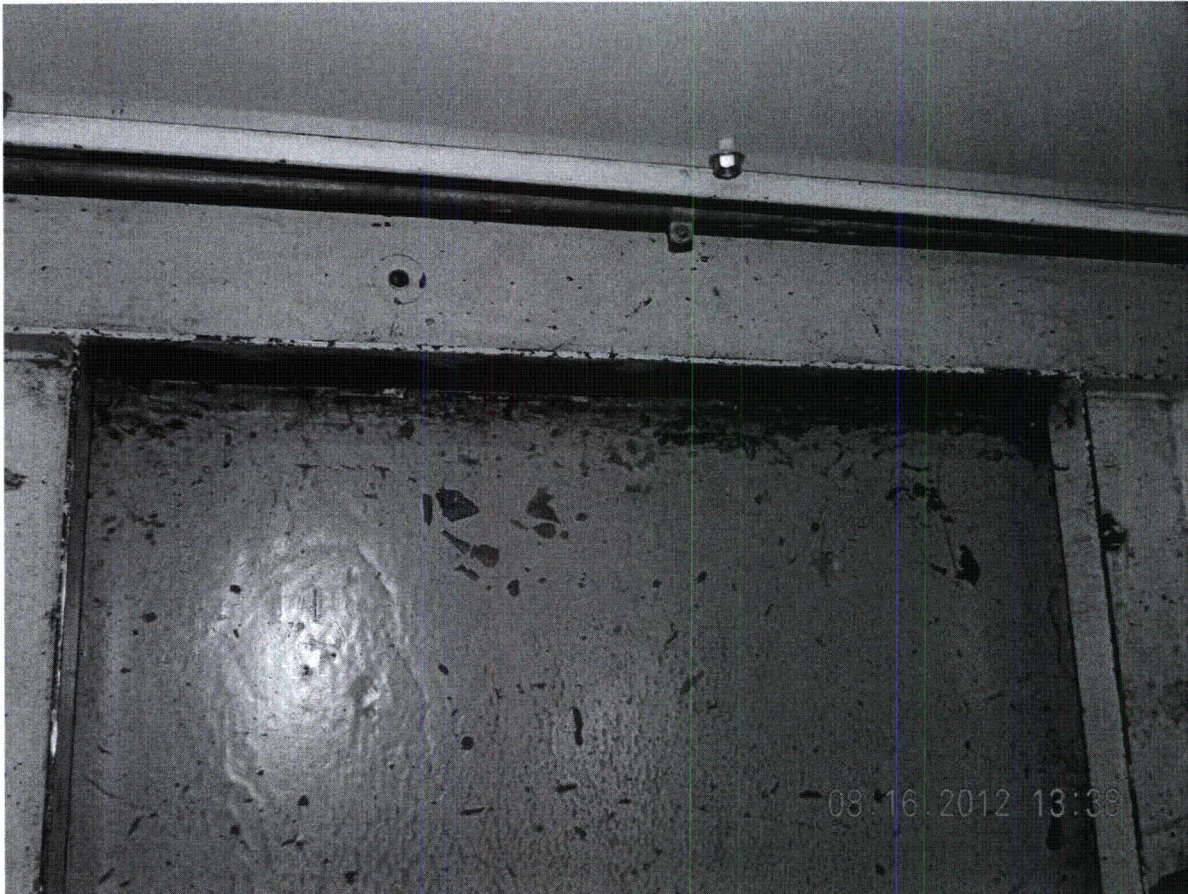
(DSCN0470)

3. Is the anchorage free of corrosion that is more than mild surface oxidation? Y N U N/A
No corrosion observed
4. Is the anchorage free of visible cracks in the concrete near the anchors? Y N U N/A
No cracks or concrete degradation observed (SEE PICTURE DSCN0470) ~ DJK 10/11/12

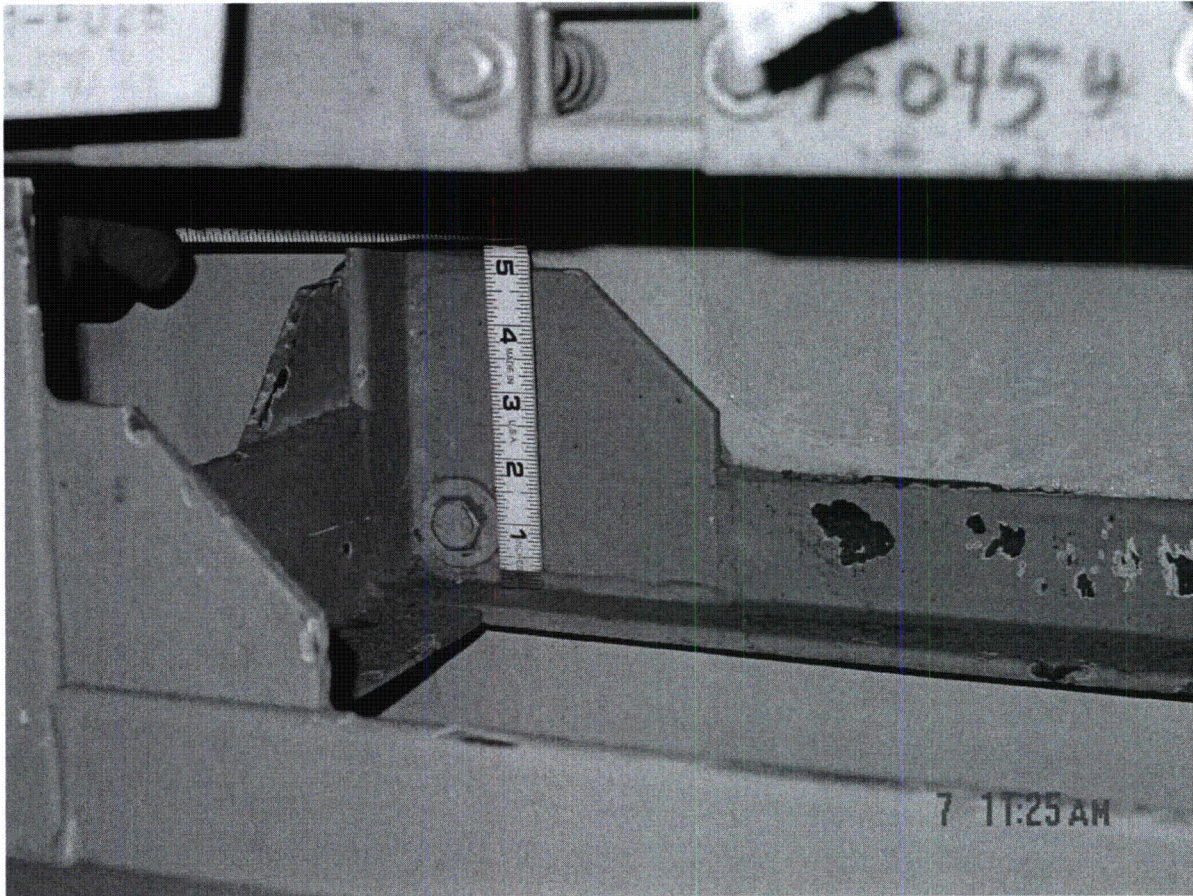
(Picture 3)

3. Is the anchorage free of corrosion that is more than mild surface oxidation? Y N U N/A
No corrosion. See picture 3.

4. Is the anchorage free of visible cracks in the concrete near the anchors? Y N U N/A
No cracks. See picture 3.

Bolt Configuration for Instrument Rack Framing to Concrete Wall

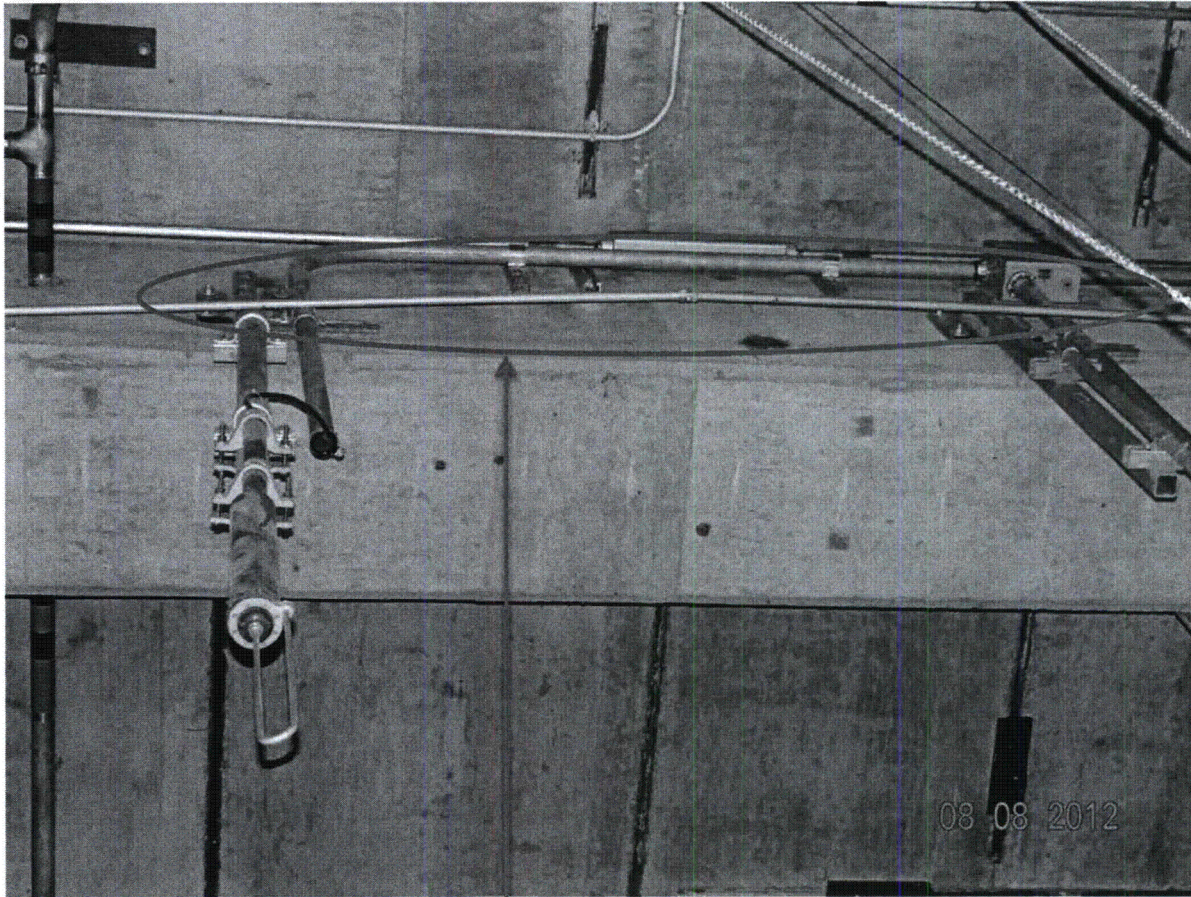
(DSC 00296)

Conduit "Unsupported"
