SAN ONOFRE NUCLEAR  
GENERATING STATION, UNIT 1

REPORT ON CABLE FAILURES—1968

SOUTHERN CALIFORNIA EDISON COMPANY  
SAN DIEGO GAS & ELECTRIC COMPANY

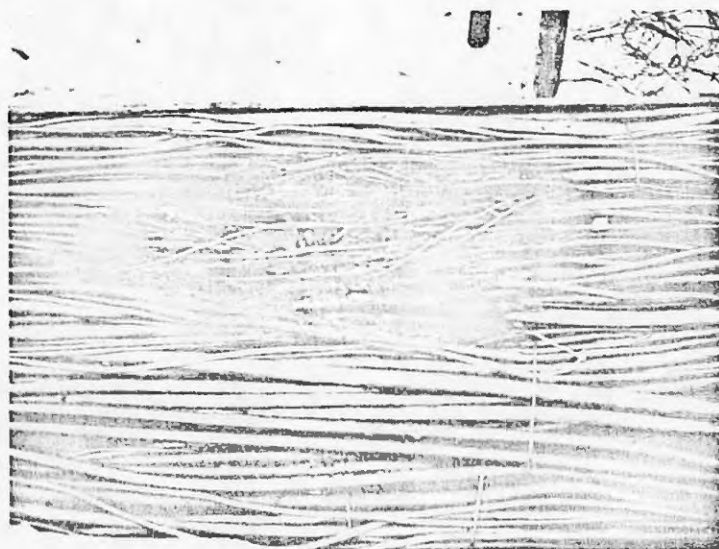
RESULTS OF CABLE  
SHORT CIRCUIT TEST

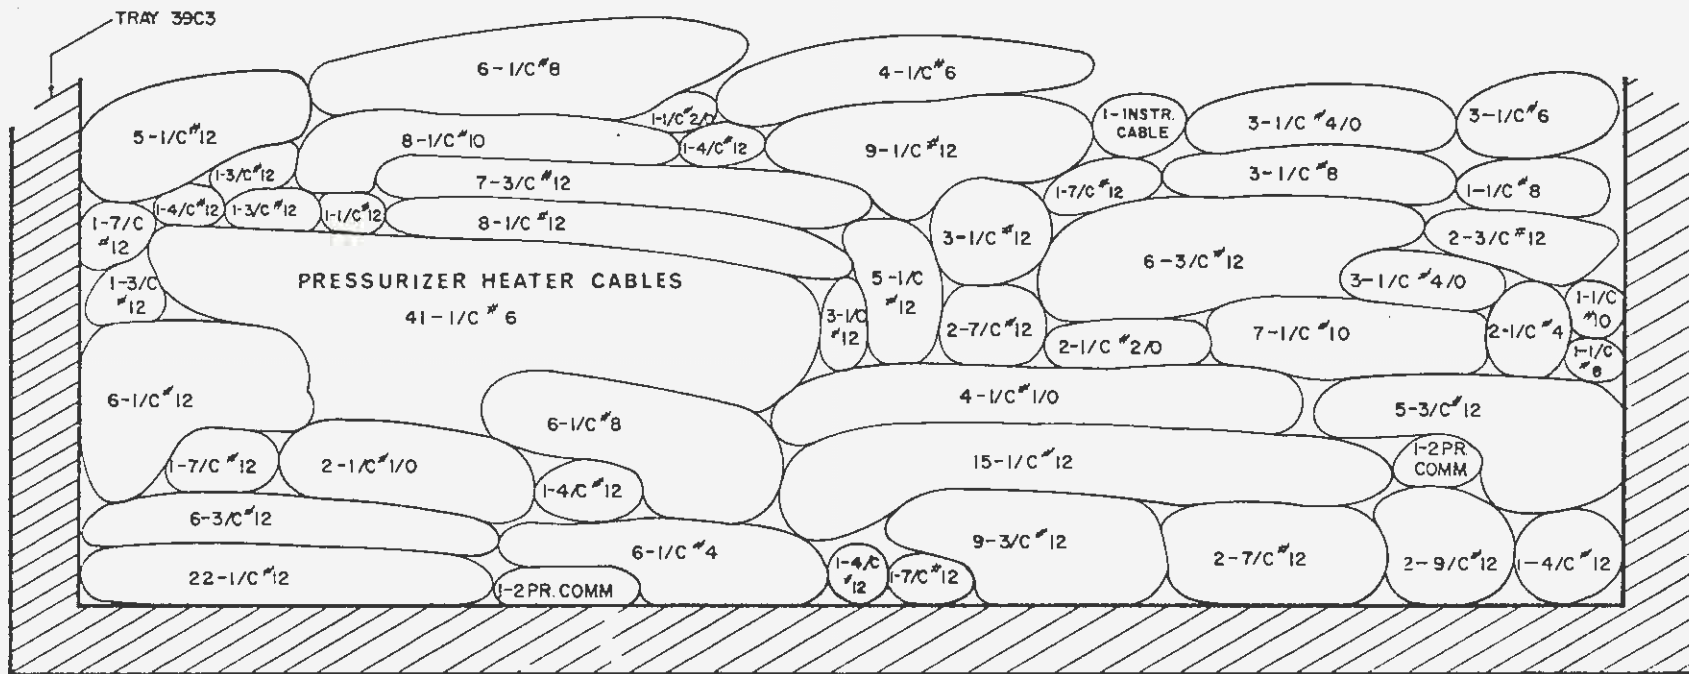
1. The No. 6 AWG wire used for the 45 pressurizer heater leads was thermally overloaded for the conditions of tray 39C3.
2. Tray 39C3 was heavily filled to a level above the side rails which impeded heat dissipation and caused heavy pressures on the lower cables with possible deformation of the cable materials.

CROSS SECTION OF CABLE TRAY  
39C3

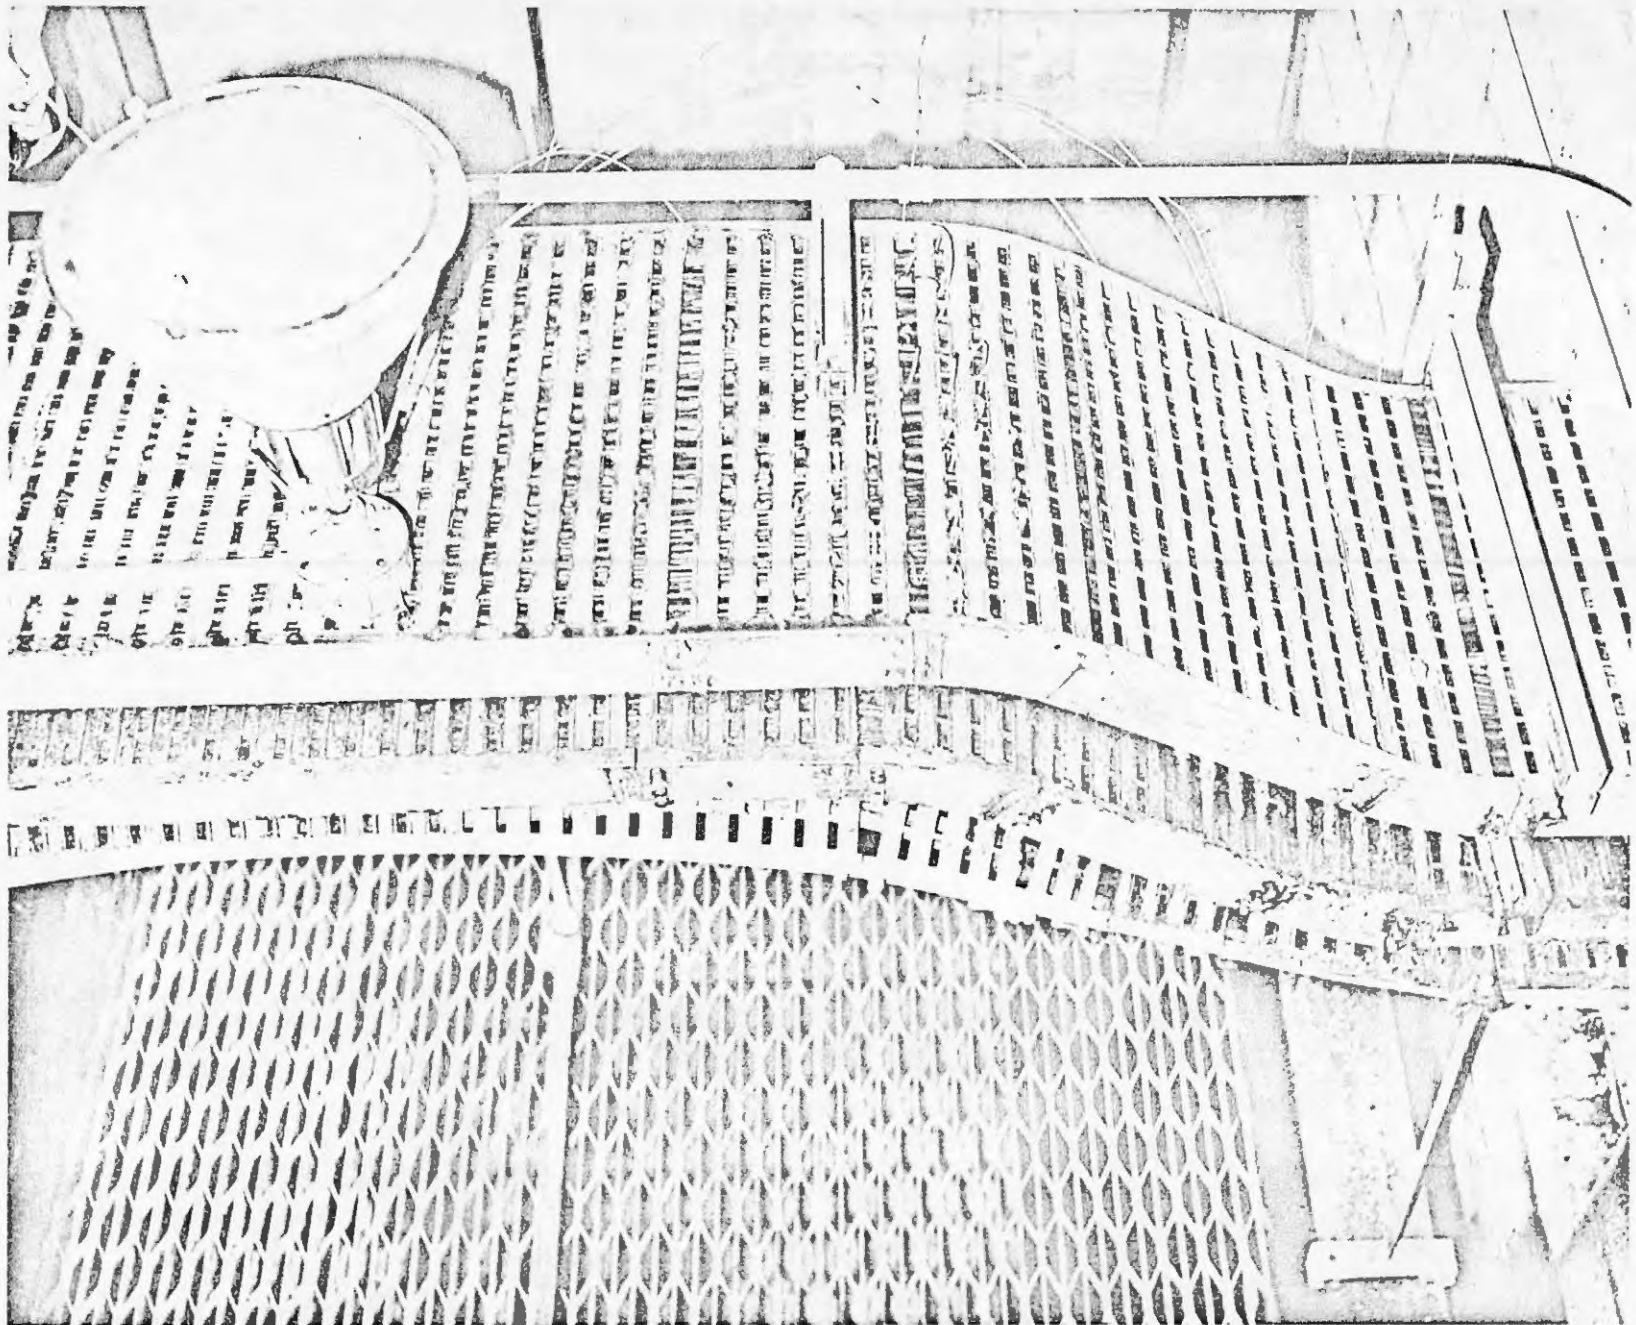
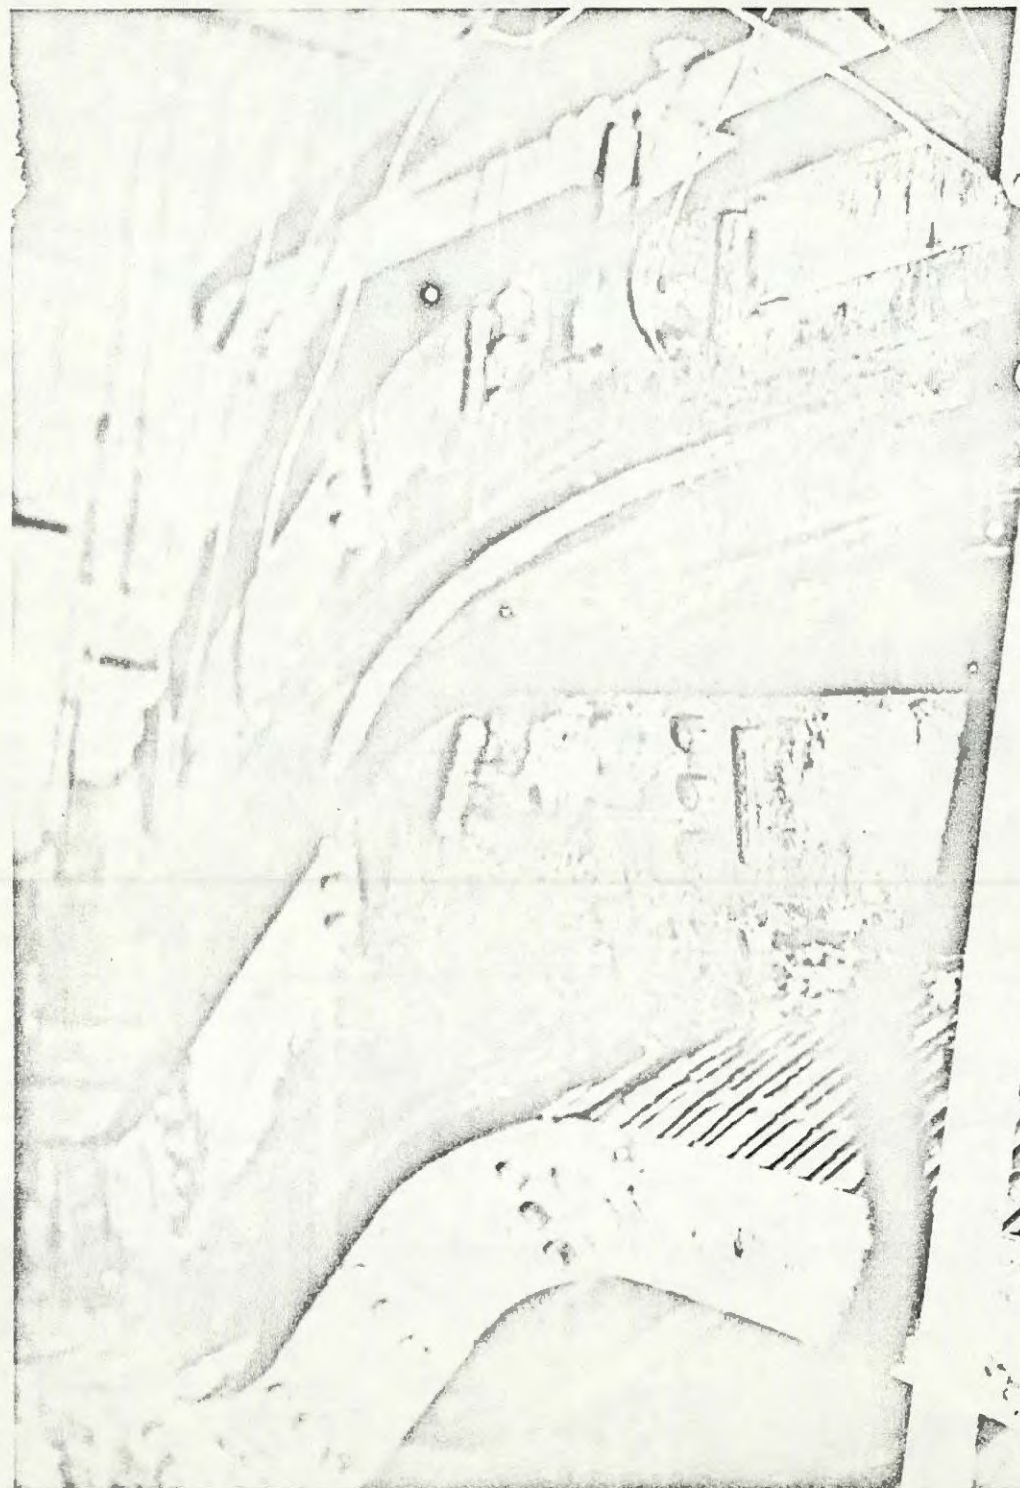
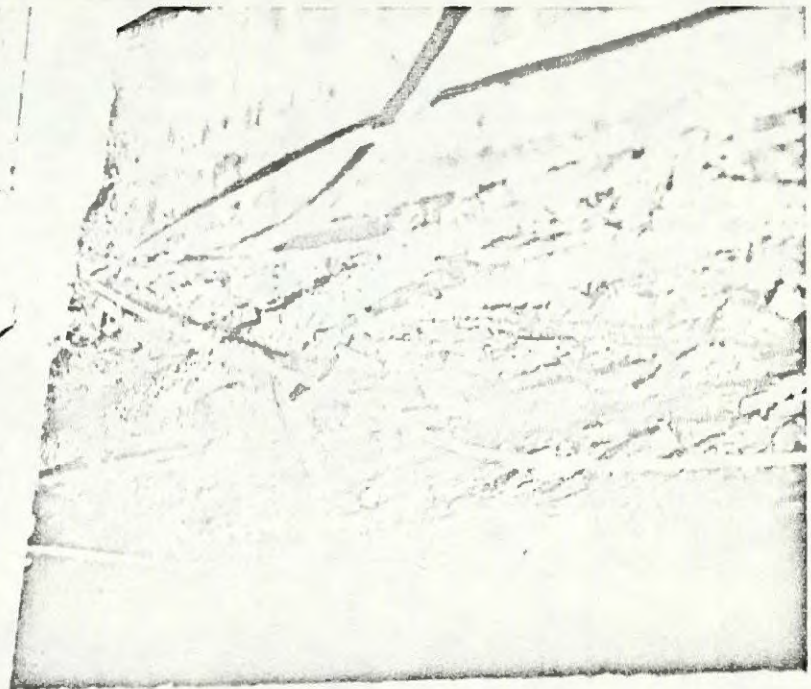
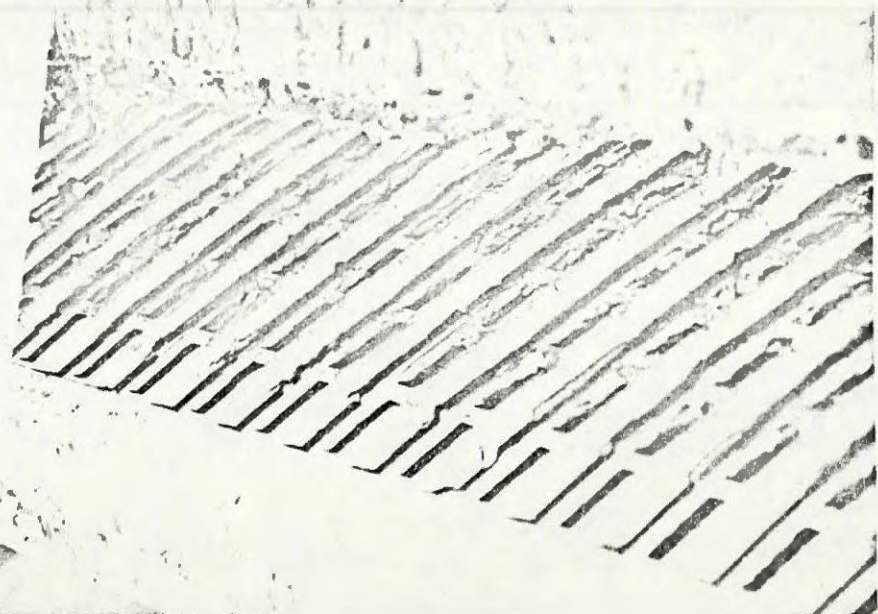
7.6 DAMAGED CABLE TRAY PICTURES

The fire was confined to three overhead cable trays stacked one above the other in the No. 2 switchgear room. The cables in these trays were badly burned for a length of 15 feet. There were 185 electrical circuits in these trays including the leads from the pressurizer heaters. The fire was of such a limited nature that there was no overheating to the grating and beams or the air intake located 38 inches above the trays.

5. The most probable cause for each of the two cable failures was thermally overloaded pressurizer heater cables coupled with heavy mechanical loading or damage resulting in a phase-to-phase fault condition between two cables of separate circuits.

1. The No. 6 AWG wires in the pressurizer heater circuits have been replaced with No. 4 AWG wires in three-conductor cables. Each group of 15, three-conductor cables has been located in a new separate tray.
2. To reduce the number of circuits carried by each 480-volt penetration and to provide for increased conductor sizes, a portion of the pressurizer heater circuits have been relocated to two additional penetrations.
