December 28, 2011
Revision 2

Omaha Public Power District

**Fort Calhoun Station
Flood Recovery Action Plan 4.1
Plant and Facility Geotechnical and
Structural Assessment**

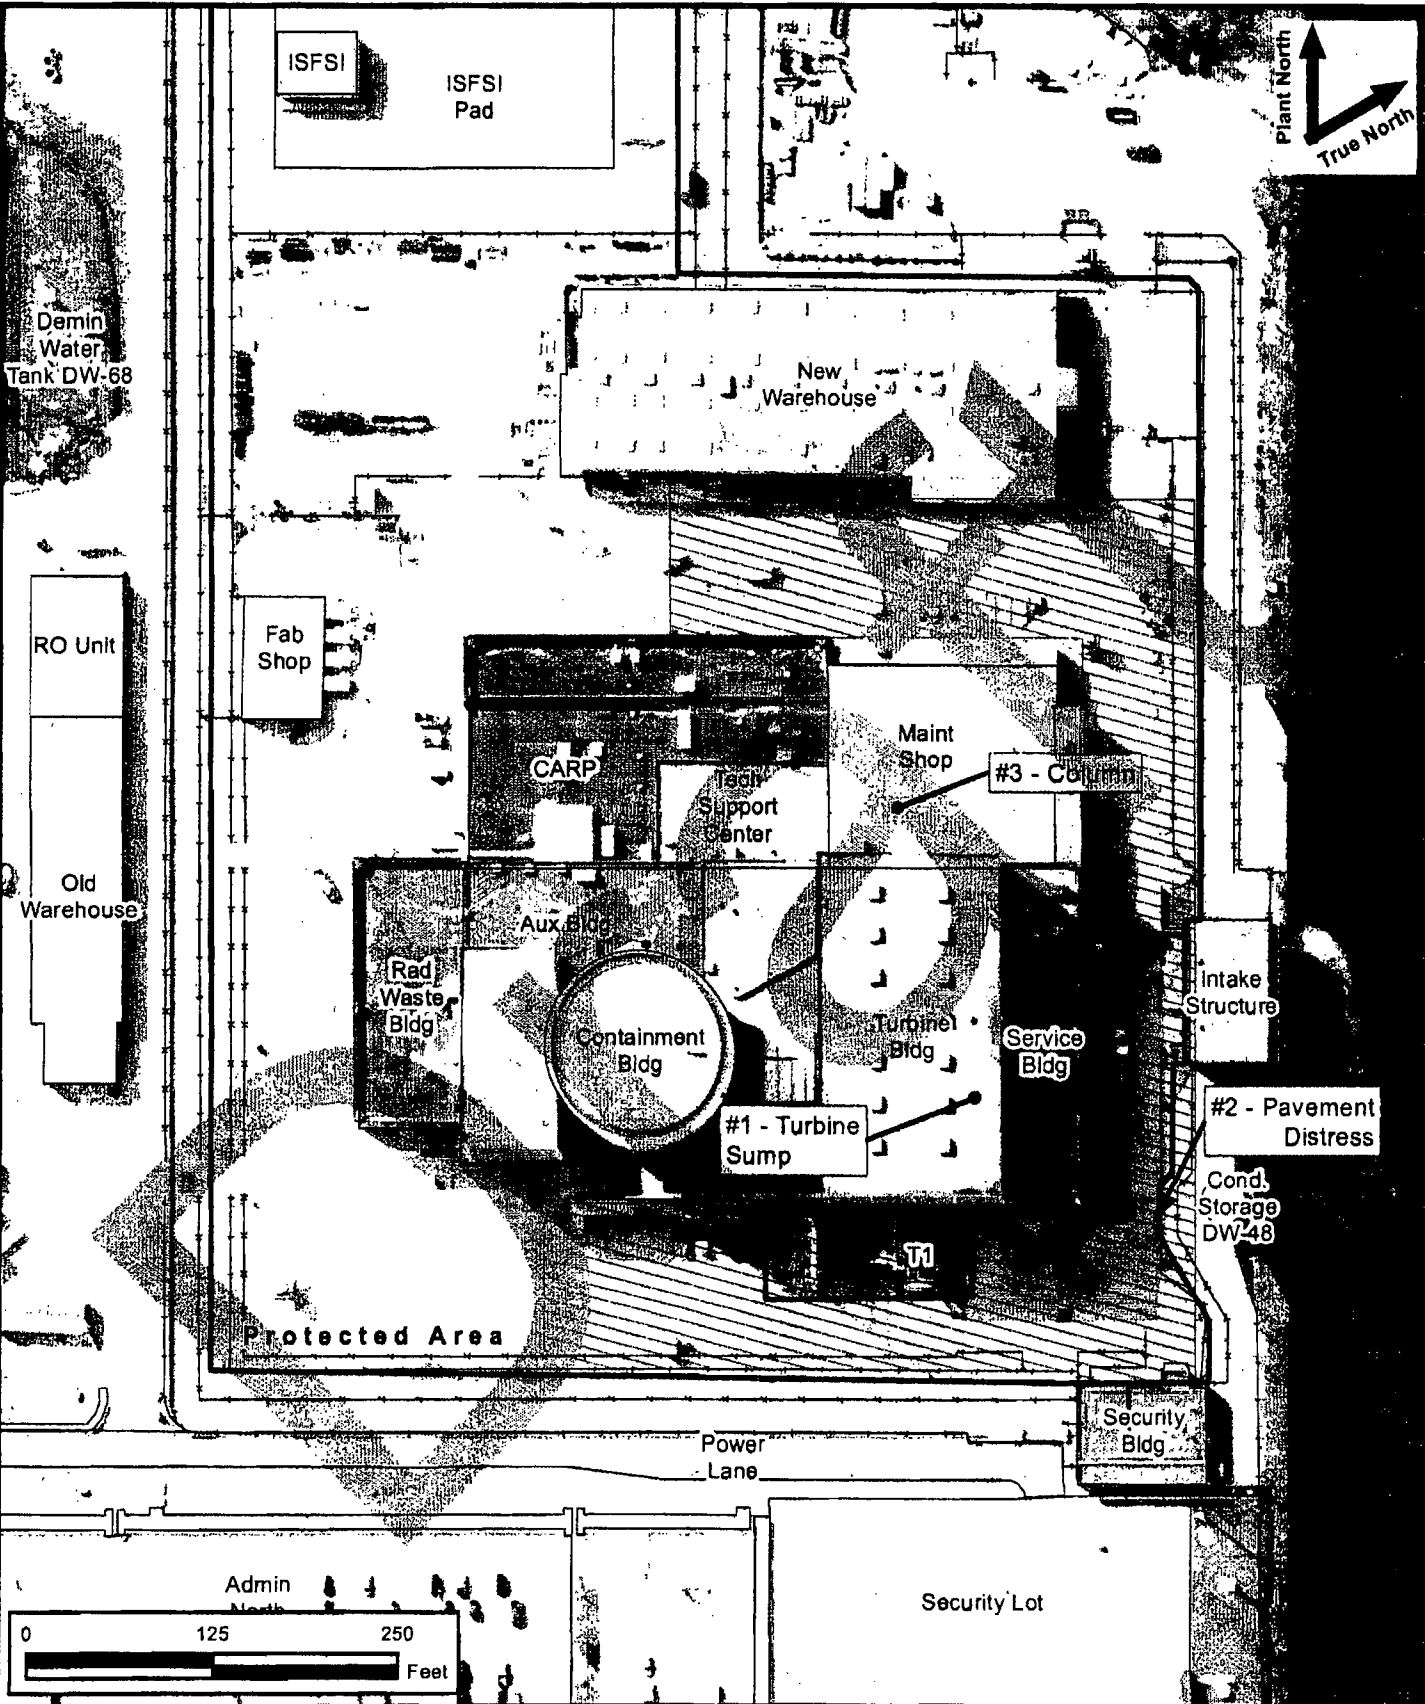
1. Increased groundwater flow into the Turbine Building sump
2. Pavement failure and sinkhole development in the paved access area between the Intake Structure and Service Building
3. Column settlement in the Maintenance Shop

The increased flow is originating from breaks in the pipes that are designed to carry water from the floor drains in the basement of the Turbine Building. These drains are also used to drain equipment in the Turbine Building. The structures potentially affected by the CPFMs associated with the Triggering Mechanism (Subsurface Erosion/Piping) for Key Distress Indicator #1 are presented in Section 4.1.1. A complete description of each structure is presented in its respective subsection of Section 5.0.

- OPPD should perform remedial work to stop the uncontrolled drainage of the groundwater into the broken Turbine Building basement drainage system piping and fill the voids beneath the basement floor slab.
- In addition to drainage system repair, the voids created by the subsurface erosion/ piping should be filled.
- A grouting program should be implemented to fill the voids and determine the volume of the voids.

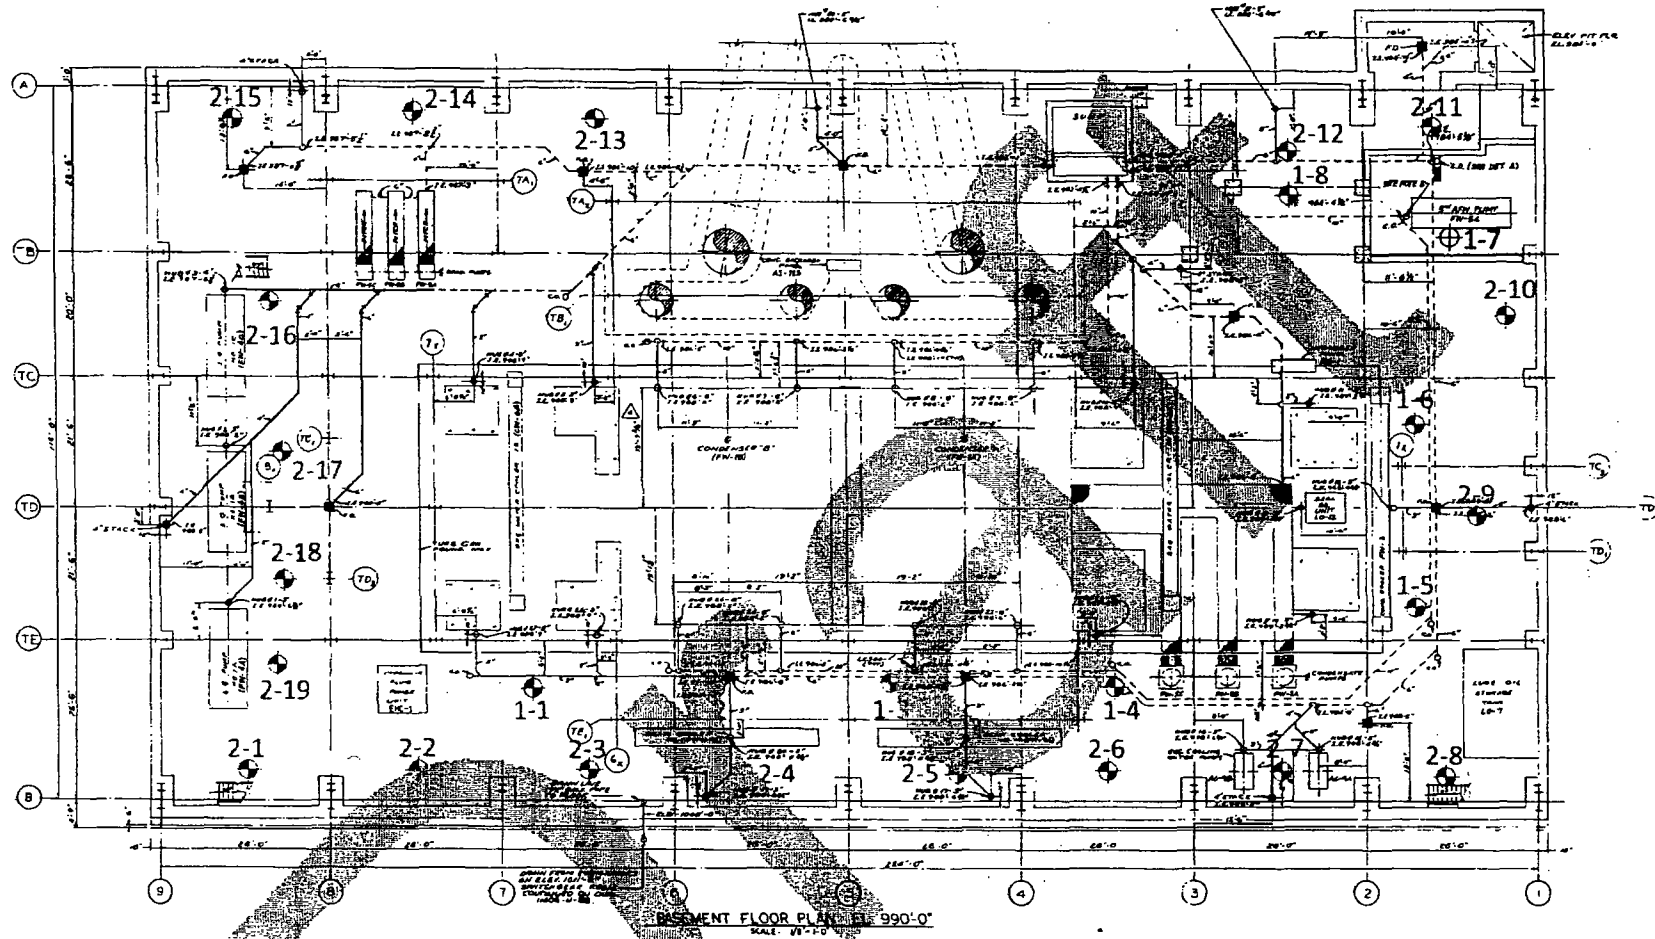
Preliminary locations for the proposed drill holes are shown in Figure 4-2. Eight holes were located in areas of anomalies as identified during Ground Penetrating Radar (GPR) testing and analysis. Nineteen holes were distributed around the Turbine Building basement perimeter to further explore for voids and determine their connection with surrounding structures. The locations shown in Figure 4-2 are preliminary and approximate. A detailed drilling plan will be developed based on a site examination with the appropriate OPPD personnel to determine locations that minimize impacts on the structure, underground piping, and equipment.

1. Drilling locations 1-x are located near anomalies as identified in GPR analysis.
2. Drilling locations 2-x are spread along the basement perimeter for void exploration.
3. Drilling location 1-7 has been removed due to equipment conflicts.

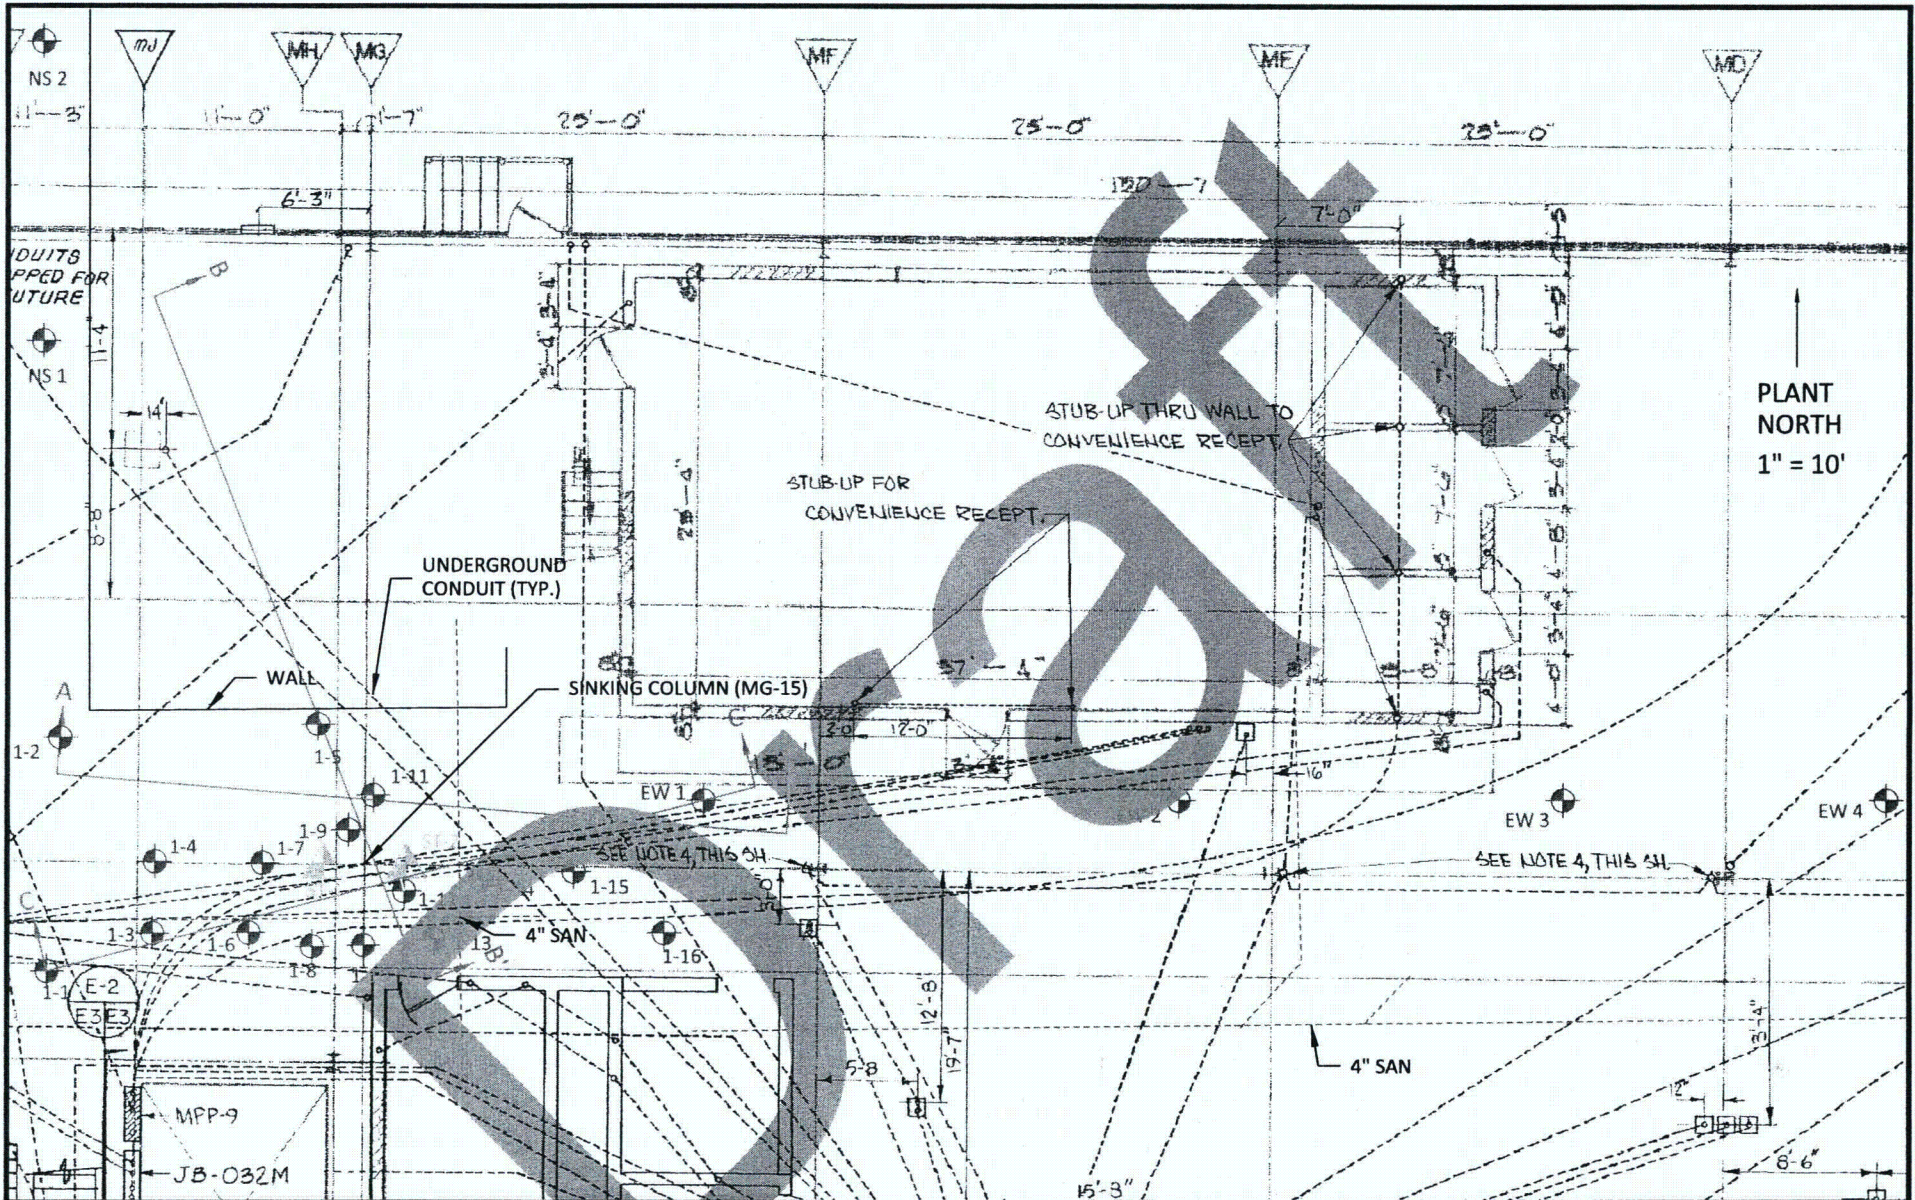
FIGURE
4-11

- Within about 3.5 feet of the settled column, void space averaged 6.2 inches
- Within about 4.5 feet of the settled column, void space averaged 5.8 inches
- Within about 5.5 feet of the settled column, void space averaged 5.5 inches
- Within about 7.5 feet of the settled column, void space averaged 5.3 inches
- Beyond about 7.5 feet from the settled column, void space averaged 1.4 inches
- Beyond about 18 feet from the settled column, void space averaged 0.5 inches

The above statements related to void space are illustrated in cross sections A-A', B-B', and C-C' presented as Figures 4-12, 4-13, and 4-14. The Section locations are shown in Figure 4-11.

- Physical modifications to remediate the distress in the Maintenance Shop should be implemented as planned.
- Further investigations could be undertaken by OPPD as part of the design for the remedial work to repair the Maintenance Shop and Technical Support Center distress.
- Physical modifications outlined in the KDI #1 forensic investigations should be completed before the physical modifications to remediate the distress in the Maintenance Shop and Technical Support Center are implemented.

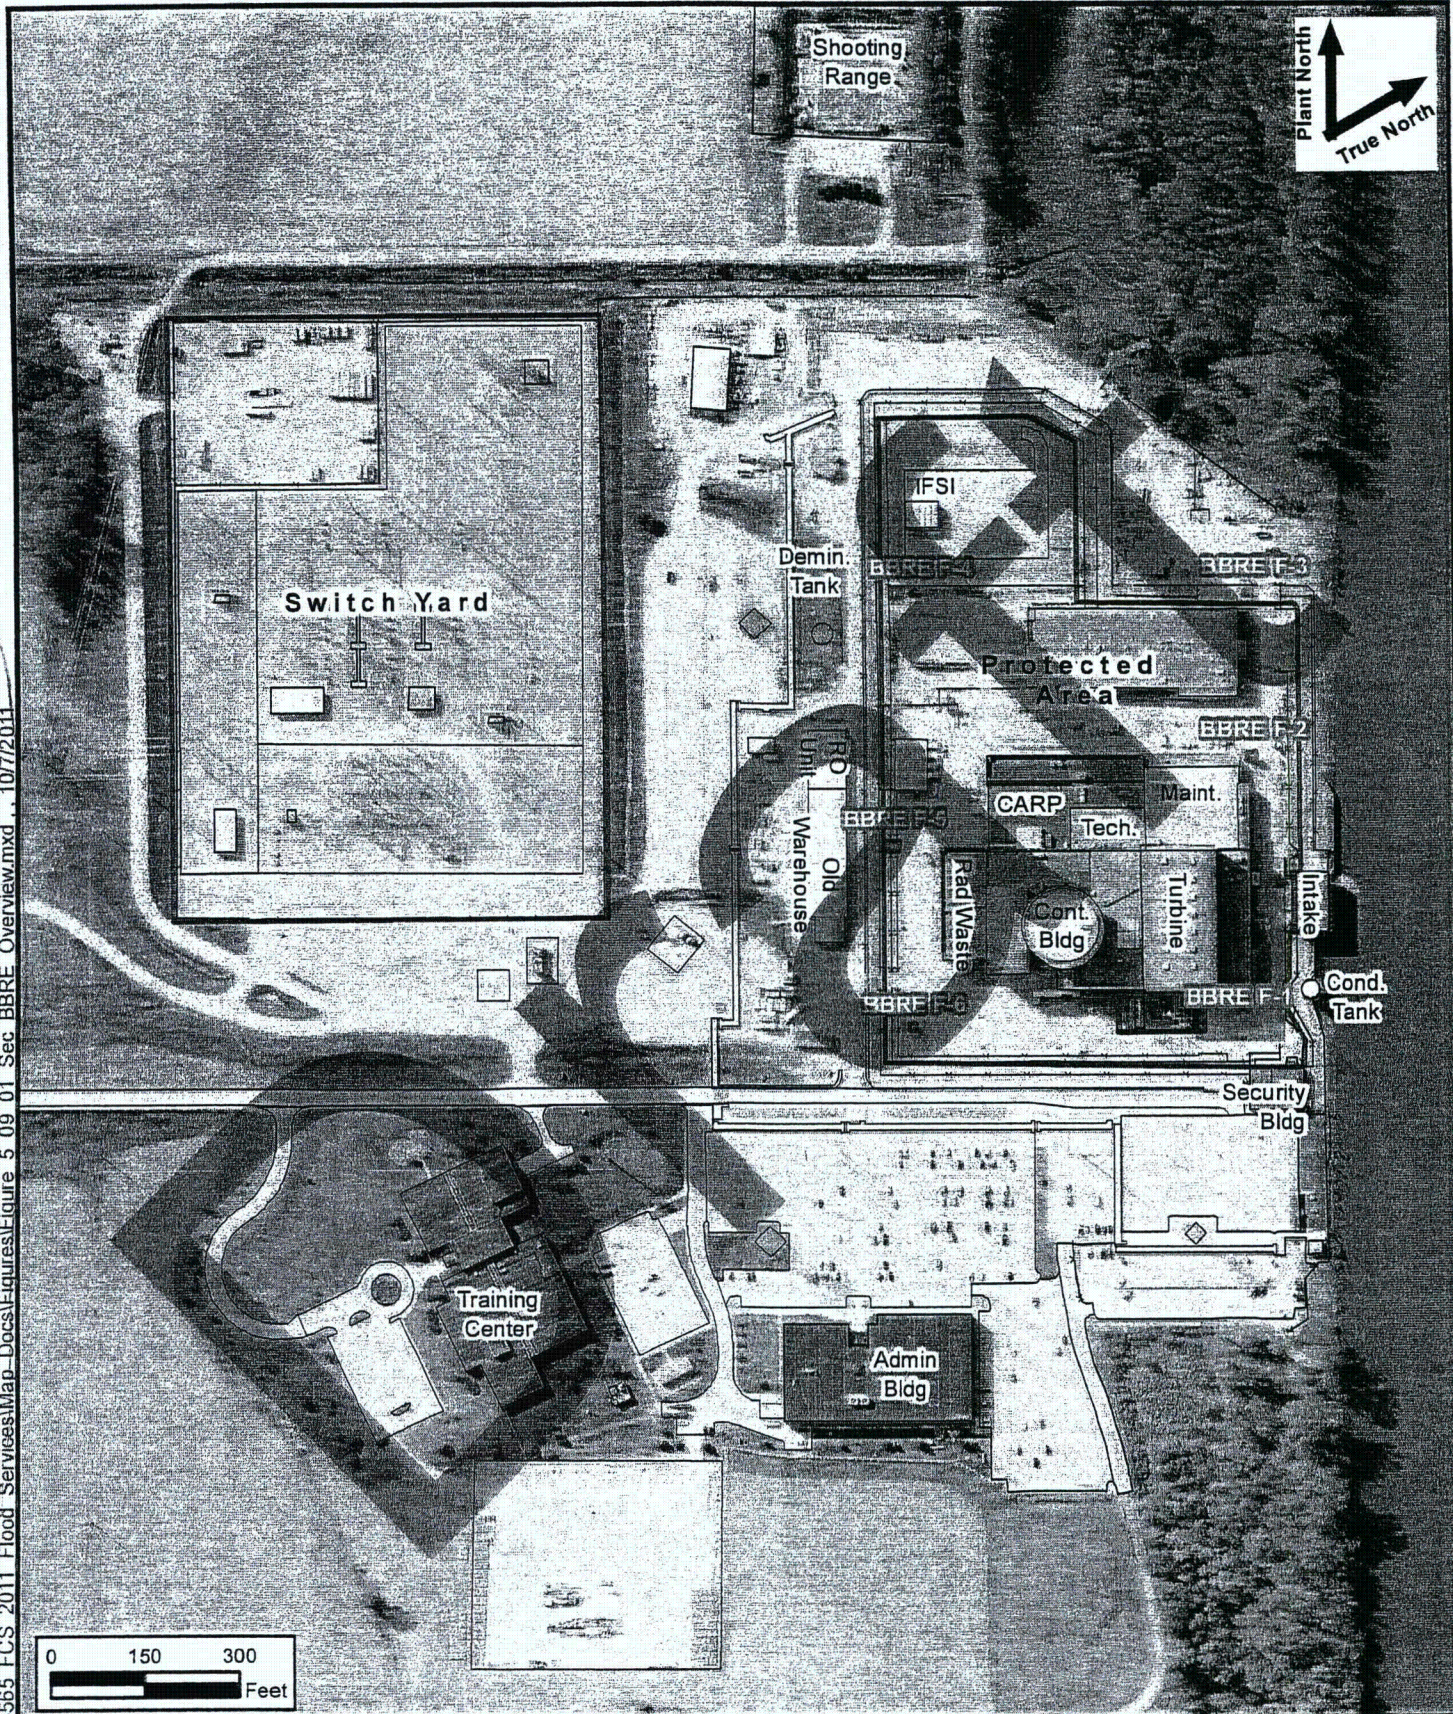
**Security BBRE Overview
Fort Calhoun Station**

- There is a hole in the pavement and void area beneath the pavement north of the Security Building and east-southeast of MH-5. The hole and void area are outside of the perimeter of the Aqua Dam that surrounded the facility. The pavement failure occurred at the intersection point of pavement jointing. The hole in the pavement is irregular-shaped and is more than 1 ft wide both in the north-south and east-west directions. The void area beneath the hole was approximately 4 ft in diameter by 0.8 ft deep, as measured with a tape measure through the hole.
