Section 5.12

Underground Cable Trench

5.12 Underground Cable Trench

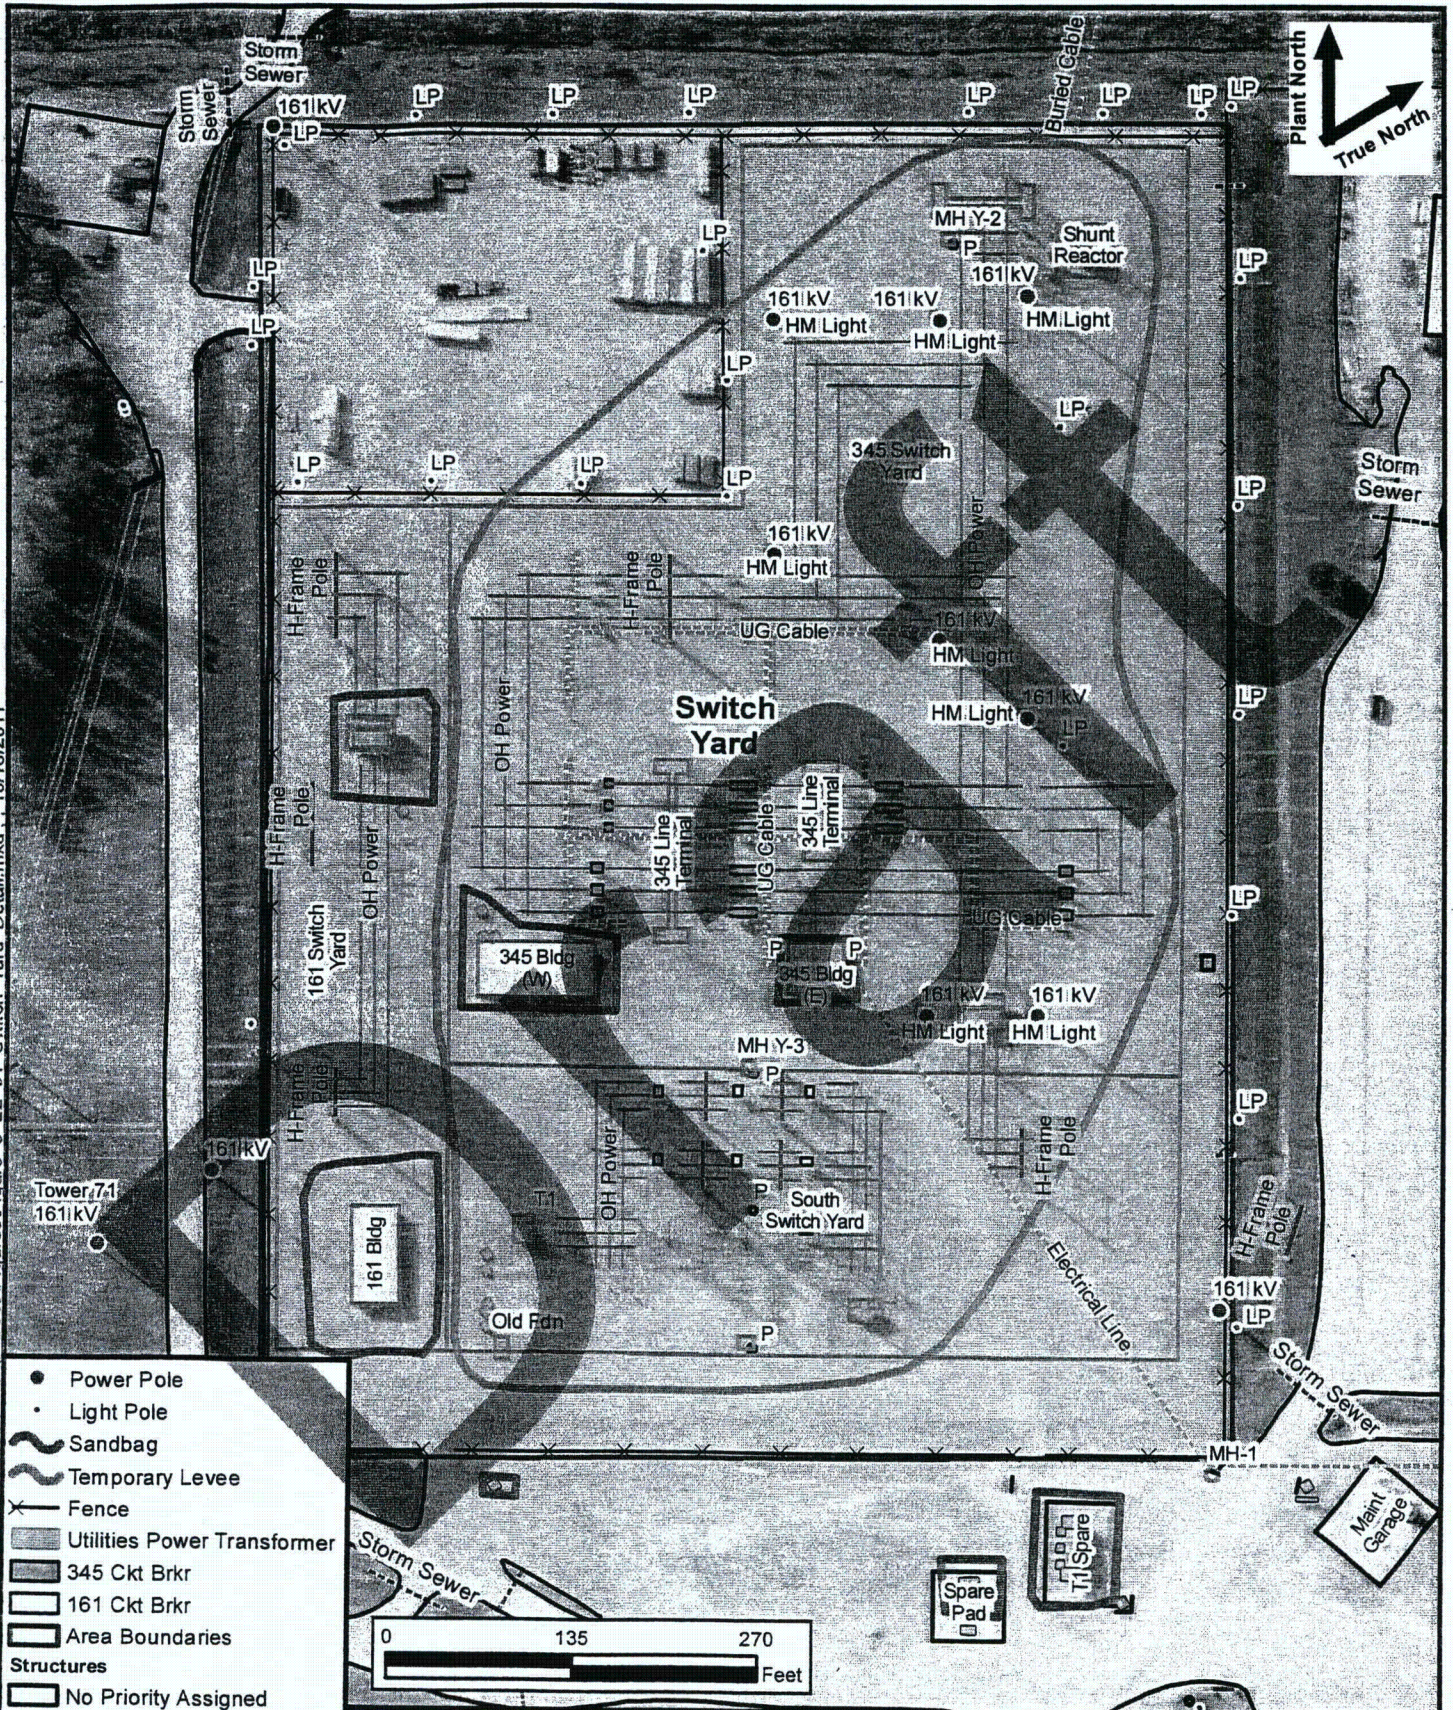
Projects\OPPD\164565_FCS_2011_Flood_Services\Map Docs\Figures\Figure 5.22.01 Switch Yard Detail.mxd 10/13/2011

The South Switchyard is in the southern portion of the site (see Figure 5.22-1). All facilities in the South Switchyard are inside the temporary levee. A transformer structure (T1) is located in the southwest corner. A pre-existing oil containment berm comprised of rock surrounds the transformer. Storm drain pipes carrying flow from the area inside the containment berm were plugged due to inundation of the outlet pipes. Parts of the storm intake were observed at the southwest containment area. A second transformer structure (T2) is located in the southeast corner. An oil containment berm comprised of rock surrounds the transformer. Storm drain pipes carrying flow from the area inside the containment berm were plugged due to inundation of the outlet pipes. An erosion channel in the west bank of the drainageway to the east was observed as possibly the outlet for the storm outlet pipe. Parts of the storm intake were observed at the northeast containment area. The South Switchyard area has overhead Switch Towers and Transmission Towers that were subjected to saturated subgrades. Underground utilities between the structures were subjected to percolating floodwaters. A manhole structure southwest of T2 had the lid removed and was being pumped at the time of the inspection. A precast trench heads west from the manhole to another vault in the southwest corner of the Switchyard. The lids from the precast trench have been removed and are adjacent to the trench. The precast trench opening into the manhole is open. The trench is nearly full of sediment the farther the distance from the manhole, with water up to the top surface at the west end. The visual appearance of the sediment in the trench suggests that the manhole pump pulled in the sediment from around the trench until the pump was turned off and the water drained out, leaving the sediment. Low areas inside the levee on the south and east end have ponded water up to a few inches deep.
