2.0 SITE HISTORY, DESCRIPTION, AND BASELINE CONDITION

Plant and Facility Geotechnical
and Structural Assessment

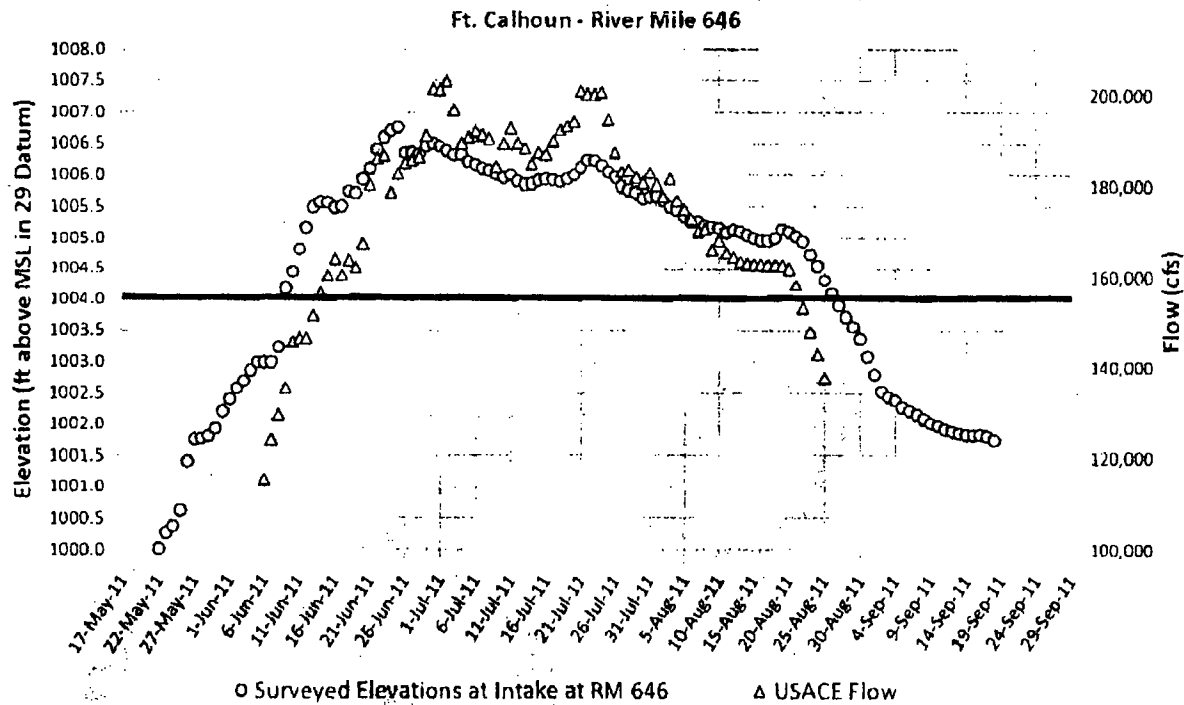
Figure 2-7 – Flow and Water Surface Elevations (June through August) for Fort Calhoun Station, RM 646

Because FCS is located along the Missouri River (see Figure 2-5), as the releases at Gavins Point Dam were increased, floodwater encroached on the FCS site. Figure 2-7 presents the water surface elevations as surveyed on site at RM 646 and the flow rate as predicted by USACE and interpolated to RM 646 by HDR. As discussed previously, the peak water surface elevation at FCS occurred on June 25, 2011, at an elevation of 1006.85 ft.

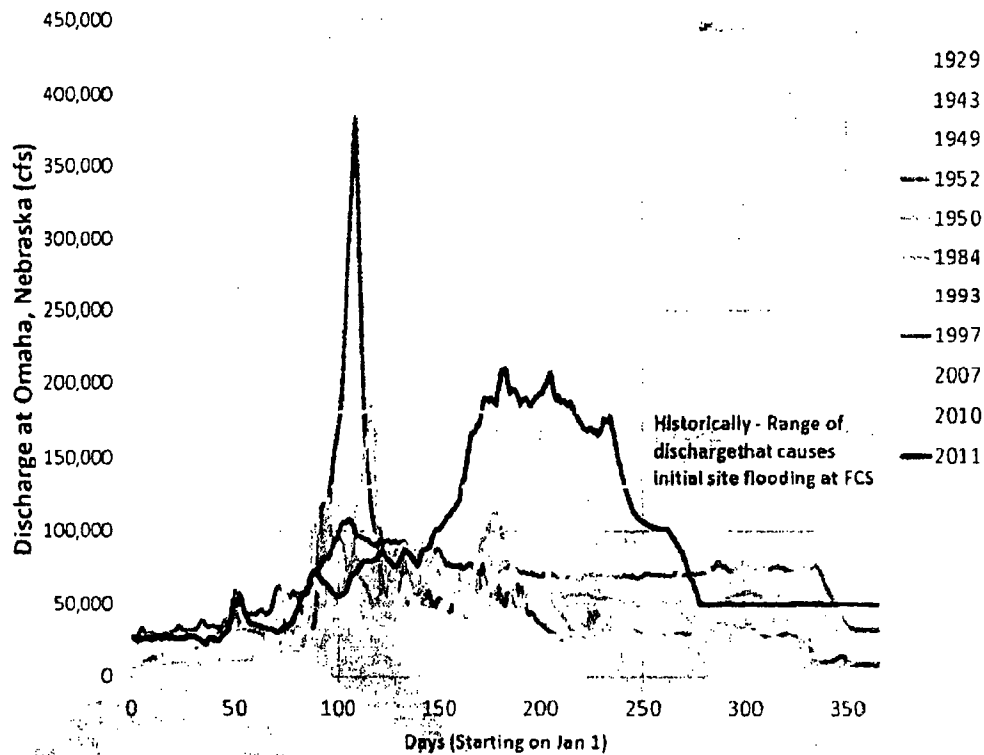
Figure 2-8 – Comparison of Discharges on the Missouri River at Omaha in Years when Flooding Occurred (1928 to 2011)

flows that flooded the site in 2011. Of the five flood events at the FCS site (1929, 1943, 1949, 1952, and 2011), the first four all receded from the site within 7 to 14 days. The 2011 event covered the FCS site for almost 75 days.

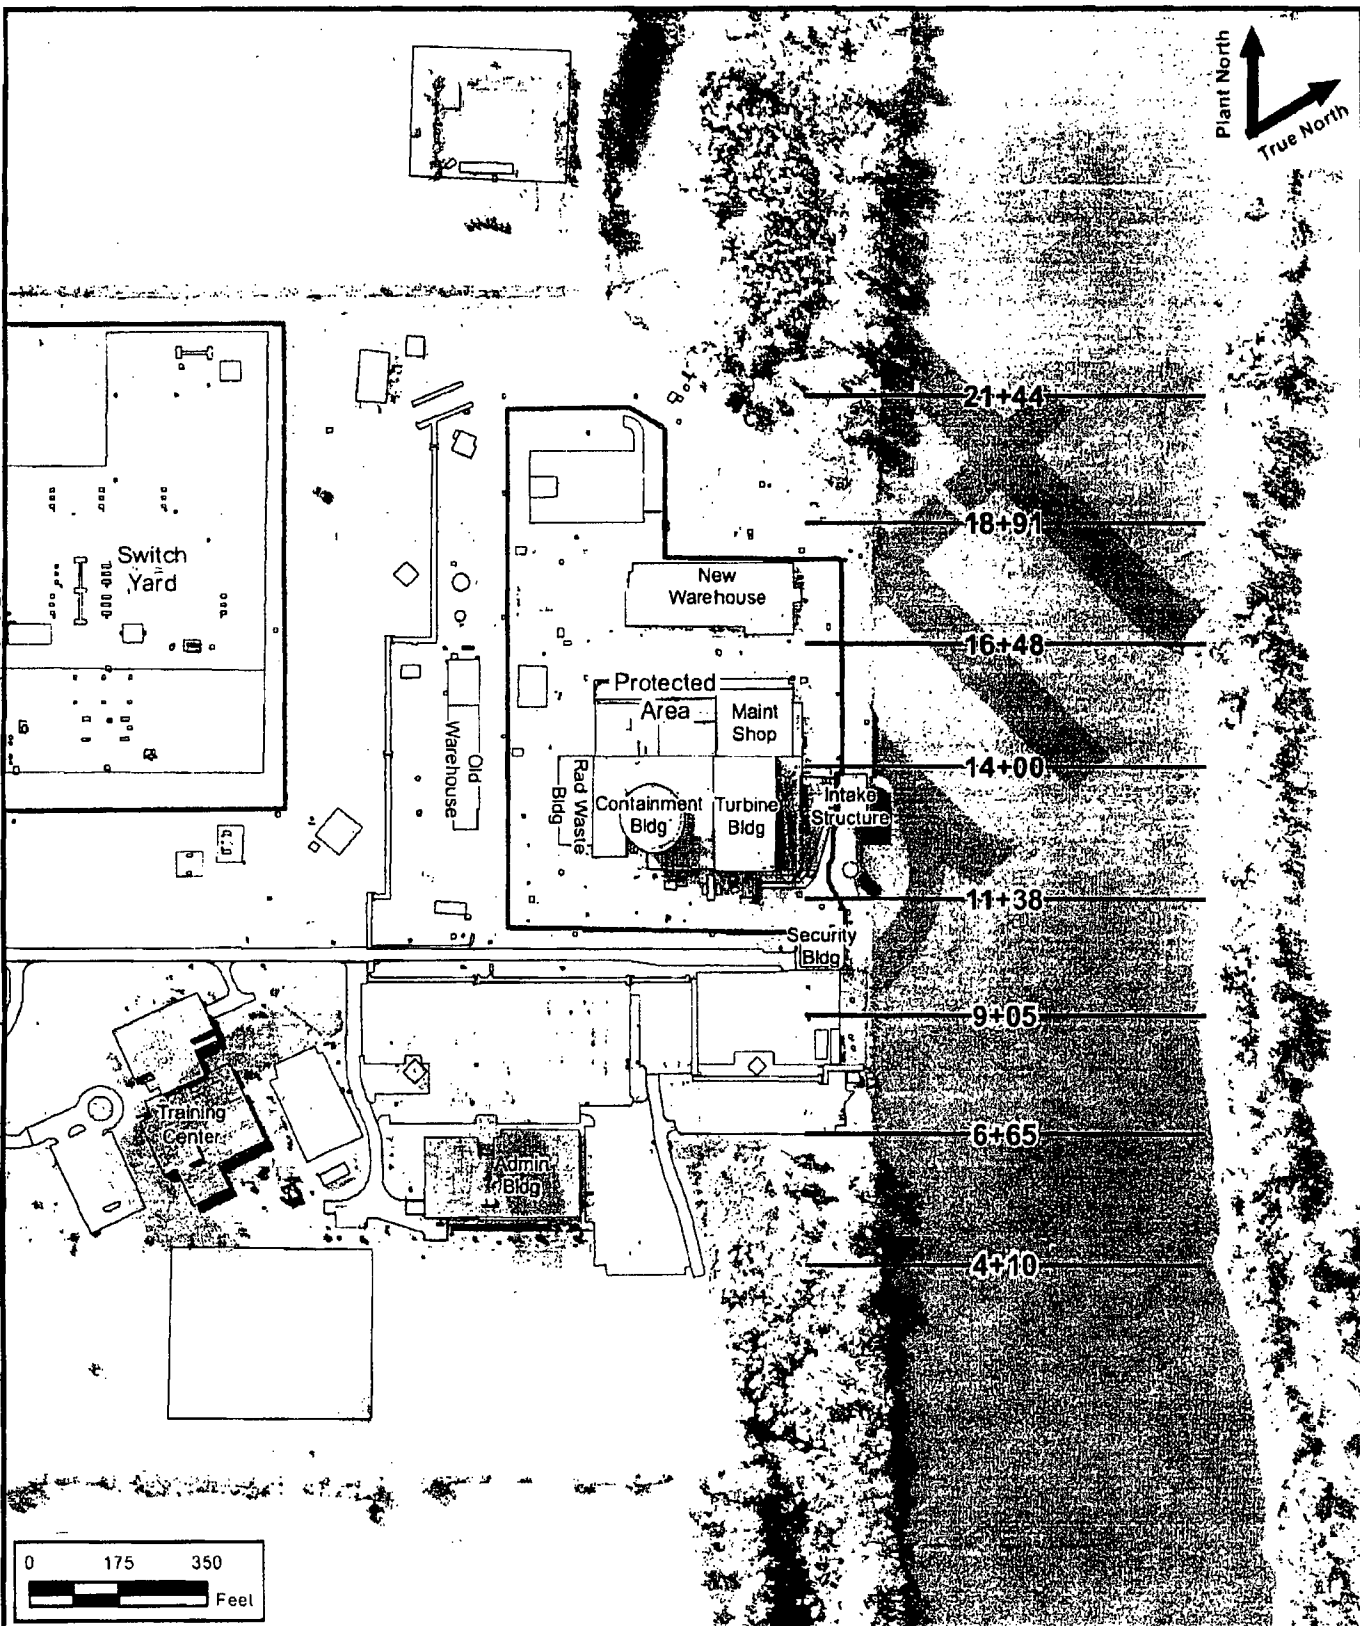
Hydraulic Cross-Section Stations
Fort Calhoun Station
 Plant and Facility Geotechnical and Structural Assessment

As a result of flood flows, additional channel degradation and bank erosion have occurred in the vicinity of FCS. A detailed evaluation of changes in the stage-discharge rating curves applicable to the Missouri River near FCS is being performed at this time. USGS surveyed the river in the vicinity of FCS in fall 2008 and again on July 25, 2011. The survey in 2008 was performed in National Geodetic Vertical Datum of 1929 (NGVD 29), and the survey in 2011 was performed in North American Vertical Datum of 1988 (NAVD 88) and converted to NGVD 29. Figure 2-9 shows the locations of the surveyed hydraulic cross sections, and Figure 2-10 shows a comparison of the channel bathymetry throughout the surveyed reach between 2008 and 2011 at Stations 4+10 and 6+65. Figures 2-11, 2-12, and 2-13 provide comparisons of the remaining surveyed hydraulic cross sections. It is clear that the channel has degraded by 10 ft or more across most of the channel. This is true in all the cross sections from station 4+10 to 21+44.

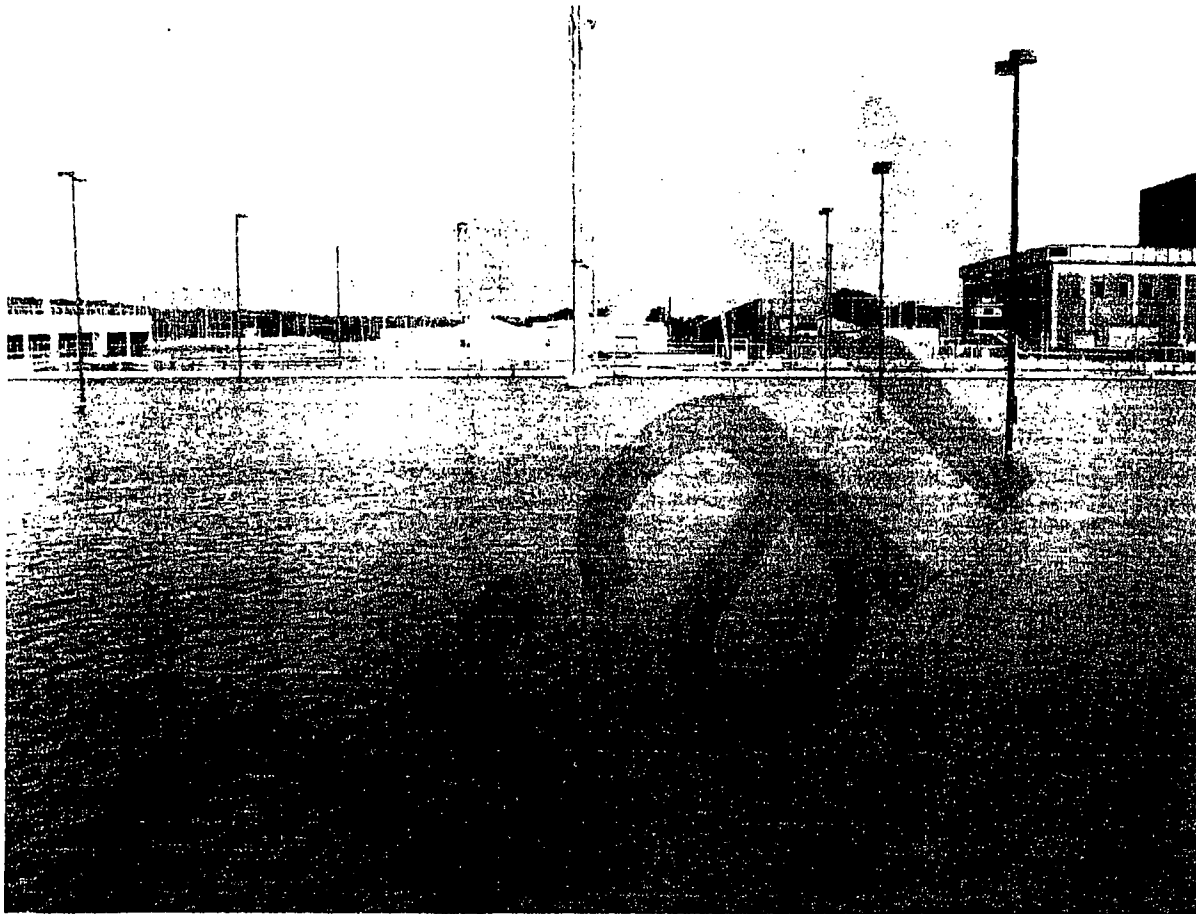
On July 12, 2011, personnel from HDR visited FCS to observe and investigate the impact of floodwater on FCS. Photos 1 and 2 are images of floodwater at FCS. Flow paths and velocities through FCS as observed are shown in Figure 2-14. A figure depicting the high water elevations as surveyed is provided in Figure 2-15.

Photo 1 – Floodwater at FCS, Looking North from the Administration Building toward the Old Warehouse

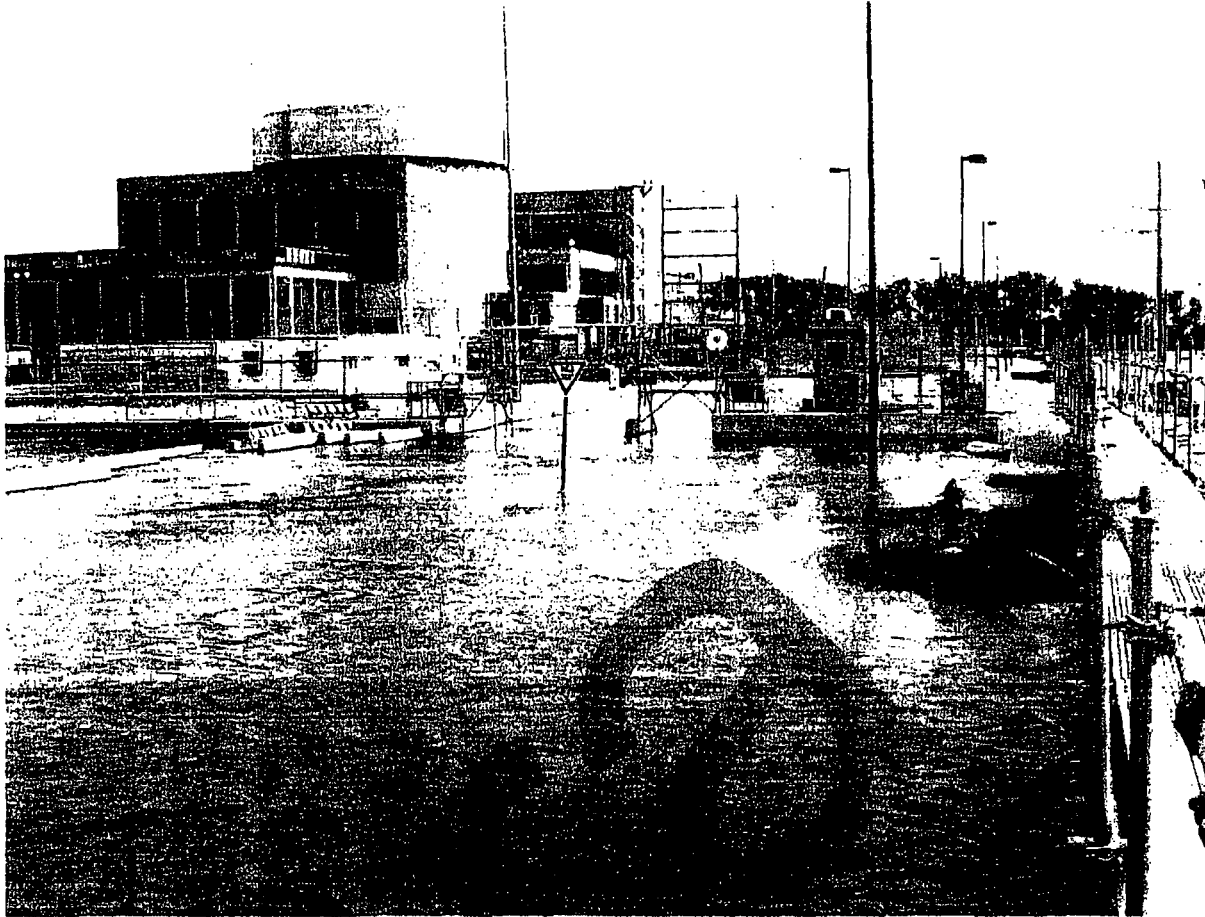
Photo 2 – Floodwater at FCS, Looking East toward the Containment

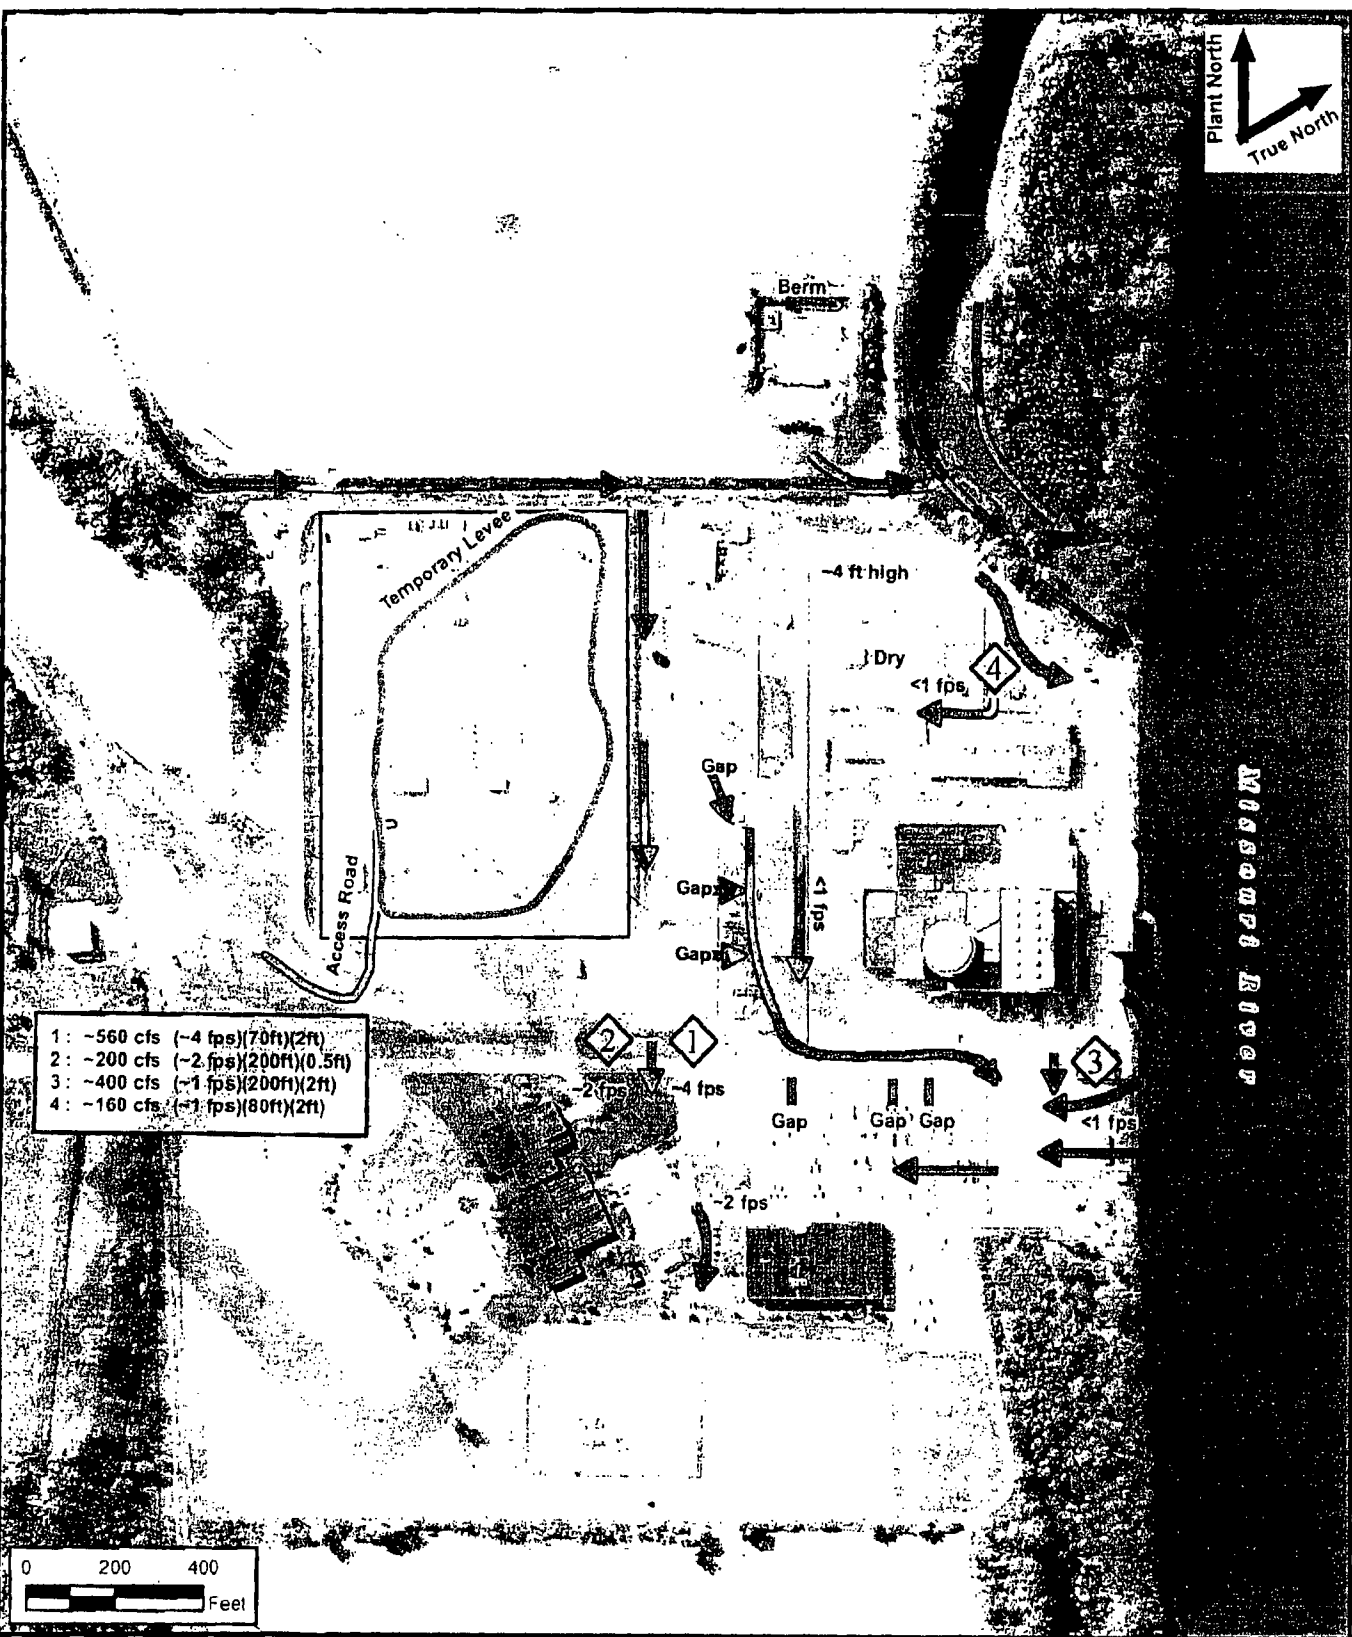
- 1: ~560 cfs (~4 fps)(70ft)(2ft)
- 2: ~200 cfs (~2 fps)(200ft)(0.5ft)
- 3: ~400 cfs (~1 fps)(200ft)(2ft)
- 4: ~160 cfs (~1 fps)(80ft)(2ft)
