APPENDIX C
AREA WALK-BY CHECKLISTS (AWCs)

Area Walk-By Checklist (AWC)

Room 105 Floor El. 545 Bldg. AUXB

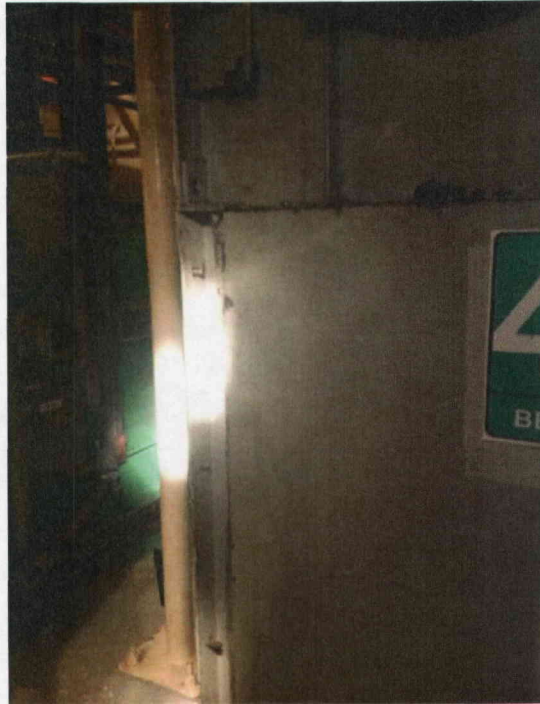
<i>Anchorage for cover plate of E31-4 does not have nuts, see Photo 2. Concern has been judged not to represent an adverse condition regarding the component's seismic performance.</i> | X | | | |

Photo 2
Missing Nuts on Cover of E31-4

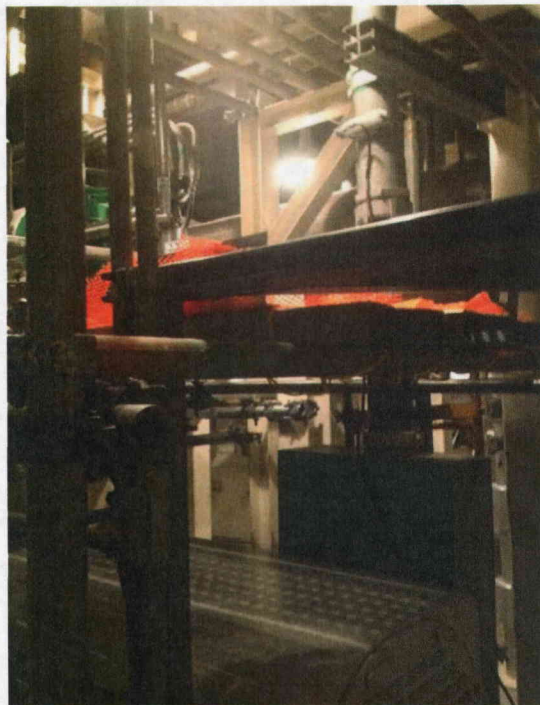
Photo 3
Temporary Scaffolding Restrained

Temporary scaffolding installed in area, judged not likely to cause interaction.

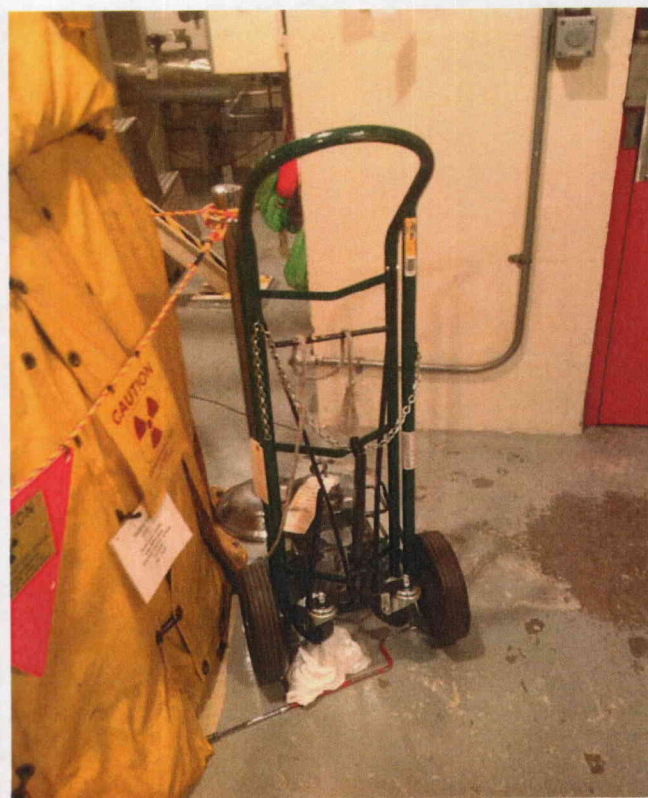
A dolly was found unrestrained in the area. Since the dolly had restraining chains on it, it was judged that it is temporarily located at the position found in the room and will be returned to its storage location and tied when work is done. Also, no sensitive equipment found in the vicinity of this dolly.

Photo 2
Unrestrained Dolly in Area

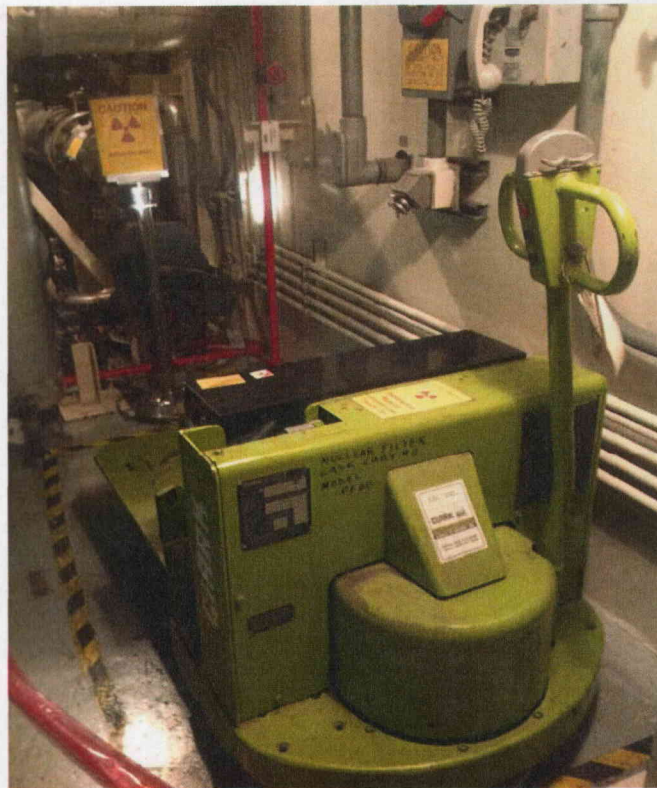
Nuclear filter cask cart unrestrained adjacent to components. There are no sensitive equipment in the zone of influence of this cart and it is judged OK. It is also noted that this cart appear to be temporarily in the area.

Photo 2
Nuclear Filter Cask Cart Not Restrained

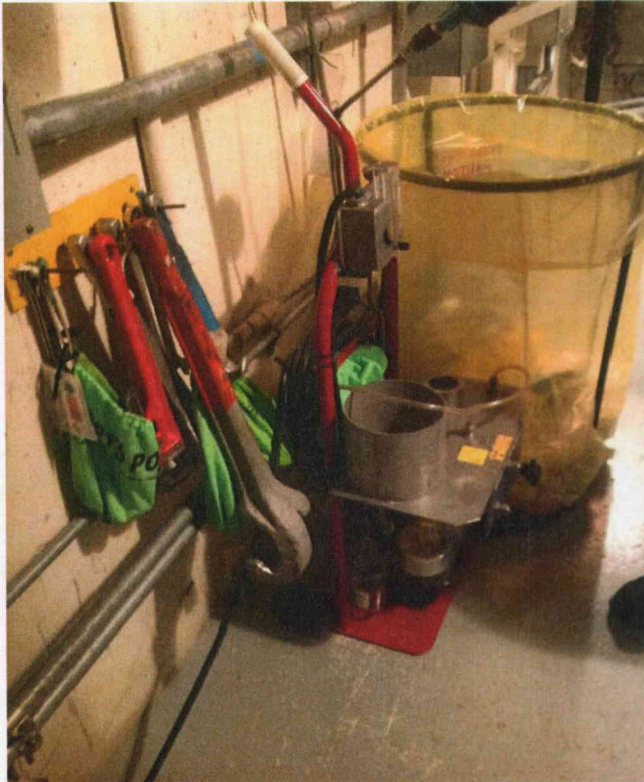
*RP cart and dolly not restrained.
In a subsequent visit to his area on the next day, it was observed that this cart was properly restrained.*

Photo 1
Dolly Not Restrained

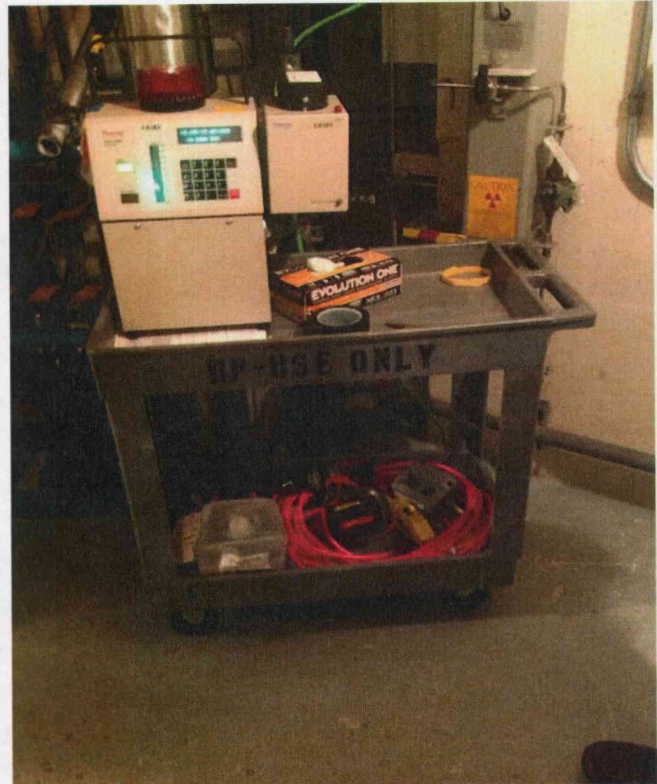
Photo 2
RP Cart Not Restrained

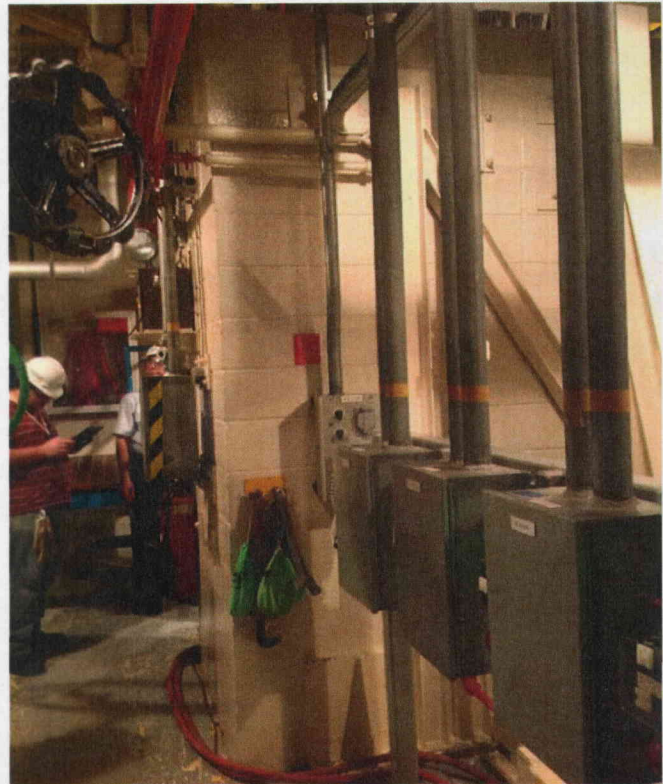
Photo 2
Masonry Wall

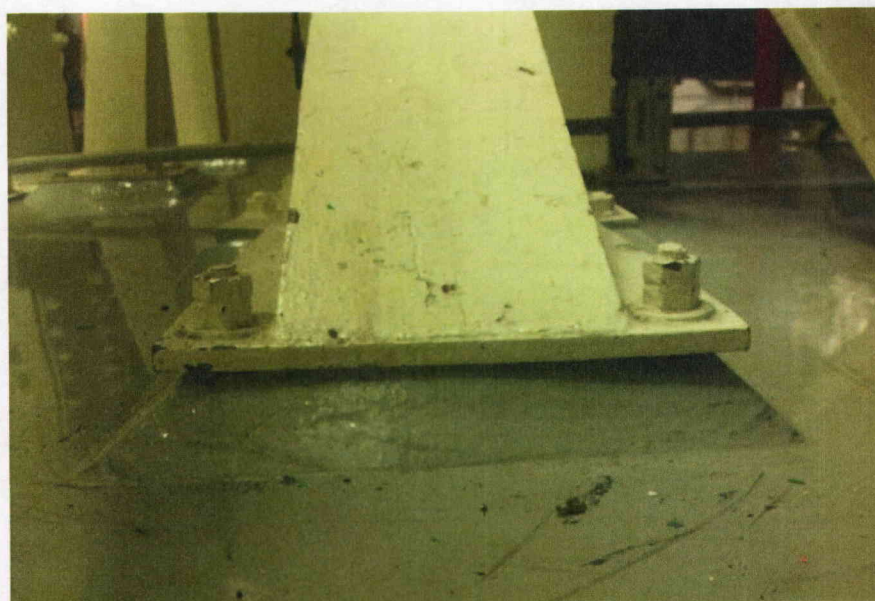
Photo 2
Gap Between Grout and Anchor Plate

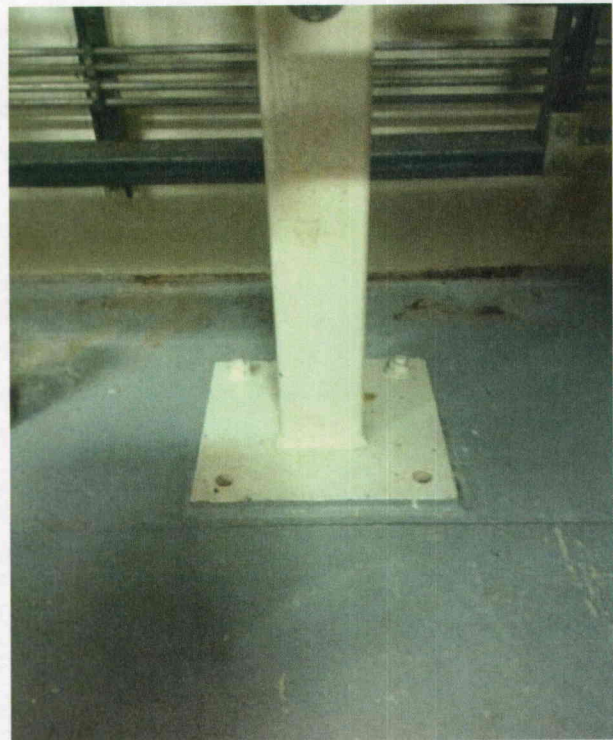
Photo 2
Missing Anchor Bolts

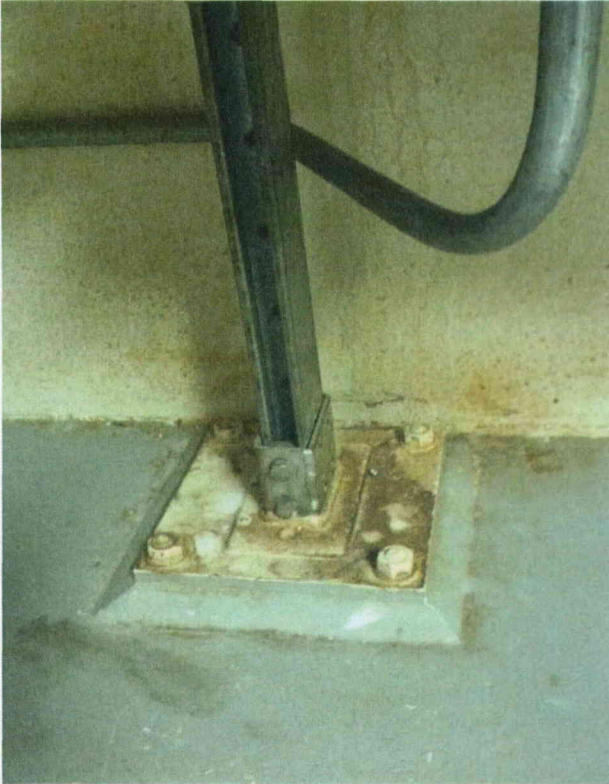
Photo 3
Minor Corrosion on
Anchor Plate

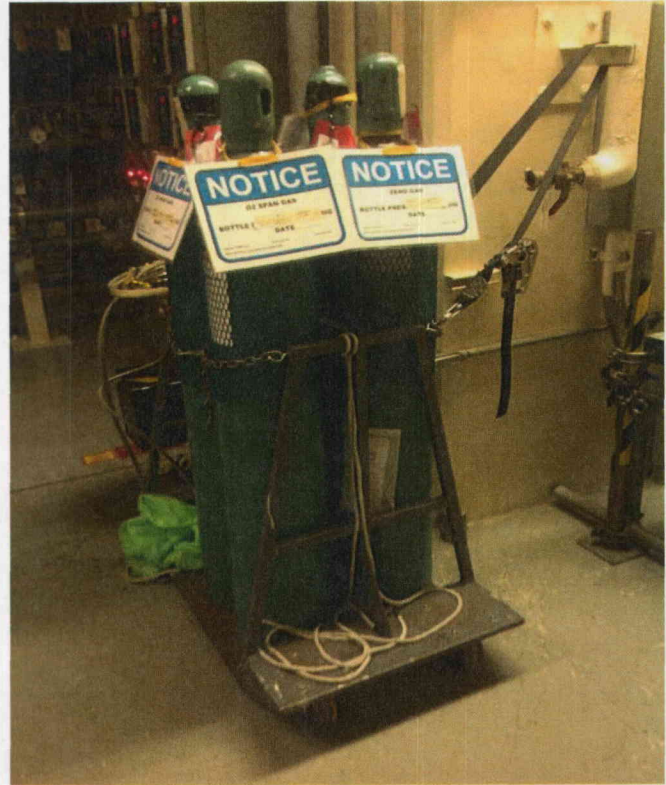
Photo 4
Cart Containing Gas Canisters
Loosely Restrained

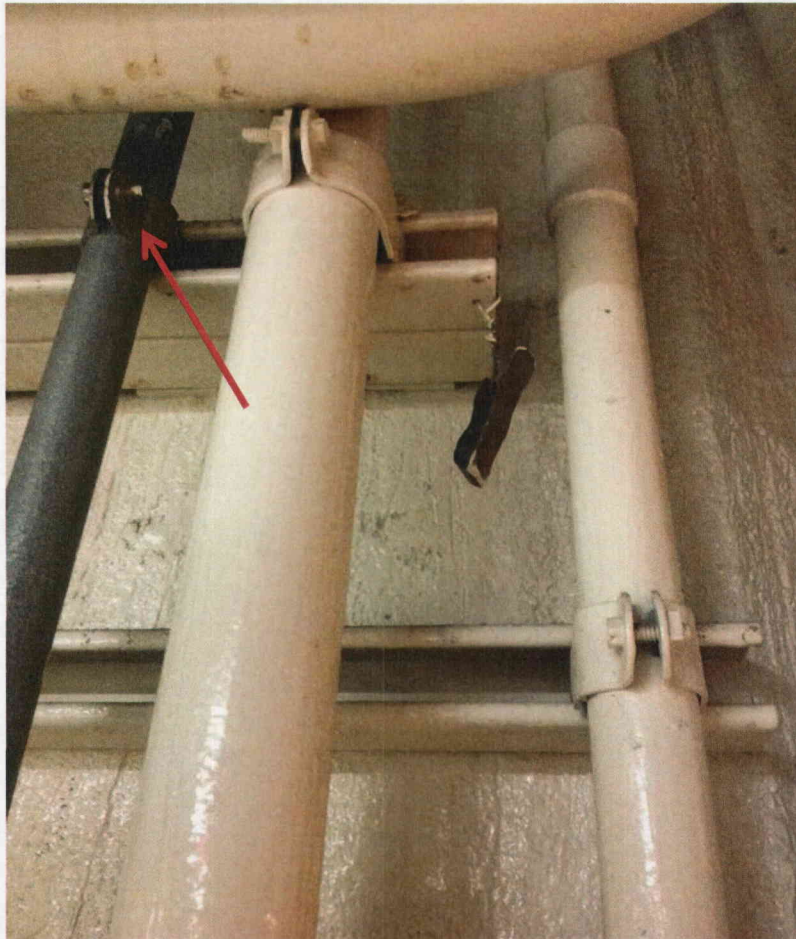
Photo 1
Nut Missing on Conduit

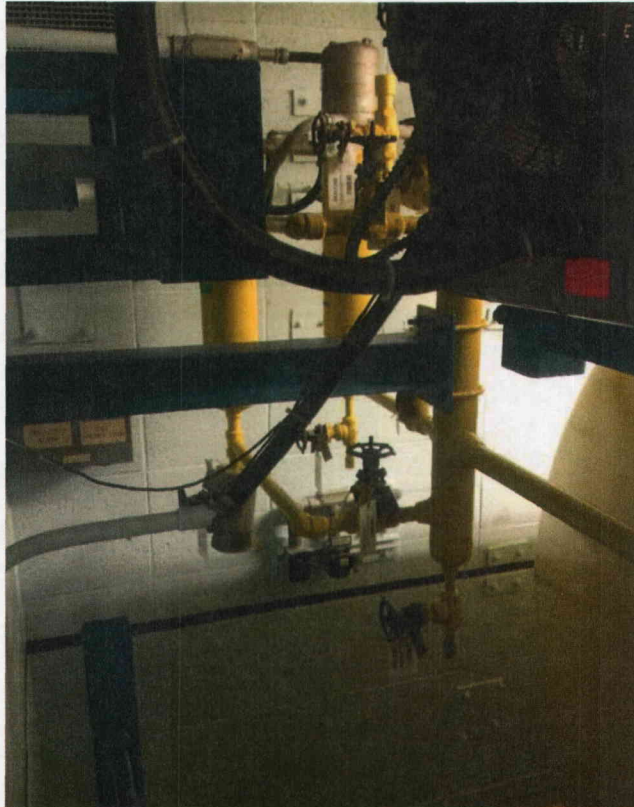
**Photo 1
Masonry Wall**

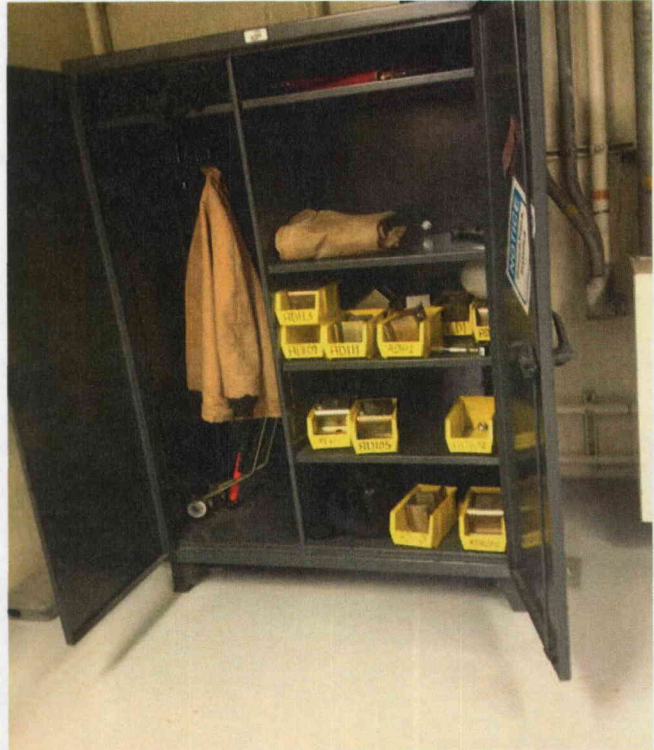
Photo 2
Supply Cabinet Left Open

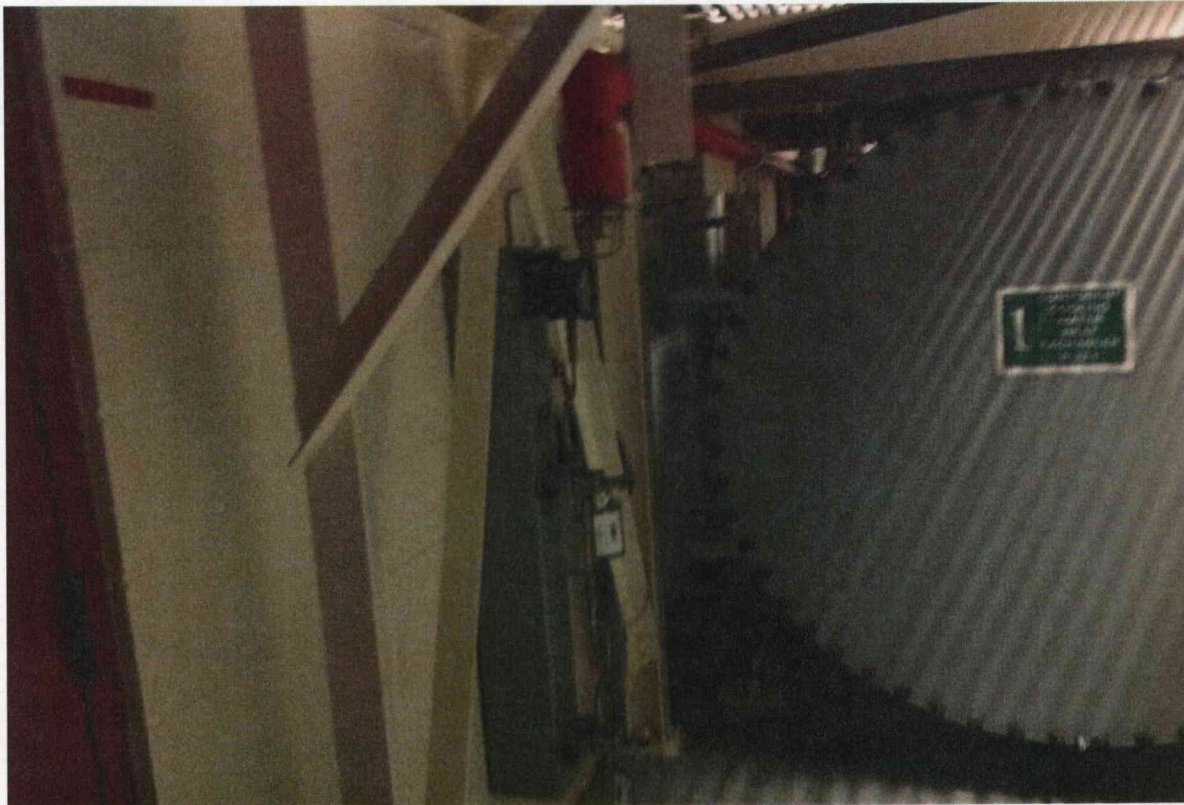
Photo 1
General View of Room 328
Masonry Wall Adjacent to Heat Exchange E22-1

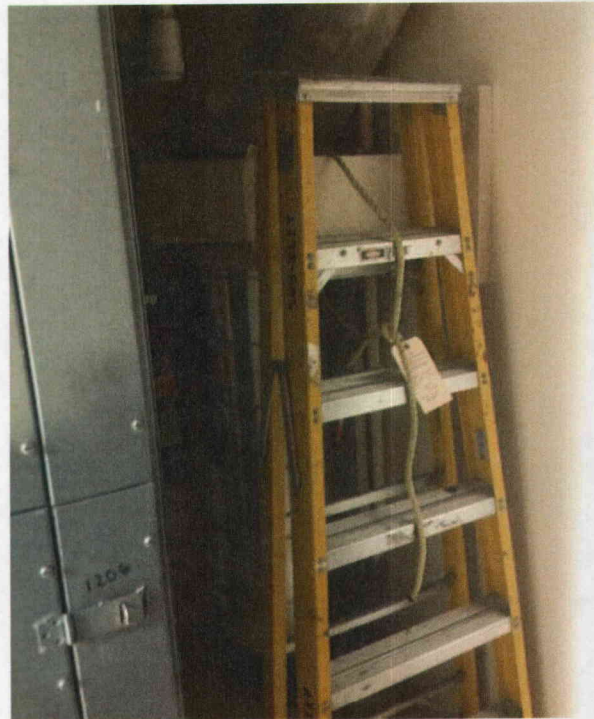
Photo 2
Ladder Loosely Tied Adjacent to MCC F11A

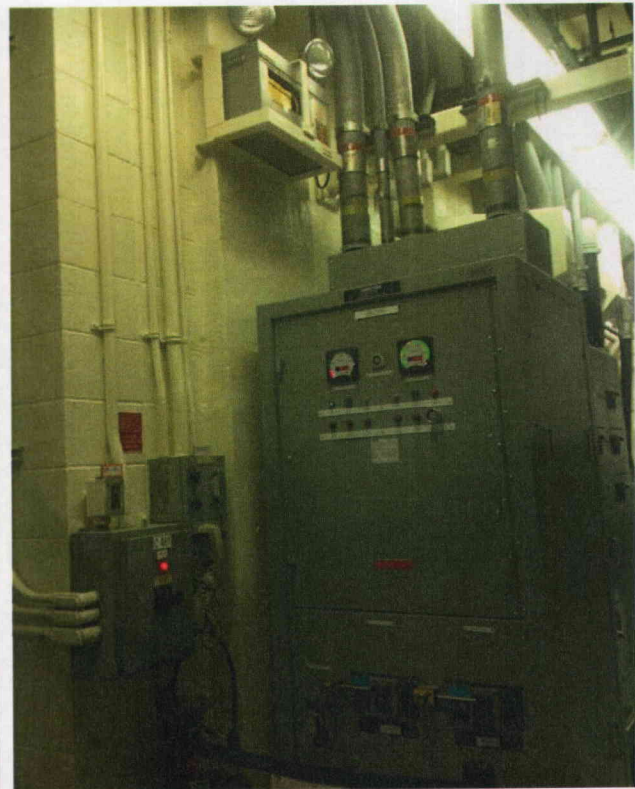
Photo 2
Masonry Wall Adjacent to Components

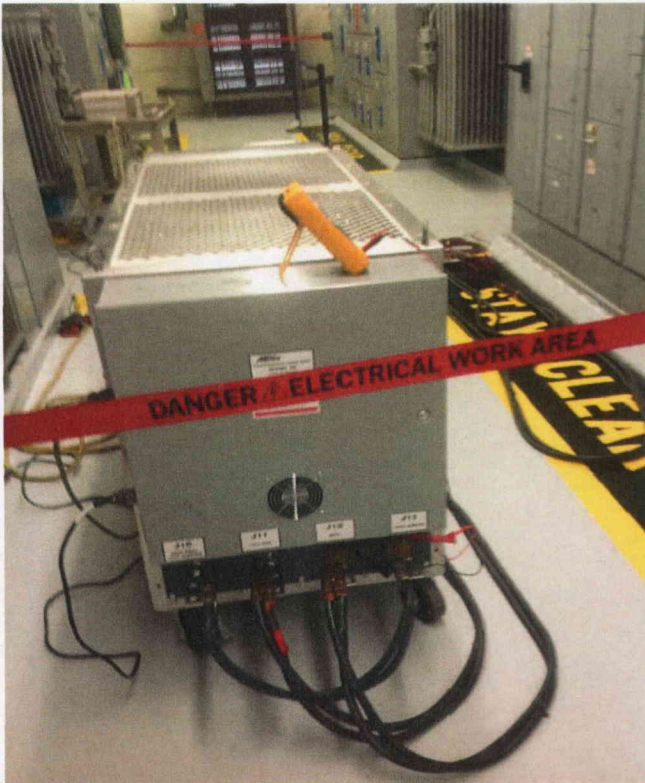
Photo 3
Unrestrained Work Cart

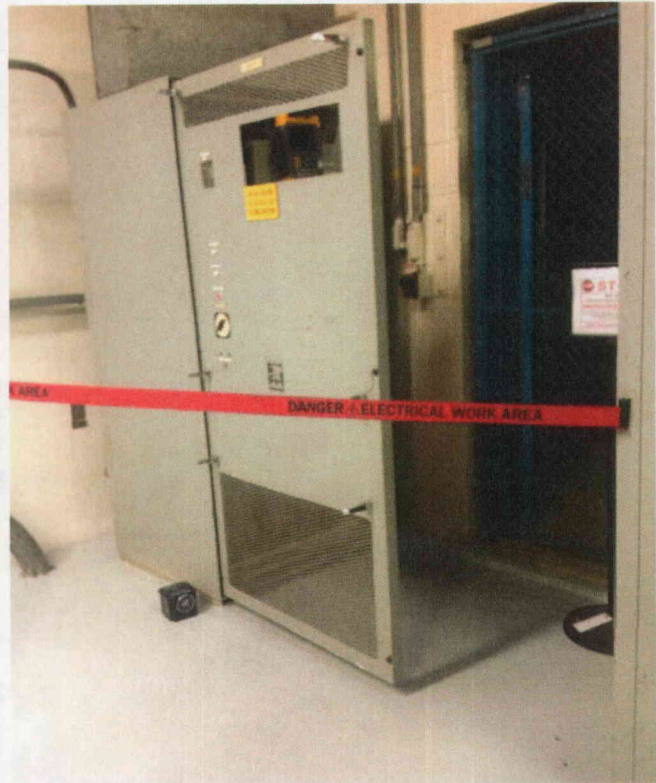
Photo 4
Cabinet DCB-2P Door Left Open

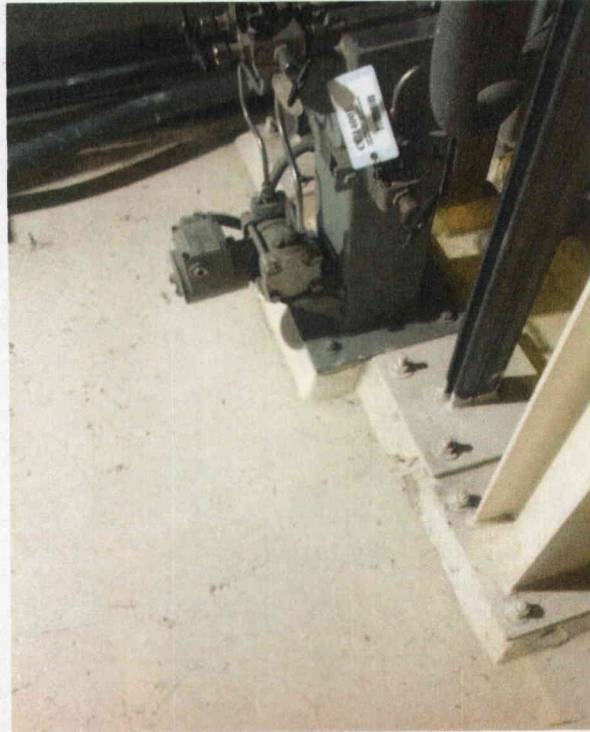
Photo 1
Damaged Grout

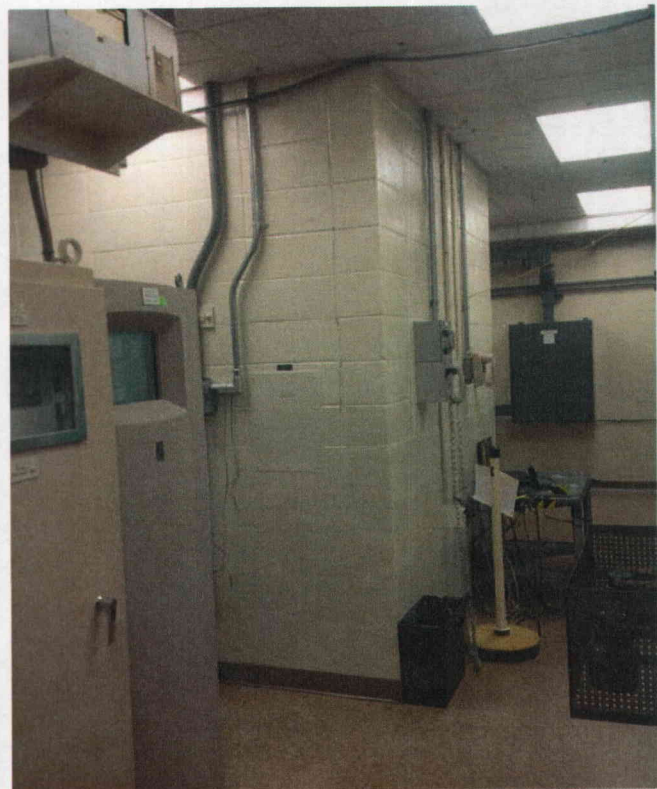
Photo 2
Crack in Masonry Wall

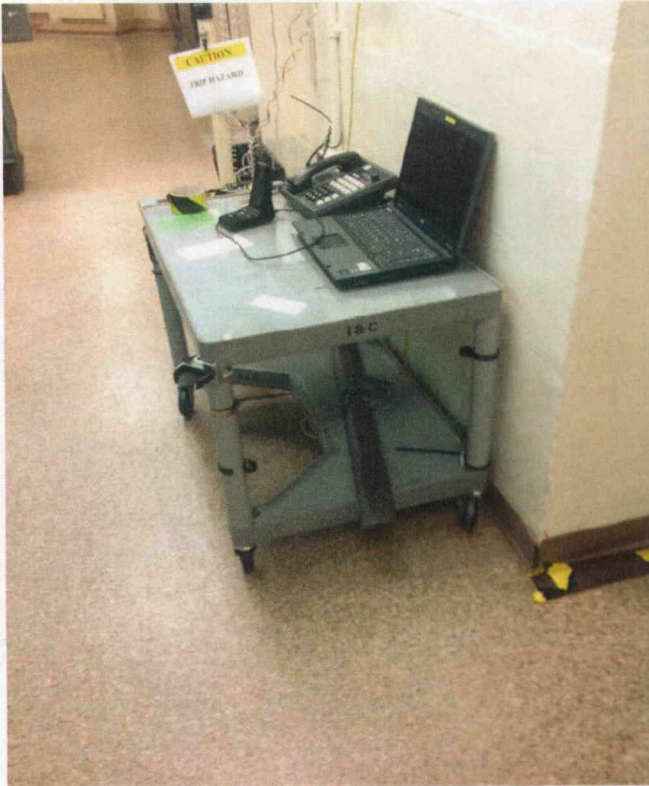
Photo 3
Unrestrained I&C Cart

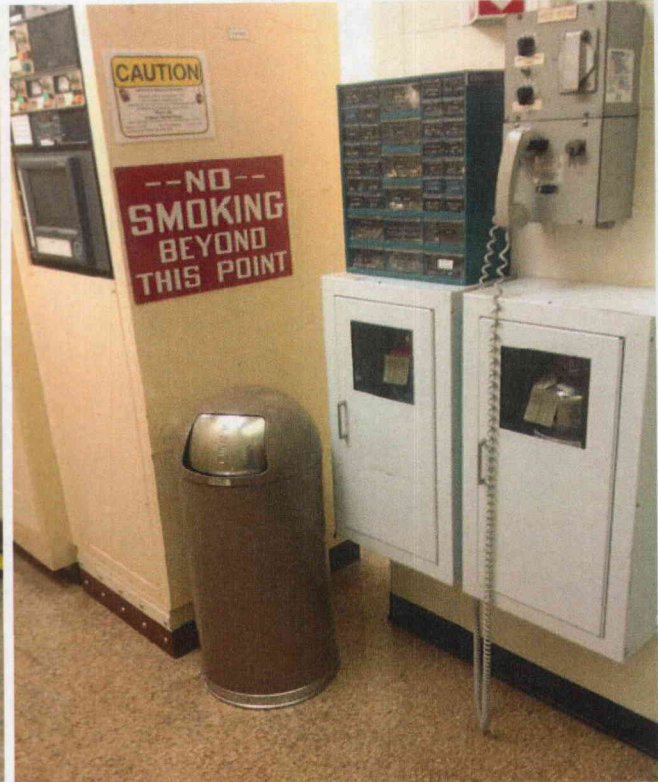
Photo 4
Unrestrained Trash Can and Light Bulb Storage

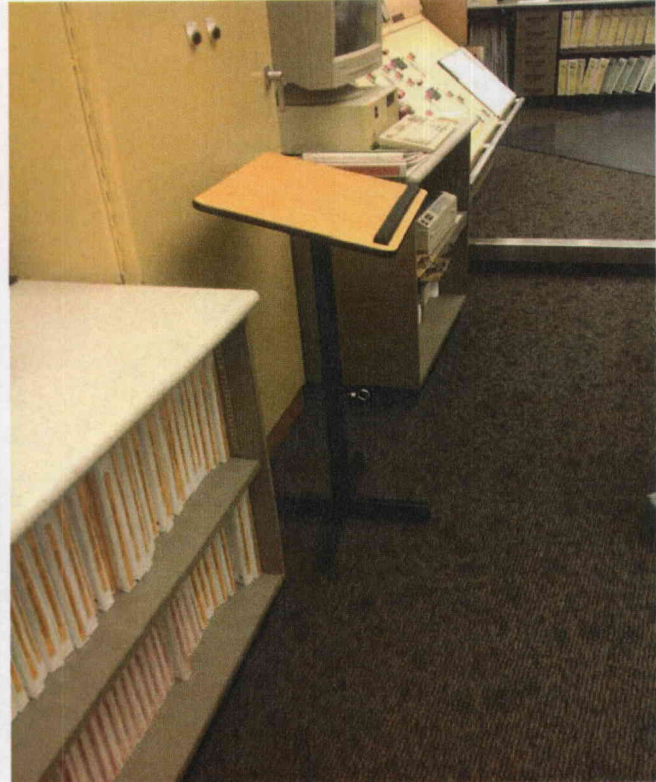
Photo 2
Small Podium Not Anchored

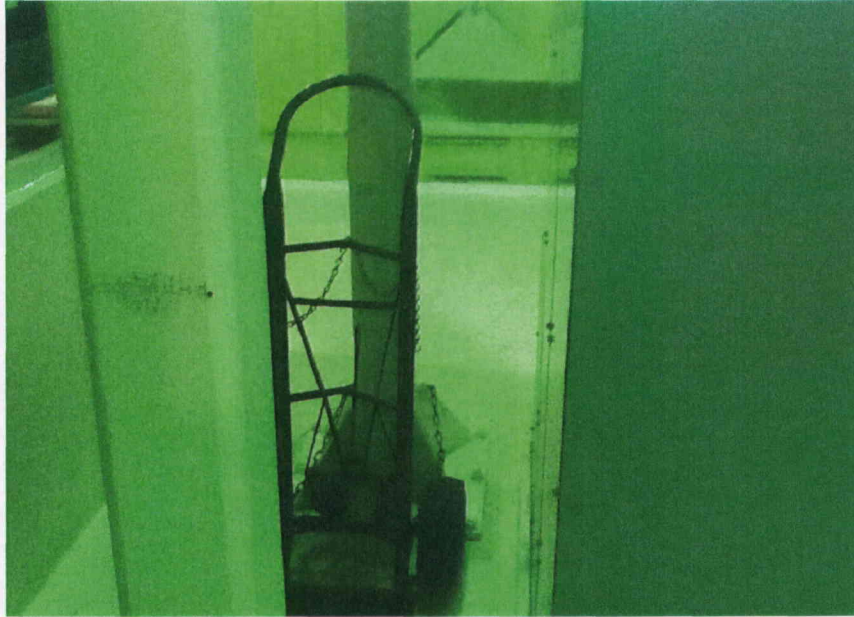
Loosely Tied Dolly in Room 515

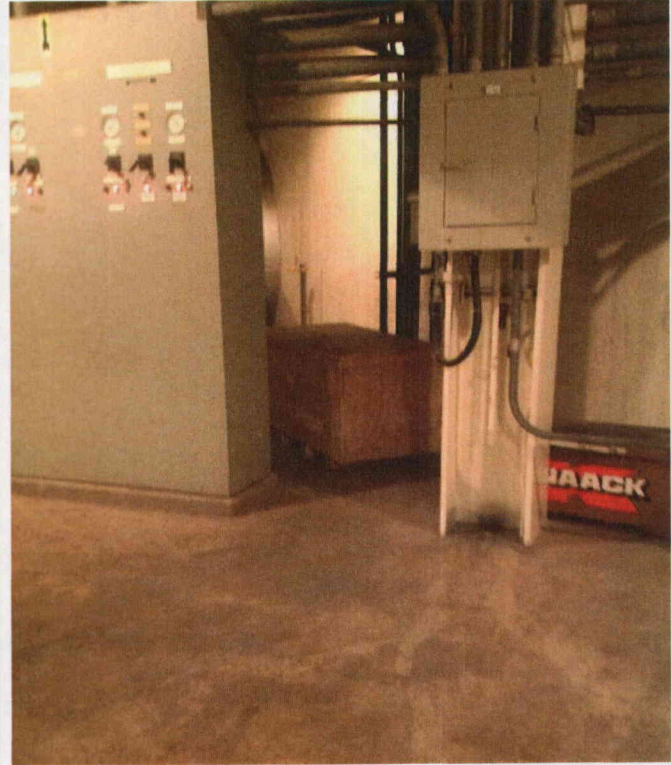
Photo 2
Unrestrained Storage Containers

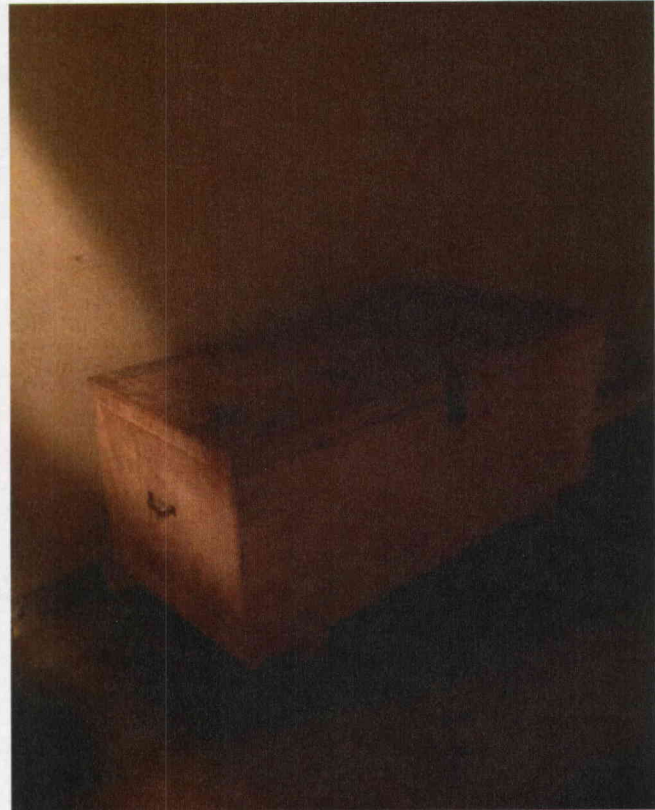
Photo 2
Unrestrained Storage Container

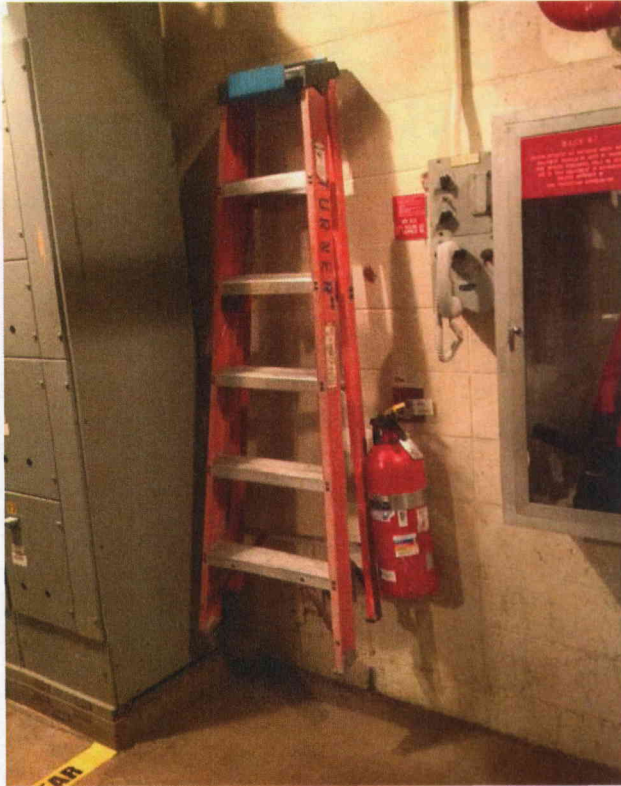
Photo 1
Fire Extinguisher not Restrained
and Masonry Wall

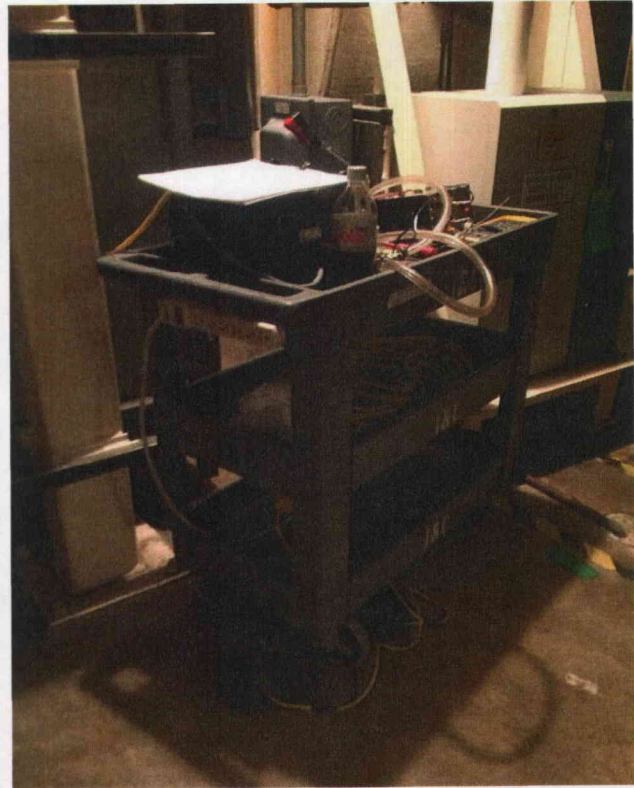
Photo 2
Cart Not Restrained

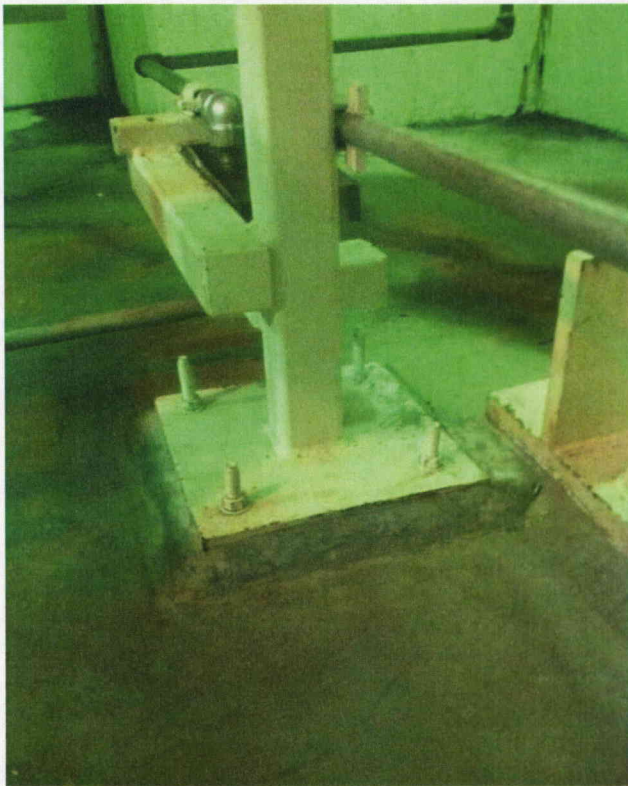
Photo 1
Anchor Threading
Substantially Past Nut

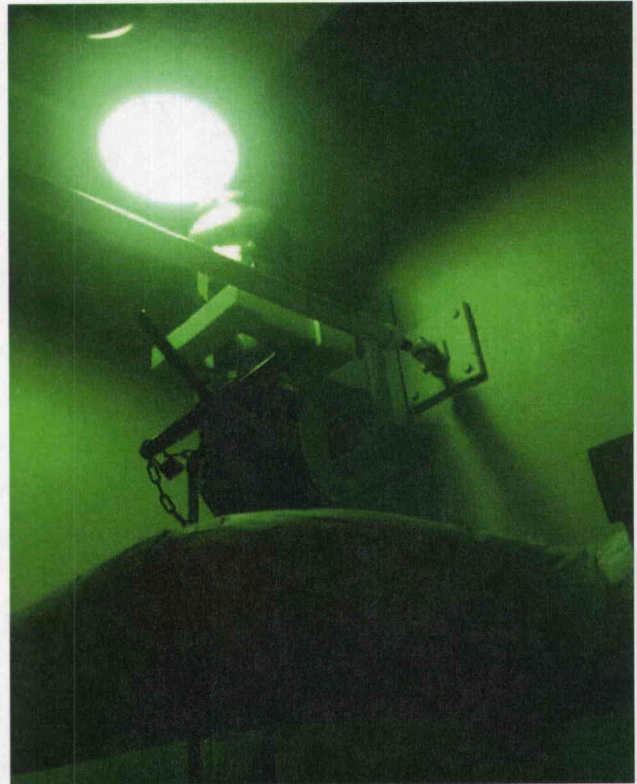
Photo 2
Hanging Light
Touching Component

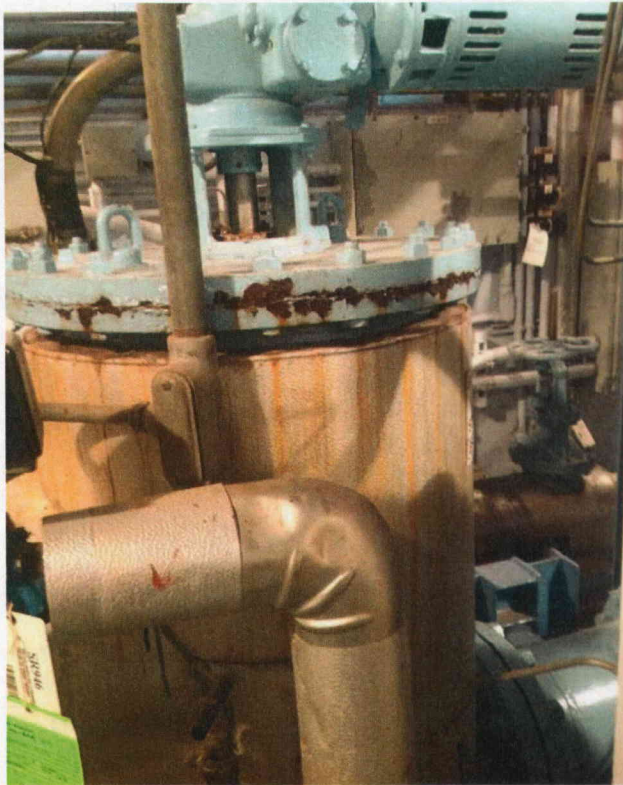
Photo 1
Minor Corrosion

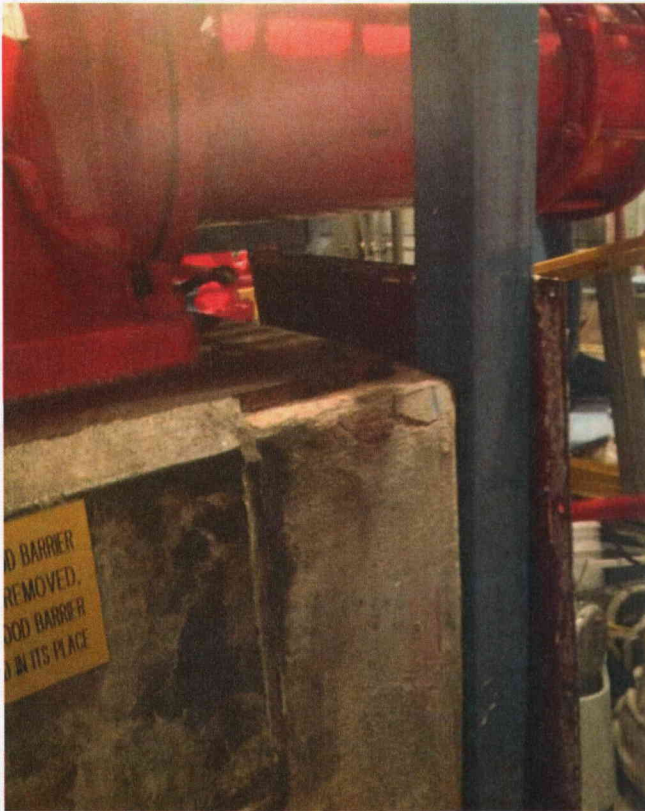
Photo 1
Damaged Grout

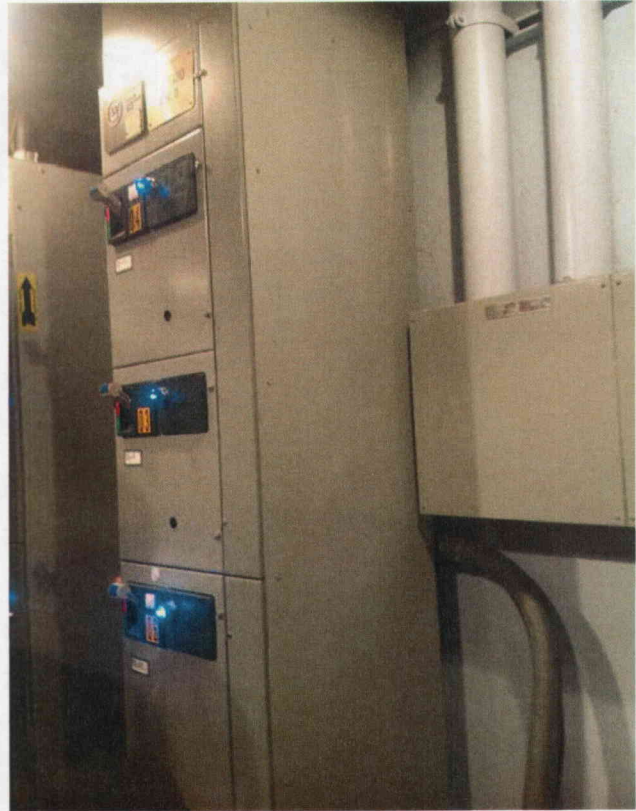
Photo 2
**Movement of MCC Restrained
by Adjacent Component**

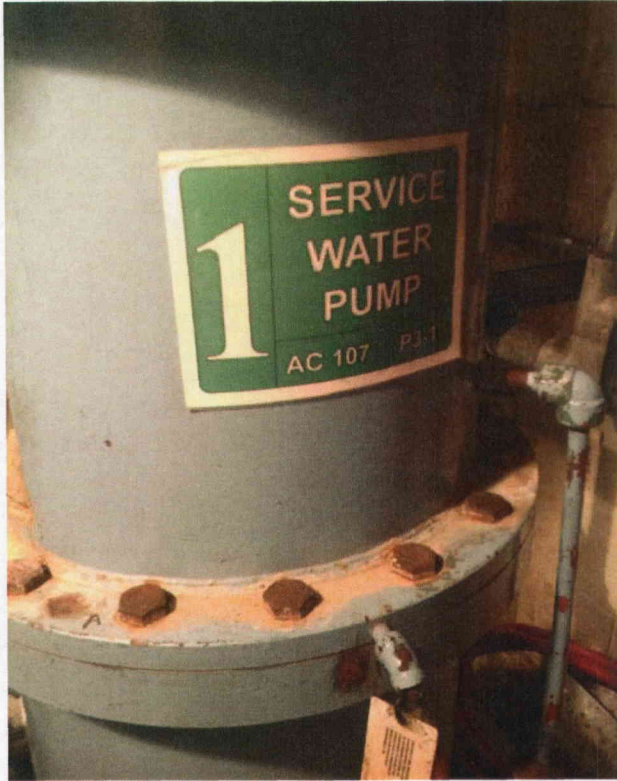
Photo 1
Minor Corrosion of Pump P3-1

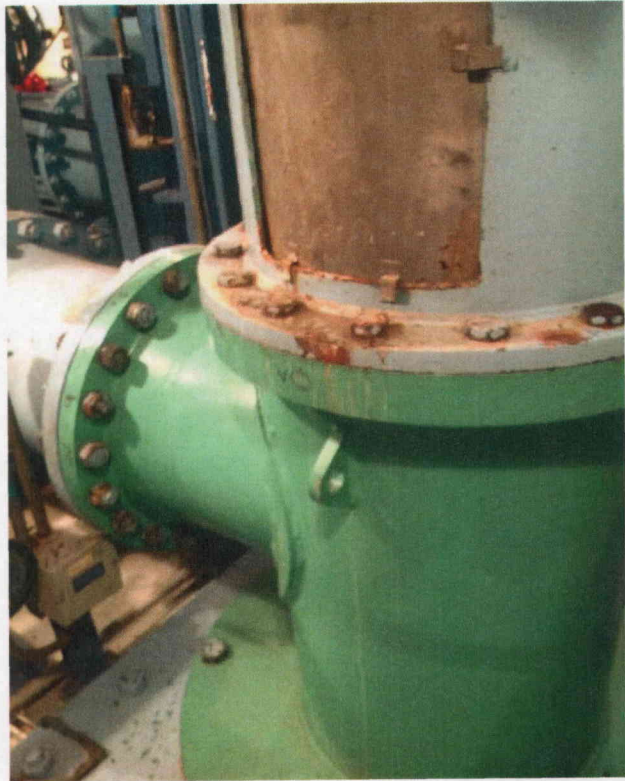
Photo 2
Minor Corrosion of Pump P3-3

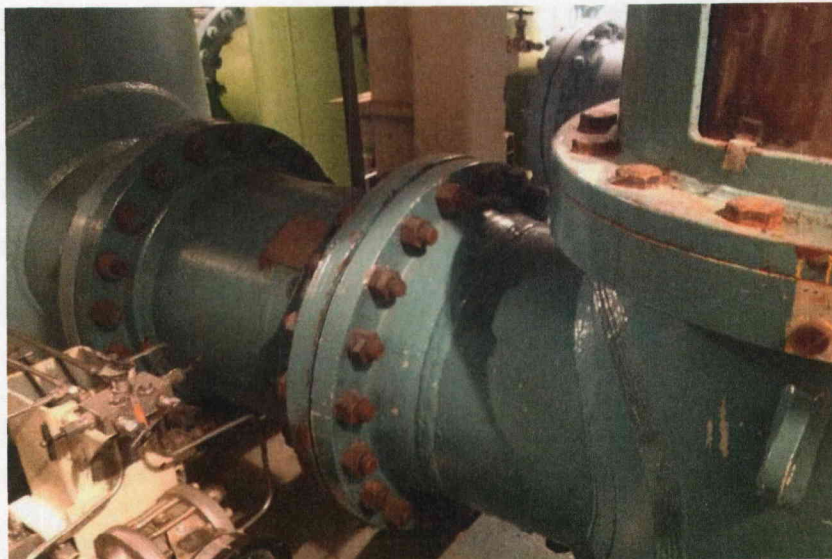
Photo 3
Minor Corrosion of Pump P3-2

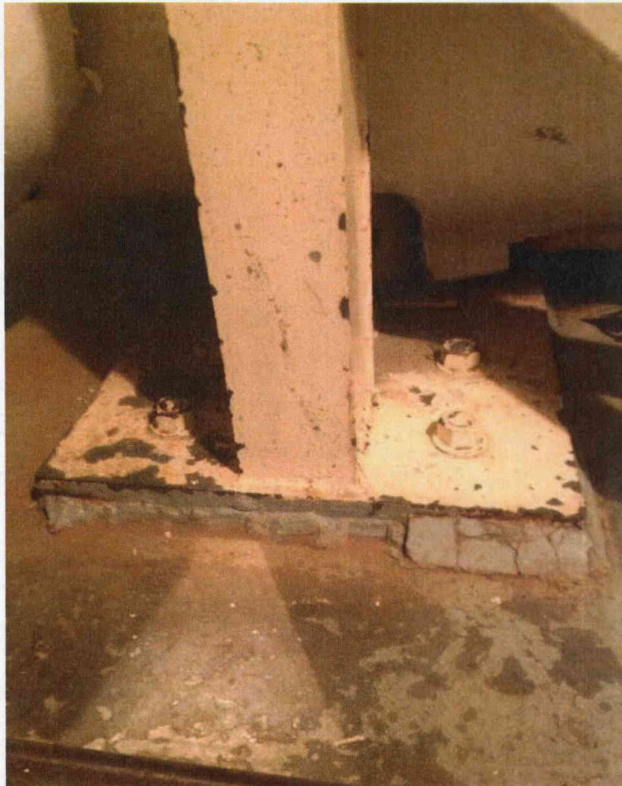
Photo 1
Damaged Grout

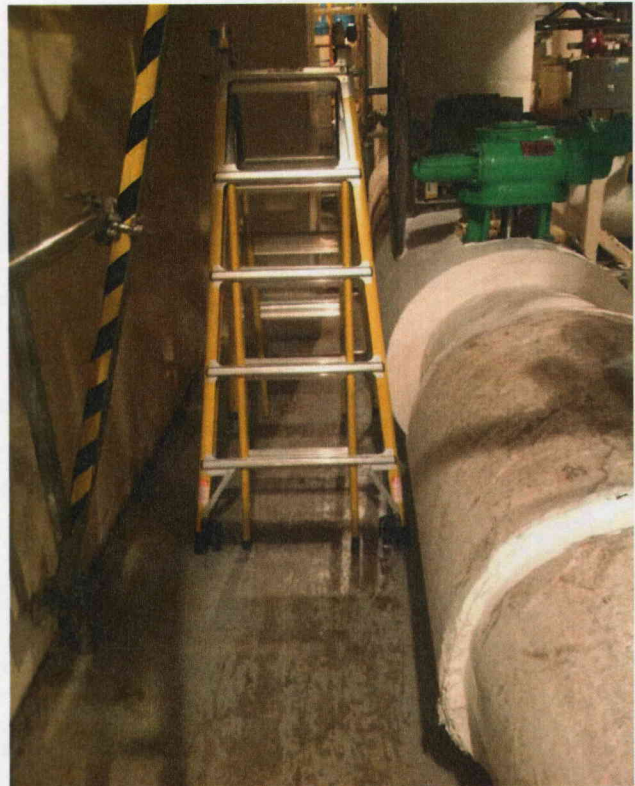
Photo 2
Ladder Not Restrained
