May 7, 2014

SUBJECT: PALISADES NUCLEAR PLANT INTEGRATED INSPECTION REPORT
05000255/2014002

Inspection Report (IR) 05000255/2014002, 01/01/2014 – 03/31/2014; Palisades Nuclear Plant; Equipment Alignment; Inservice Inspection Activities; Refueling and Other Outage Activities; Radiological Hazard Assessment and Exposure Controls.

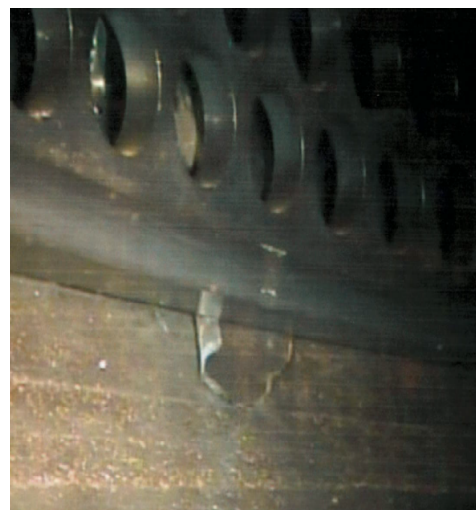
The 2014 refueling outage included the removal of the core barrel to support more comprehensive reactor vessel inspections than can typically be conducted. This activity was pre-planned for reasons not related to the pump impeller concern, but coincidentally allowed for a more thorough inspection for foreign material in the reactor vessel. The licensee anticipated finding the suspected broken piece from the PCP-C vibration event in October 2011 in the vessel. The reactor vessel FOSAR activities identified two pieces of broken impeller; one piece was removed from the vessel and the other piece was lodged between the reactor vessel and the bottom corner of the flow skirt. The licensee attempted to remove the lodged piece using several methodologies, including pulling using vice grips and pushing using hydraulic tools. Despite the application of approximately 3,000 pounds per square inch (psi) of force, the piece did not move.

View of the impeller piece looking up from below the flow skirt.

Since the licensee could not remove the impeller piece from the vessel, Operability Evaluation CR-PLP-2014-01510 was developed to evaluate the operability of the reactor vessel. The piece was tapered in thickness from $\frac{3}{16}$ inches to roughly one inch wide,
