SUBJECT: ARKANSAS NUCLEAR ONE, UNIT 2 – SUMMARY OF CONFERENCE CALL
WITH ENTERGY OPERATIONS, INC. TO DISCUSS 2014 STEAM
GENERATOR TUBE INSPECTIONS (TAC NO. MF3897)

SUMMARY OF MAY 27, 2014, CONFERENCE CALL
REGARDING SPRING 2014 STEAM GENERATOR INSPECTIONS

ARKANSAS NUCLEAR ONE, UNIT 2

STEAM GENERATOR TUBE INSPECTION DISCUSSION POINTS
ENERGY OPERATIONS, INC.
ARKANSAS NUCLEAR ONE, UNIT 2

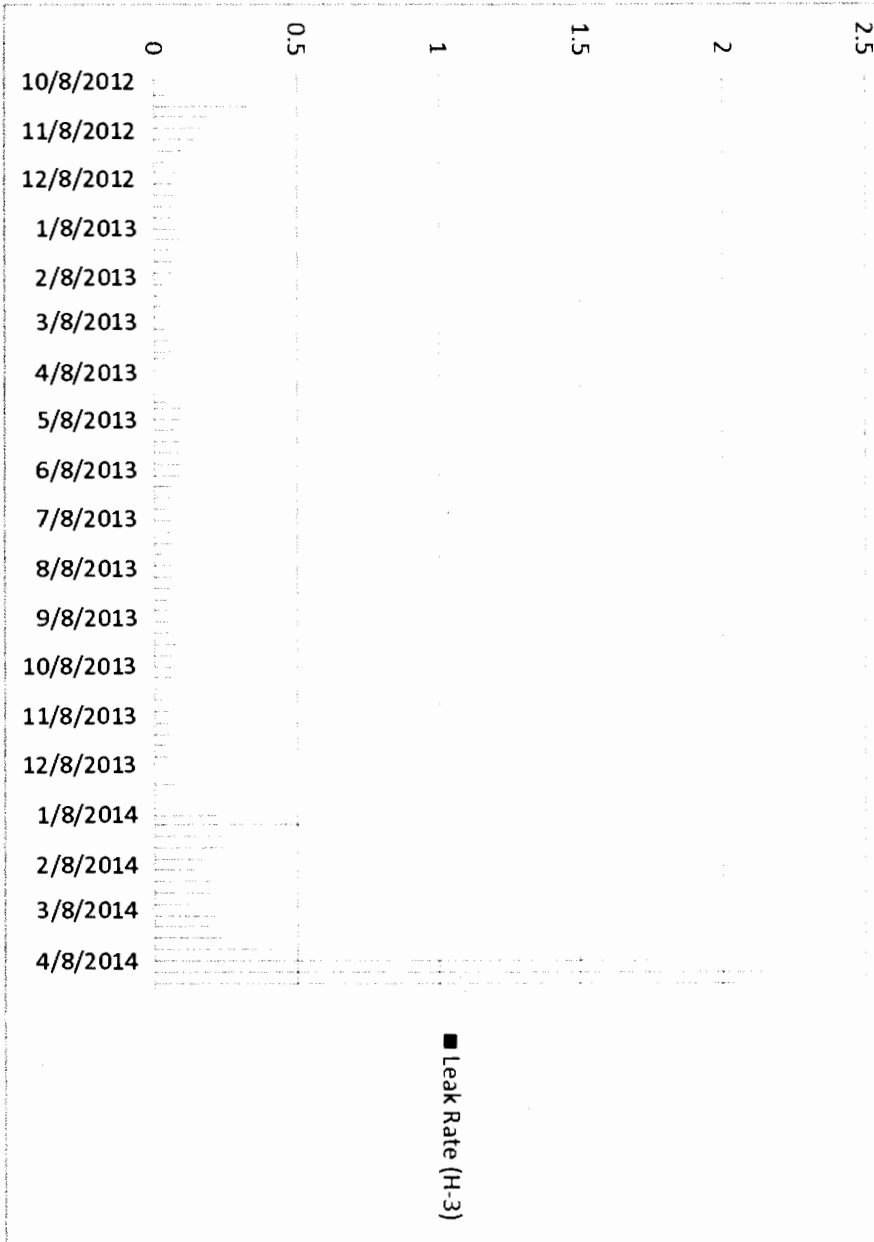
ANO2 SG Primary to Secondary Leak Rate (H-3) Gallons per Day (GPD)

- In the ANO-2 SG Primary to Secondary Leakrate (H-3) Gallons per Day (GPD) graph on page 7 of Enclosure 2, the y-axis units are GPD.
- Verification of anti-vibration bar (AVB) positions will be performed with eddy current auto analysis after the SG tube inspections are complete. The estimated time to complete the verification is 2 weeks.

No indication of primary-to-secondary leakage present prior to the current refueling outage (2R23).

(Argon – 41 less than minimum detectable, Tritium ~ 1 gallon per day)
