LOST CREEK ISR, LLC

September 19, 2014

**Re: 7-Day Notification of Spill – 11166 (Report #14)
Lost Creek ISR Project Permit #788**

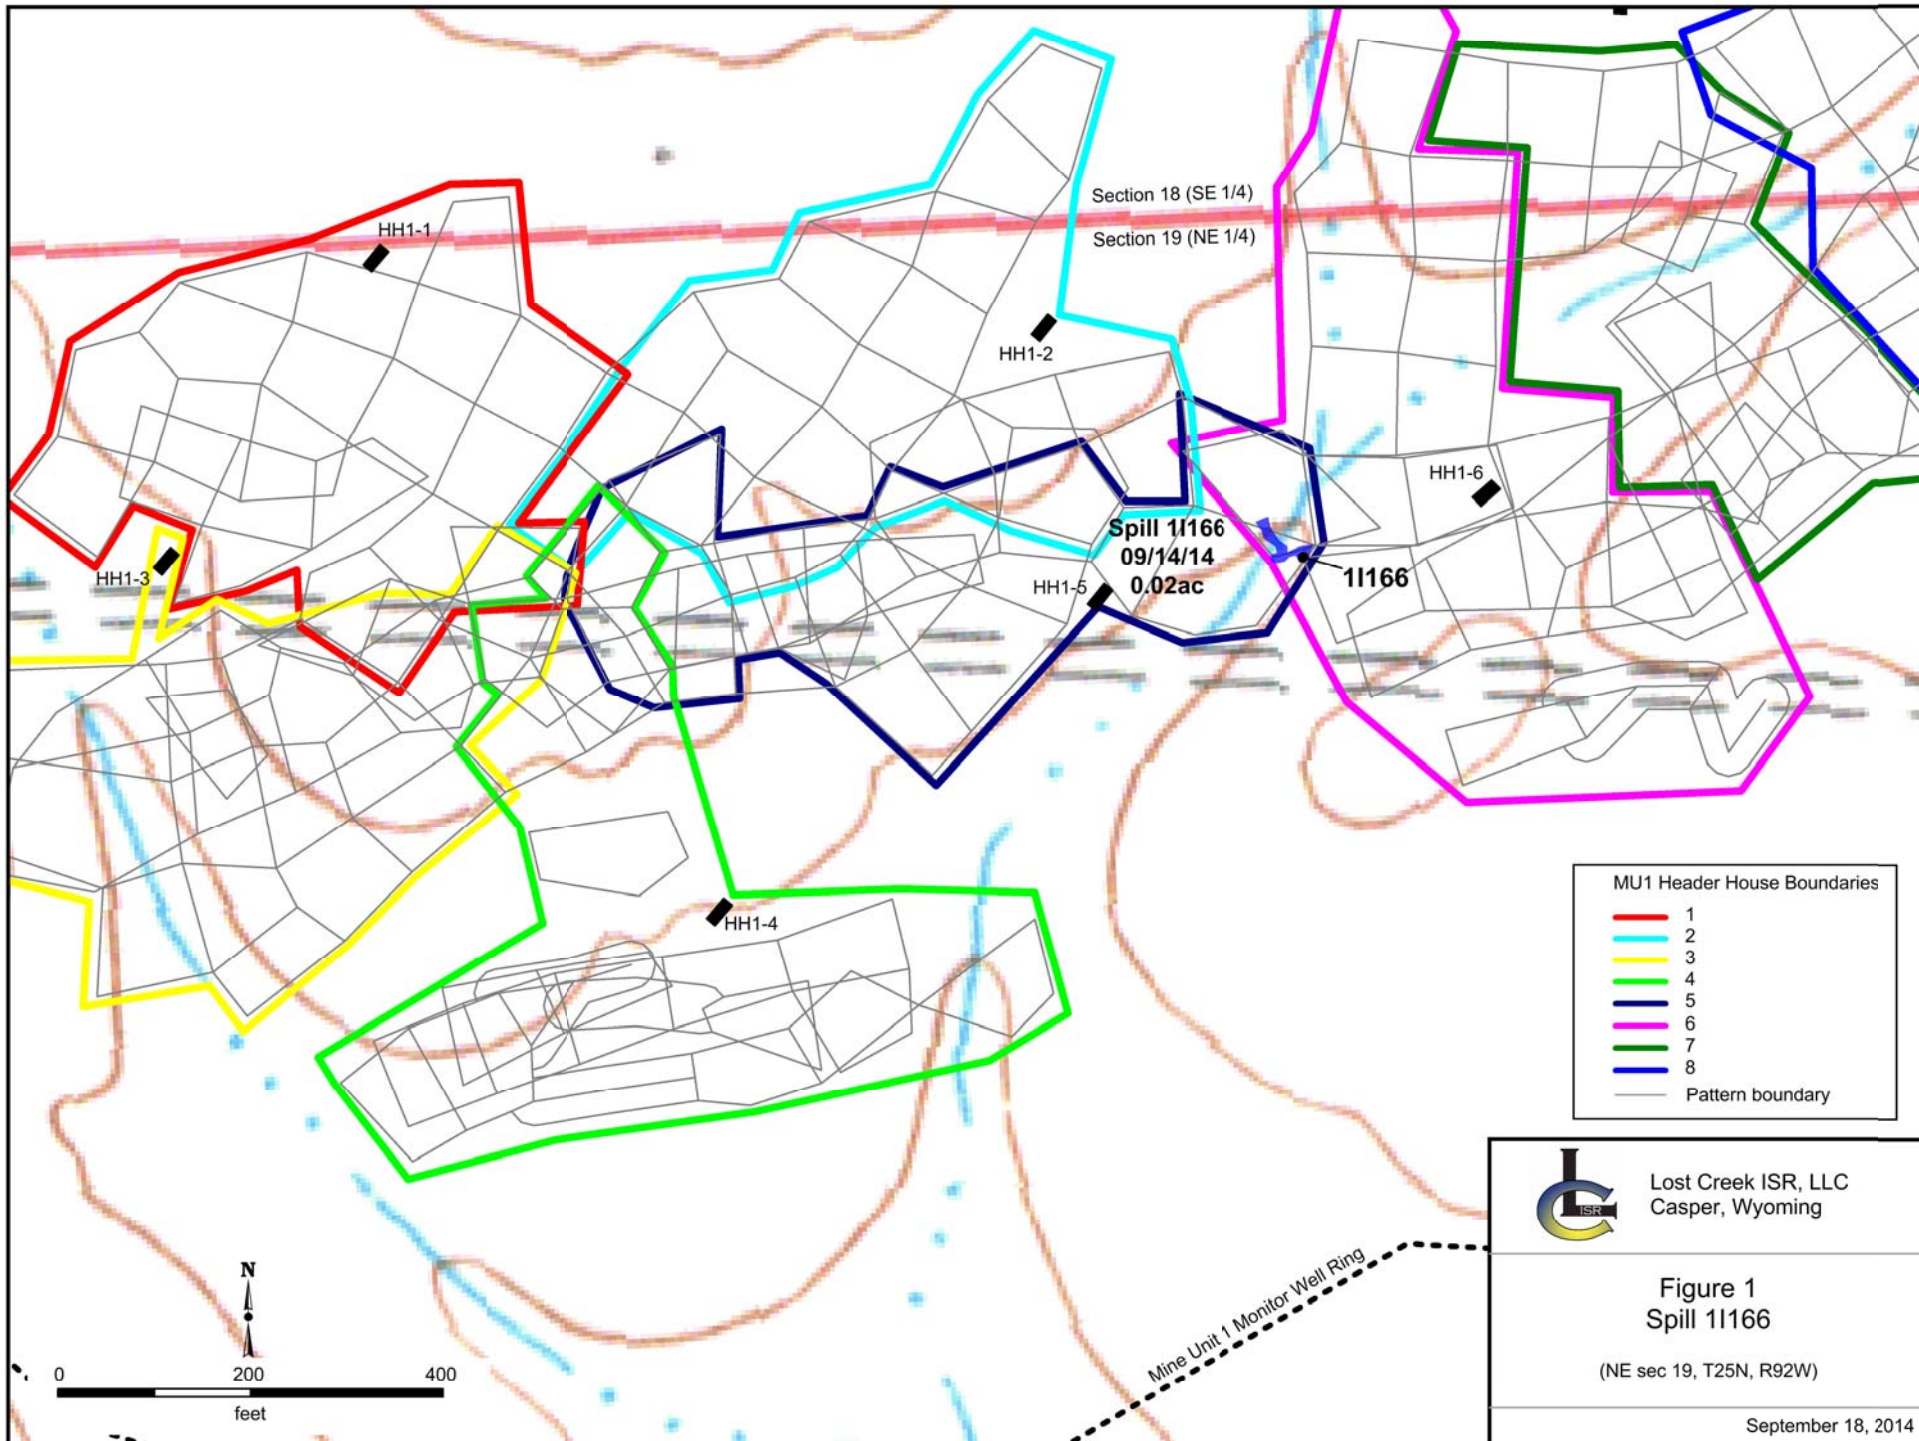
Attachments: **Figure 1: Spill 11166**

Pursuant to Wyoming Department of Environmental Quality (WDEQ) regulation, Lost Creek ISR, LLC ("LCI") hereby provides a written report detailing a release of injection fluid that was reportable to WDEQ. Using the spill report webpage, LCI notified WDEQ of the spill on September 14, 2014 (Incident ID 140915-1258). LCI notified the NRC of the spill via email to John Saxton and Linda Gersey on the same day it was reported to the WDEQ. Spill volume was estimated to be approximately 370 gallons which is not greater than the reportable limit of 420 gallons. However, the spill did reach the dry ephemeral drainage to the southwest of the well. The spill originated from well 11166 near Header House 1-6 (HH1-6) within Mine Unit 1 in the NE quarter of the NE quarter of Section 19, T25N, R92W and is shown on **Figure 1** attached.

The spill was discovered by a wellfield operator during routine inspections of the wellfield at approximately 1320 hrs on September 14, 2014. It was believed that spill started sometime after 1020 hrs that same day since the previous inspection of the area at that time did not reveal a spill. The fluid originated at well 11166 and flowed past well 11167, just to the west of 11166, and then northwest to the drainage. The soil around the well was excavated to investigate the source of the leak. The source was discovered to be a crack in the casing approximately 1 foot long extending down from just below the ground surface. The crack was believed to be the result of damage to the well sustained in late 2013 but there was no evidence of leakage prior to the spill. Records had not been maintained of the repair or follow-up MIT by the Drill Supervisor at the time and therefore it is not known if a new mechanical integrity test (MIT) had been completed following the repairs. (The Drill Supervisor on staff at the time is no longer with the Company). The initial MIT for the well on August 8, 2013 had passed. A sample of the spilled water was collected and will be analyzed for uranium. Composite soil samples were also collected from the spill area and will be analyzed for uranium and Ra-226.

The immediate corrective action was to shut down flow to the well from the associated header house (HH1-6). Other corrective actions include:

- The well casing was repaired and an MIT will be performed prior to use. The MIT truck was not immediately available due to necessary repairs. (To be completed prior to well use)
- Modifying the MIT procedure OPS-022 to provide better clarity on the requirement and importance of performing MITs following well repairs. (To be completed by October 3)
- Discussing the SOP changes and the need for MITs following repairs to injection wells. (To be completed by October 17)
- Investigate and review records to verify if any well that has been repaired has had an MIT performed. (To be completed by October 31)
