SUBJECT: COMANCHE PEAK NUCLEAR POWER PLANT  
DOCKET NO. 50-446  
UNIT 2 FOURTEENTH REFUELING OUTAGE (2RF14) STEAM GENERATOR  
180 DAY REPORT

# Comanche Peak Nuclear Power Plant 2RF14 Steam Generator 180 Day Report

This report is being submitted pursuant to TS 5.6.9, "Steam Generator Tube Inspection Report," to provide the results of the most recent CPNPP Unit 2 Steam Generator inservice inspection.

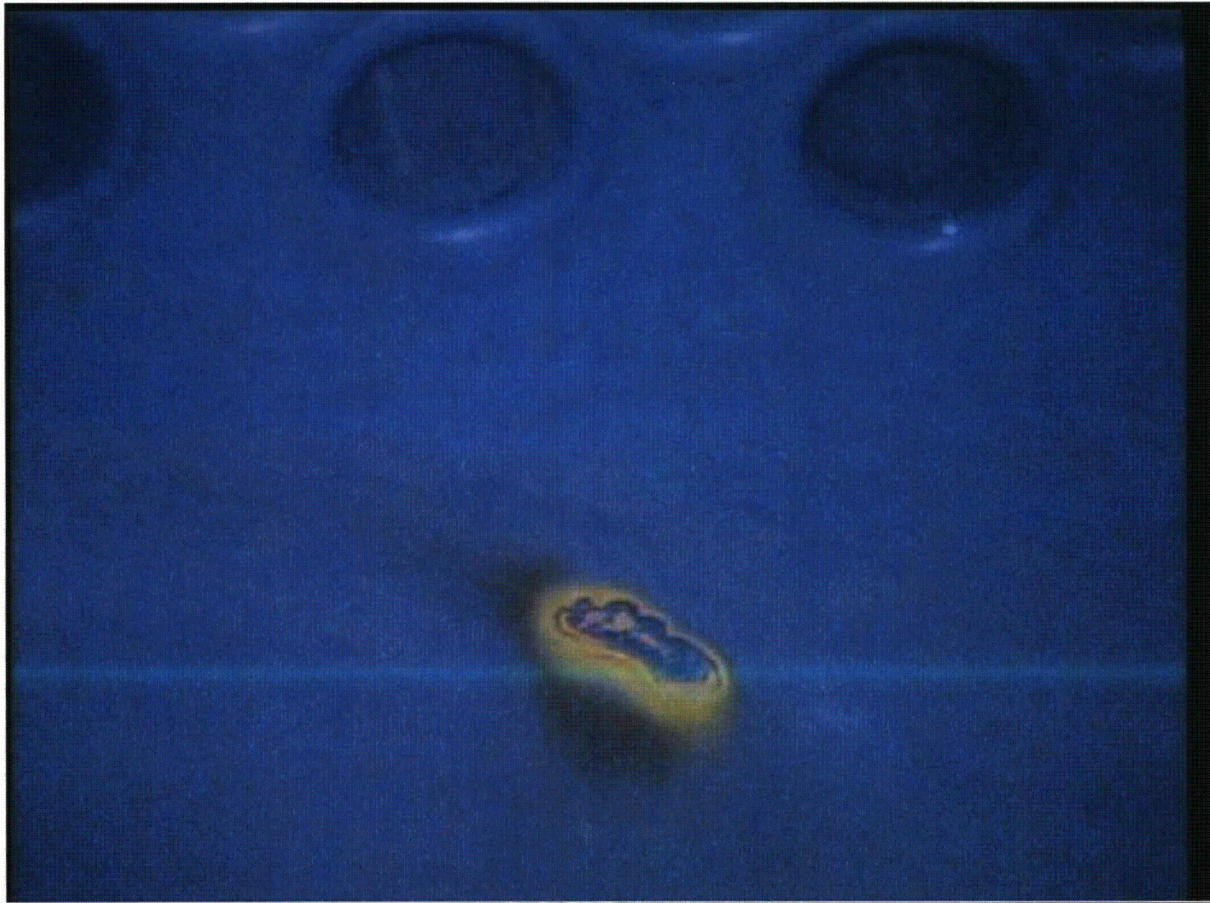
**Figure 3C: Photograph of Indication in SG1 Cold Leg Channel Head Cladding**

Video inspections were performed in the SG channel heads. A discoloration was observed in the cladding of SG 1 CL. Upon closer inspection, the discoloration was apparently caused by a flaw in the cladding, was located in the vicinity of the joint between the channel head shell and the tubesheet, and was near the peripheral tube R36C100. The channel head indication was documented in a condition report (CR-2014-004897). A photograph of the indication is included (Figure 3C); it appears as a yellow/orange discoloration in the cladding. Engineering judged that there was a breach in the cladding at this location and that the discoloration resulted from the magnetite formed at the base metal surface behind the cladding. The reported flaw was estimated, by review of the photographs taken of the flaw, to be approximately 5/8-inch long and approximately half as wide.

A precursory review of historical inspections was performed; this review determined that the discoloration was visible in 2003. Since the indication was observed as early as 2003, engineering judged that the corrosion has been slowly developing since the initial operation of the SGs. An assessment of the growth of the observed flaw starting from the beginning of plant operation in Cycle 1 was made. Based on the corrosion rate progression during outages (aerated condition in the channel head) and during plant operation (deaerated condition in the channel head), engineering determined that the depth of the surface flaw in the base metal could be up to 0.00122 inch in depth at present. Continued operation for three more fuel cycles (through 2RF17) would result in further increase in the flaw depth to 0.00148 inch.

The acceptability of the flaw for continued operation was evaluated by comparison to the allowable planar flaws for ferritic steel in Table IWB-3510-1 of the ASME Boiler and Pressure Vessel Code, Section XI, 1998 Edition through 2000 Addenda. The allowable surface flaw depth of 1.9% of the bowl thickness is taken from Table IWB-3510-1 for the conservative flaw depth to the length ratio of zero. The SG bowl thickness is approximately 5.3 inches, giving an allowable surface flaw depth of 0.10 inch. Since the estimated depth of the flaw, projected to the end of Cycle 17, is significantly less than the allowable depth, the flaw is acceptable for continued operation for at least three more fuel cycles.

During a SG1 channel head bowl scan and as previously discussed, a discoloration was observed in the cladding. An evaluation of this condition was performed which concluded that the surface flaw is of a very small magnitude, such that no detrimental impact of the SG performance criteria would be realized.

Based on the assessment, no additional action was performed during 2RF14 and inspection and re-characterization is recommended during the next inspection outage of the SGs in 2RF16.
