H. B. ROBINSON STEAM ELECTRIC PLANT, UNIT NO. 2
DOCKET NO. 50-261/RENEWED LICENSE NO. DPR-23

RESPONSE TO NRC REQUEST FOR ADDITIONAL INFORMATION RELATED TO
THE PRESSURIZED WATER REACTOR INTERNALS PROGRAM PLAN FOR AGING
MANAGEMENT OF REACTOR INTERNALS (TAC NO. ME9633)

Westinghouse Technical Bulletin (TB), Reactor Internals Lower Radial Support Clevis Insert Cap Screw
Degradation (TB-14-5)

Subject: Reactor Internals Lower Radial Support Clevis Insert Cap Screw Degradation	Number: TB-14-5
System(s): Reactor Coolant System, Reactor Internals, Lower Radial Support System	Date: 08/25/2014
Affects Safety-Related Equipment Yes <input type="checkbox"/> No <input checked="" type="checkbox"/>	S.O.: NA

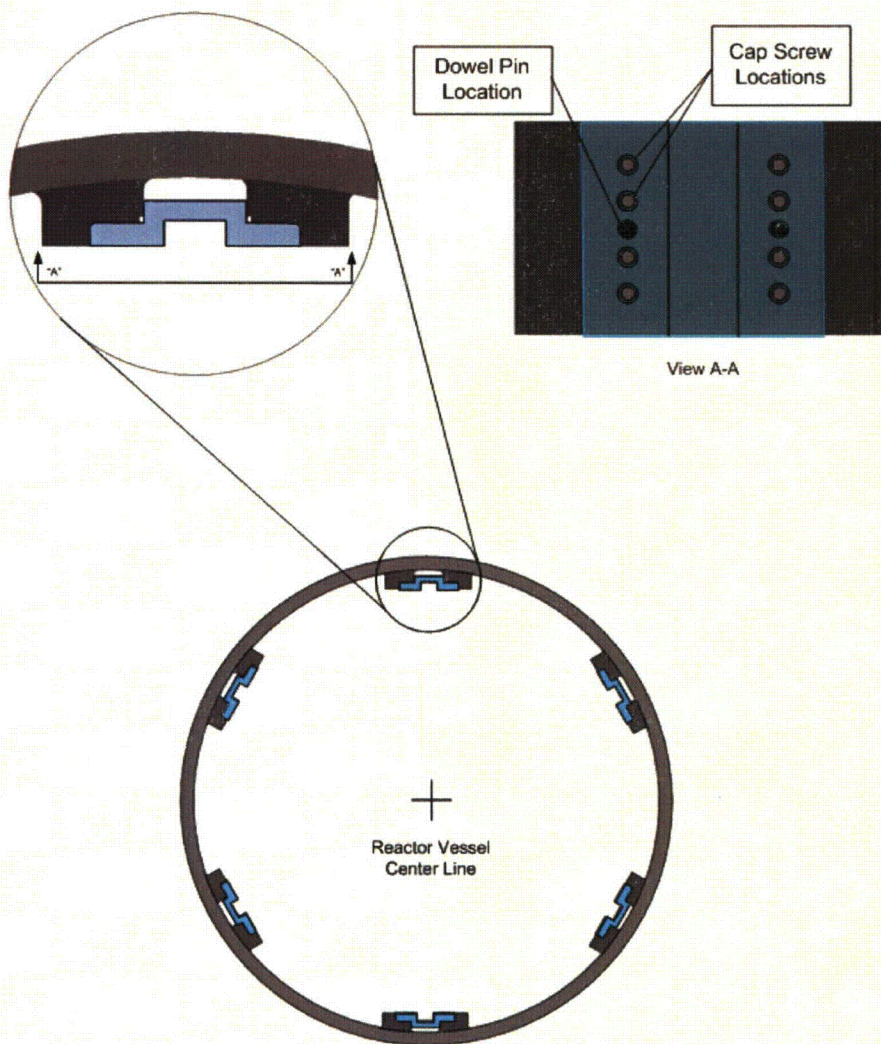
Figure 1 - Example of Lower Radial Support Clevis Insert, Cap Screw and Dowel Pin Locations

During a 10-year in-service inspection (ISI) in March 2010, an anomaly was observed in the lower radial support clevis inserts. The 10-year ISI program includes a remotely operated visual inspection of the vessel after the core barrel is removed. This visual inspection examines the condition of the six clevis inserts, including general integrity of bolted and welded connections. Figure 1 provides an overview of the radial support clevis insert configuration. Each clevis insert at the plant inspected features 8 cap screws and 2 dowel pins which provide for retention of the insert. At a total of 7 (out of 48) bolt locations, there was visual evidence that the bolt head had detached from the shank. On one of the clevis dowel pins, the lock welds on the pin had broken and the pin was slightly rotated and displaced deeper into the insert. Reviews of video images from the previous 10-year ISI vessel inspection showed no indications of wear, fractures, or other anomalies with the clevis insert cap screws or dowel pins at any location.

During the spring 2013 refueling outage, 29 bolts were removed and replaced. The primary concern was that the clevis insert bolt would continue to degrade eventually leading to a condition where the clevis insert would be able to completely dislodge once the lower internals were removed. When the internals are assembled into the reactor vessel the clevis insert is effectively trapped by the interfacing lower internals components. Once the lower internals are removed, and if there is significant degradation of the designed fits and hardware, there is a potential for the insert to be dislodged from the mating vessel lug. Once dislodged from the vessel lug, reinstallation was viewed as being of high commercial consequence due to the customization needed to reestablish the required design gaps for this component. The number of replacement bolts was determined based on structural evaluations of the bolts assuming that none of the original bolts were functional. Evaluations (discussed later) showed that no bolts were required to maintain the intended safety function. The evaluations, to determine the number of required replacement bolts, were primarily focused on ensuring that the bolts would remain functional for the remaining life of the plant.

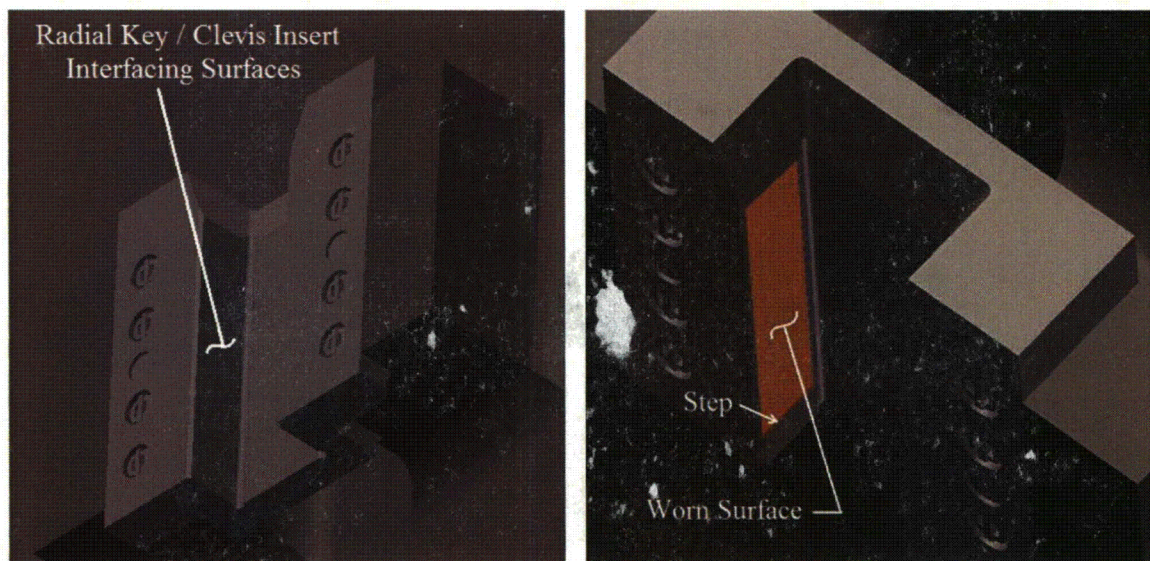
Figure 2 - Example of Wear at the Radial Key/Clevis Insert Interfacing Surface

- Radial key/clevis insert interfacing surfaces; look for aggressive or abnormal wear as compared to previous inspection, if available. The radial key does not make contact with the full length of the clevis insert; if wear is significant it would be visible as a step located toward the bottom end of the clevis insert as shown in Figure 2.
- Interface between the clevis insert and vessel lug (see Figure 3); look for signs of looseness or dislocation. Faces of the insert and vessel lug are generally flush; dislocations may be visible by the insert protruding toward the vessel centerline as compared to the vessel lug.

As Note 2 of Table 4-5 of MRP-227-A indicates, the bolts were screened-in because of stress relaxation and associated cracking. However, the failures of the bolts alone do not result in a loss of the intended safety function of the lower radial supports. The loss of function of the lower radial supports is linked more closely to increased motion of the lower end of the core barrel caused by wear on the clevis insert or vessel attachment interface. Therefore, although it is one of many barriers to loosening of the insert, management of the bolt failures does not directly address management of the functional performance of the component. To ensure that the functional performance is being managed, it is recommended to ensure that the MRP-227-A inspections (ASME Section XI, VT3) for the clevis inserts include the following scope:

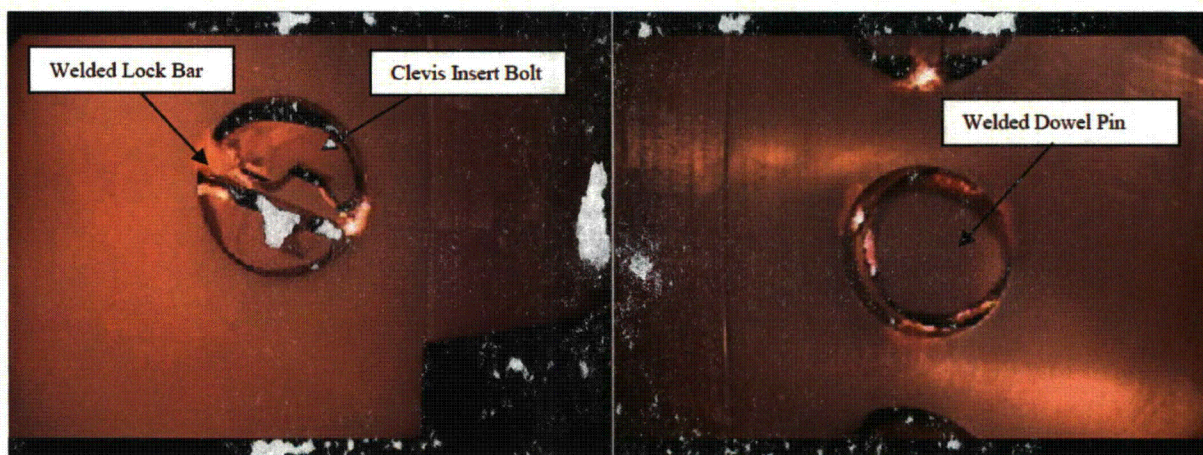
Figure 4 - Examples of Bolt and Dowel Pin Related Degradation

- Look for wear between the bolt head and lock bar and/or bolt head dislocation.
- Look for broken tack welds and dislocation of the dowel pin.

While these methods have been shown to be less than adequate in detecting bolt failure, the indications described have been shown in one case to manifest themselves as a result of bolt failure and prior to any notable loosening of the clevis insert or increased wear between the radial key and clevis insert.

While managing the functional performance is the primary goal of the recommended inspections, this TB recommends that the scope of the inspection also include the following as a means of reducing maintenance risk associated with clevis insert bolt degradation (Figure 4):

Some optional methods that could be used to improve the reliability of crack detection and enhance the management of maintenance risk include activities such as ultrasonic examination of bolts and/or bolt replacement.

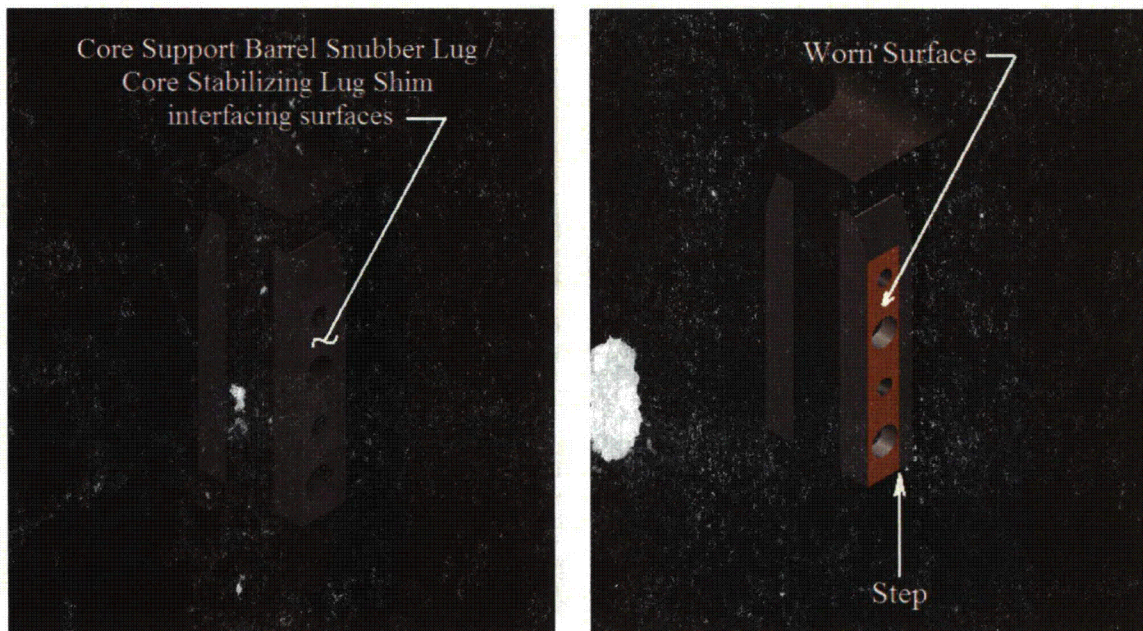
Figure 5 - Example of Wear at the Core Support Barrel Snubber Lug/Core Stabilizing Lug Shim Interfacing Surface

- Core support barrel snubber lug/core stabilizing lug shim interfacing surfaces (see Figure 5); look for aggressive or abnormal wear as compared to previous inspection, if available. The core support barrel snubber lug key does not make contact with the full depth of the core stabilizing lug shim. If wear is significant it would be visible as a step located toward the vessel side of the clevis insert as shown in Figure 5.
- Interface between the core stabilizing lug shim and the core stabilizing lug (see Figure 6); look for signs of looseness or dislocation. Looseness may be visible by gapping between the core stabilizing lug shim and the core stabilizing lug when looking radially outward toward the lug.

For the CE-designed plants, the components similar to the clevis insert bolts are the core stabilizing lug bolts. Neither these bolts, nor the core stabilizing lug shims (CE components similar to the Westinghouse clevis inserts) were screened in as part of MRP-191 (Reference 4). As a result, no inspection recommendations are provided for these components in MRP-227-A. However, considering these bolts are Alloy X-750, installed with similar preload stress, and at similar operating temperatures as the Westinghouse clevis insert bolts, these bolts are also potentially susceptible to PWSCC. Since the function of core stabilizing lugs is identical to that of the Westinghouse lower radial supports, similar inspections for looseness of the insert should be conducted to ensure function is maintained. Specific recommendations for inspection scope are as follows:

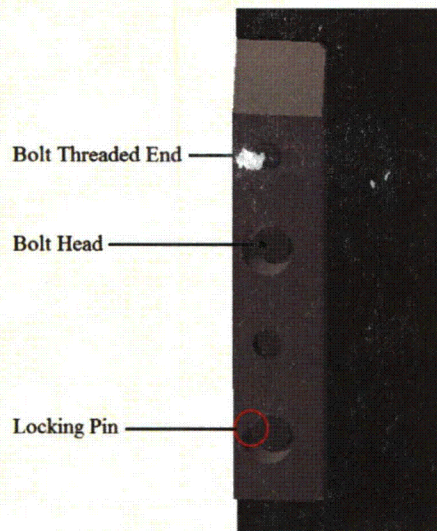
Figure 7 - Identification of Hardware

- Bolt heads; look for wear between the bolt head and the shim and/or bolt head dislocation.
- Bolt threaded end; look for signs of the bolt threads backing. Bolt threads should generally be recessed from the face of the shim; look for differences in the amount of recess between the two bolts threaded into the shim being viewed.
- Locking pins; look for dislocation, wear, or failure of the locking pin.

As previously discussed, these methods may be less than adequate in detecting bolt failure, however they may manifest themselves as a result of bolt failure and prior to any notable loosening of the core stabilizing lug shim or increased wear between the core support barrel snubber lug and core stabilizing lug shim.

While managing the functional performance is the primary goal of the recommended inspections, it is recommended that the scope of the inspection also include the following as a means of reducing maintenance risk associated with clevis insert bolt degradation (Figure 7):

Similar to the recommendations for the Westinghouse-designed plants, optional methods such as ultrasonic examination of bolts or bolt replacement could be used to improve the reliability of crack detection and enhance the management of economic risk.
