RS-14-250

Peach Bottom Atomic Power Station, Unit 2  
Renewed Facility Operating License No. DPR-44  
NRC Docket No. 50-277

**Subject:** Supplemental Response to NRC Request for Information Pursuant to 10 CFR 50.54(f) Regarding the Seismic Aspects of Recommendation 2.3 of the Near-Term Task Force Review of Insights from the Fukushima Dai-ichi Accident

1. Seismic Walkdown Report In Response To The 50.54(f) Information Request Regarding Fukushima Near-Term Task Force Recommendation 2.3: Seismic, Updated Transmittal #1 (Annex A) for the Peach Bottom Atomic Power Station, Unit 2, Report No. RS-14-250

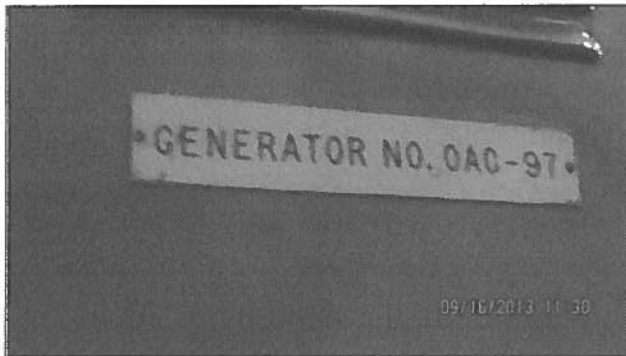
*Note: Diesel Generator Control Panel 0AC097*

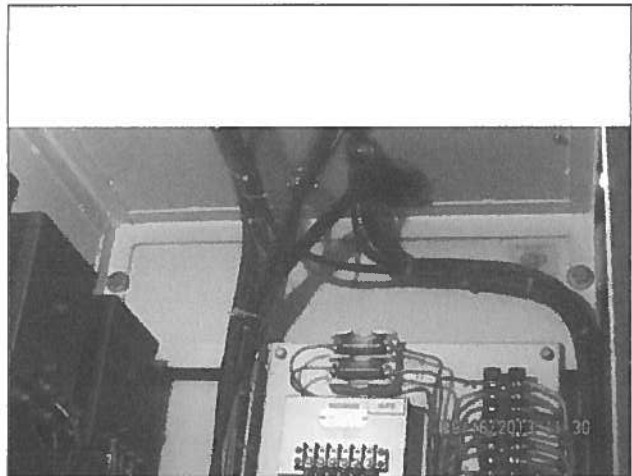
*Note: Mounting to adjacent cabinet*

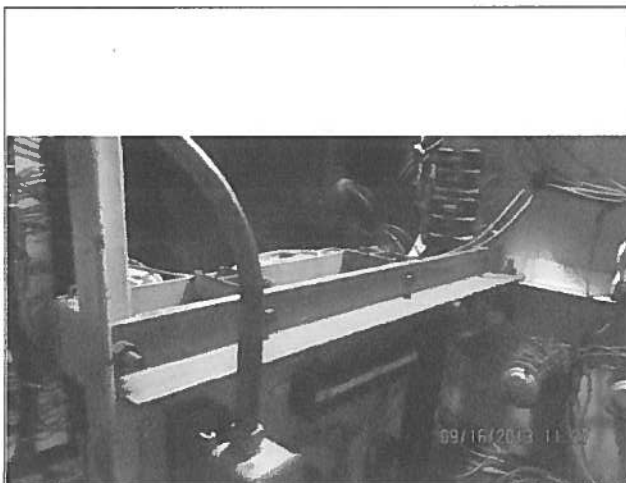
*Note: Internal mounting*

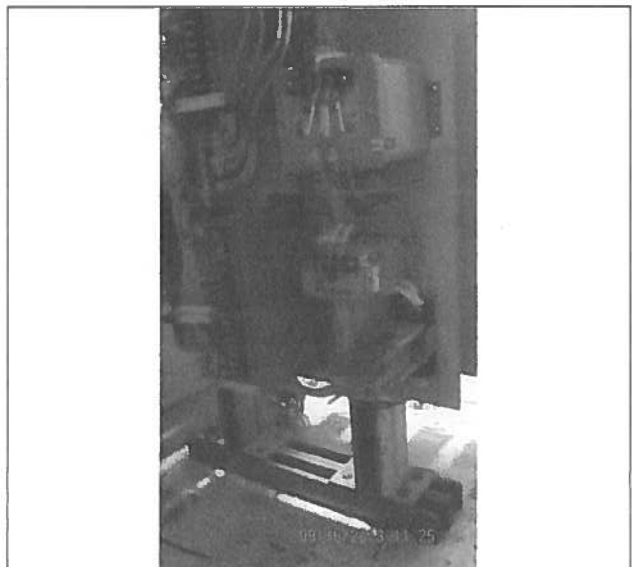
*Note: Internal mounting*

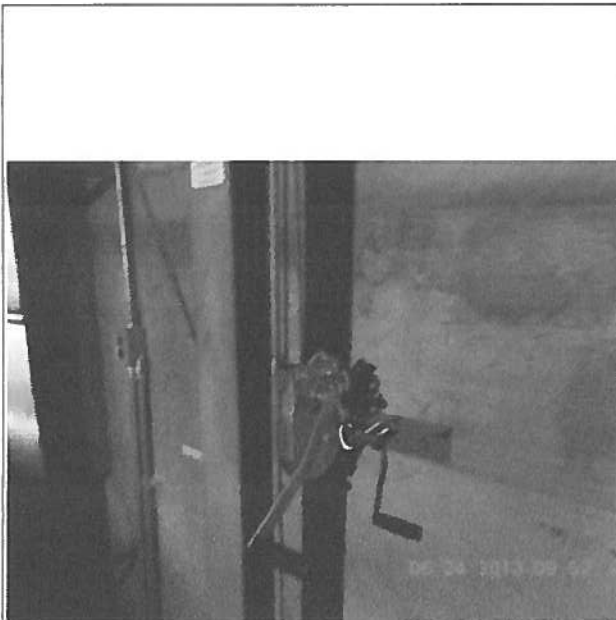
**Note:** *Breaker Hoist*
