SUBJECT: NRC INSPECTION REPORT 040-08903/14-001

Report: 040-08903/14-001

Licensee: Homestake Mining Co. of California

Facility: Former Grants Mill

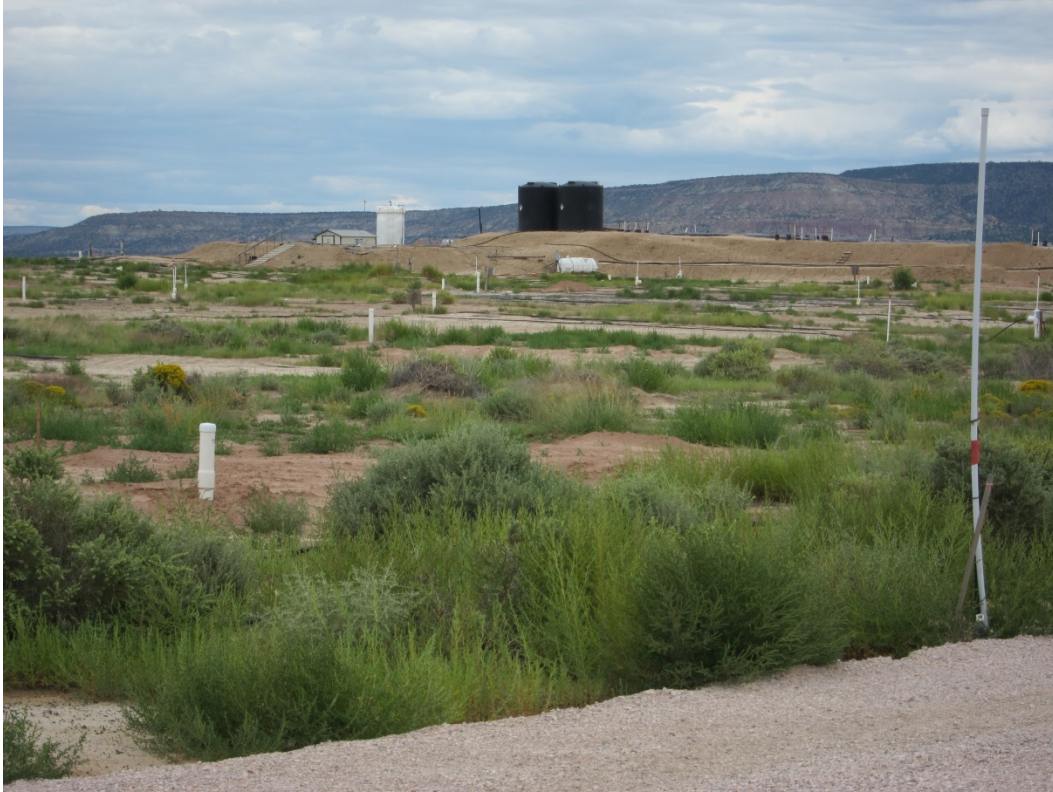
Figure 1: Top of Large Tailings Pile with zeolite-based pilot water treatment system in background

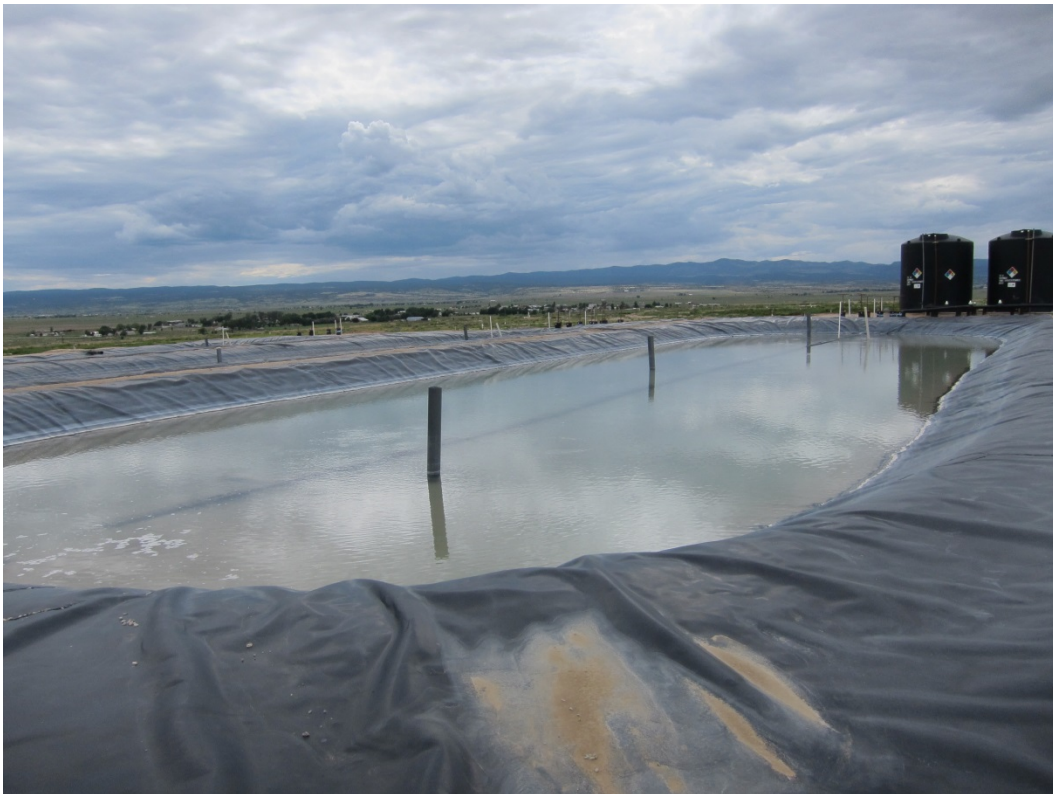
Figure 2: One of three zeolite pilot test system treatment cells

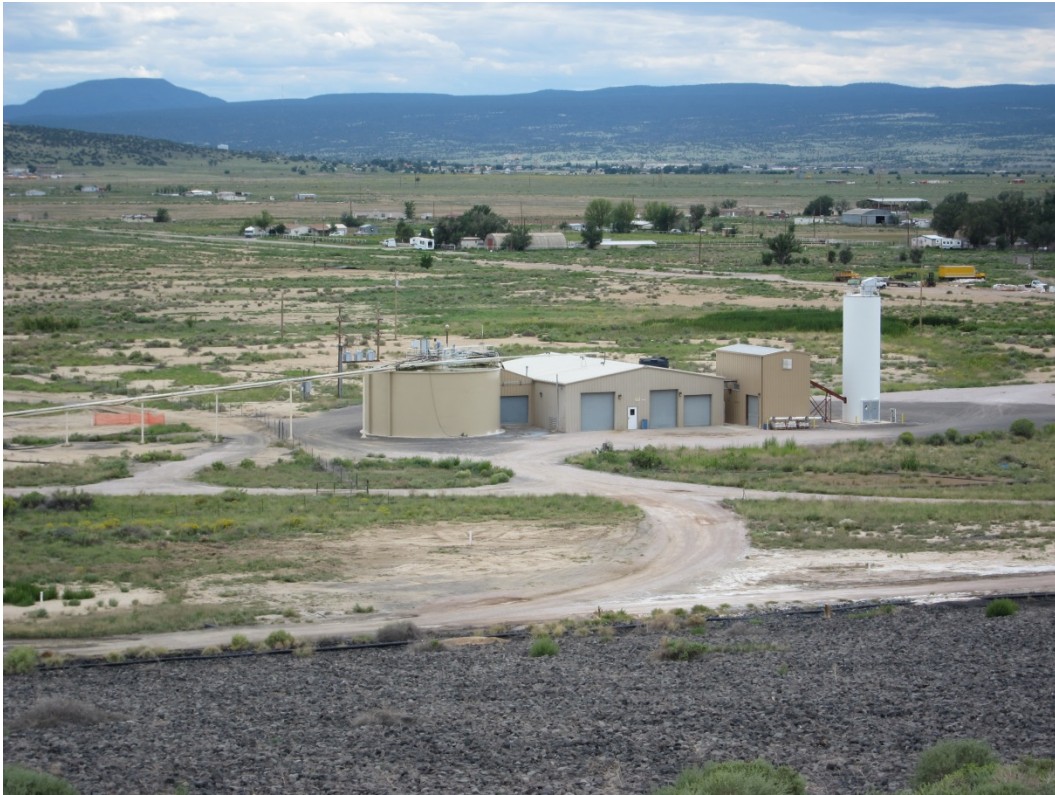
Figure 3: Water treatment facility in service with reverse osmosis equipment

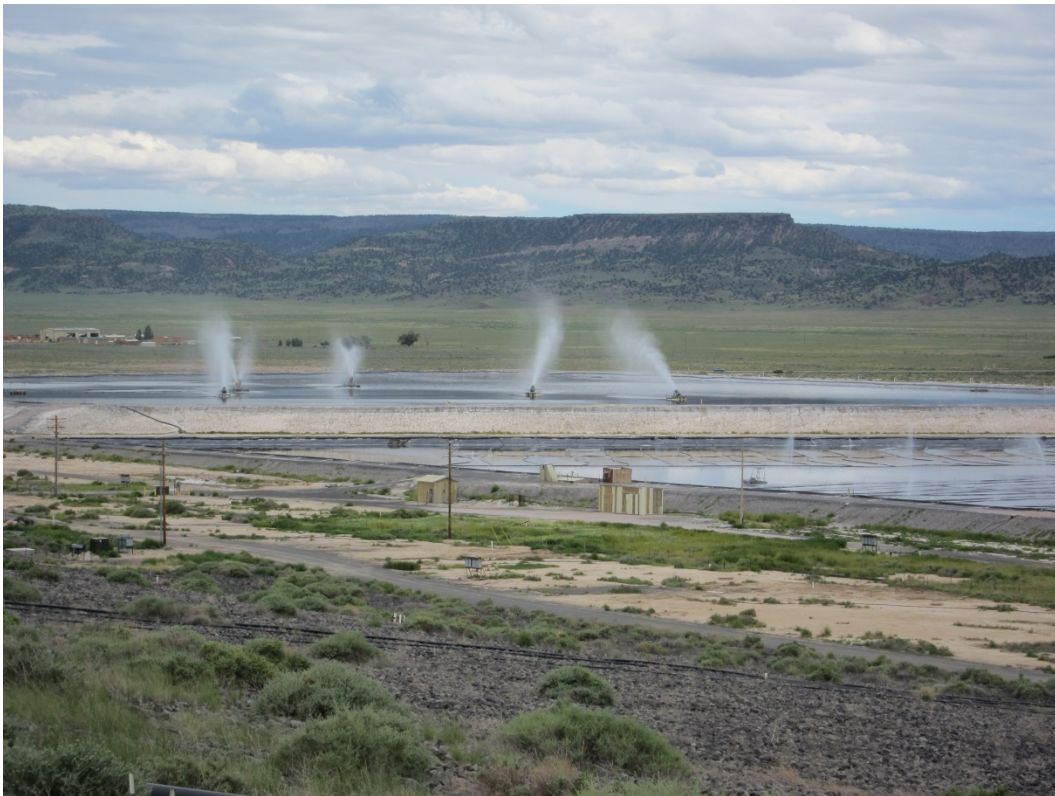
Figure 4: Evaporation pond sprayers in service
