**SUBJECT: PALISADES NUCLEAR PLANT, NRC INSPECTION REPORT 05000255/2014010,  
PRELIMINARY WHITE FINDING**

Report No: 05000255/2014010

Facility: Palisades Nuclear Plant

Inspection Report 05000255/2014010, 8/11/2014 – 10/30/2014, Palisades Nuclear Plant, Occupational Dose Assessment.

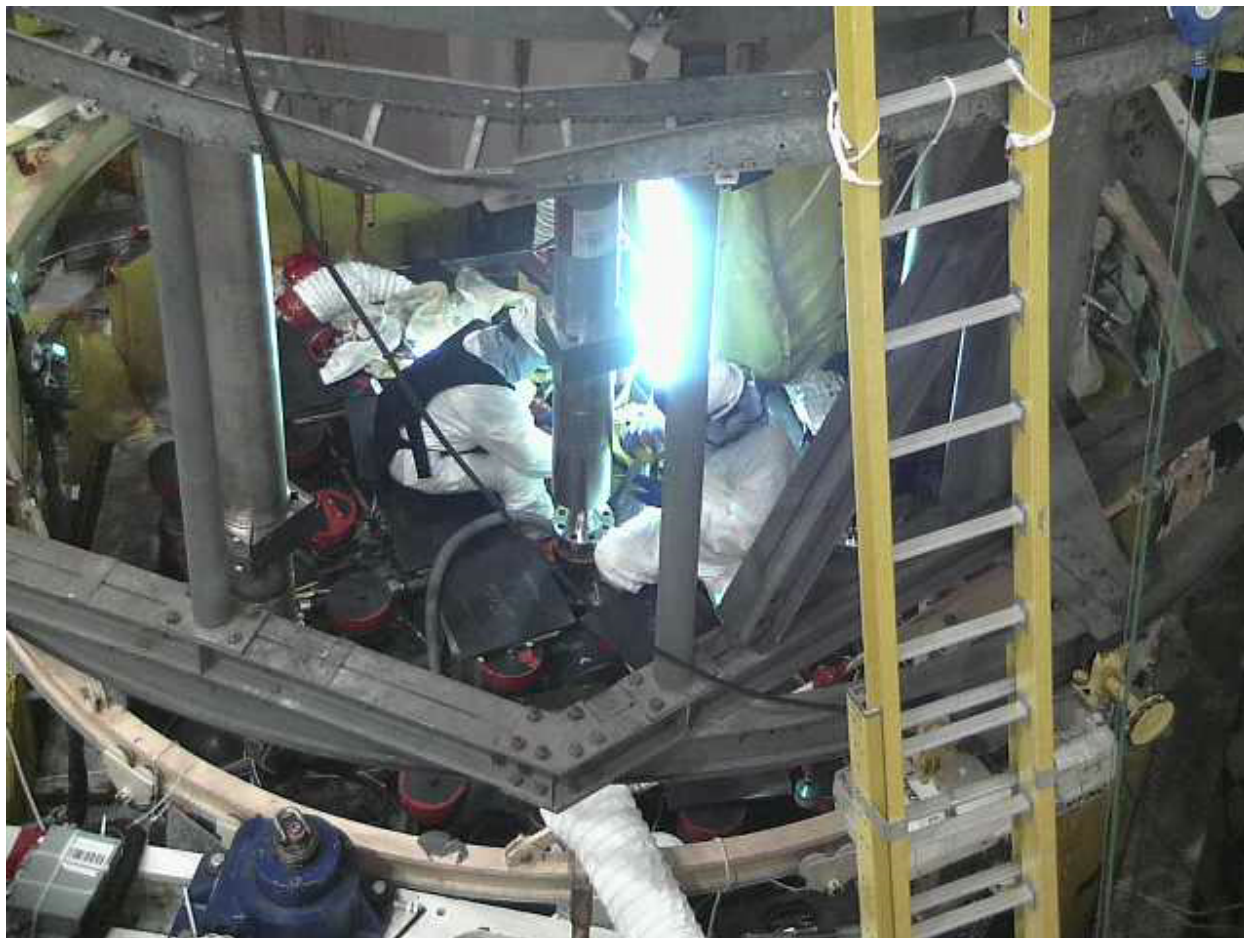
Worker at 9 o'clock position is wearing shield vest with significant gaps at the sides. Notice the seated position negates the protective qualities of the shield vest for the gonads, while the dosimeter for those organs remained shielded by the vest.

Worker at 5 o'clock position appears to be seated without a shield vest.

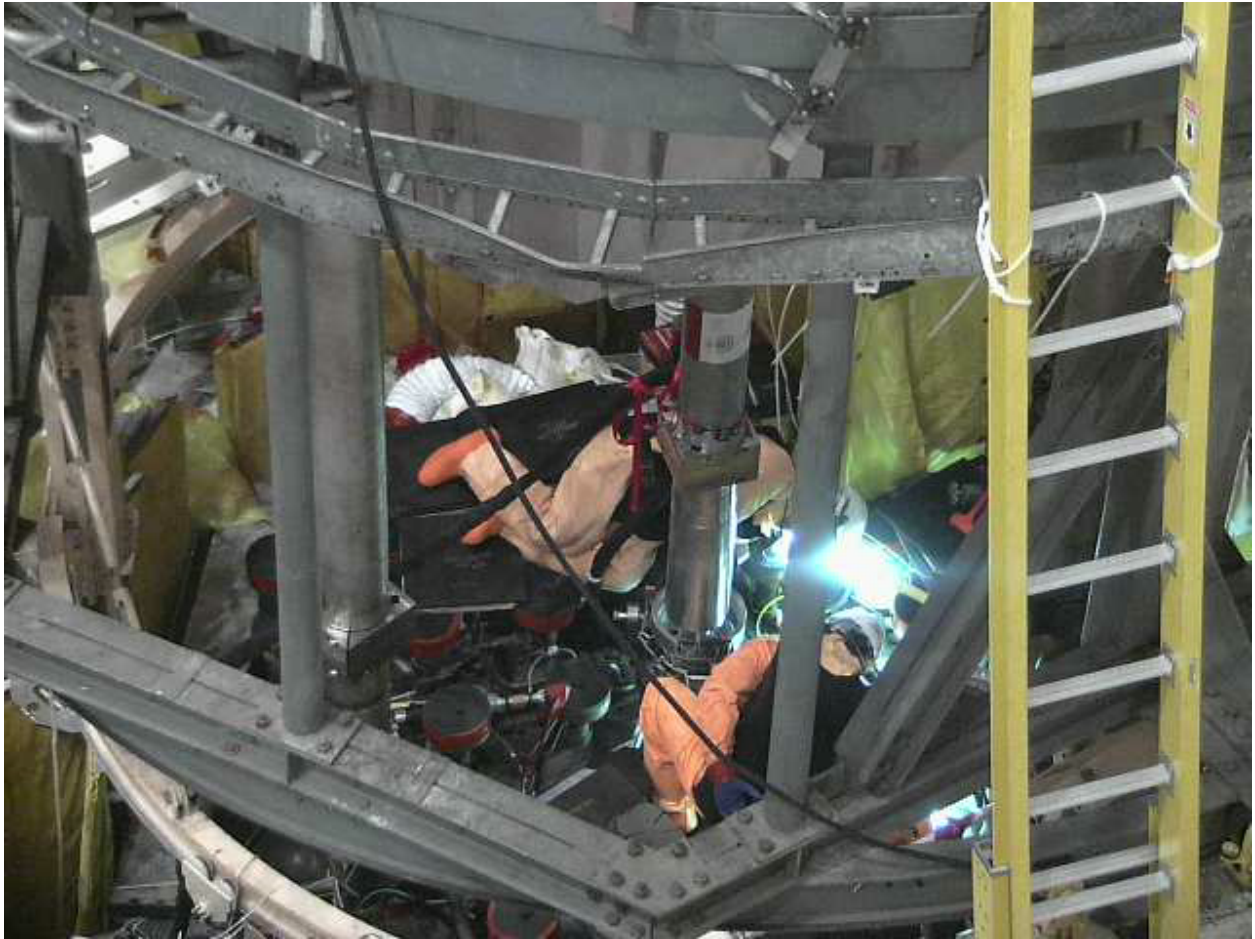
Worker at 12 o'clock wearing a shield vest with an apparent gap between the front vest and side back vest and the worker is lying down.

Worker at 5 o'clock wearing a shield vest and appears to be seated.

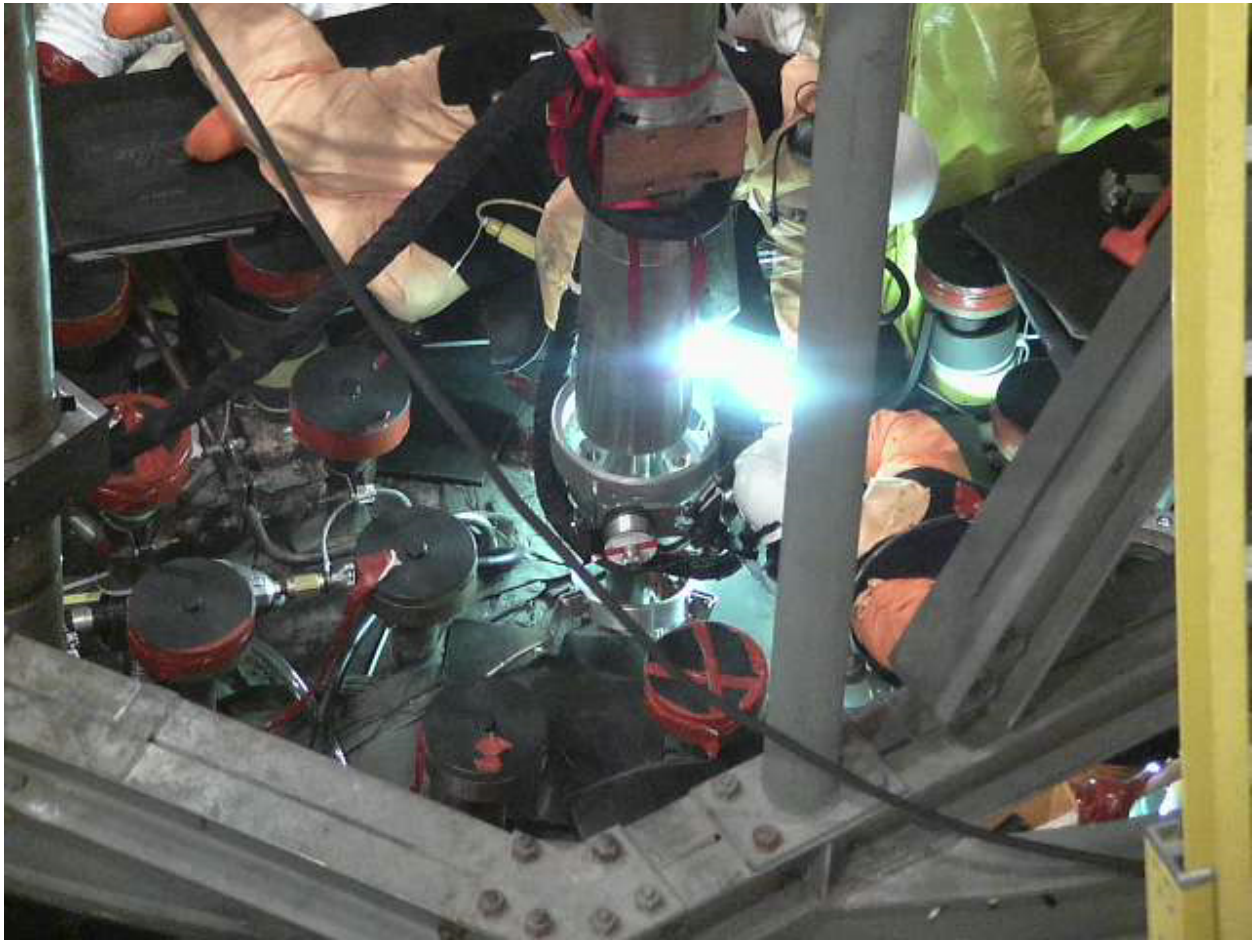
Worker at 12 o'clock wearing a shield vest with a possible gap between the front vest and side back vest and the worker is lying down. Additionally, the shielded vest might be covering the dosimeters on the worker's right thigh.

Worker at 5 o'clock wearing a shielded vest.

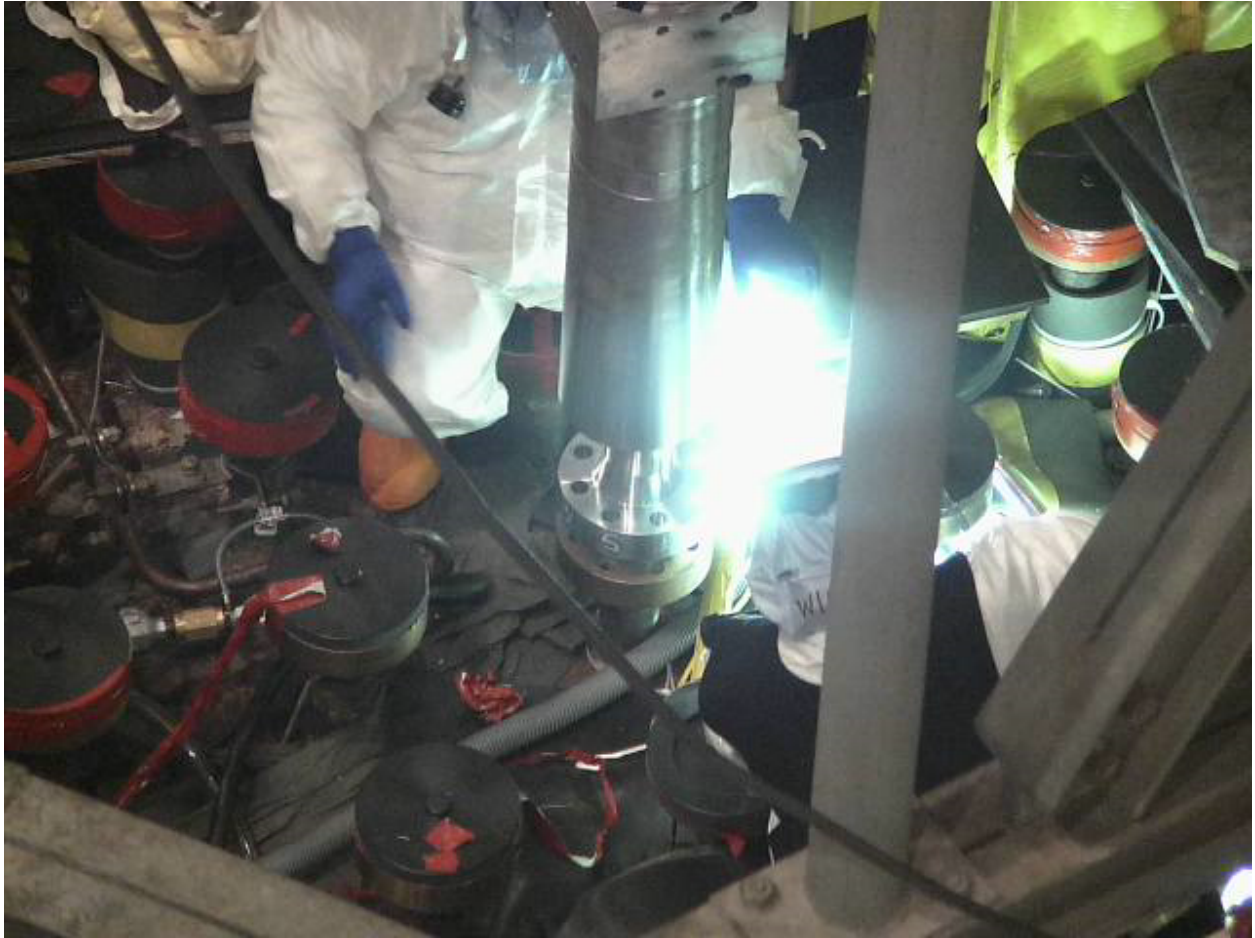
Worker at 11 o'clock not wearing a shield vest and appears to be seated.

Worker at 5 o'clock wearing a shield vest and appears to be seated.

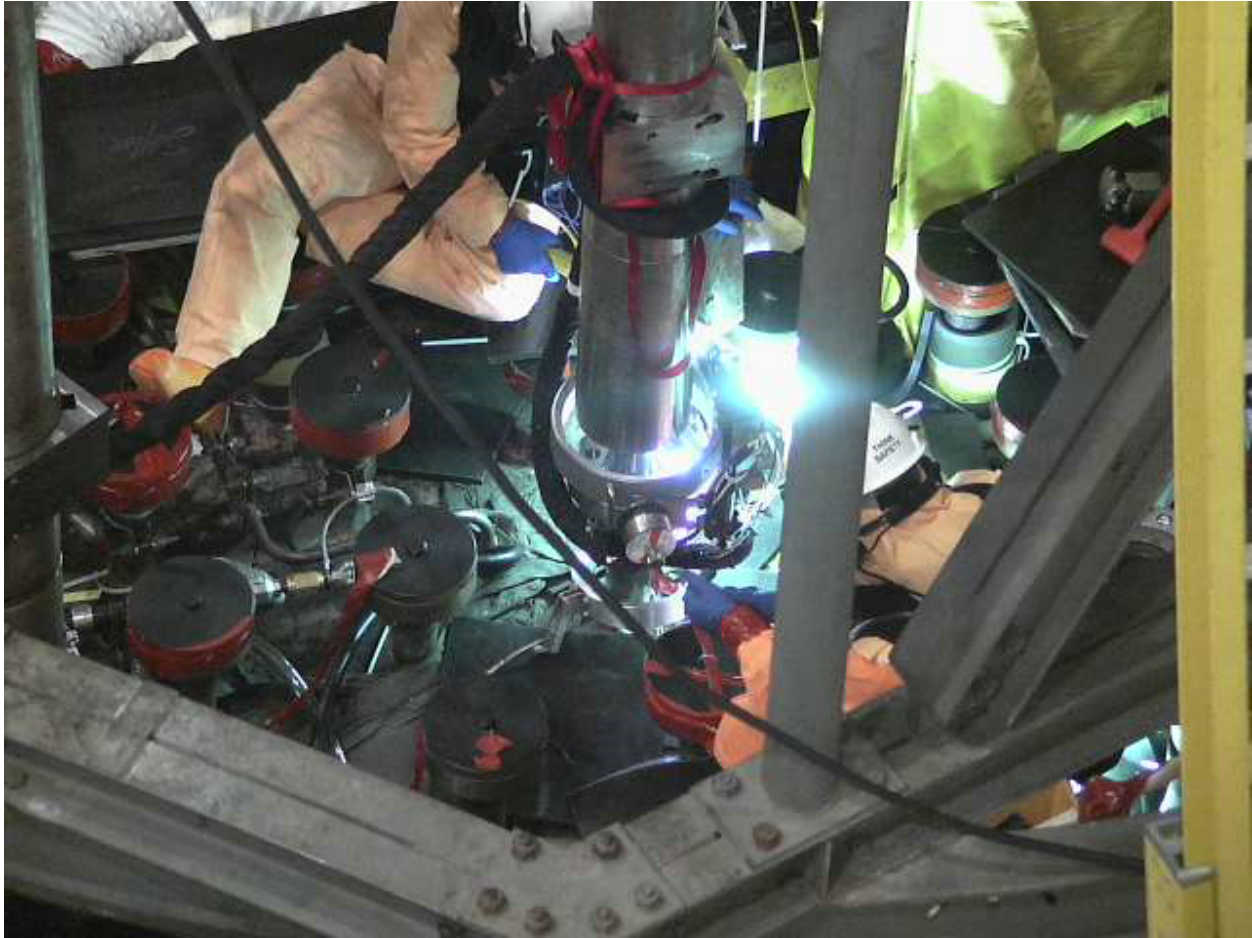
Worker at 11 o'clock wearing a shield vest and appears to be seated.

Worker at 5 o'clock wearing a shield vest and appears to be seated.

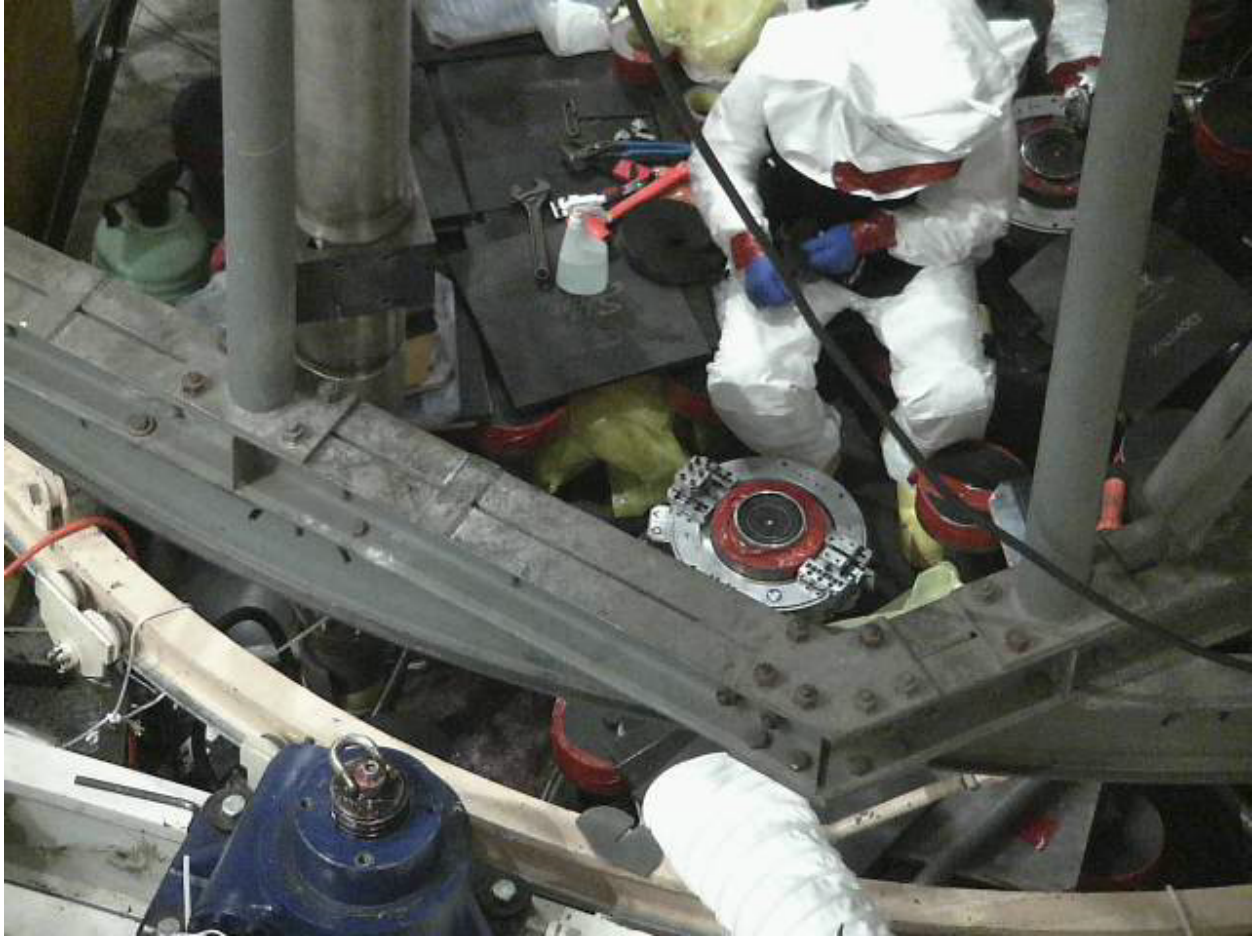
Worker at 12 o'clock wearing a shielded vest and appears to be seated. Note that the seated position negates the protective qualities of the shield vest for the gonads. While the dosimeter for those organs remained shielded by the vest.

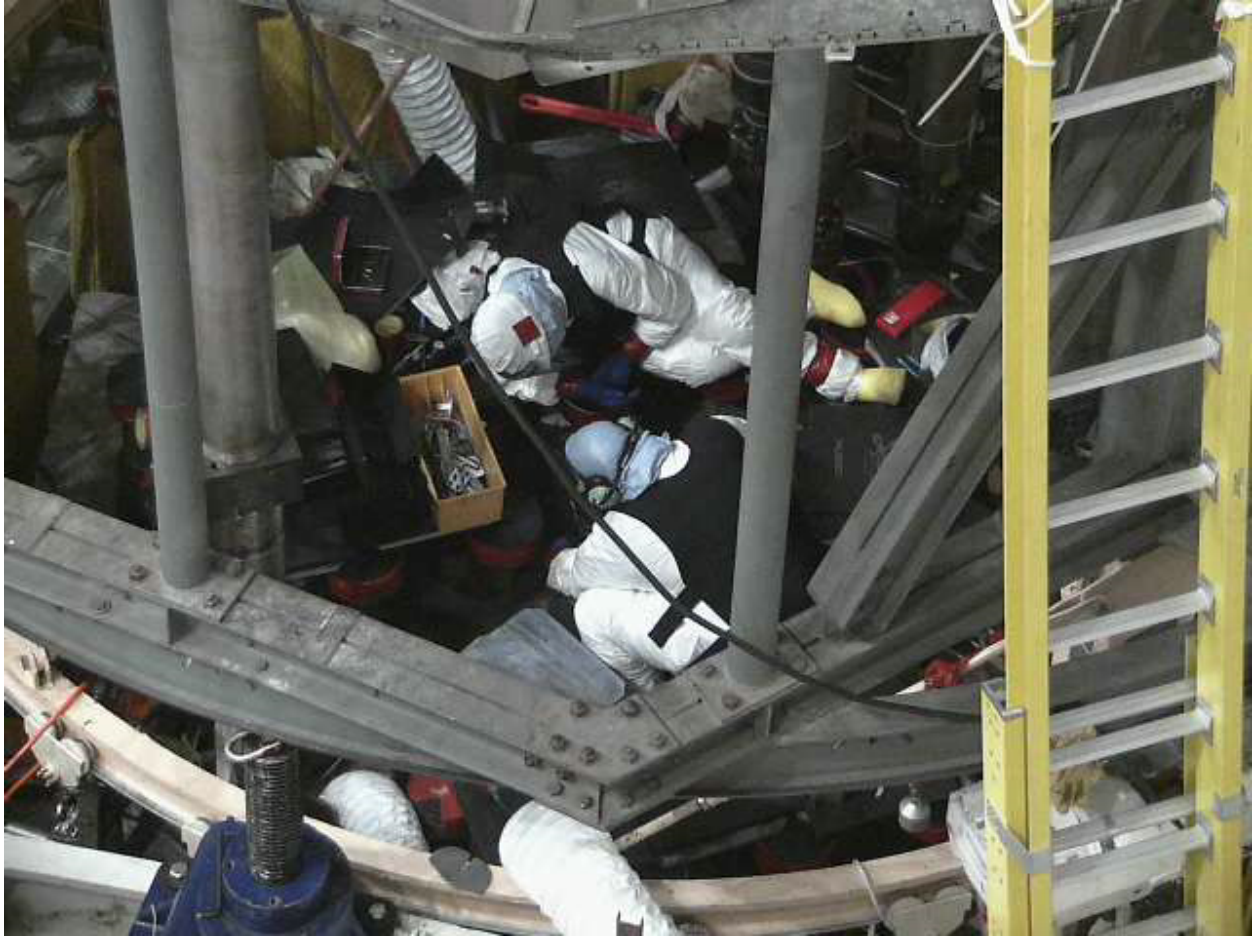
Worker at 12 o'clock wearing a shield vest with an apparent gap between the front vest and side back vest and the worker is lying down.

Worker at 6 o'clock wearing a shield vest with a significant gap between the front vest and side back vest and appears to be seated.

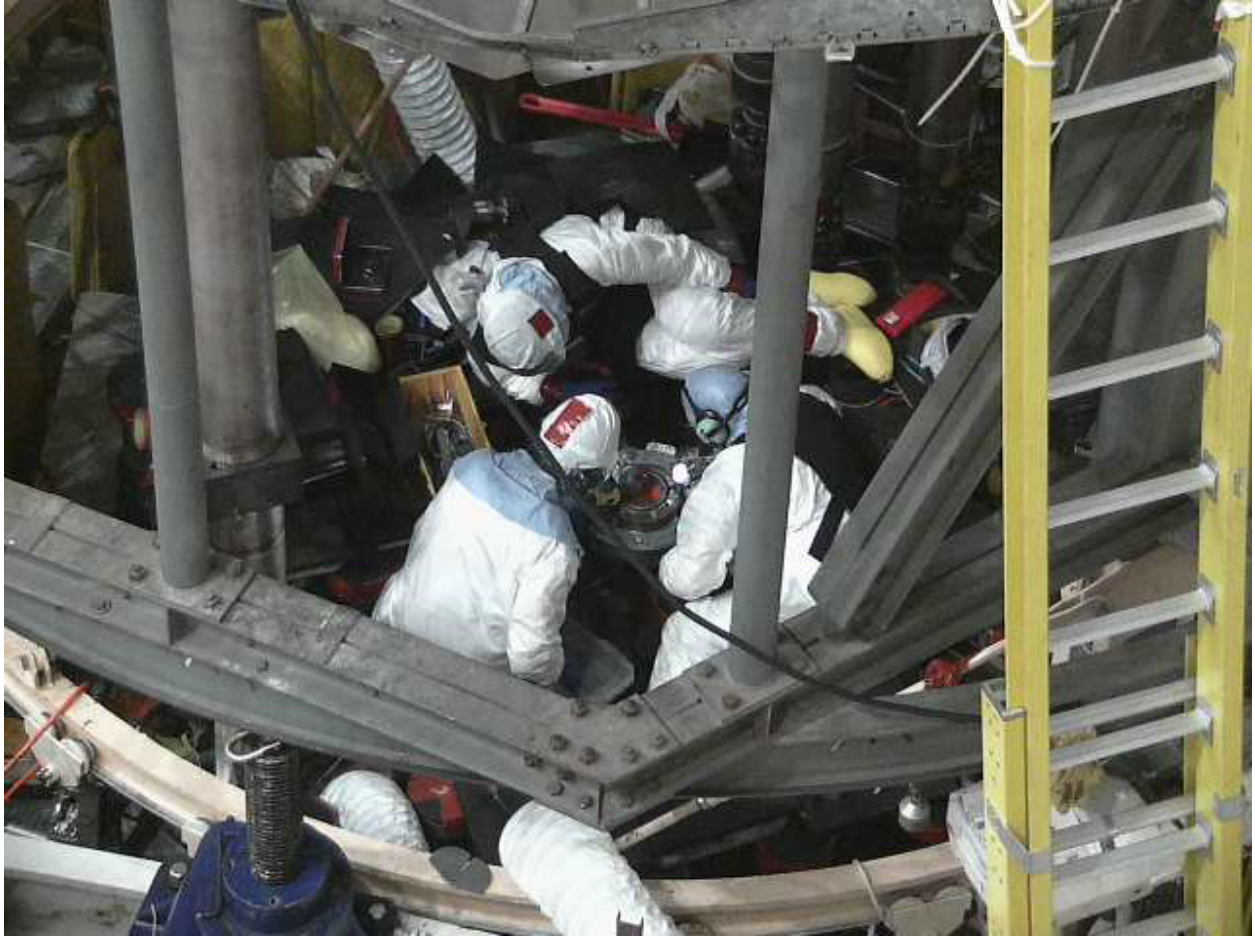
Worker at 12 o'clock wearing a shield vest with an apparent gap between the front vest and side back vest and the worker is lying down.

Worker at 5 o'clock wearing a shield vest with a significant gap between the front vest and side back vest and appears to be seated.

Worker at 7 o'clock not wearing a shield vest and appears to be seated.

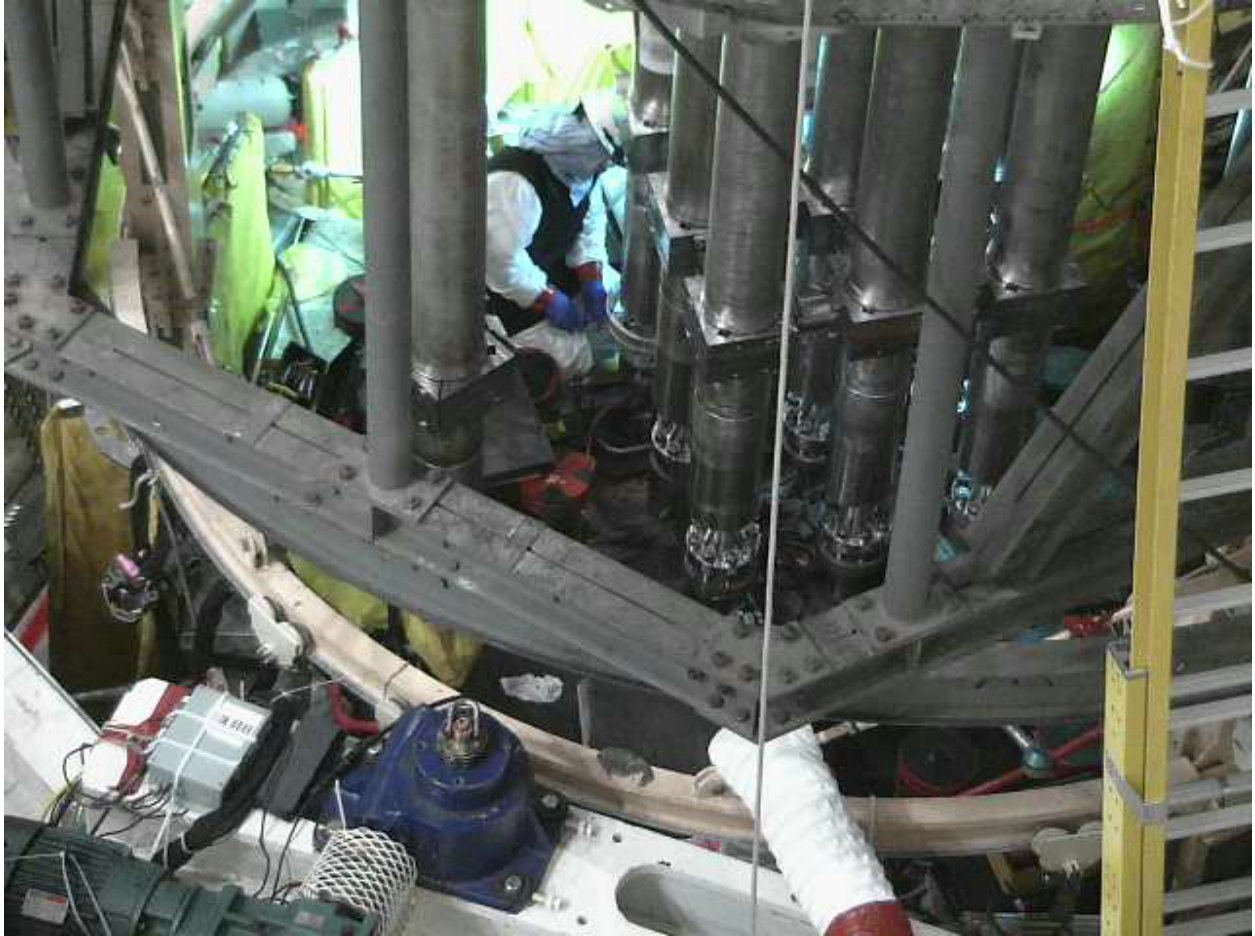
Worker at 11 o'clock wearing a shield vest with an apparent gap between the front vest and side back vest and appears to be seated.

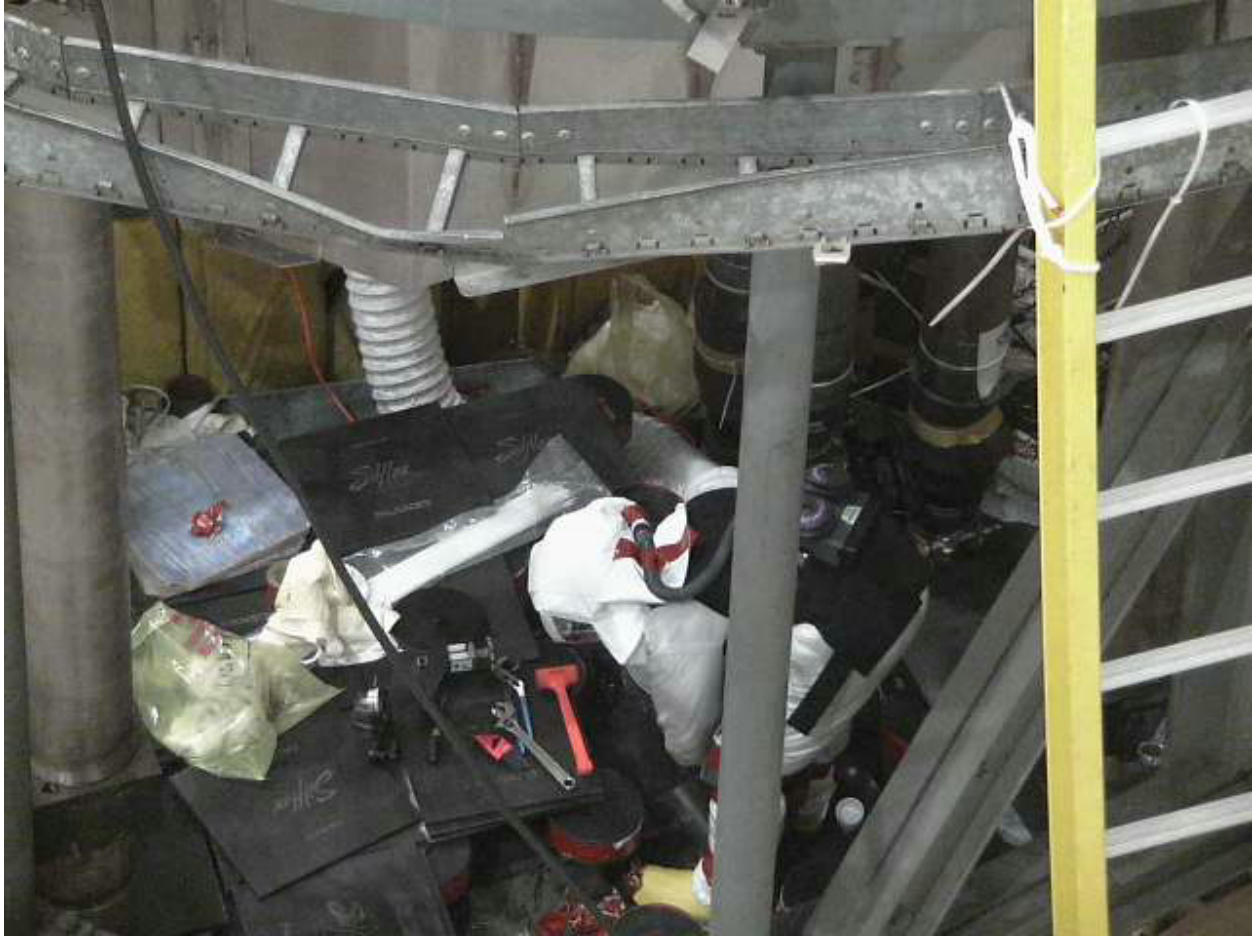
Worker at 5 o'clock wearing a shield vest with a significant gap between the front vest and side back vest and standing.
